# SLATE GROUTING

By Remo Capolino, RRC, PE

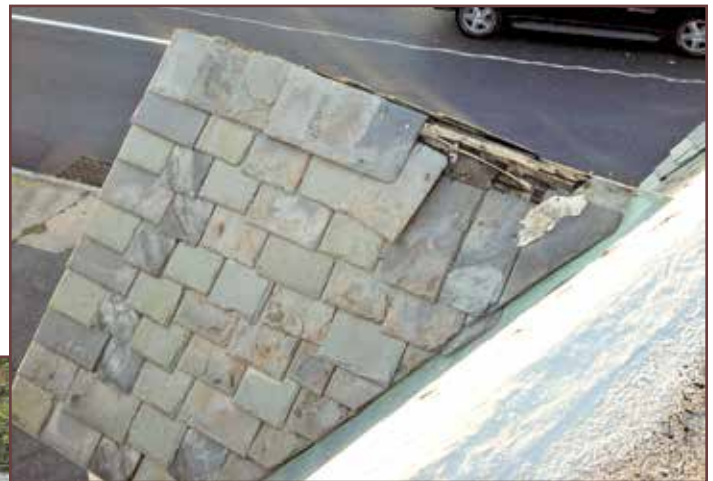
Figure 2 – Areas of slate requiring repair (photo courtesy of SlateSavers).

A one-story commercial building in Mattituck, NY, has a multicolored slate mansard roof with uneven coursing (Figure 1). In 2004, the building owner complained of significant and frequent loss of slates and was investigating the removal and replacement of the slate roof with asphalt shingles. In lieu of removal and replacement with asphalt shingles, the alternative of slate grouting was accepted. Slate repairs were made (Figure 2); ridges, open valleys, and other flashings were coated with a UV-stable reinforced liquid membrane (Figures 3 and 4); and the slate was grouted.

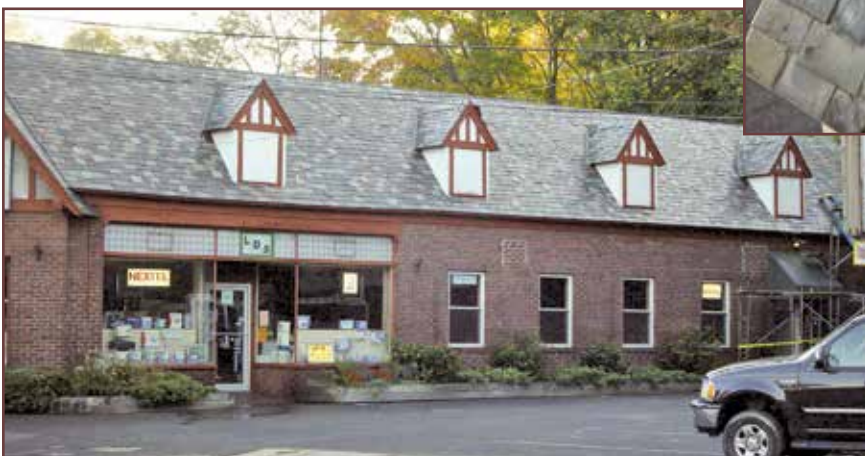
Figure 1 – Overview of varied-color slate roof.

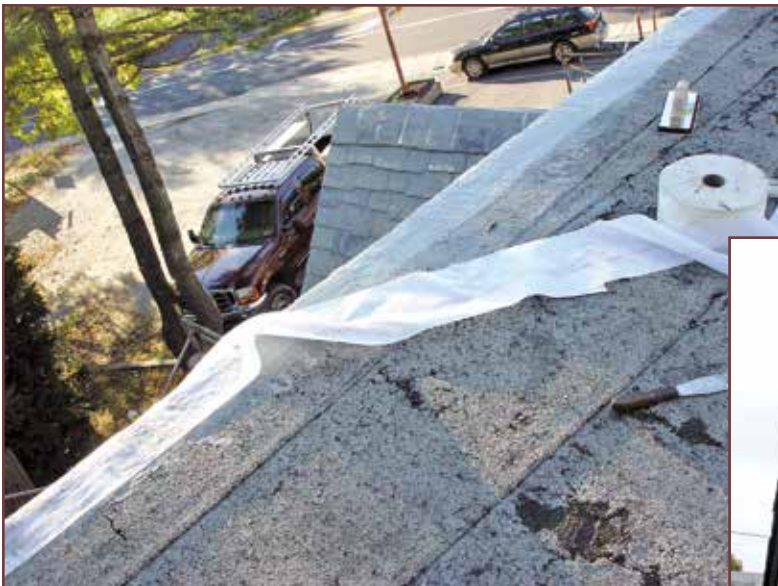
Figure 3 – Installation of reinforced liquid flashings (photo courtesy of SlateSavers).

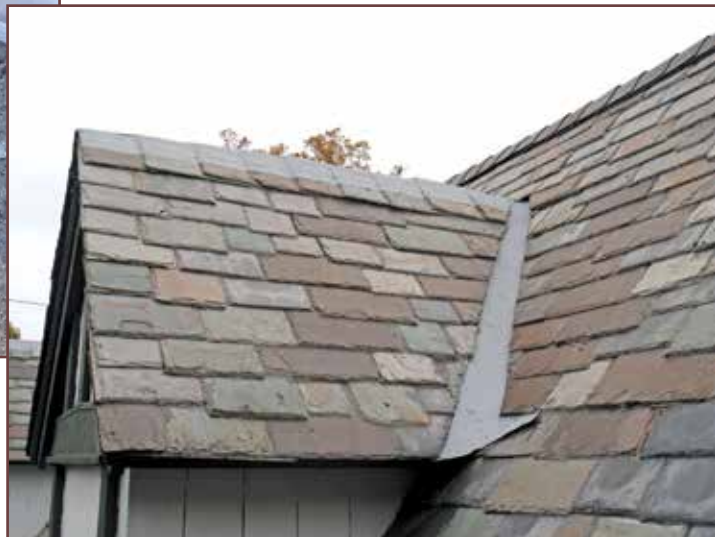
Figure 4 – Installation of reinforced liquid flashings.

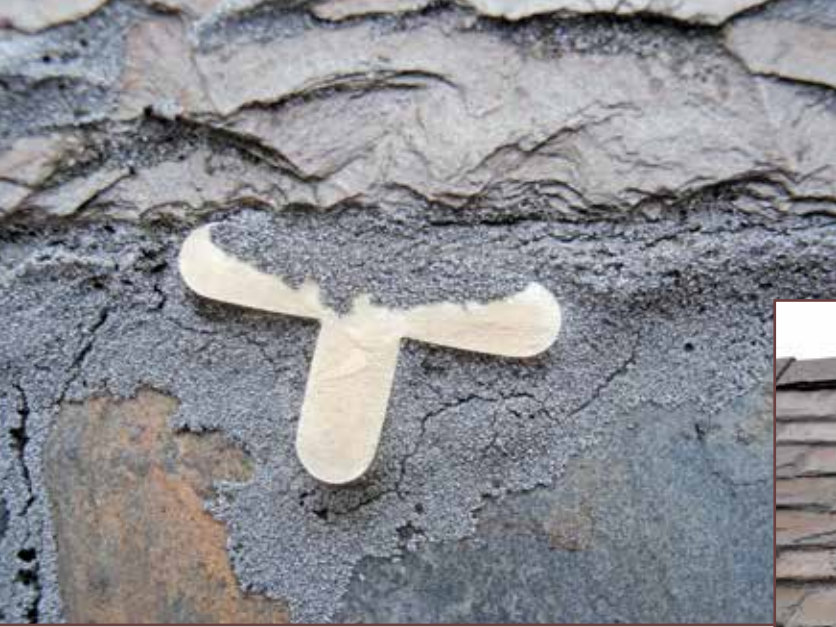
Figure 5 – Slate shim installed low becomes exposed.

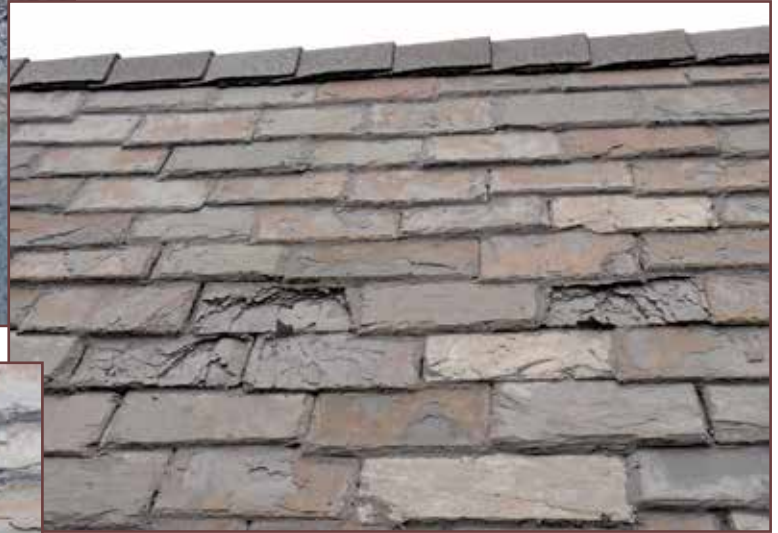
Figure 6 – Overview of freeze/thaw-damaged slate after grouting.

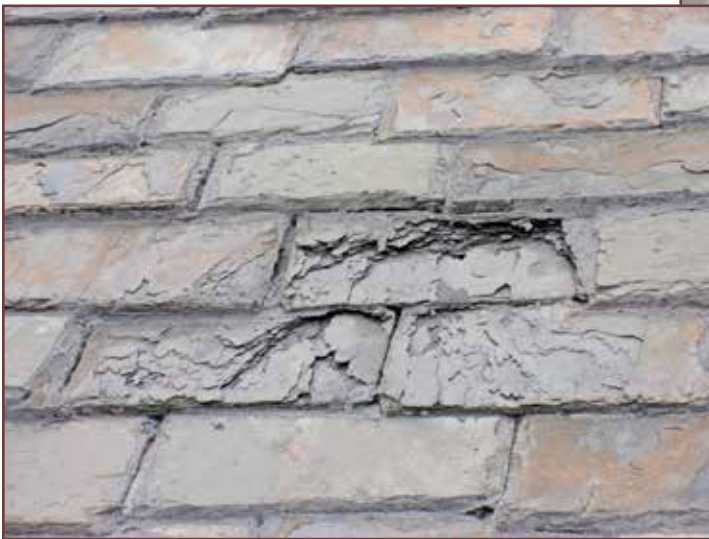
Figure 7 – Close-up of freeze/thaw-damaged slate after grouting.

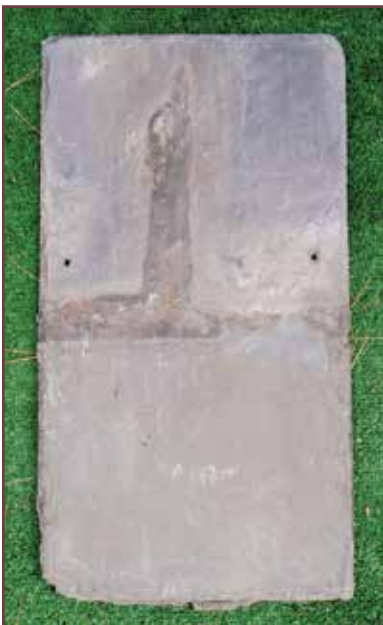
Figure 8 – Depth of penetration of grout injection.

Slates from a grouted roof were removed to determine the depth of penetration of the grout injection. At the observed slates, the penetration of the grout was almost two inches past the edge of the overlying slate (Figure 8). A vertically orientated crack in one slate that effectively left two skinny slates—each attached with a single nail—was observed to have slate grout in the crack and between this slate and the underlying slate. This had effectively glued the broken slate in place, making its removal and replacement unnecessary.

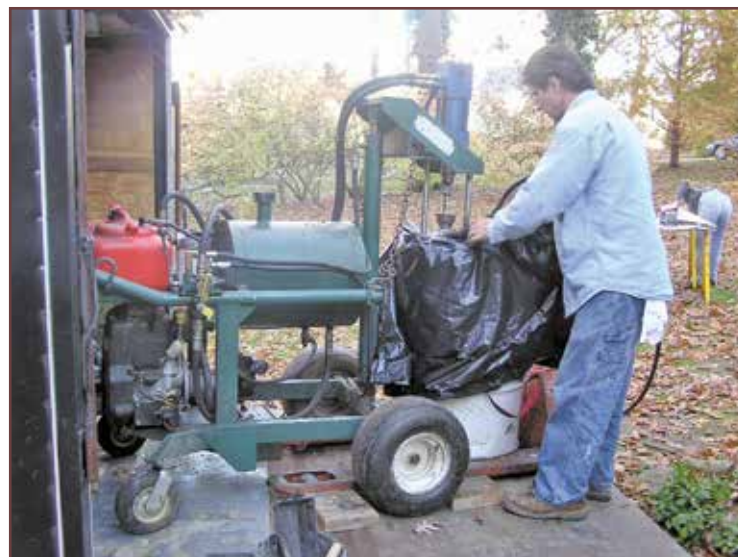
Figure 9 – Airless grout pump.

with a reinforced, UV-stabilized liquid membrane to provide an additional 10 to 20 years of useful service life. Slate grouting was done with the airless pump (Figure 9) and specialized grout-injection nozzle (Figure 10).

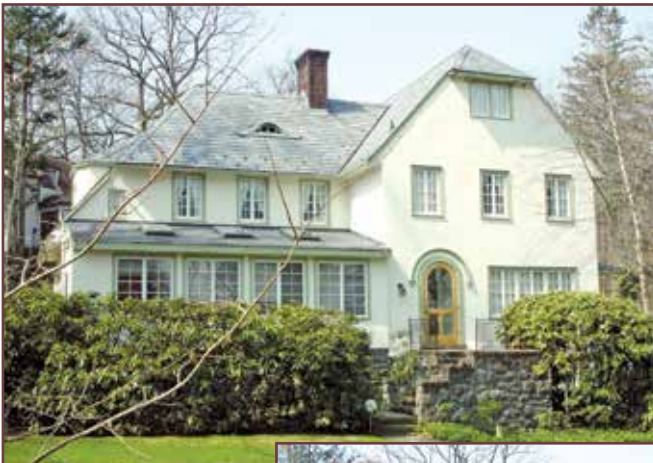
Figure 12 – Overview prior to slate grouting (photo courtesy of SlateSavers).

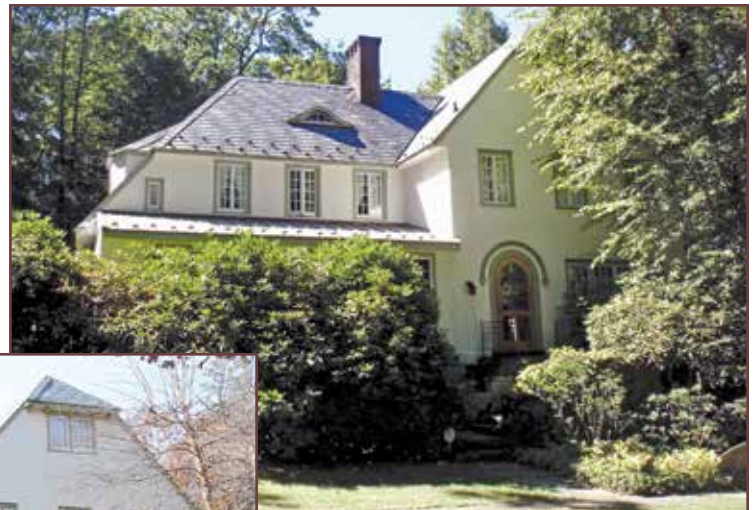
Figure 14 – Overview eight years after grouting.

The building was revisited in September of 2014 and was found to be performing well. Again, the owner indicated that not a single slate has fallen/slipped and that there have been no leaks since the roof was grouted. The overall aesthetics of the slate roof have not been changed, and the grouting material cannot be detected from the ground. Photos of a single elevation before, two years after, and ten years after (Figures 12, 13, and 14) show that to the general public, the installation of the slate grouting is invisible. However, the serious problems of leakage and falling slates have stopped.

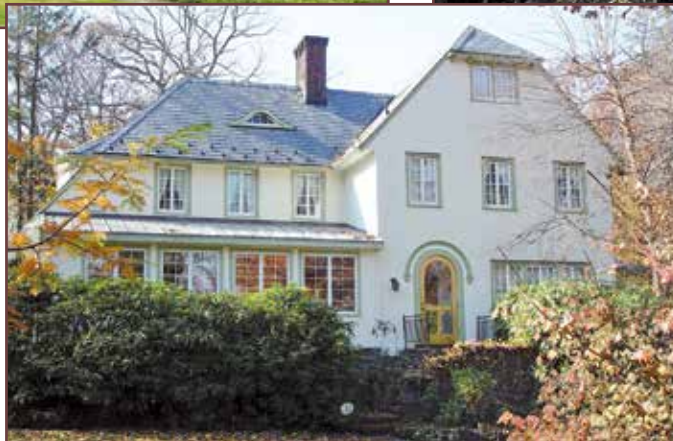
Figure 13 – Overview two years after grouting (photo courtesy of SlateSavers).

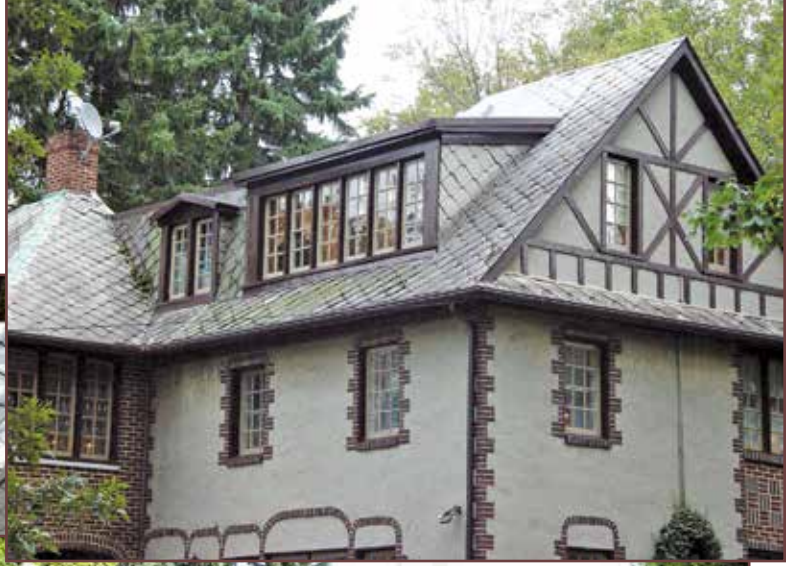
Figure 15 – Grouting of tile roof (photo courtesy of SlateSavers).

The use of this technology is not limited to slate. Tile and asbestos shingles can be grouted with the same/similar benefits being achieved (Figures 15, 16, and 17). After close-up viewing and hands-on examination of the grouted roof after a decade of service, no deterioration of the concealed grout was observed. Since most roof dete-

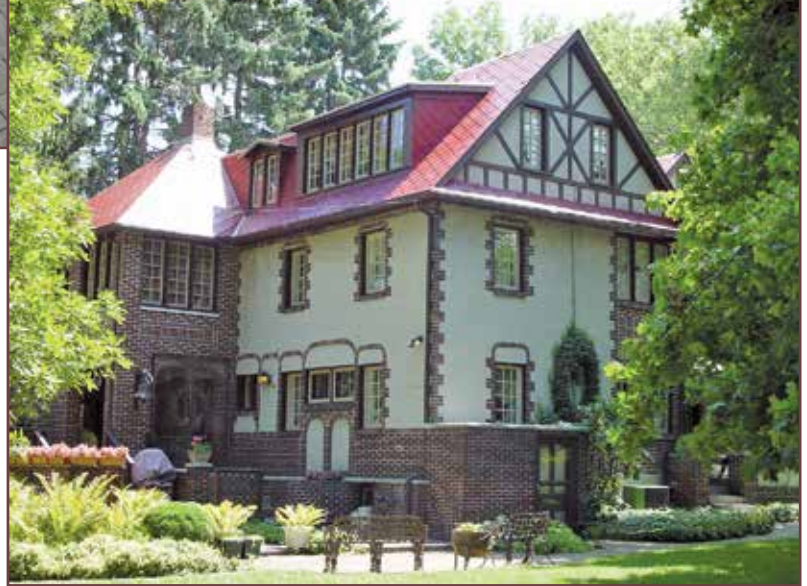
Figure 17 – Overview after tile grouting (photo courtesy of SlateSavers).
