Kimbell Art Museum Expansion

By Keith Simmons, RRO

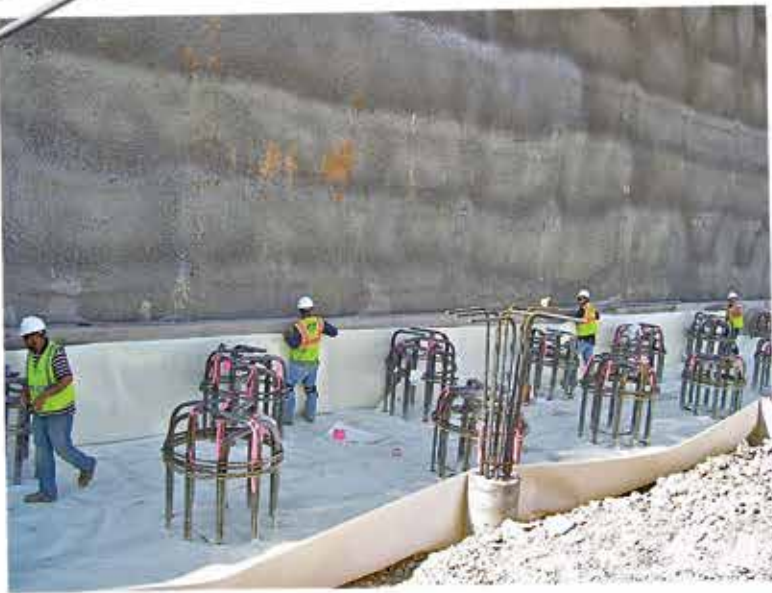
Photo 1 – HDPE waterproofing.

the excavation, high-density polyethylene (HDPE) waterproofing was installed (*Photo 1*). The manufacturer's required seam tape was adhered to the end laps, seams, and flashings to provide a continuous mechanical bond with the concrete cast upon it. Careful inspection of this product was provided by Drytec to supplement the oversight by Beck and the waterproofing subcontractor.

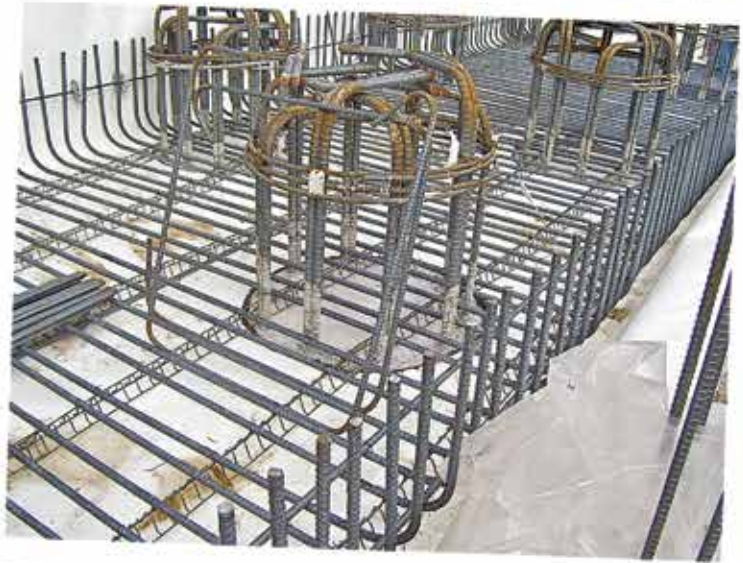
Photo 2 – Steel reinforcing in piers.

needed to carefully fold the waterproofing membrane away from a concrete pour, taking care not to destroy the membrane, which would need to be extended up and above at a later date to tie in with vertical below-grade waterproofing. Careful inspection by all parties also ensured that waterproofing membranes were not punctured during installation of steel reinforcing (*Photo 2*).

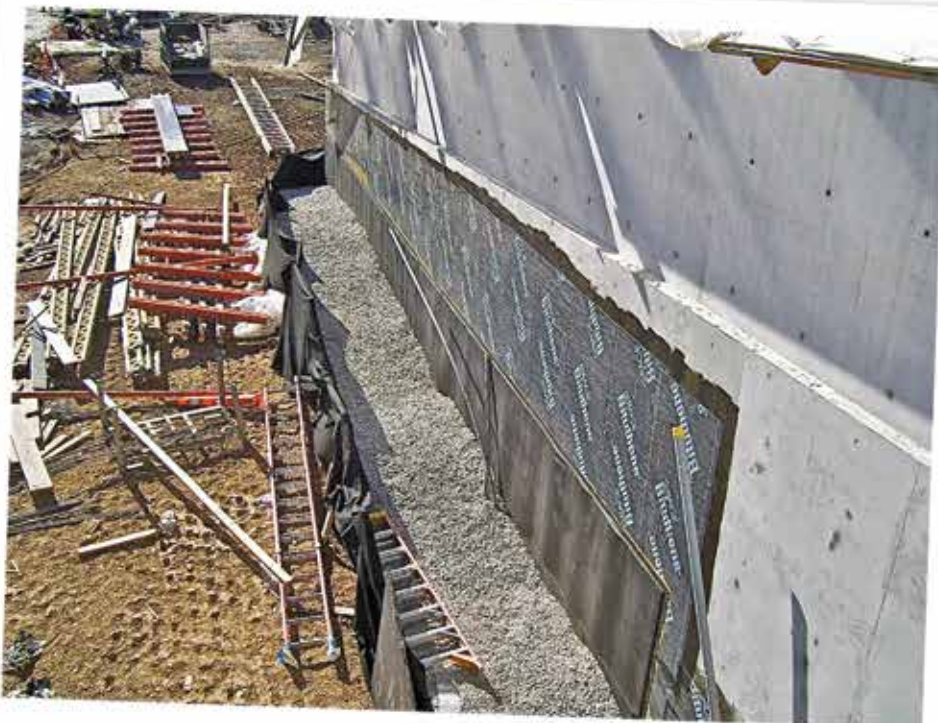
After the below-grade concrete had been properly prepared, the chosen primer was applied to the walls and allowed to dry. After this, a self-adhering waterproofing membrane (*Photo 3*) was fully adhered

Photo 3 – Self-adhering waterproofing membrane.

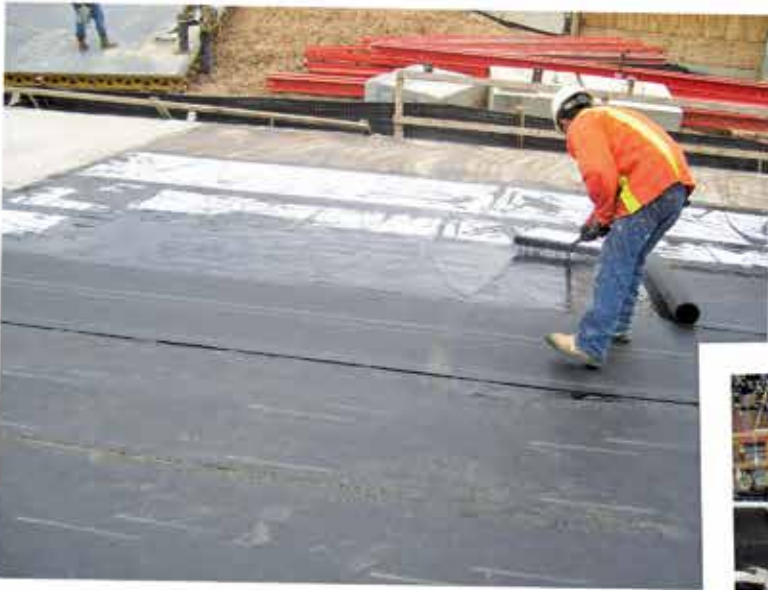
Photo 4 – Modified asphalt with polyester reinforcement.

At the roof level (which is actually ground level), the architect of record chose to install a hot, modified-asphalt system. The concrete decks were primed with an approved material, followed by a hot mopping of modified asphalt with spun-bounded polyester reinforcement embedded in the hot bitumen (Photo 4). The temperature of the bitumen was monitored to meet equiviscous temperature (EVT) criteria during applications. The manufacturer's protection sheet (Photo 5) was hot-mopped as a part of the installation after all surface defects in the concrete were properly addressed.

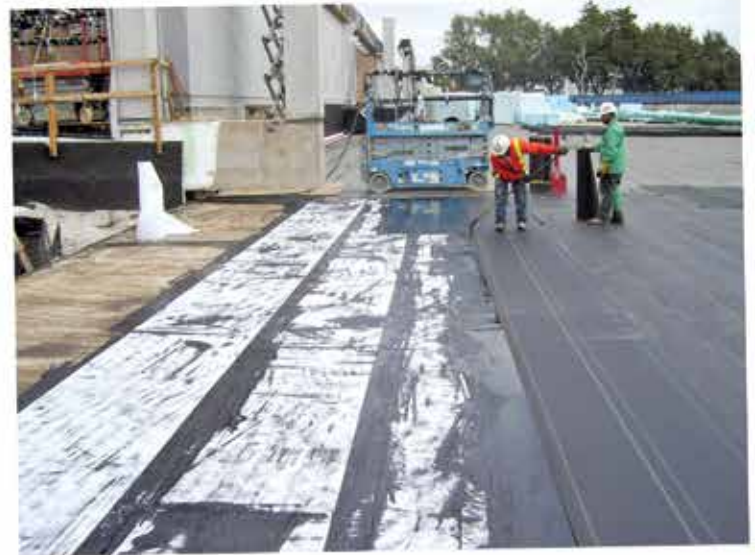
Photo 5 – Protection sheet.

to the walls, with careful oversight being provided as noted previously. Prior to the backfill being installed, a drainage mat and associated protection board were installed.

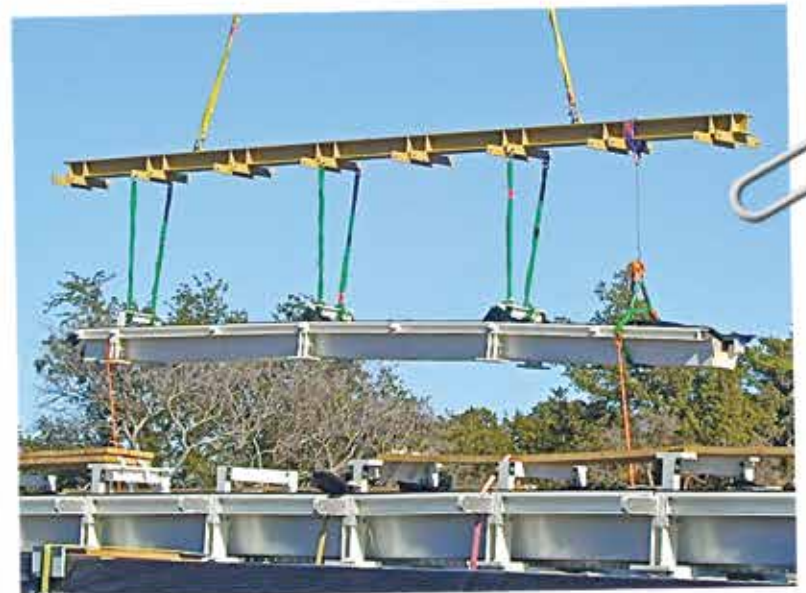
nyl chloride (PVC) cladding (Photo 6) were lifted onto the 100-foot-long Douglas-fir "glue-lam" beams (Photo 7). A series of photovoltaic solar panels are installed in a low-profile sawtooth-monitor fashion. Fritted glass and fabric scrims illuminate

Photo 6 – Common gutters.

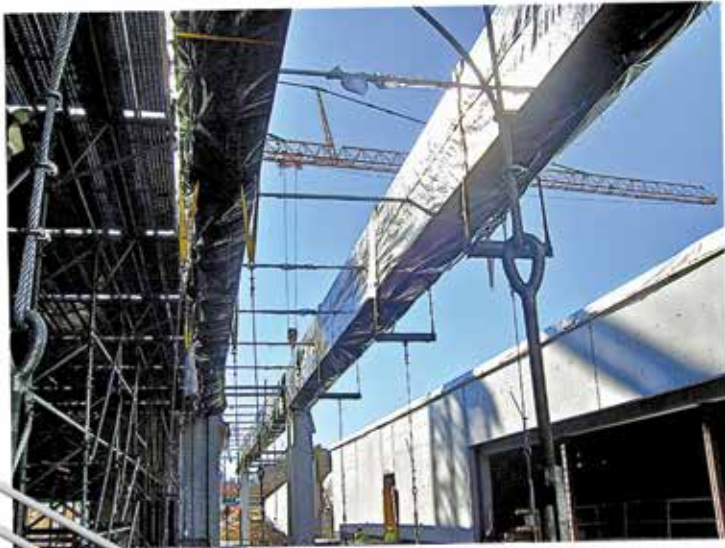
Photo 7 – Douglas-fir “glue-lam” beams.
