ANALYZING INCREASED SOLAR-DRIVEN MOISTURE THROUGH TWO RAIN-WETTED CLADDING ASSEMBLIES

By Lonnie Haughton, MCP, LEED AP, CDT

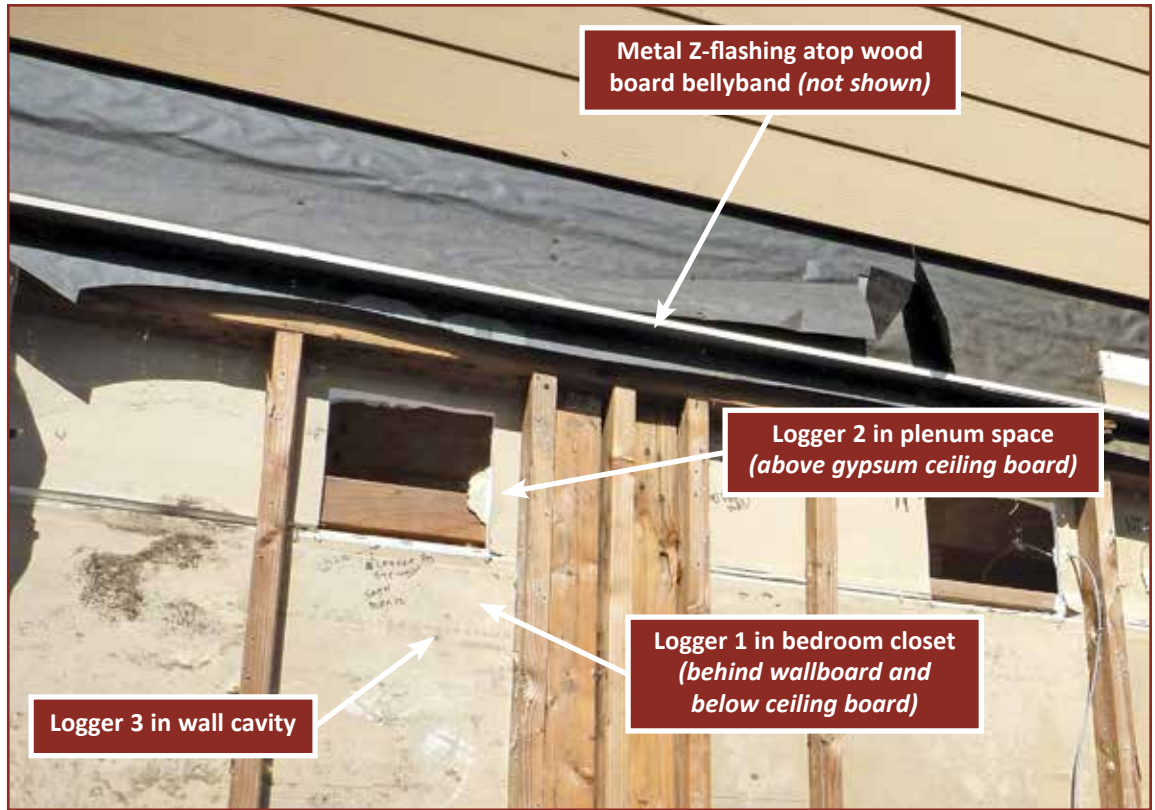
Photo 2 – Parallel wall: At buildings with fiber-cement lap siding, wood board bellybands (not seen in photo) below metal Z-flashings were installed at the rim/plenum transitions.

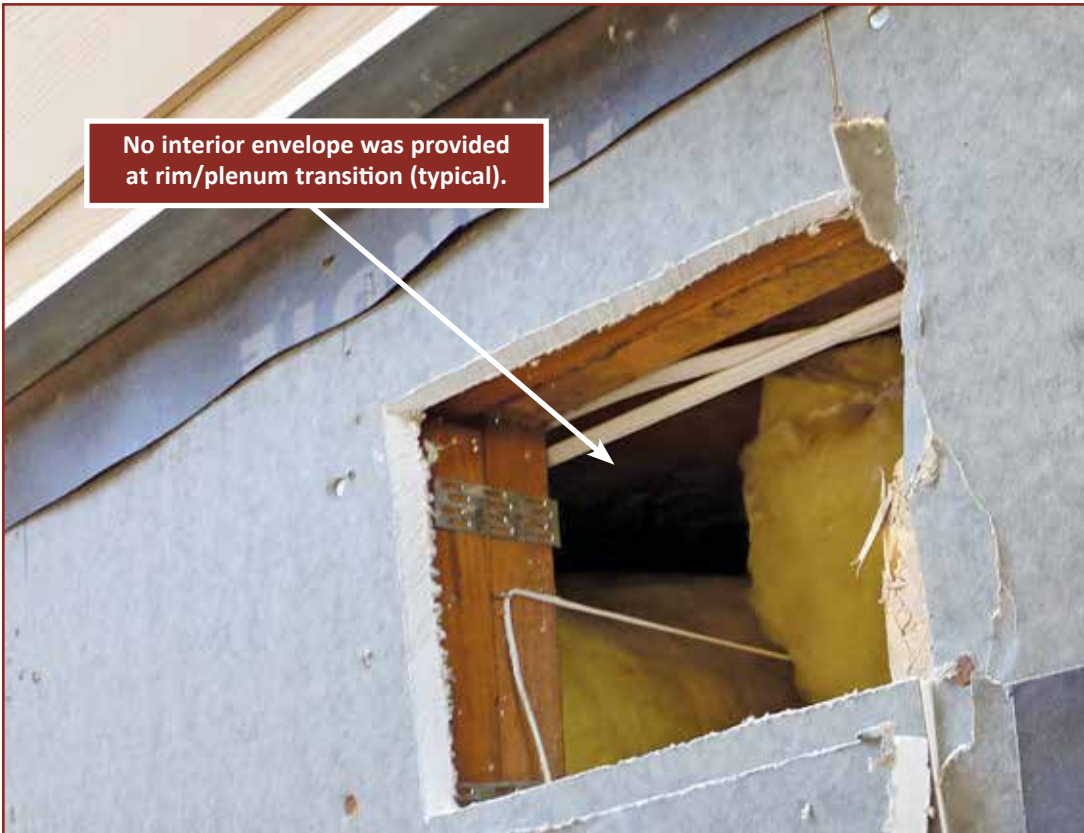
Photo 4 – Perpendicular wall (siding): Plenum space above drop ceiling terminates at inside face of the exterior gypsum sheathing behind the wood board bellyband and the fiber-cement siding.

4. This demonstrated again that the source (and route) of the increased moisture above the ceiling was solar-driven migration through the perpendicular wall (*Photo 4*) where the absence of an interior envelope had created the path of least resistance.

16. It is worth noting that the solar-heated moisture being pushed through these open rim/plenum transitions would be substantially diminished if an engineered wood sheathing had been installed behind the stucco (see *Photo 3*) and the fire-rated fiber-cement lap siding system (see *Photo 4*).

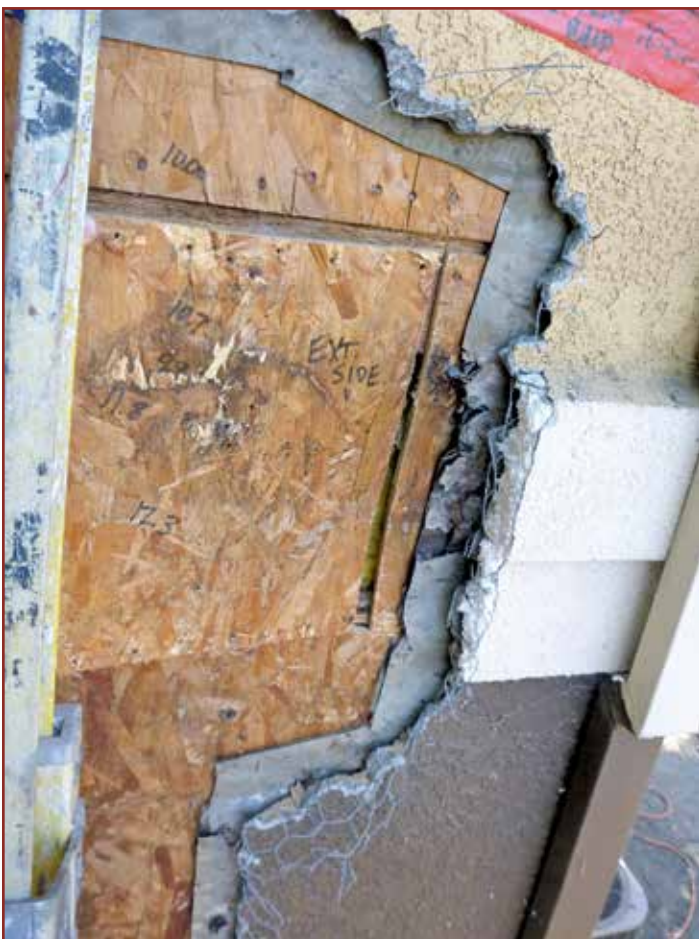
Photo 5 – Perpendicular wall: Typical EPS foam bellyband at rim/plenum transition provides aesthetic relief between lower and upper floors. (At building corners, stucco is installed to OSB shear panels).

Typical for mass-produced housing projects here in California, certain portions of the stucco cladding were installed over OSB shear panels (Photos 5 and 6); but for most of the stud bays, the building paper serving the stucco was backed only by steel “line wires,” per Photo 1.

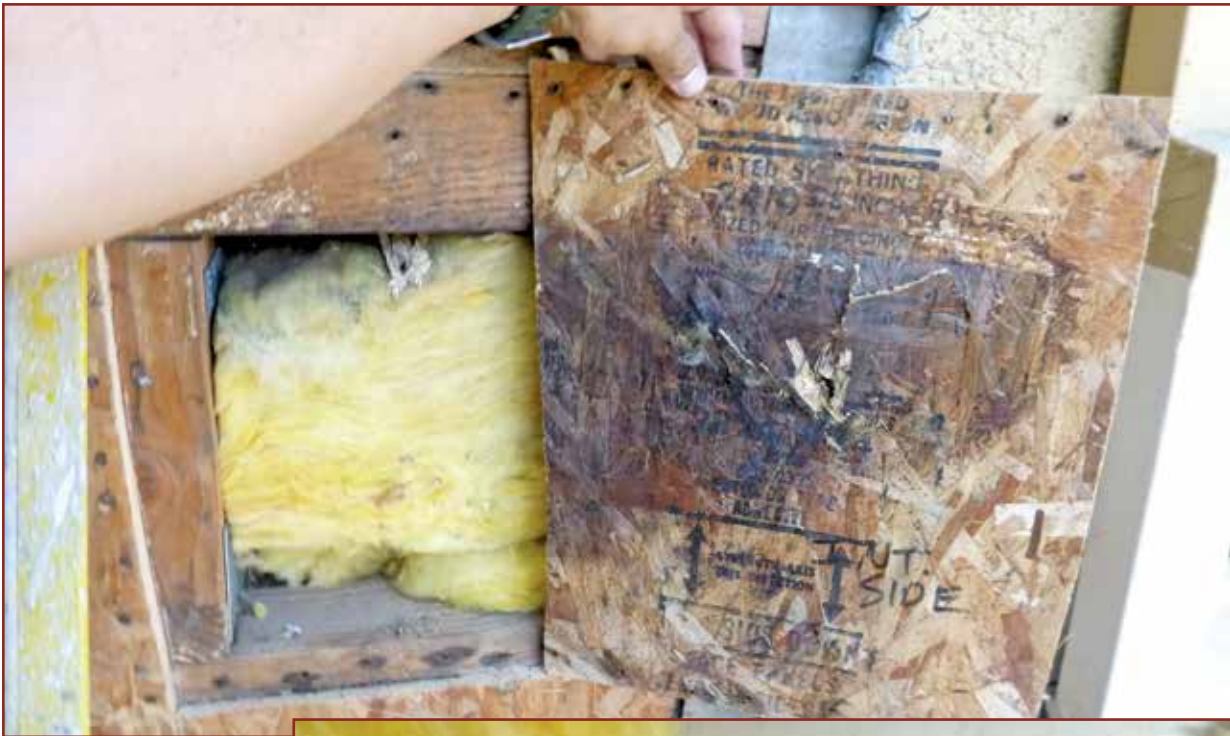
Photo 6 – Perpendicular wall (stucco): No interior envelope was provided at the rim/plenum transition.

A key goal of our testing program was to evaluate potential sources of the excess water vapor and related condensation damage (e.g., Photos 6 and 7) observed at the rim/plenum transitions.⁴

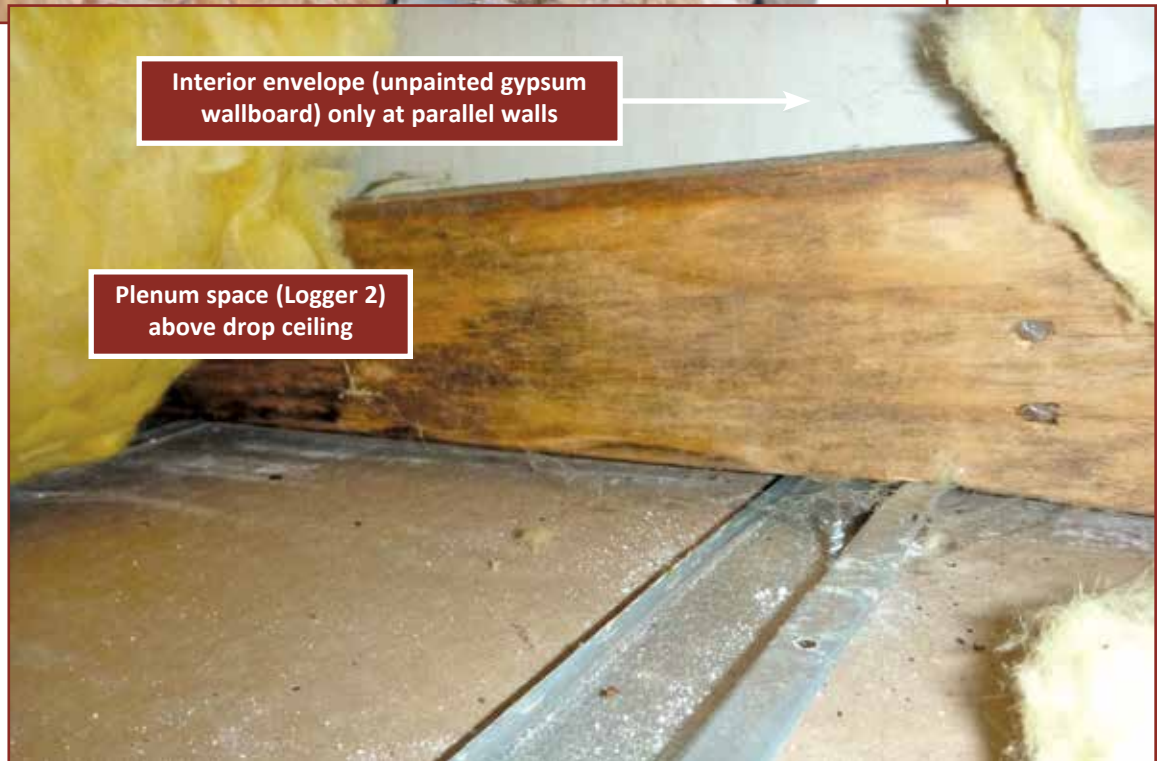
Photo 7 – Typical closet ceiling and interior envelope at parallel wall. At all apartments, the drop ceilings are constructed from gypsum board panels hung from steel resilient channels.

3. Further, because the daily rise of the heating phases at the green line occurs approximately one to two hours later than at the red line (even though these two data loggers are only inches apart), the unpainted gypsum wallboard (see Photo 7) above the drop ceiling also served to satisfactorily retard the daily drives of solar-driven moisture.

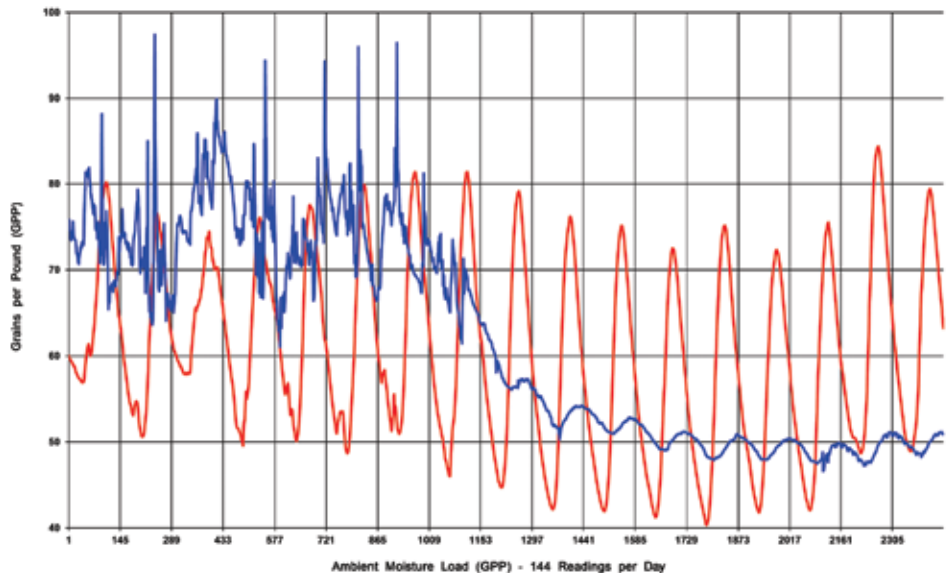
1. The tenants had moved out of the apartment by Day 8, as documented (per the blue line) by the dramatic decline of ambient moisture measured by Logger 4.
2. More importantly, as indicated by the red line, daily cycles of increased/decreased levels of ambient moisture occurred within the exterior wall (Logger 3) in direct correspondence to solar heating and nighttime cooling.

Graph 1 – Unit B: The blue line tracks ambient moisture ratio (GPP) at interior Logger 4, while red line records exterior wall cavity (Logger 3) – 144 readings per day for 17 days (starting at 12:00 a.m.).

Further, this investigation and similar recent datalogger testing by our firm indicate, as evidenced by *Graph 1*, that diffusion (due to vapor concentration differentials) into exterior walls of occupant-produced “lifestyle” moisture generally is far less likely to cause damage than is convection (via air pressure differentials) of humid interior air into exterior walls due to unsealed gaps and voids. As noted within ASTM International’s *Manual 18, Moisture Control in Buildings: The Key Factor in Mold Prevention*, “Requiring careful moisture management by the occupant is no substitute or excuse for inadequate moisture-resistant design.”¹⁷

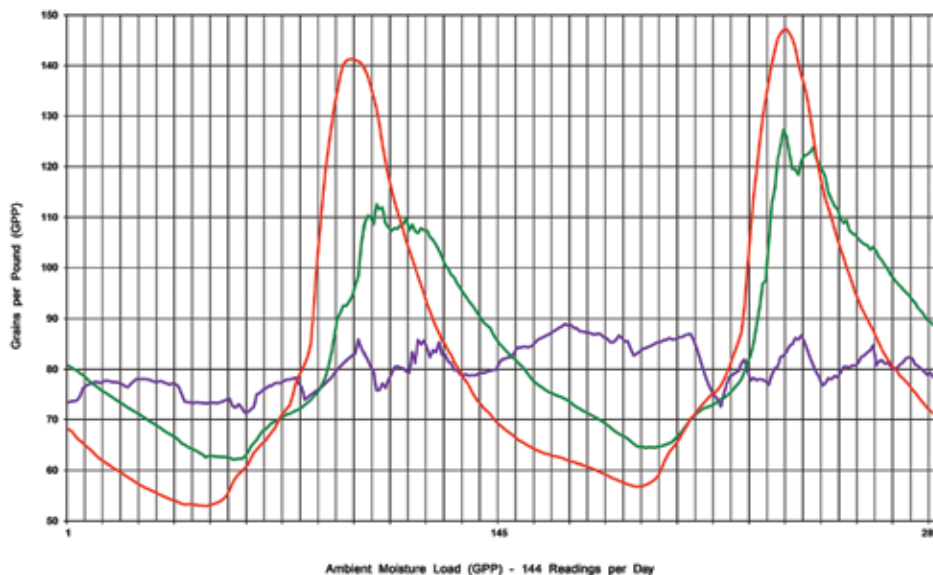
Graph 4 – Unit F (stucco, parallel wall): Purple line records GPP ratio in closet; green line records plenum; and red line records exterior wall (144 readings each for days 14 and 15, starting at 12:00 a.m.). Every vertical line on this graph corresponds to one hour.

1. The closely similar, cyclic shapes of the red line (exterior wall, Logger 3) and green line (plenum space, Logger 2) again prove that the daily cycles of increased/decreased moisture within the ceiling cavity correspond to solar heating and nighttime cooling of the rain-wetted stucco walls.¹²

2. However, because the greatly dissimilar shape of the purple line (bedroom closet, Logger 1) is not consistent with direct solar heating, the interior envelope—typical painted gypsum wallboard—at this apartment has, to a great degree, resisted and tempered the daily pushes of solar-driven moisture.

4. Therefore, the most likely source (and route) of these daily increases in ambient moisture above the ceiling was the opposite perpendicular wall (Photo 3), where the absence of an interior envelope had created the path of least resistance.

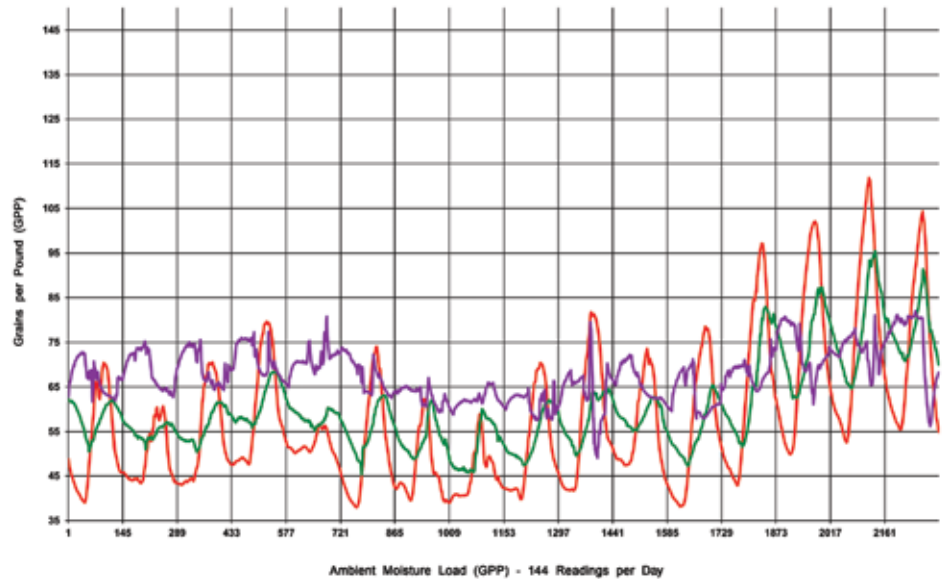
reference the weather matrix at *Figure 1*) similarly produced strong increases in average moisture content at Logger 2 (plenum = green line = 24.2%) and logger 3 (exterior wall cavity = red line = 31.8%).

And again, the data from Logger 1 (closet = purple line = 6.1% increase) and kitchen Logger 4 (6.7%, not graphed) indicated that solar heating (from the same stud bay) of the wetted siding below the rim had not greatly impacted humidity levels within the occupied rooms. Then, to better confirm this analysis, we reviewed data (per *Graph 6*) from the hottest days (Days 14 and 15) of this testing period.

Graph 5 – Unit G (siding, parallel wall): Purple line records GPP ratio in closet, green line records plenum, and red line records exterior wall – 144 readings per day for 16 days (starting at 12:00 a.m.).

Note also that comparing *Graphs 3* and *4* (stucco: south-facing parallel wall at Unit F) with *Graphs 5* and *6* (lap siding: north-facing parallel wall at Unit G) reveals highly different shapes for the moisture cycles being recorded at the two red lines. At *Graphs 3* and *4*, we see high, steep, and narrow spikes of increased vapor on hot, sunny days, while the corresponding red line cycles at *Graphs 5* and *6* tend to be flatter and wider.

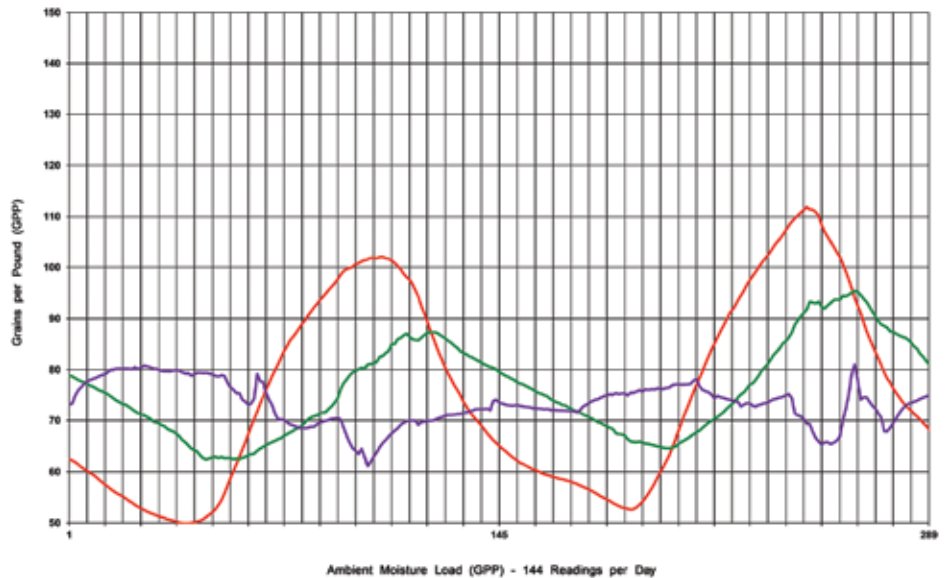
1. The generally similar shapes of the red line (Logger 3) and green line (Logger 2) again demonstrate that the daily cycles of increased/decreased moisture within the ceiling cavity corresponded to solar heating and nighttime cooling of the wetted siding assembly.

2. Again, because the generally dissimilar shape of the purple line (Logger 1) is inconsistent with direct solar heating of the occupied spaces, the interior envelope (painted wall-board) had resisted and tempered the spikes of solar-driven moisture.

Graph 6 – Unit G (siding, parallel wall): Purple line records GPP ratio in closet; green line records plenum; and red line records exterior wall (144 readings each for days 14 and 15, starting at 12:00 a.m.) Every vertical line on this graph corresponds to one hour.

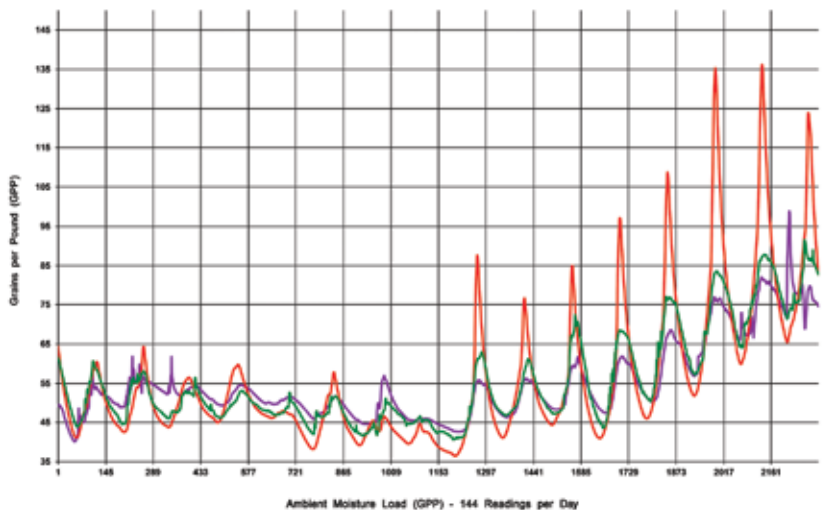
Graph 9 – Unit H (siding, perpendicular wall): Purple line records GPP ratio in closet, green line is plenum space, and red line is exterior wall – 144 readings per day for 16 days (starting at 12:00 a.m.).

Finally, *Graph 9* for the south-facing perpendicular wall at Unit H (also clad with fiber-cement) again showed large increases in average moisture content at all four loggers: Logger 1 (bedroom closet = purple line = 31.2%), Logger 2 (plenum = green line = 39.4%), Logger 3 (exterior wall cavity = red line = 49.6%), and also kitchen/bathroom Logger 4 (25.4% – not graphed).

And yet again, close correspondence between the shapes and timing of the purple and green lines during the final five days demonstrated that solar heating of the rain-wetted perpendicular walls (all of which lacked an interior envelope at rim/plenum transitions, per *Photos 3* and *4*) had driven moisture directly into the occupied bedroom and the plenum cavity above.

After review, we concluded that these seemingly “early” spikes of moisture at this south-facing perpendicular wall at Unit H represented the expected effects of direct heating of atypically high amounts of trapped moisture within the wall assembly—very likely due to rainwater leakage behind the wood bellyband boards.¹³

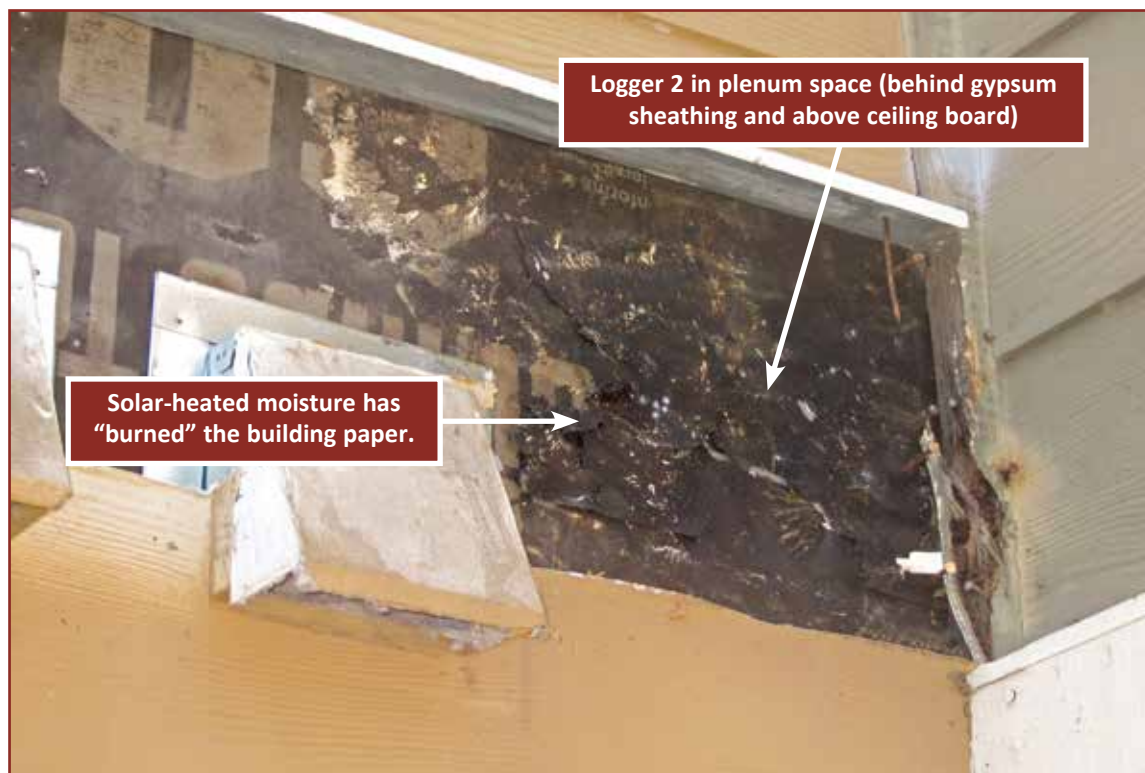
Photo 9 – Rainwater infiltration at nonsealed joints and transitions at metal Z-flashings has led to increased levels of solar-driven moisture migration through the exterior walls (see Graph 9).

15. Building envelope investigators in climate zones that experience alternating periods of rainy and sunny weather will encounter the conditions seen in *Photo 9*, where wetted areas at asphaltic building papers exhibit a pattern of deterioration visually consistent with having been burned. Clearly, such damage results from solar heating of rainwater infiltration trapped behind the cladding or siding.
