# NIGHTMARE ON CEDAR STREET

By Lynne Christensen

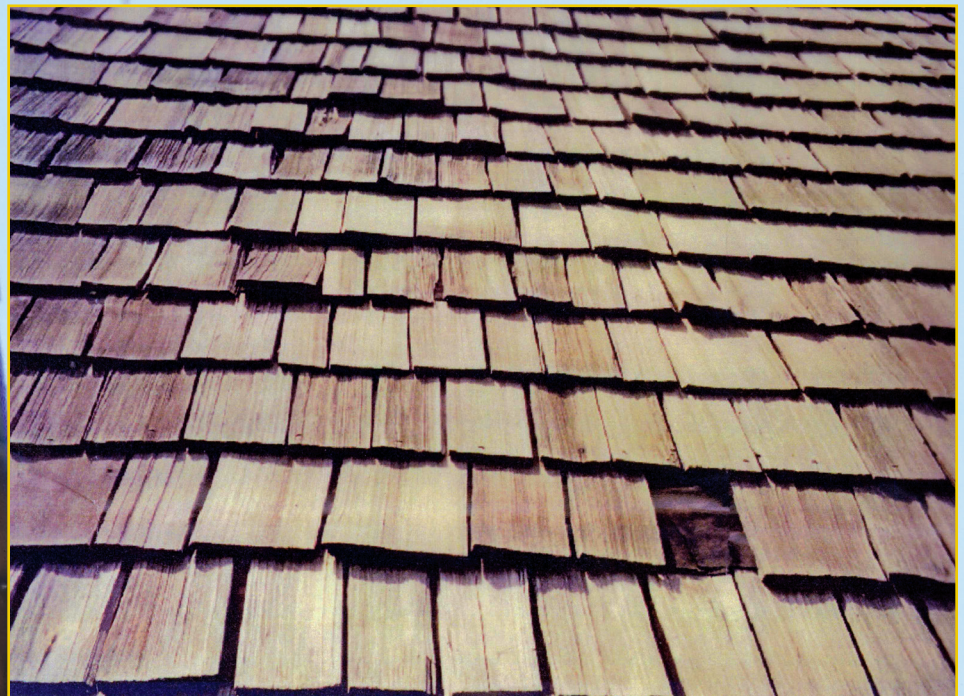
Photo 1 – Rot-felted application where felt paper has started to degrade following UV exposure.

works with the system, not as a stand-alone item. Rot felt will also wick unwanted moisture up into the roof system (See *Photo 1*). In the same nasty vein, Ralph the Rotfelter likes to interlay cedar shingles with felt; this practice is not recommended by the CSSB. Interlay shakes, yes; shingles, no.

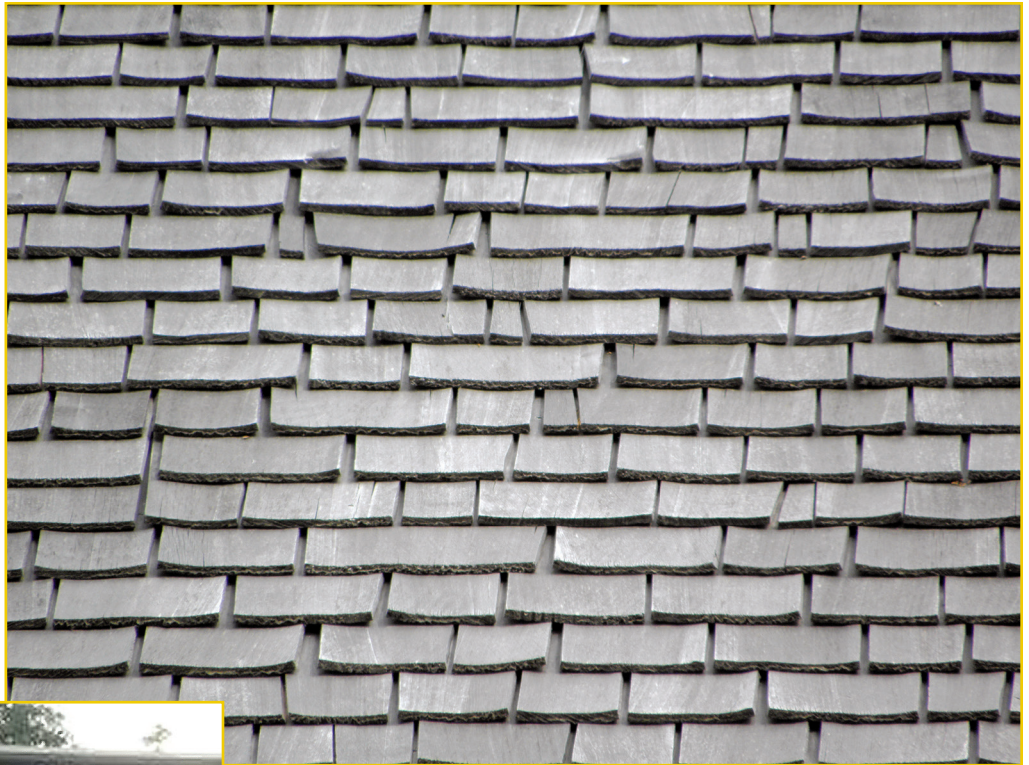
*Photo 3 – Nonpermeable membrane used beneath shingles across entire roofing deck.*

Izzy's a busy guy. With six jobs on the go, he wants a way to make everything watertight so he can bounce his crew from jobsite to jobsite, thus simultaneously juggling many projects on the go. His "solution" is to cover all his roofing decks with an ice dam barrier-type membrane, making it impervious to weather while all the jobs are in progress. This may prove good for crew assignment efficiency, but it is a moisture-barrier practice that wreaks havoc on cedar roofs. Cedar shakes and shingles need to breathe, and a nonpermeable membrane will cause the shakes or shingles to overheat and trap moisture behind the cedar shakes or shingles, thus harming the roofing system's integrity. Some examples of nonpermeable membrane issues are seen in Photos 2, 3, 4, and 5.

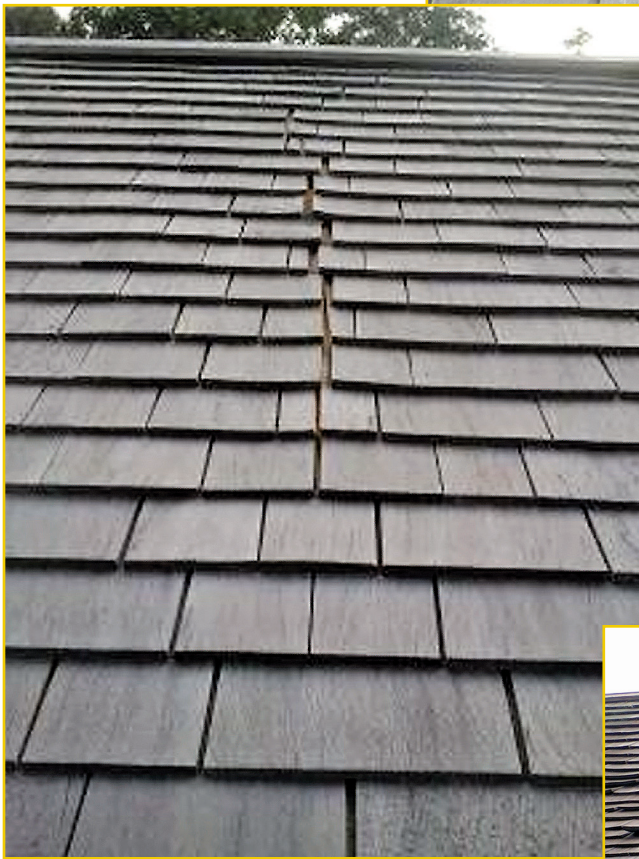
*Photo 4 – Note how shingles have split due to moisture problems caused by installation of nonpermeable membrane across entire deck. Photo 3 and Photo 4 show two more examples of product lifting, curling, and splitting due to improper usage of nonpermeable membrane across the entire roof deck.*

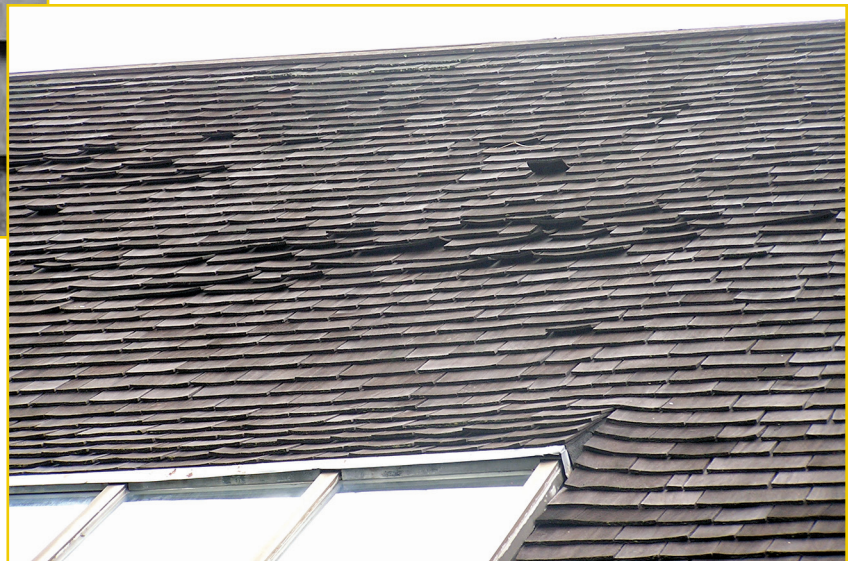
*Photo 5 – Example of product lifting and curling due to installation of nonpermeable membrane across entire deck.*

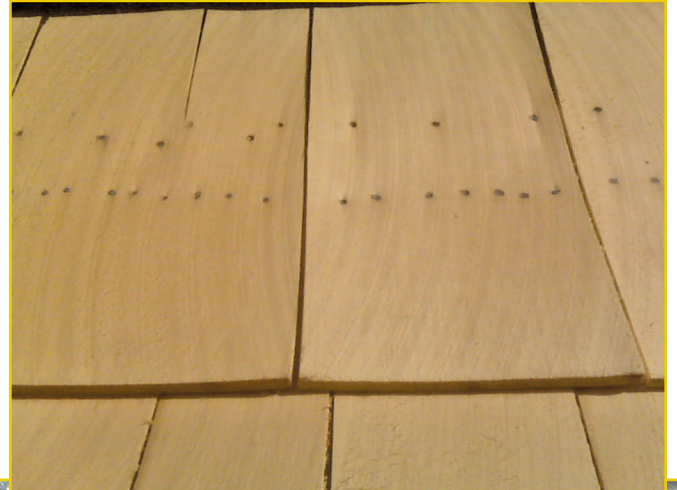
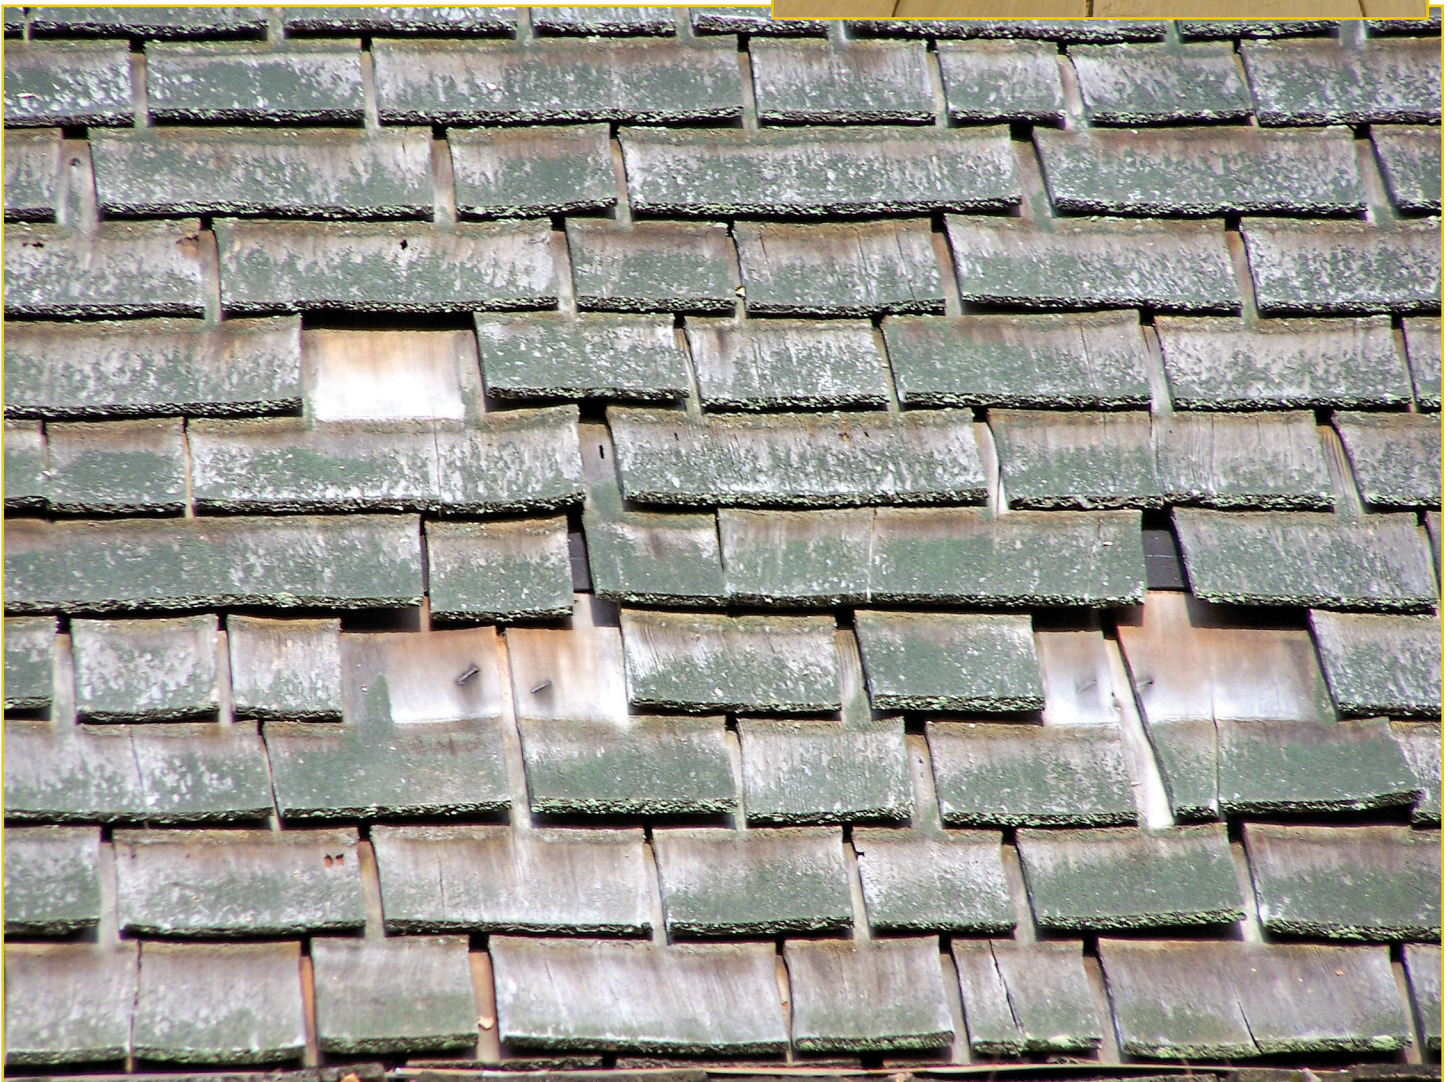
*Photo 7 – There are excessive fasteners on this application. Note the split on the top left product due to excessive fastener application.*

*High-pressure pneumatic tools can make it tempting to add in extra fasteners, but excessive fasteners will inhibit dimensional change, causing splitting and/or distortion of the shake or shingle.*

corrodes a few years after installation, and the wood roofing product gets blamed because the fasteners have failed. Freddie has struck again. For examples of fastener issues, refer to *Photos 6, 7, 8, 9, and 10*.

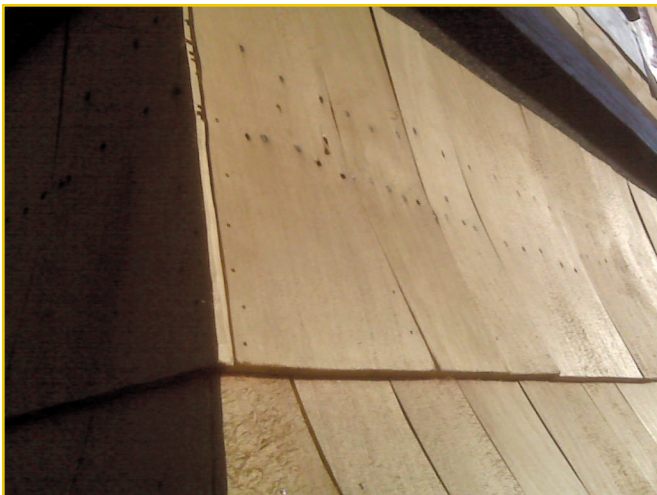
Photo 8 – Far too many fasteners on this application.

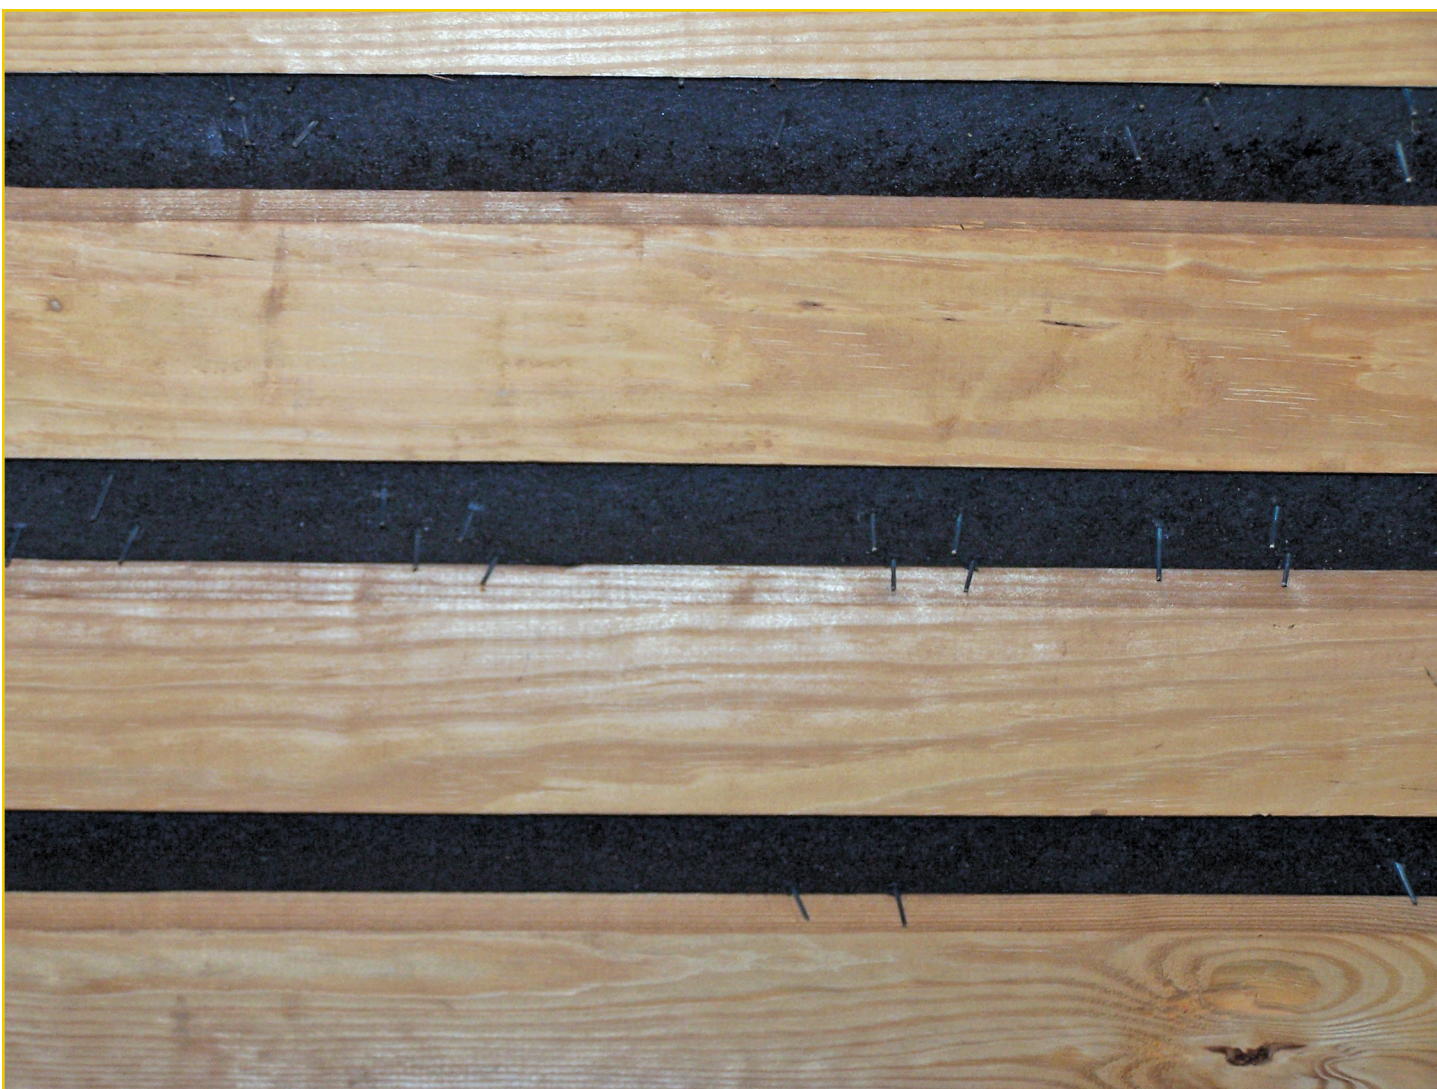
Photo 10 – Incorrect fastener application – nailing into air and missing the sheathing boards. The holding power of these fasteners is nil.

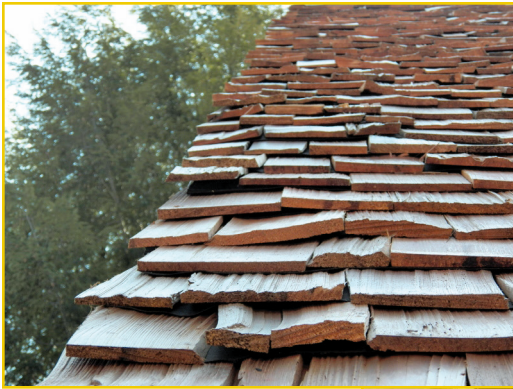
*Photo 11 – This photo shows an improper application. Some of the issues we see here are excessive flat-grain, off-grade material, lack of keyways, and uneven courses.*

in installations as seen in *Photos 11* and *12*. Again, the CSSB makes it easy to learn with this informative brochure about product quality: <http://www.cedarbureau.org/green-products/supporting-documents/product-specification-sheets.asp>.

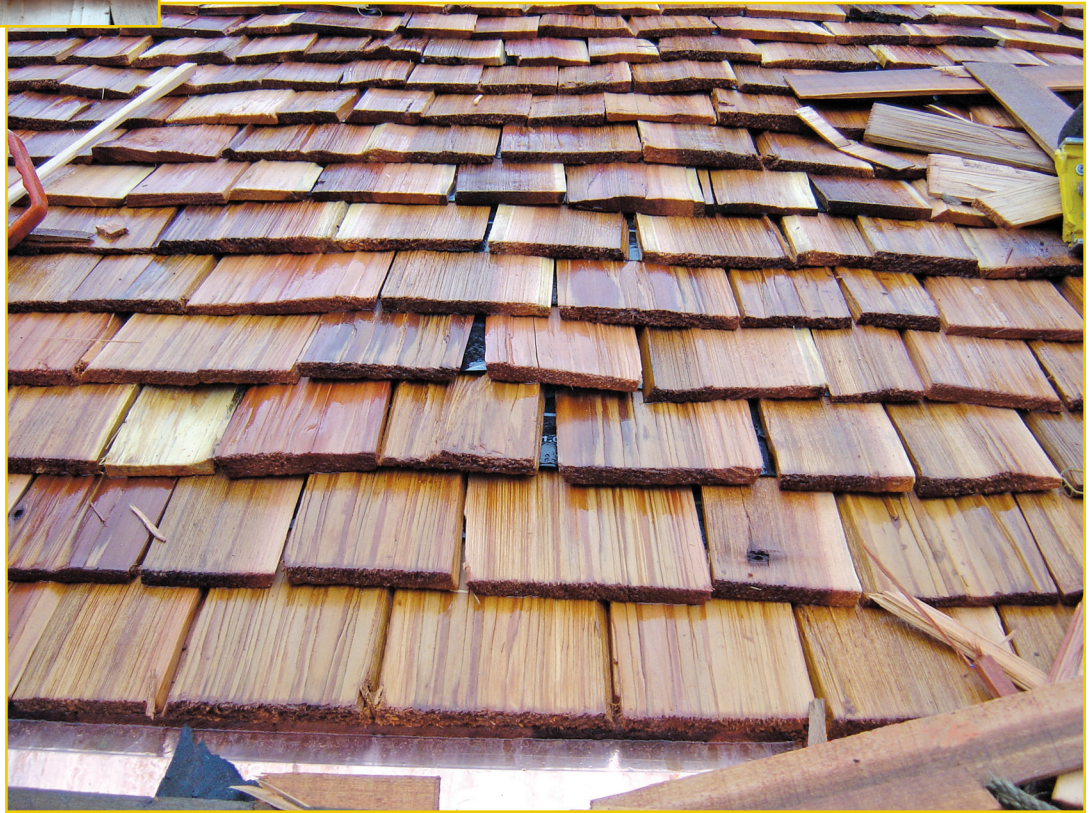
*Photo 12 – Rot felting: Ice dam barrier-type product was used for interlayment. Keyway issues and off-grade product are seen here (note excessive flat grain, sapwood, and the knot in near butt end in second course from eave.)*

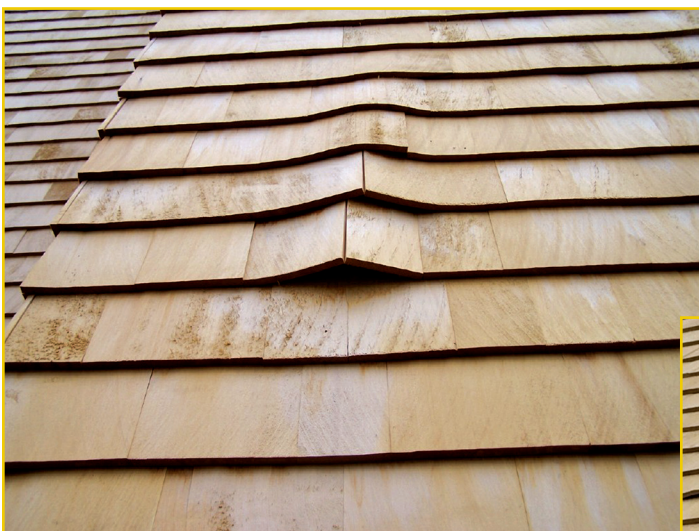
*Photo 13 – Buckling due to improper keyway spacing.*

The CSSB's installation guide provides correct keyway spacing guidance for both roofing and sidewall products. The International Residential Code states "wood shakes or shingles shall be installed according to this chapter and the manufacturer's installation instructions." It is indeed amazing to see examples of projects gone awry due to keyway issues (see *Photos 13* and *14*); the information is readily

available, and all the contractor needs to do is access, call, or email the CSSB. With cedar being a natural product, moisture entering and leaving the shake or shingle will cause expansion and contraction; proper keyway spacing accommodates this natural phenomenon.

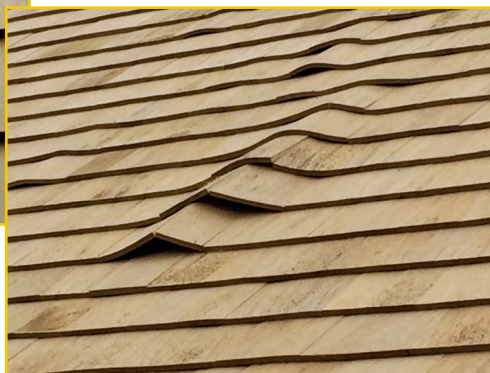
*Photo 14 – Buckling due to improper keyway spacing.*

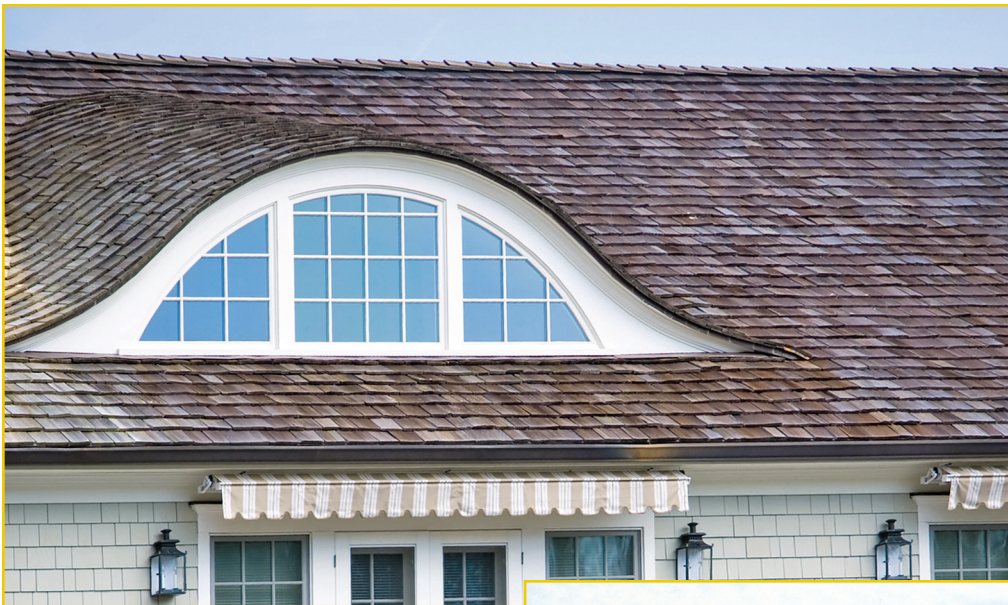
Photo 15 – Courtesy Western Wood Products. Photo by John Spaulding.

as a plausible defense, reason, or explanation. Point to the facts and use the CSSB’s informative literature to help with your next project. Homeowners, architects, builders, and consultants all appreciate a job done right. See Photos 15, 16, and 17 for examples of beautiful craftsmanship.
