# Evaluating Water Leakage in Mass Masonry Walls

By Patrick Reicher, REWC, SE, CCS, CCCA,  
and Kami Farahmandpour, FRCI, REWC, RRC, RWC, RBEC, PE, FNAFE, CCS, CCCA

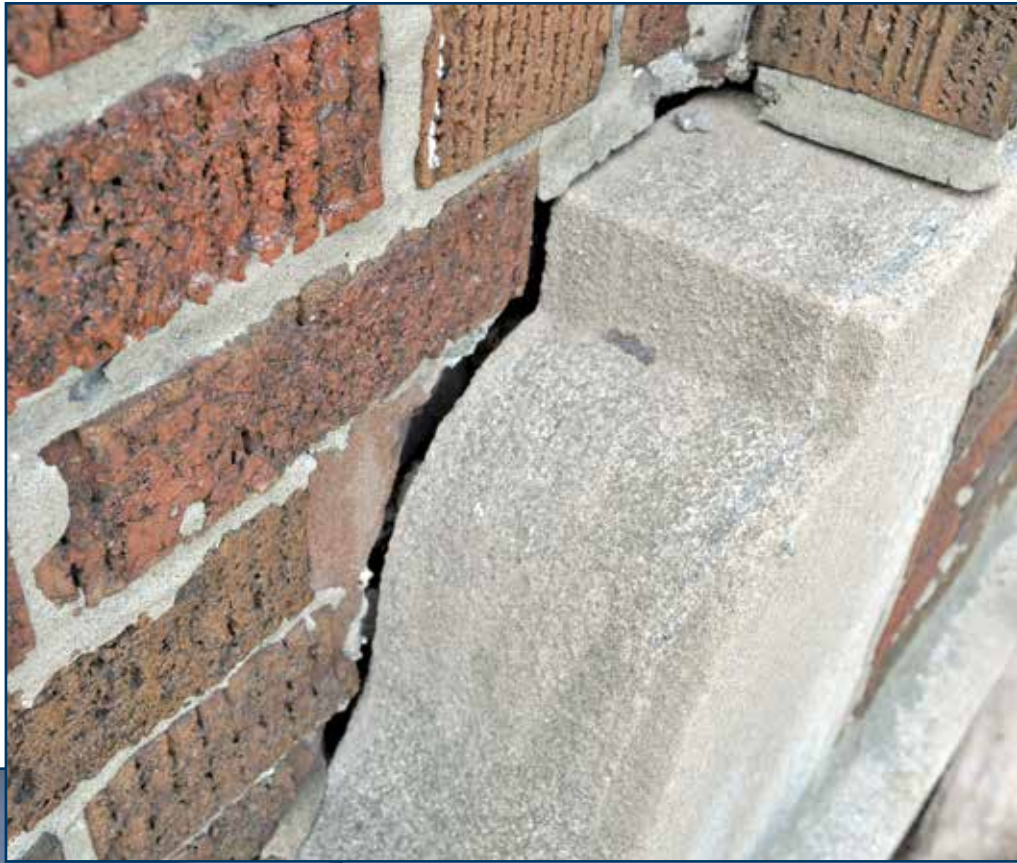
*Photo 1 – Open mortar joint between limestone and brick masonry provides a path for water penetration beyond the exterior wythe of masonry.*

1. The condition of mortar joints on the exterior face of the walls greatly impacts the quantity of water that is shed versus that absorbed into the walls. Mortar joints that bond well to masonry units typically serve to reject most of the water that contacts the exterior face of the walls. However, cracked and/or open mortar joints will provide a path for water penetration beyond the exterior wythe of masonry (*Photo 1*). For several reasons, the mortar and masonry units cannot be made completely watertight.

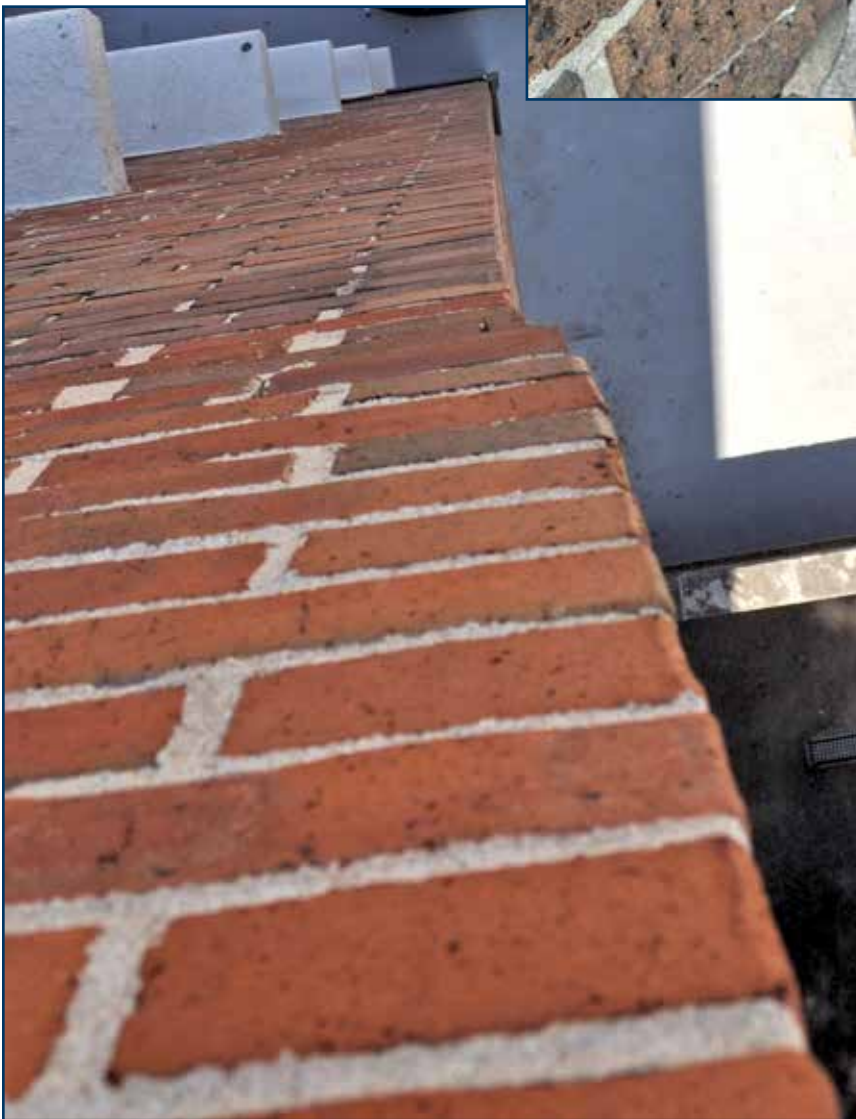
*Photo 2 – Parapet wall lateral displacement due to inadequate accommodation of irreversible expansion of the brick masonry.*

2. Mass masonry walls were typically not designed with movement joints to accommodate irreversible expansion of brick masonry, building frame movements, and movements associated with temperature and moisture. Lack of movement joints can result in stress buildup. Such stresses can cause cracking, localized displacement (*Photo 2*), failure of headers, and/or bowing. The cracks will provide a direct path for water penetration beyond the exterior wythe of masonry.

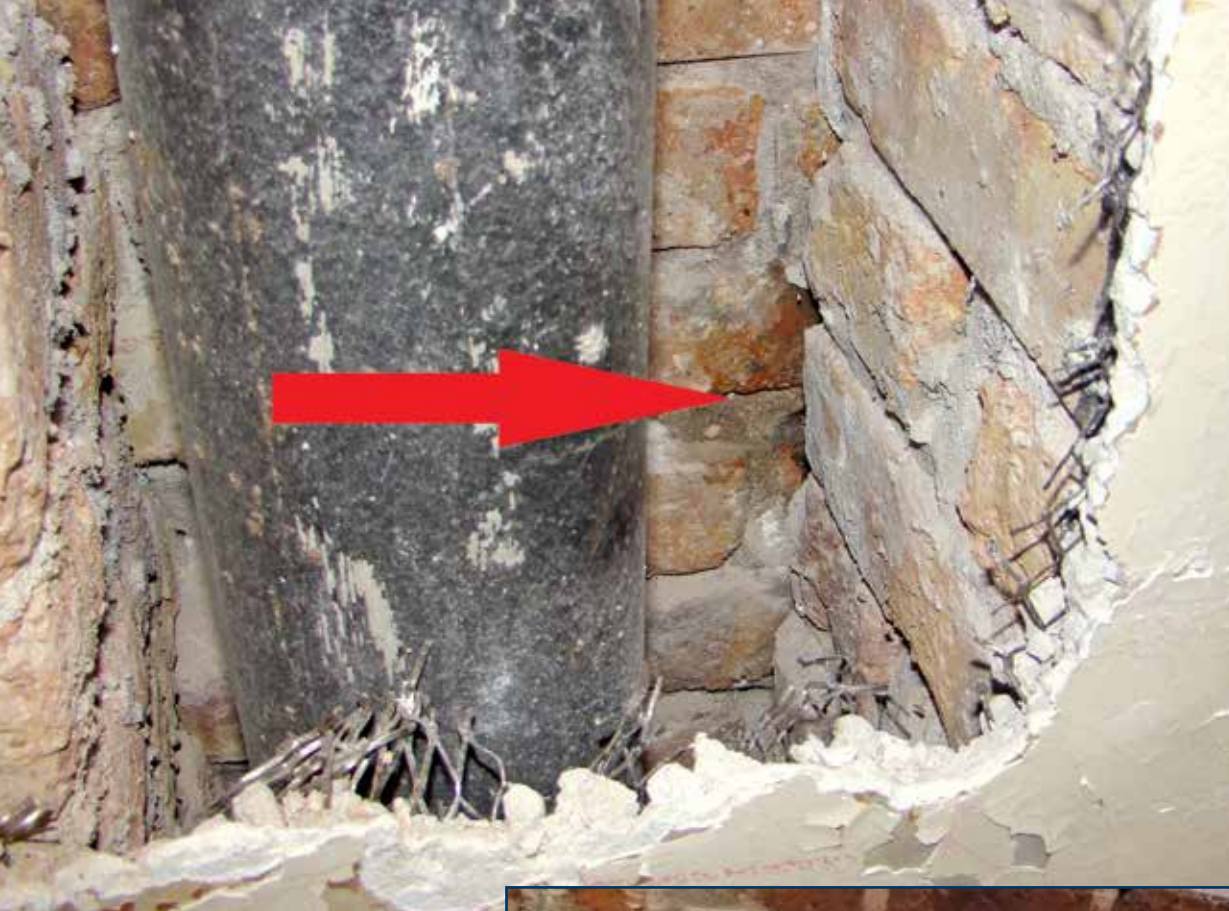
*Photo 3 – Leak location at wall section reduced from four- to two-brick masonry wythes to accommodate internal drain pipe.*

Where portions of walls become less than four wythes thick at specific locations, they will also be more susceptible to leaks (*Photo 3*). Similarly,

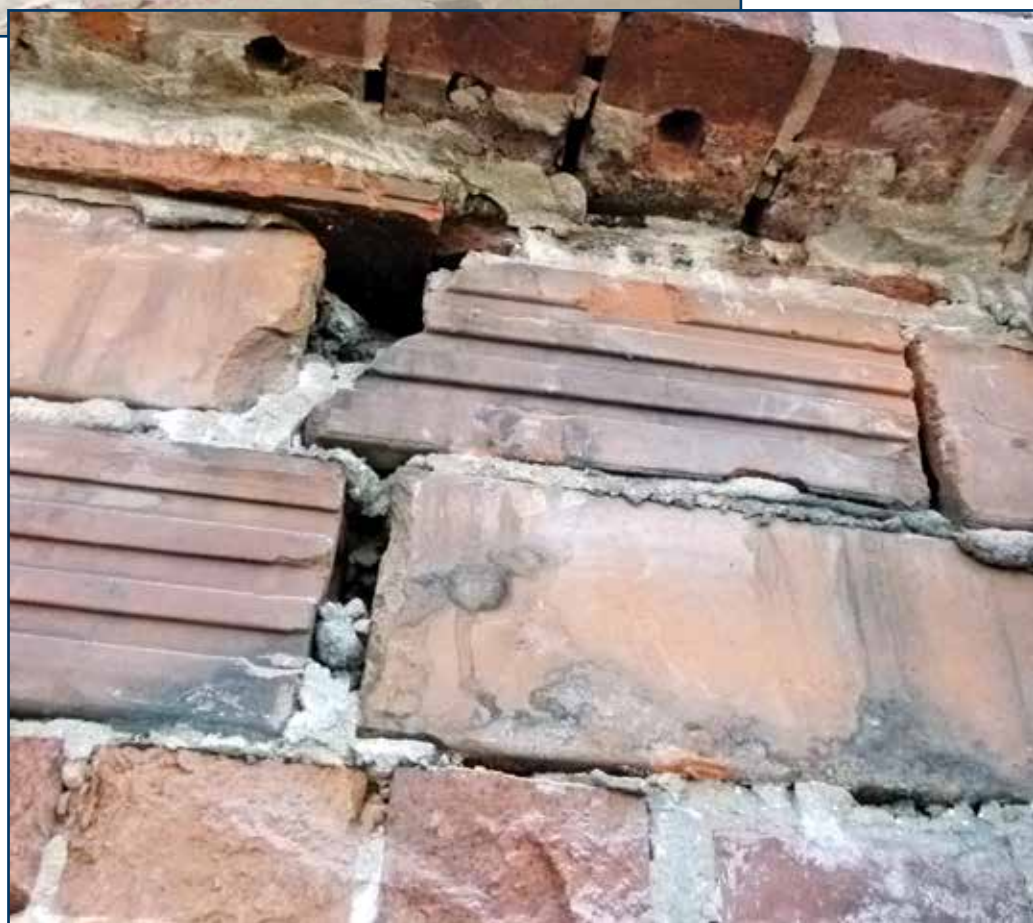
*Photo 4 – Use of hollow clay tile units as backup wythes reduces the mass of masonry that can absorb and retain moisture.*

the use of hollow units, such as hollow clay tiles, in lieu of solid masonry units as backup wythes, reduces the mass of masonry that can absorb

and retain moisture, thus increasing susceptibility of water leakage (*Photo 4*).

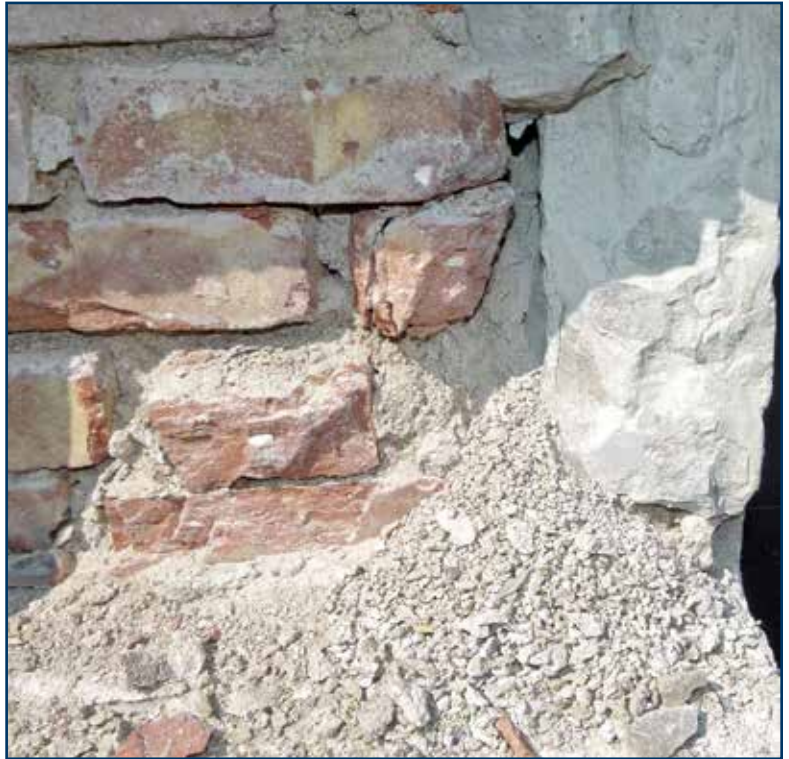
*Photo 5 – Deterioration of masonry and mortar within the exterior wall.*

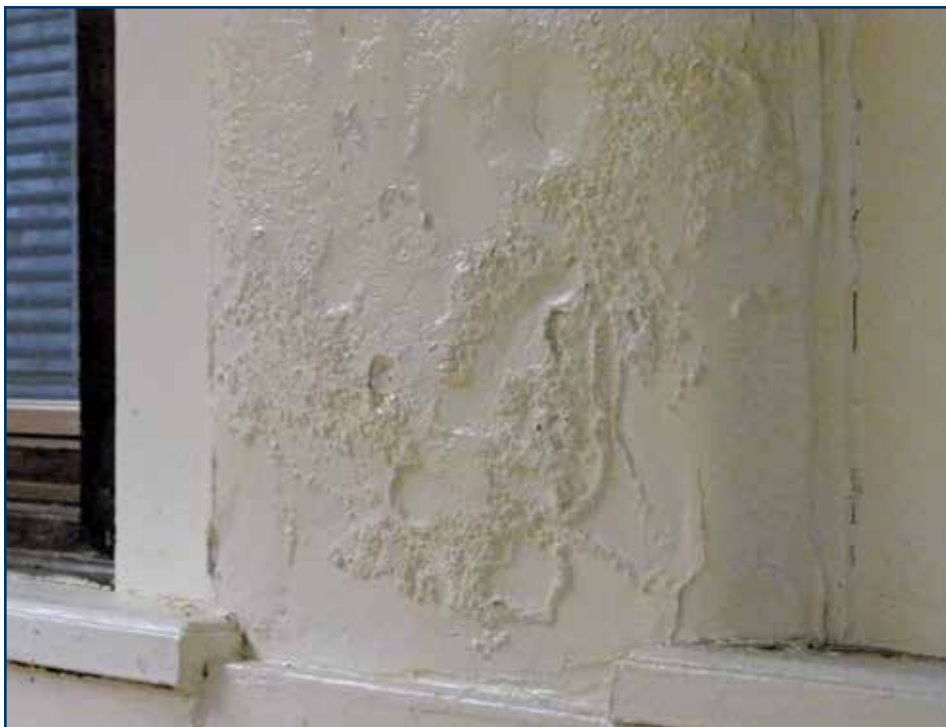
*Photo 6 – Deterioration of interior gypsum-based plaster finishes.*

interior finishes have been repaired using gypsum plaster or alternative products such as gypsum sheathing. These materials are far more susceptible to degradation due to exposure to moisture. As such, it is not uncommon to encounter mass masonry walls with gypsum-based interior finishes that exhibit ongoing plaster deterioration (*Photo 6*).

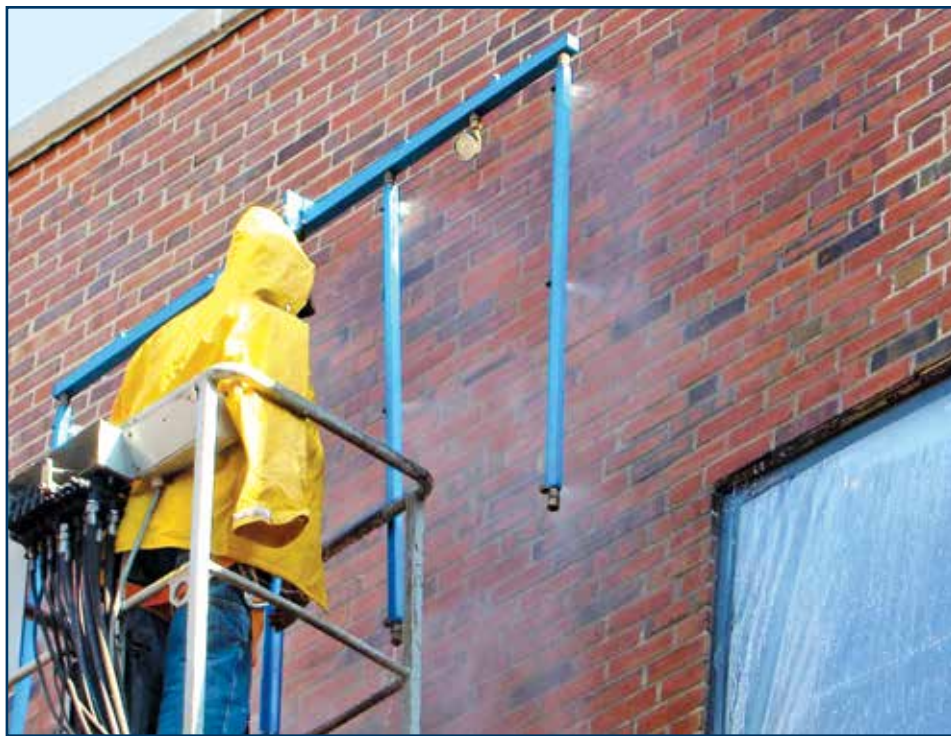
*Photo 7 – Calibrated spray rack testing performed on mass masonry wall with adjacent window opening masked to isolate the masonry.*

Procedures similar to those for ASTM E1105, *Standard Test Method for Field Determination of Water Penetration of Installed Exterior Windows, Skylights, Doors, and Curtain Walls by Uniform or Cyclic Static Air Pressure Difference*, can be utilized. This test is performed by wetting a wall area with a matrix of uniformly spaced spray nozzles that deposit a film of water to the wall's exterior surface, typically at a rate of 5 gallons per square foot per hour (Photo 7).

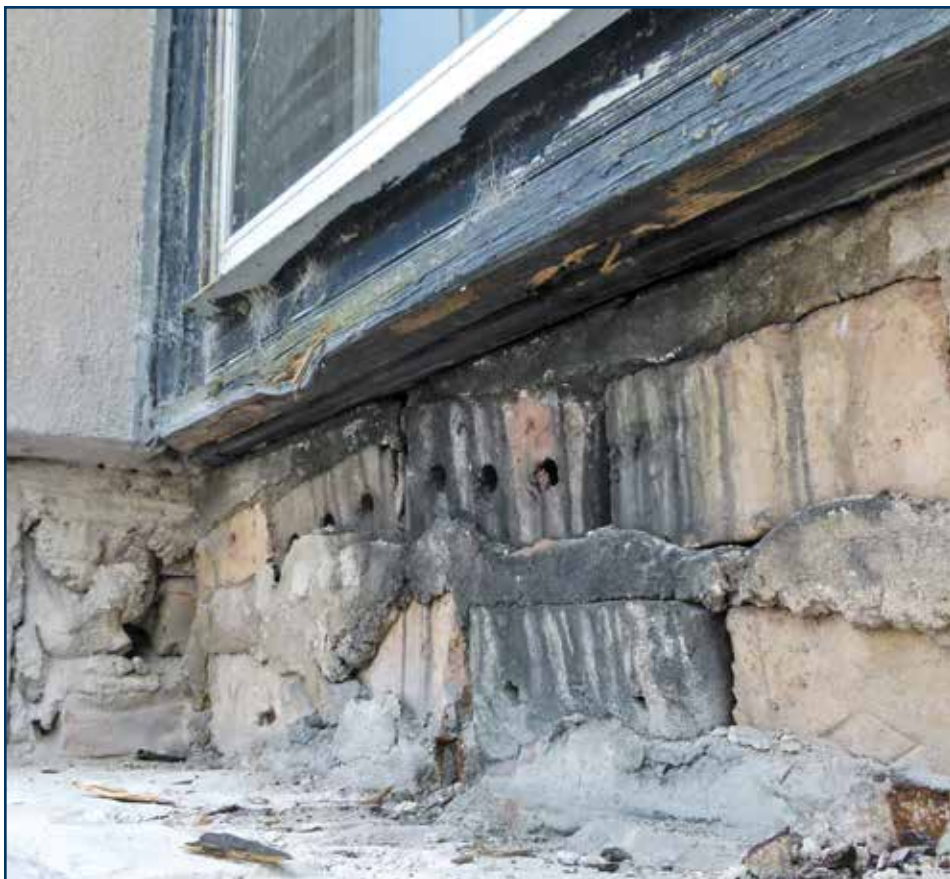
*Photo 10 – Staining on backup brick masonry indicates water travel path through wood windowsill into masonry wall.*

Exploratory openings also provide for an opportunity to observe potential water travel paths (*Photo 10*). In solid masonry walls, dirt deposits within the wall are typical indications of prolonged water travel. When examining fractures, dirt deposits within the fracture plane also help the investigator evaluate if the fracture is fresh (i.e., a result of the removal process) or old.
