# DO YOU HAVE ants in YOUR PLANTS?

## A Review of Insect Attacks on EPDM Rubber Membranes

BY LYLE D. HOGAN, RRC, FRCI, PE

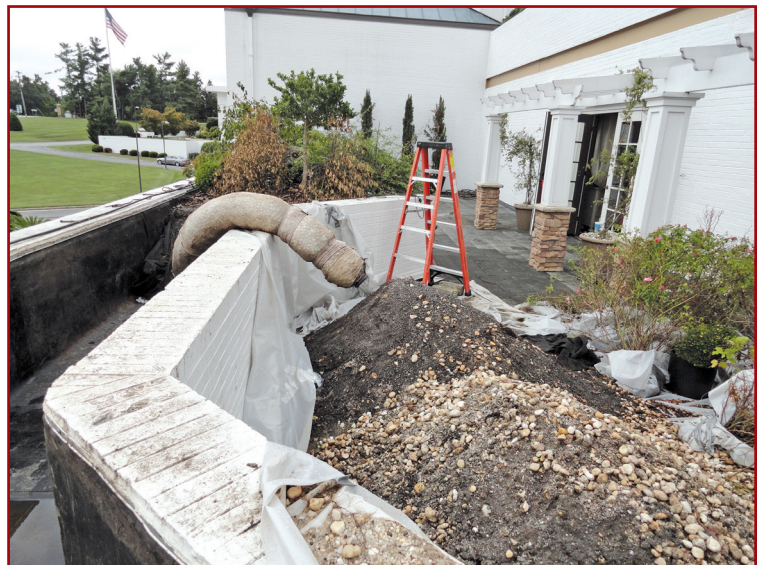
*Figure 1 – Planters are not exclusive to rooftops, as they are often found inside hotel lobbies, shopping malls, medical clinics, and the like. Furniture showrooms and executive offices were located below these planters, where substantial wetting occurred.*

Planters lined with rubber membrane are of potential concern. Certainly not exclusive to rooftops, they are often found inside hotel lobbies, shopping malls, medical clinics, and the like. *Figure 1* depicts a recent project involving furniture showrooms and corporate offices below planters, where substantial wetting occurred. The installing contractor was named in a liability insurance claim for flawed workmanship. Yet after investigation, his work was found to be satisfactory. Further investigation properly focused on the mulch and organic fill that had fostered insect colonization (*Figure 2*). Invading creatures

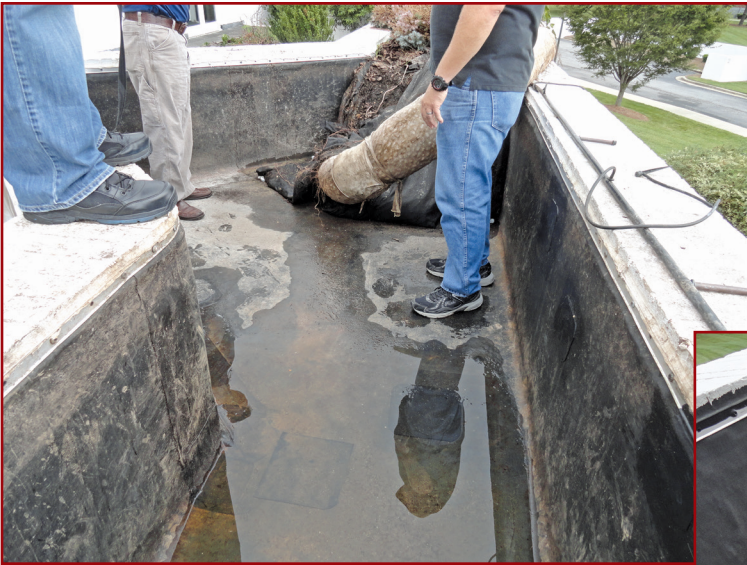
*Figure 2 – Chasing leaks in planted roofs can be tedious work. Mulch and organic fill may be the necessary environment to foster insect colonization; the invading creatures may also arrive on the various plantings being introduced.*

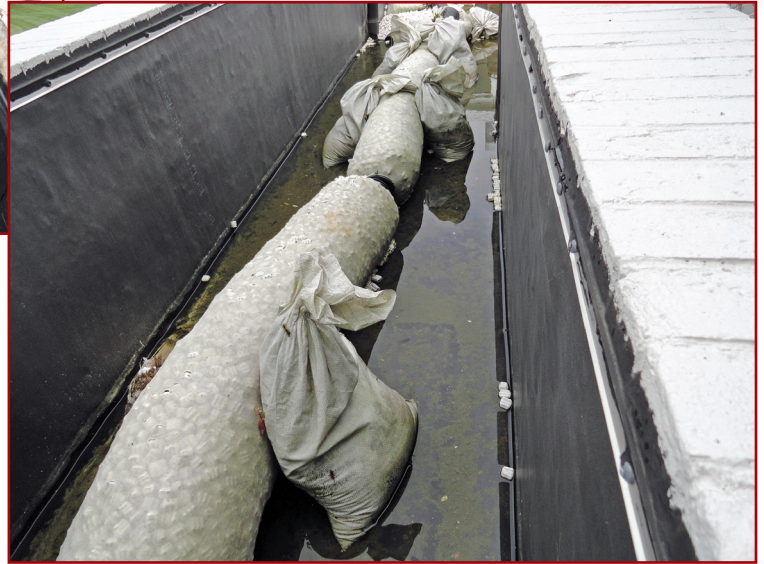
*Figure 3A – This vessel incurred substantial cost, requiring removal of overburden where insect boreholes were eventually located.*

*Figure 3B – This vessel was similarly lined with EPDM (same contract) but never received mulch, soil fill, or plantings; leaks have not occurred below it in the years since installation.*

Chasing leaks in planted roofs can be tedious work. The vessel in *Figure 3A* incurred substantial cost, requiring removal of overburden where insect boreholes were eventually located. The vessel in *Figure 3B* was similarly lined with EPDM at the same time and under the same contract. However, it never received mulch, soil fill, or plantings, and leaks have never occurred

below it in the years since installation. Again, this points to introduction of the pests by another source or trade.

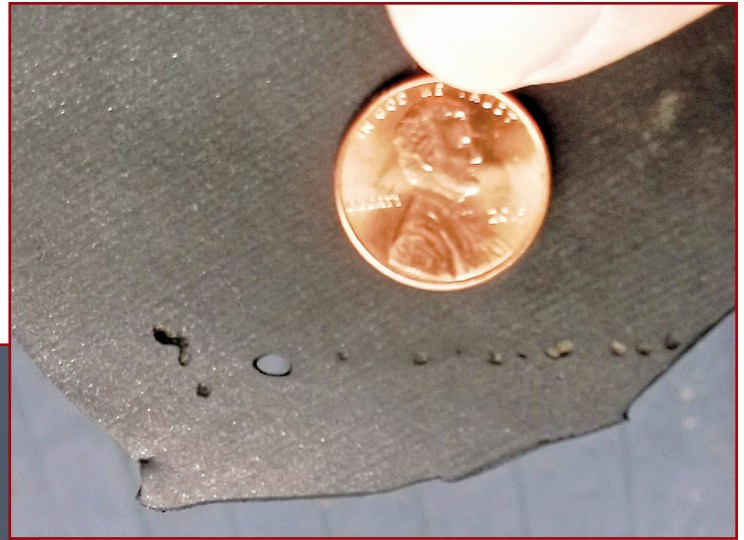
*Figure 5 – Underside of this sample shows a line of partly developed boreholes. How the creatures access the underside of a functional membrane is not understood. Indeed, there may well be topside invasion in some instances.*

The tiny insect boreholes are unique and cannot be replicated by drill gun, ice pick, golf shoes, falling limbs, spiked hail, or any other type of mechanical contact (*Figure 4*). Weld splatter marks can somewhat resemble these, but such activity is uncommon on a finished rubber roof and will not create such a condition on the underside of a sheet. Partially developed boreholes (*Figure 5*) are a sure sign of insect colonization below the membrane. How the creatures access the underside of a functional membrane is not fully understood. Indeed, there may well be topside invasion in some instances.

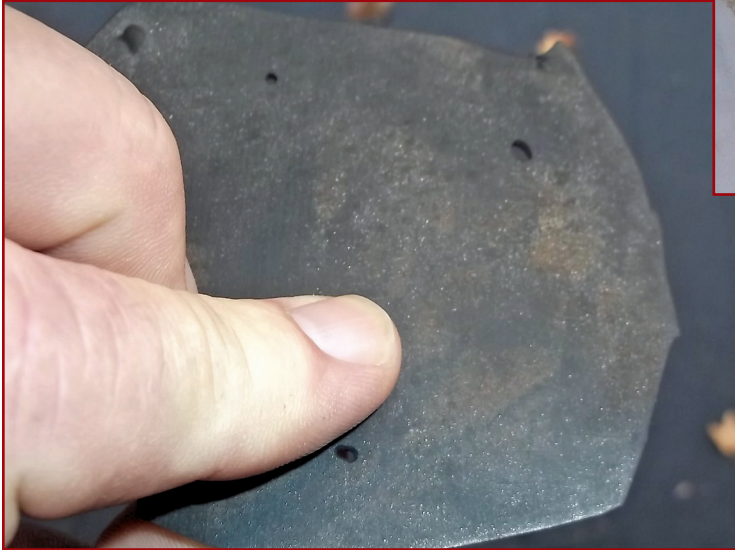
*Figure 4 – Top surface of planter liner showing tiny insect boreholes. These are unique and cannot be replicated by drill gun, ice pick, golf shoes, falling limbs, spiked hail, or any other type of mechanical contact.*

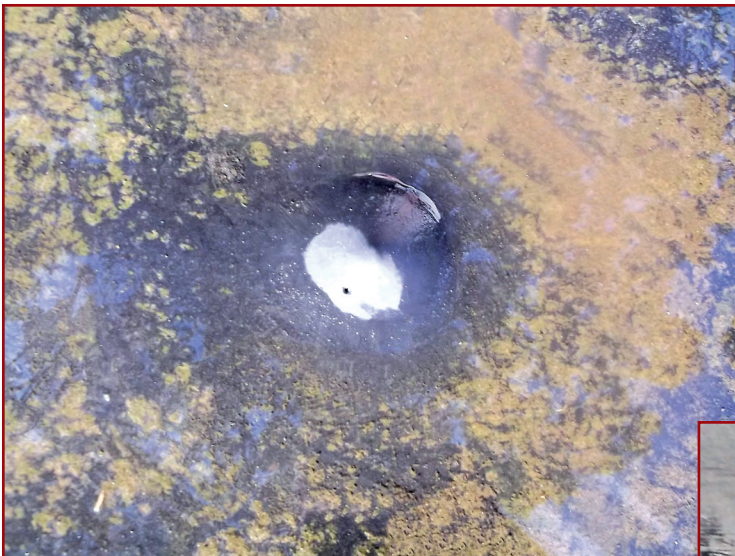
*Figure 6 – Although in near proximity, the tiny holes encountered here were not punctures from the nearby fastener head. The “tented” fasteners, however, may well provide the necessary underside space accommodation for the guilty insect to make the openings.*

On another recent project, a badly neglected rubber roof was affected. Although in close proximity, the tiny holes encountered were not punctures from nearby fastener heads (*Figure 6*). Saturated wood fiber insulation had consolidated, leaving the screw fasteners standing high in classic fashion.

These “tented” fasteners apparently provide the necessary underside space accommodation for openings to be made by the guilty pests.

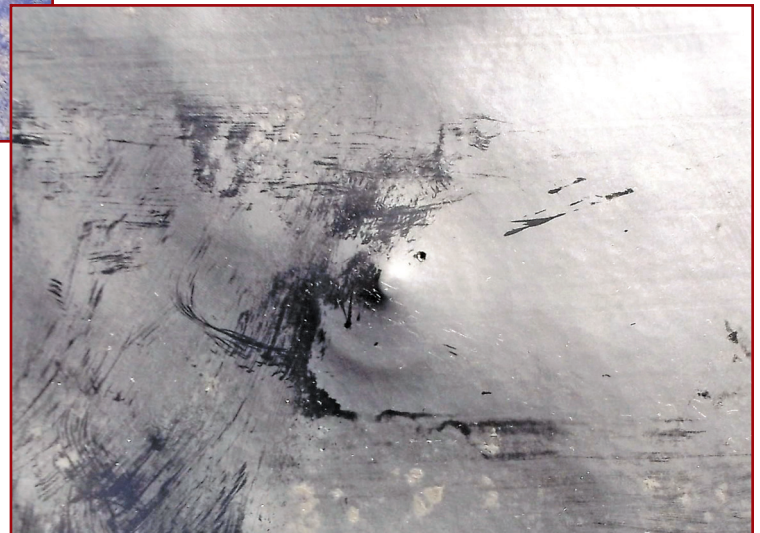
*Figure 7 – Damp/saturated wood fiber insulation has been present in the roof-related studies of insect infestation carried out by the author.*

Damp and saturated wood fiber insulation has been present below EPDM rubber in the roof-related studies of insect infestation carried out by the author (Figure 7). While the openings are quite small, prolonged ponding has exacerbated the tendency for any breach to admit a substantial amount of water (Figure 8). The same is true for planter vessels in which a film of standing water may exist throughout the entire service life.

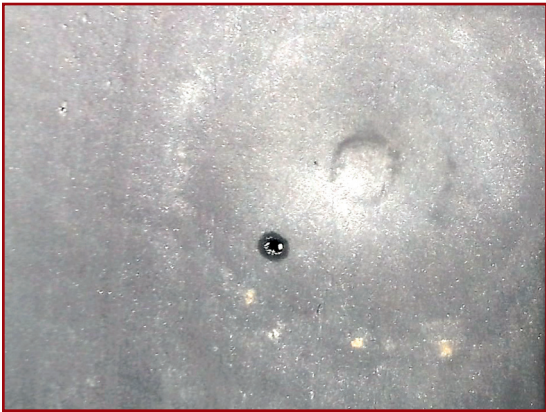
Figure 8 – While the openings are quite small, prolonged ponding can exacerbate the tendency for any breach to admit a substantial amount of water.

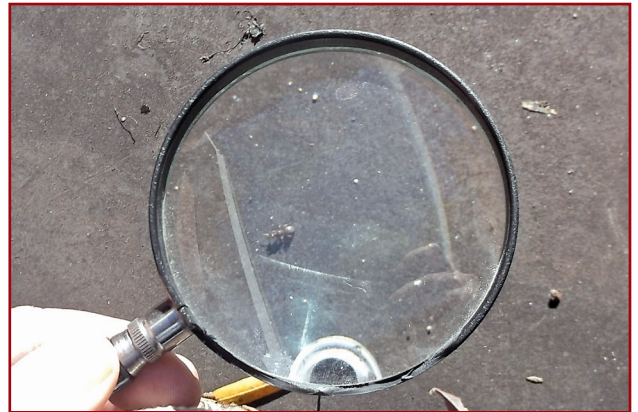
Figure 9 – These creatures were found in abundance on the most recent study carried out by the author. Still, attack from the underside is equally probable. Ants are frequently accused, but other insects may have a similar appetite for rubber membranes.

A few creatures (resembling ants) were observed in abundance on this particular roof and may be the source of the boreholes encountered (Figure 9). Ants especially like nesting in wood fiber, and they tend to puncture the membrane from the underside as they expand their territory in search of food. It is unclear how long it takes for holes to manifest, but punctures from the topside are most frequently associated with insects in the larval stage. After hatching, the larvae attempt to burrow in order to escape predators, and this can lead to penetration from the top. This burrowing can frequently be a multigenerational process, with each generation of larvae burrowing a little deeper.<sup>2</sup> Still, attack from the underside is equally probable, based on findings in other instances. Ants are frequently accused, but other insect varieties may have a similar appetite for rubber membranes. It is also not clear whether they in fact consume the material or merely puncture it.

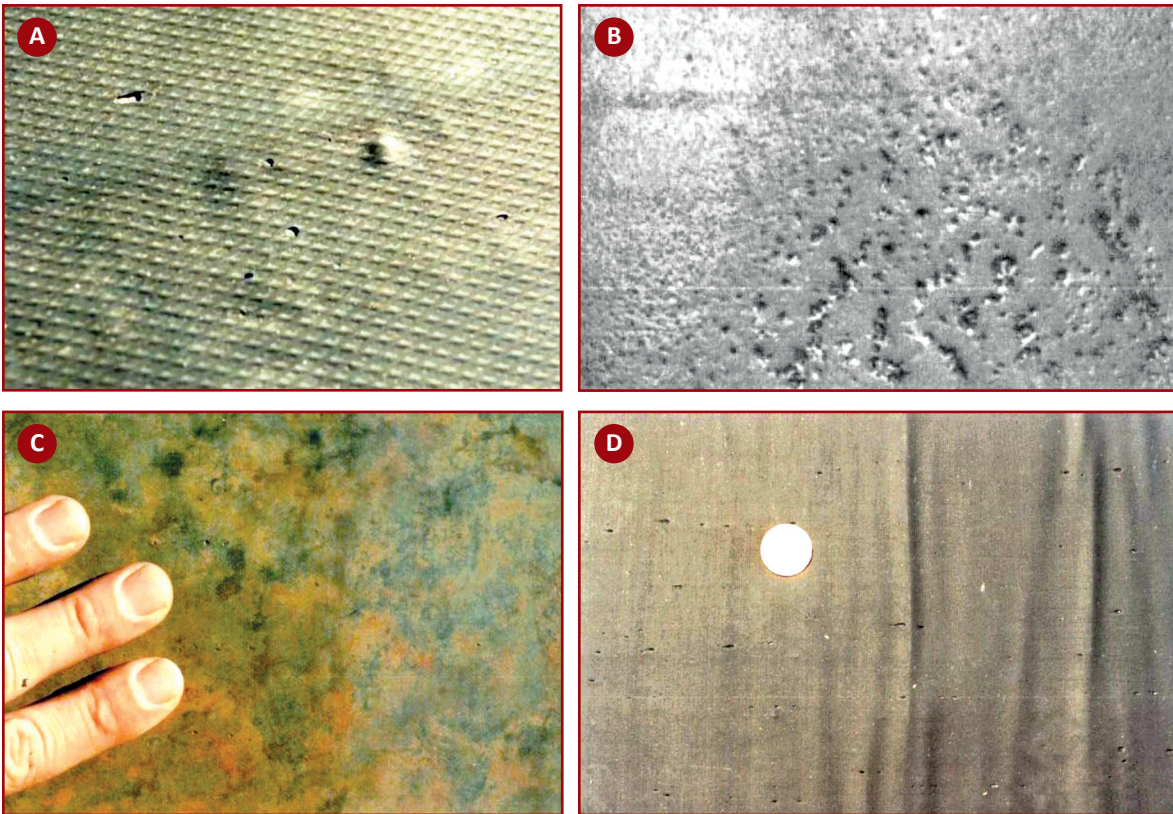
Figures 10A-D – Insect boreholes should not be confused with “comets” and related blemishes that may occur on EPDM rubber. This condition is certainly not rampant and is scarcely different than small manufacturing defects that may be encountered with other membrane types.

Insect boreholes should not be confused with “comets” and related blemishes that may occur on EPDM rubber (Figure 10A-D).

The condition is certainly not rampant and is scarcely different than small manufacturing discrepancies that may be encountered with other membrane types. It should be noted that EPDM membranes are actually a two-layer arrangement. Comets are virtually certain to occur to some extent during manufacture, mostly due to speed of the advancing sheet. At that point, the material is unvulcanized, quite hot, and soft. To manage the likelihood of comets aligning in the finished product, two sheets are blended together while on the carrier belt, making the probability of alignment statistically remote. Other products have their own nuances, so this discussion is not offered to indict rubber roofing.
