# DESIGN ISSUES: *The Devil in the Details*

By Don Kilpatrick

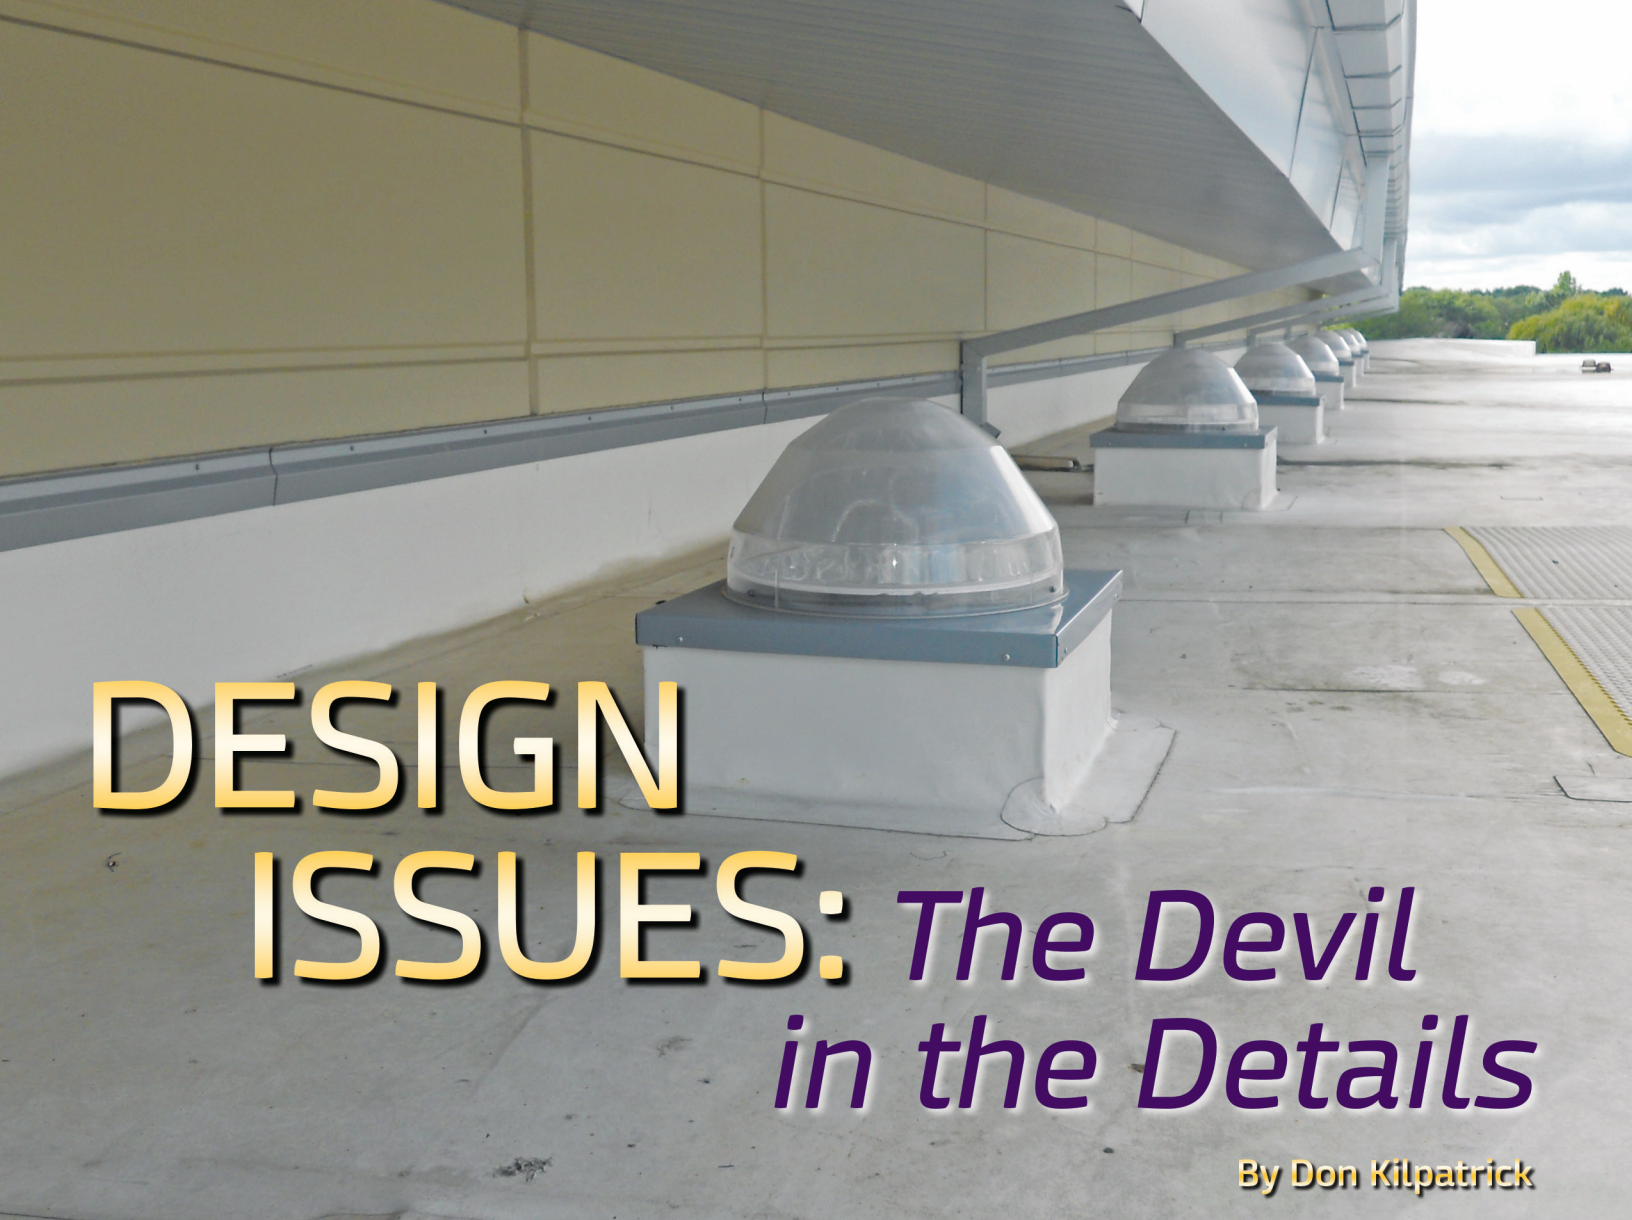
*Figure 1— New construction featuring an array of solar tubes. It is assumed that performance could have been optimized if the units were installed without the cover of the overhead-projected soffit.*

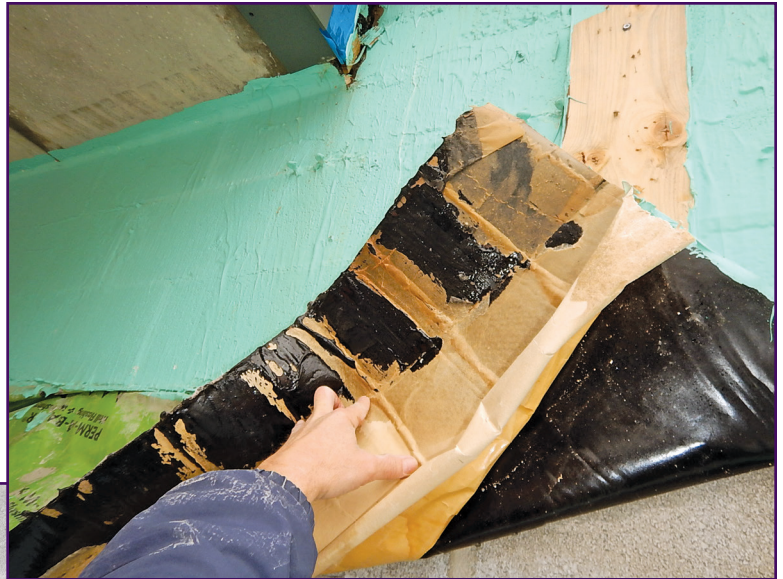
Figure 3 – Two months after seeing Figure 2, note the same TWF with intermittent loss of release paper and exposure to the elements, leaving self-adhesive or “sticky” side compromised to the extent that failure will occur.

fail. Most with experience in the field have firsthand practical knowledge with these types of shortcomings—while fulfilling the role of a third-party inspector, engaged to review a site-specific feature, or by chance observing construction site details or workmanship of marginal integrity. (It is hard to unsee some things; see Figure 1.) Each set of circumstances can cost building owners tens of millions of dollars. Some would argue that the default exposure is much more painful to watch, as it is accompanied by a sense of helplessness (Figures 2 and 3).

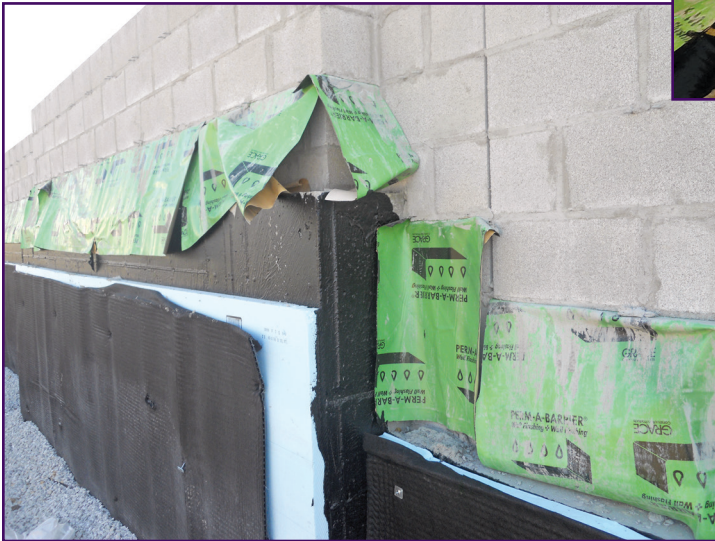
Figure 2 – Sight to be “unseen”—the birthplace of future performance issues with a through-wall flashing (TWF) condition.

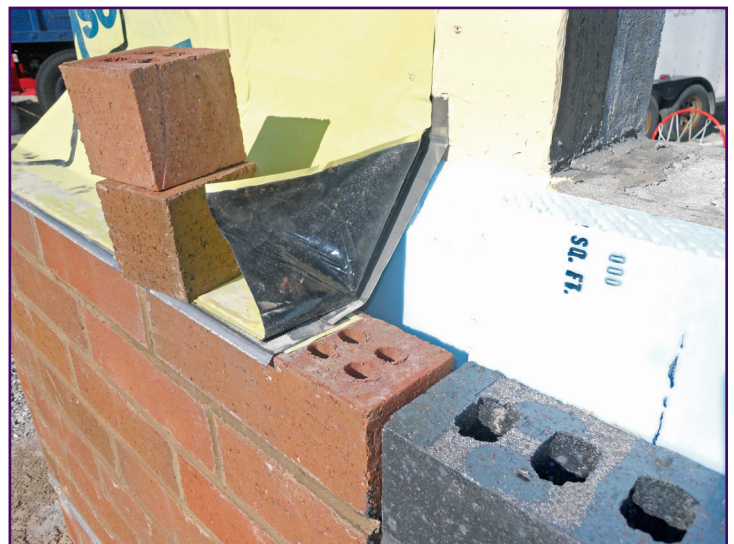
Figure 4 – Full-scale mock-up of a TWF condition on a new construction project. The design intent includes full support for the self-adhering membrane through the wall cavity.

of credibility. The process shall additionally acknowledge any special needs related to acceptance testing of materials, including full-scale mock-ups demonstrating proof of concept and standard of acceptance for the workmanship (Figure 4). On existing buildings, the consultant should work closely with the owner's in-house or outsourced environmental team, establishing proper protocols for hazardous materials, should they be encountered.

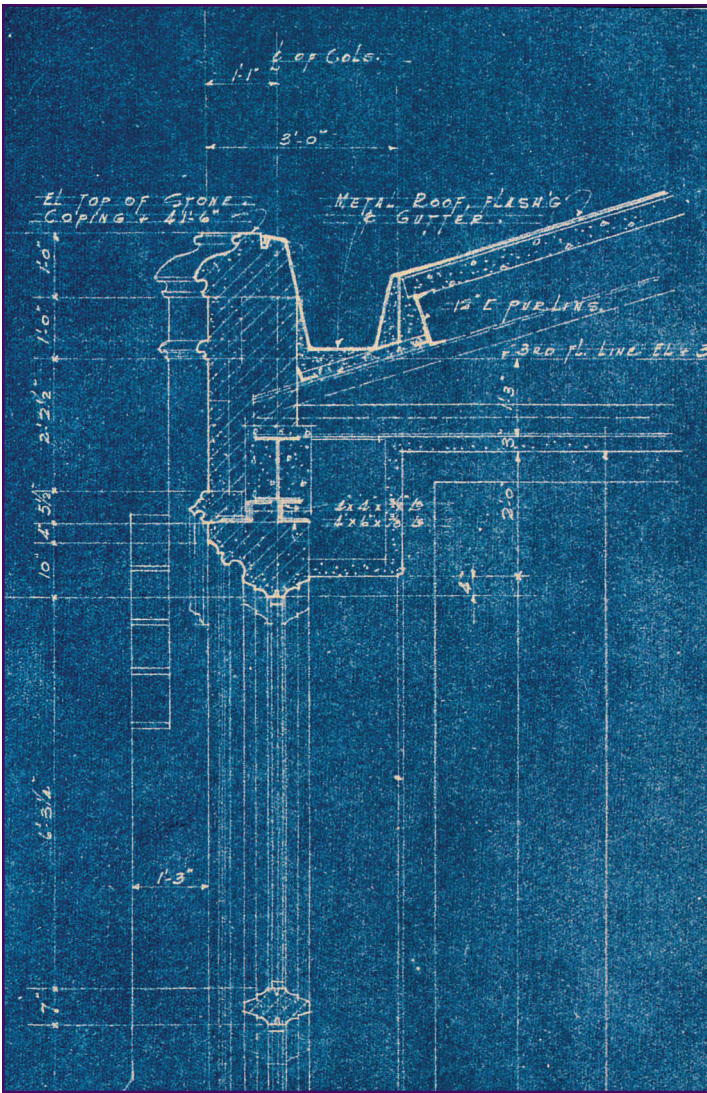
Figure 5 – A sample section drawing from original blueprints at low profile parapet/integral gutter/window head, additionally represented by Figures 6 and 7.

The availability of a roll or two of original drawings (best if both the architectural and the structural elements are represented) can be of significant value in the process. Through the review of project record documents, the team can learn much about the nature of the construction. These "blueprints" are found to contain pertinent information relative to site-specific conditions and areas of interest for the project currently in the queue (Figure 5).

In the example shown in Figure 5, after a few hours of investigation in the confines of a dirty attic space, the team emerged with a field sketch that brought clarity to the section found in the original building drawings (Figure 6). With an additional review of the structural drawings (more notably, the steel schedule notations), the field measurements were cross-checked against those shown on the drawings. The key parameters of the as-built condition were established to an extent that the team's efforts could move to full design with a comfort level that all variables had been acknowledged (Figure 7).

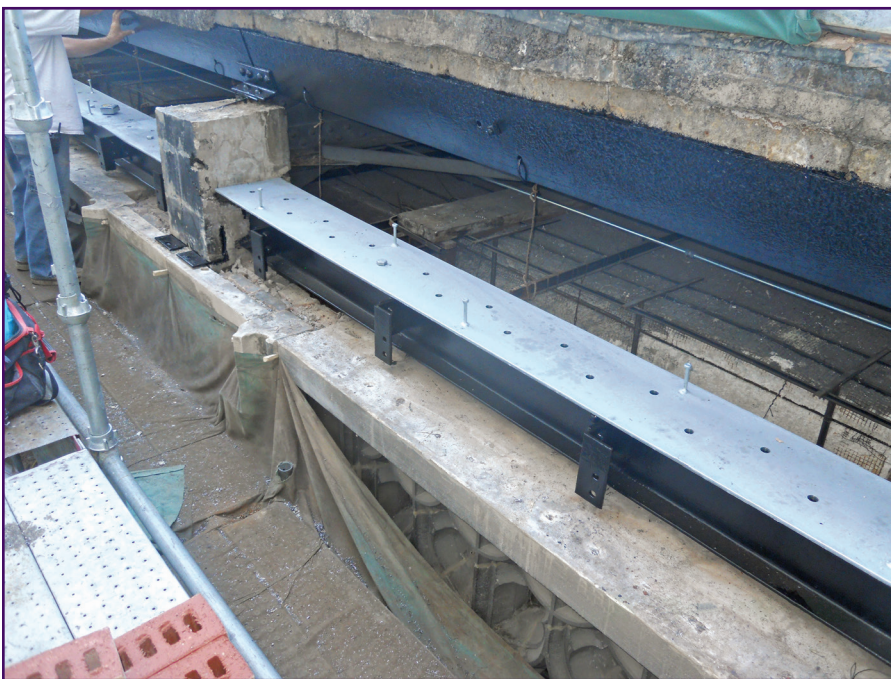
Figure 7 – Repairs underway at conditions represented by Figures 5 and 6.

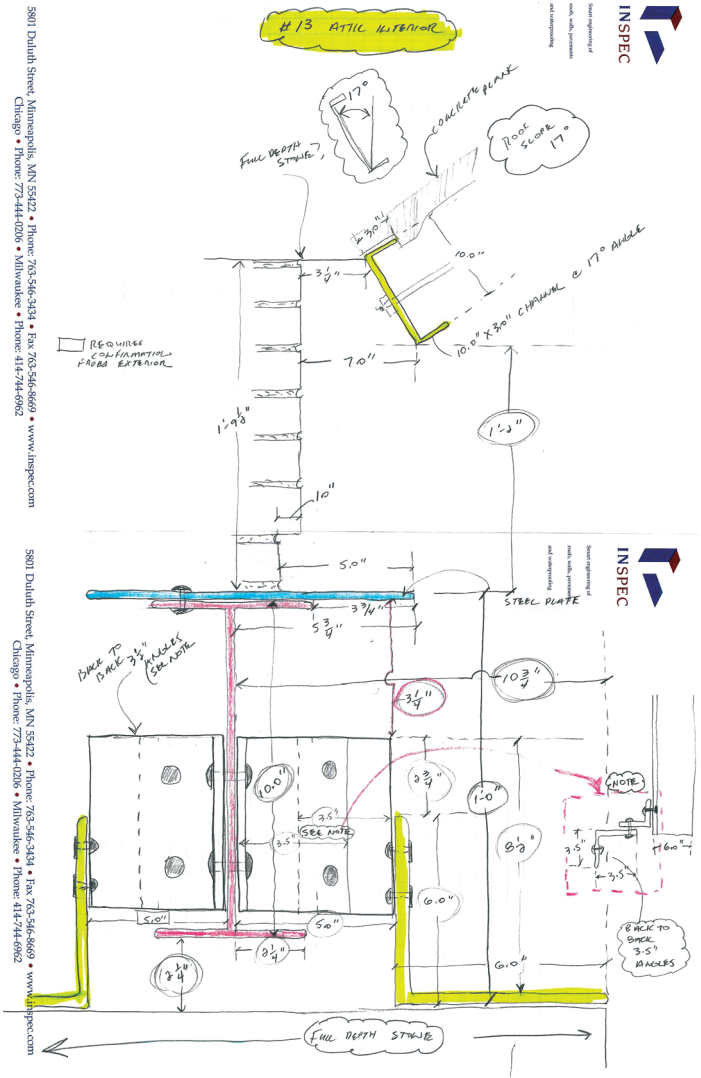
Figure 6 – Field sketch derived from a few hours of crawling around in the attic, additionally referenced in Figures 5 and 7.
