EFFECTIVE STRATEGIES TO RESTORE AND UPGRADE HISTORICAL STEEL WINDOWS

BY ARTHUR FEMENELLA SR.

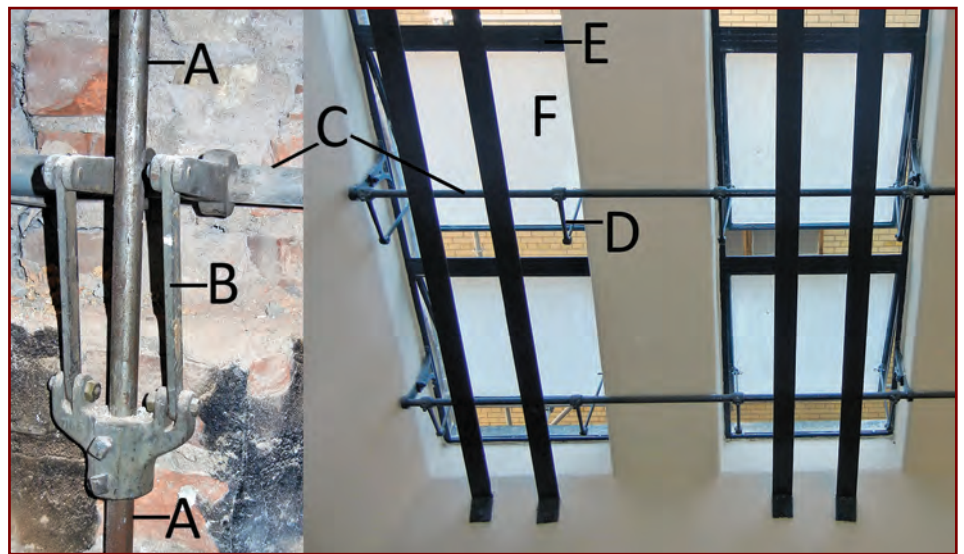
Figure 1 – Typical continuous window at Yale University's Payne Whitney Gym. The mechanism at the left is buried within a cavity in the exterior wall. Section "A" is a continuous vertical rod that is connected to all of the horizontal rods ("C") in the window. The bottom of "A" is connected to a screw mechanism that rises or falls as the operator turns a geared crank that is accessible from the interior of the building. As the crank is turned, the screw mechanism rises, causing "A" to rise. As "A" rises, the hinged lever arms at "B" transfer the upward displacement into rotational movement of "C". As "C" passes through the wall, it is connected to lever arms "D" that transfer the rotational movement of "C" into horizontal displacement of "F," the opening sash. "E" indicates the hinge location of the sash.

At the continuous window installation seen in *Figure 1* at the Payne Whitney Gym at Yale University, one operator can open 45 sashes at one time by operating one geared crank. These systems often fall into disrepair due to lack of maintenance. Any corrosion that develops in the lever arm connections restricts operability. With a good understanding of the system, however, they can be successfully returned to full and easy operation.

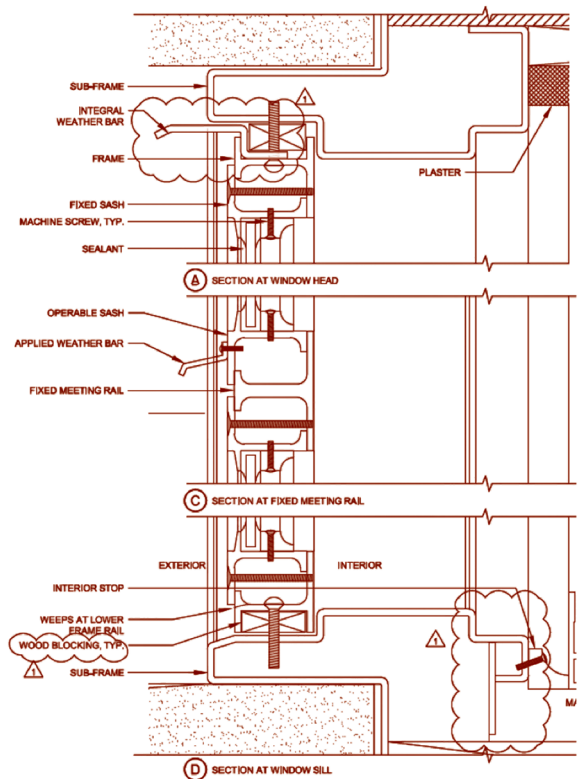
Figure 3 – Typical window details prepared for the Nealon Courthouse.

Numerous upgrades were made to the windows during the project to increase energy efficiency and ensure proper water drainage and resistance to corrosion (Figure 3).

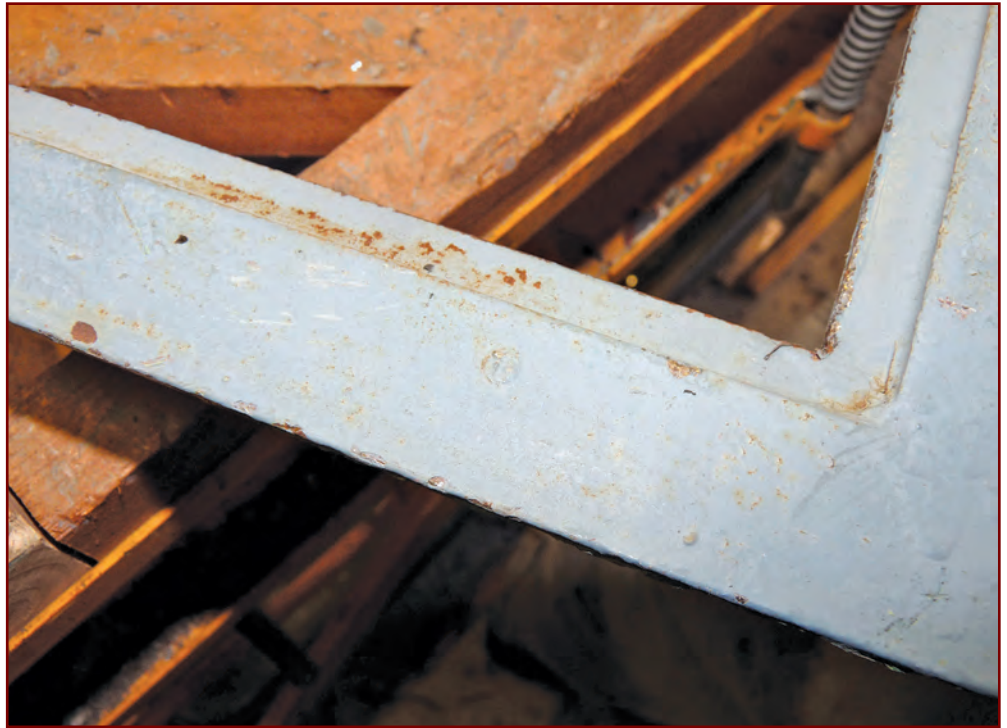
Figure 5 – Example of minor corrosion of the steel sash.

If the windows exhibit minor corrosion (see Figure 5), no rust jacking, and the paint is in fairly good condition, repairs can typically be completed in situ. For remediating minor corrosion and damage, complete the following:

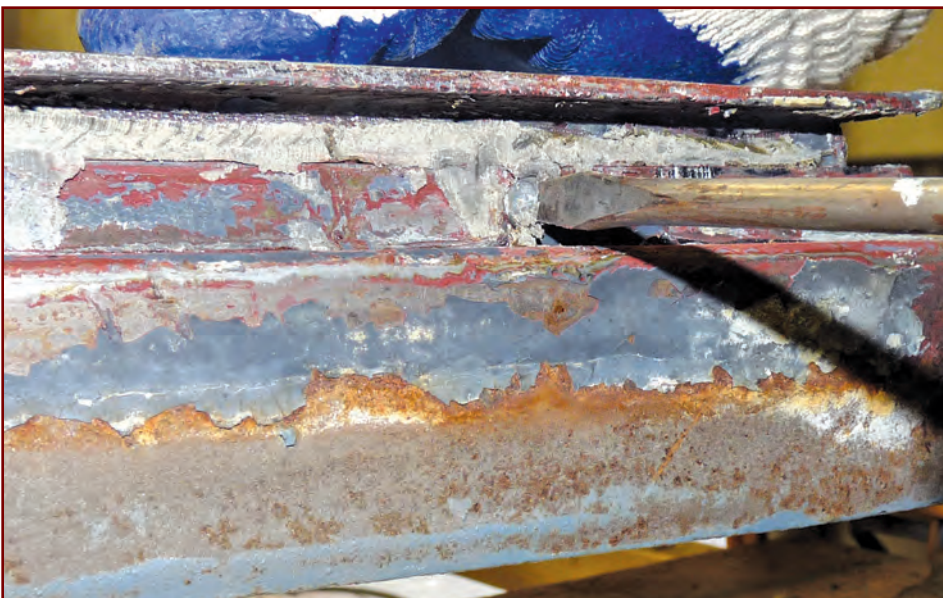
Figure 6 – Example of moderate corrosion of the steel sash.

For windows with moderate corrosion (see Figure 6), the above steps are followed as well. In addition, minor straightening of the sash or frame may be required.

1. To straighten the sash in situ, remove the glass and glazing. Using a wood or metal member to distribute the load, use clamps or an improvised come-along to exert pressure on the affected window member. Often, due to “metal memory,” the section has to be forced slightly beyond the ultimate desired plane to create a good fit. The frame can be returned to plane in a similar manner.
2. Corrosion may be so great that the proper closing of the sash is not possible. In these conditions, grind the uneven portion of the frame or sash back to its original design plane.
3. Moderate corrosion may result in divots or uneven surfaces once the corrosion is removed. These can be filled with special epoxies impregnated with steel filaments that are designed for these repairs. We have used Ferrobond® products by Abatron, Inc. to good effect.

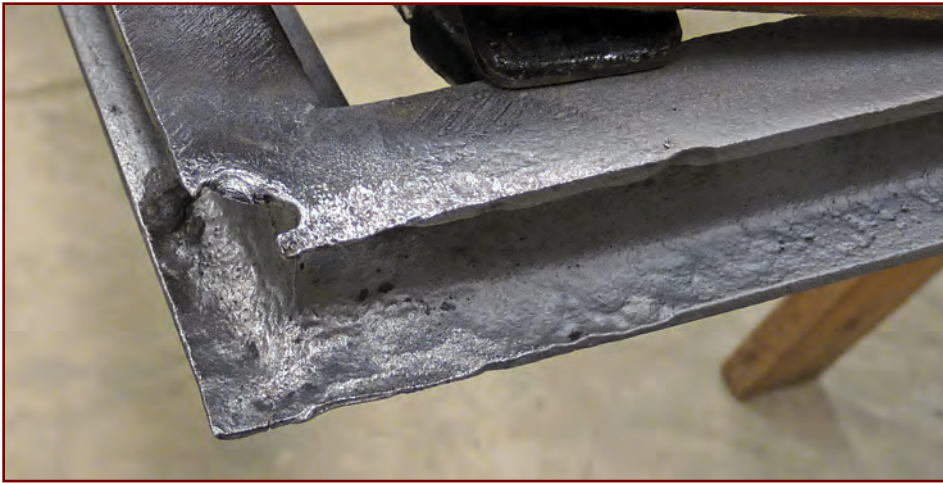
Figure 7 – Example of severe corrosion of the steel sash.

Windows exhibiting severe corrosion (see Figure 7) can often be economically and effectively restored by qualified craftsmen with extensive field experience. Severe corrosion is evidenced by sections of the sash or frames that are corroded to the point they have no structural integrity, have severely deformed or misaligned frames or sash, or are missing metal sections. Again, all of the methods discussed to solve minor and moderate corrosion should be employed first.

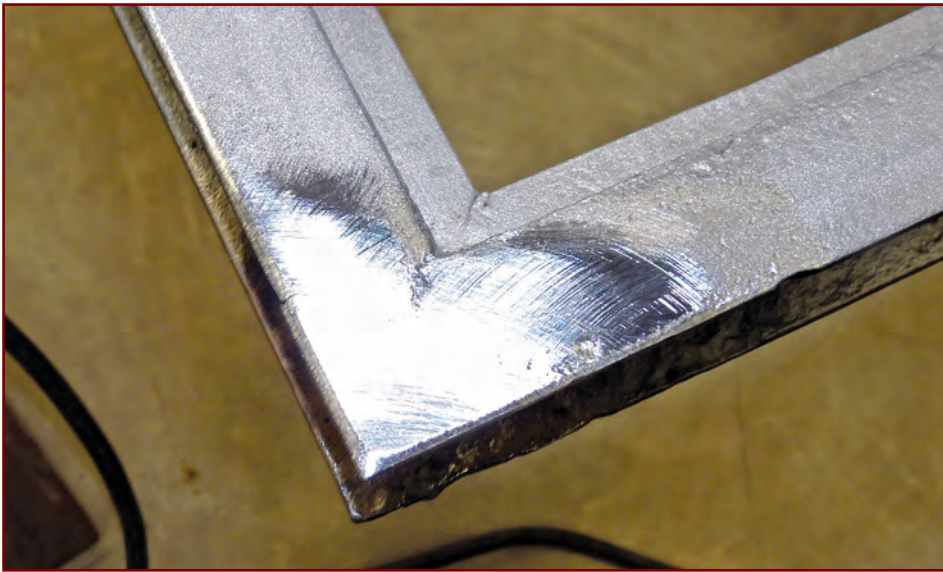
Figure 8 – Repair of severe corrosion. After removal of corroded material, an oversized new steel piece is welded in place. Repair patch is then ground down to match original profile.

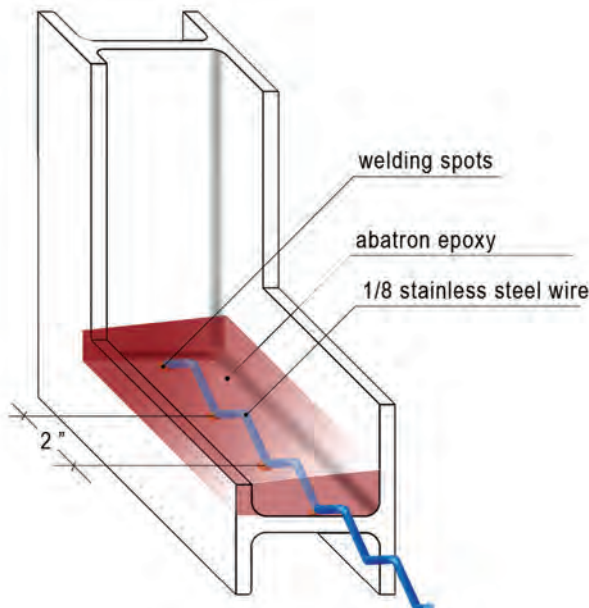
Figure 9 – Augmenting water-shedding capabilities.

5. Check all tapped fastening points. If corroded, weld shut, redrill, and tap if the fastening location cannot be moved.
6. Check initial documentation, and note where standing water occurred and corrosion was most severe. At Nealon, we found that all of the lower sections of the frames were severely corroded. This was due to the design that created a water trap. Our repair to these sections corrected this original design flaw. We filled the trough of this section with epoxy filler that was pitched to the exterior. We reinforced this repair with stainless steel $\frac{1}{8}$ -in. wire that was welded to the steel frame (see *Figure 9*).

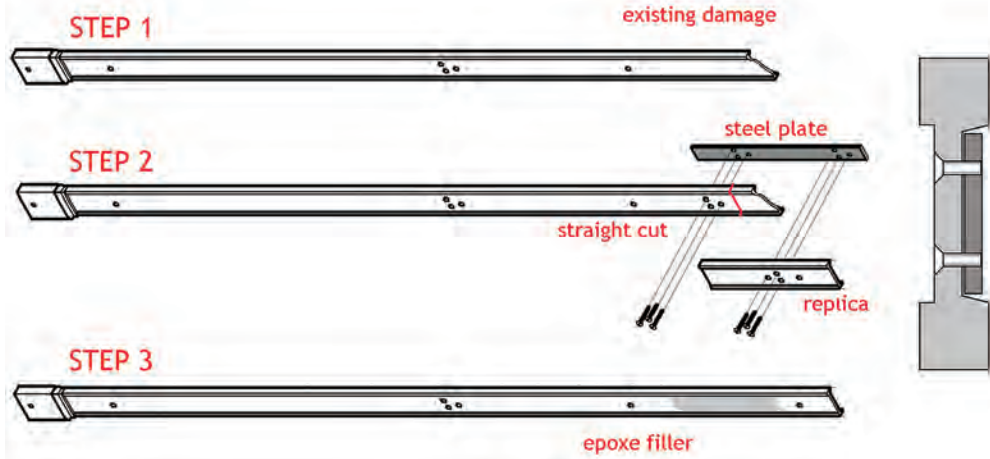
Figure 10 – Cast iron repair.

had runs of the different profiles cast. We cut the damaged sections from the cast iron and cut pieces of the new iron to fit, attaching them with stainless-steel splints (see *Figure 10*). We also made a number of tungsten inert gas (TIG) weld repairs to the cast iron, employing a silicon bronze rod.

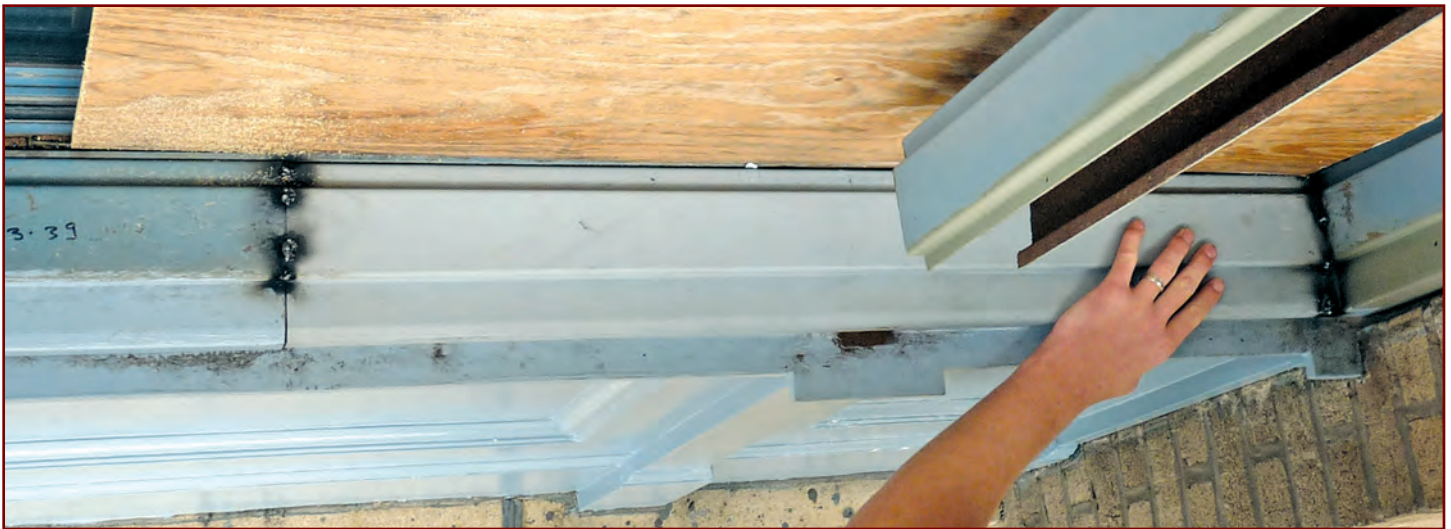
Figure 11 – Sub-frame repair in process. Replacement section tack-welded in. There is a steel backing plate that spans the joint. Welds will be made continuous along the joint and ground flat to the profile. Where required, epoxy patch material will be added.

8. The subframe assembly at Nealon had to be repaired in situ. This involved the cutting out and replacement of sills and headers. We had runs of the various profiles fabricated. At the site, damaged sections were cut away, leaving plumb and straight edges. New sections were cut and welded in place. After tack

weld, the full bead was welded, ground flat, and filled with epoxy putty (see Figure 11).
