LOW-SLOPE ROOFS ARE ROTTING

By Dwight D. Benoy, PE, and Pamela Jergenson, CCS, CCA

Low-slope roofs are rotting, resulting in major repair costs. Recently investigated roofs on three multifamily residential buildings had failed prematurely. All three buildings were less than ten years old and were located in a northern climate.

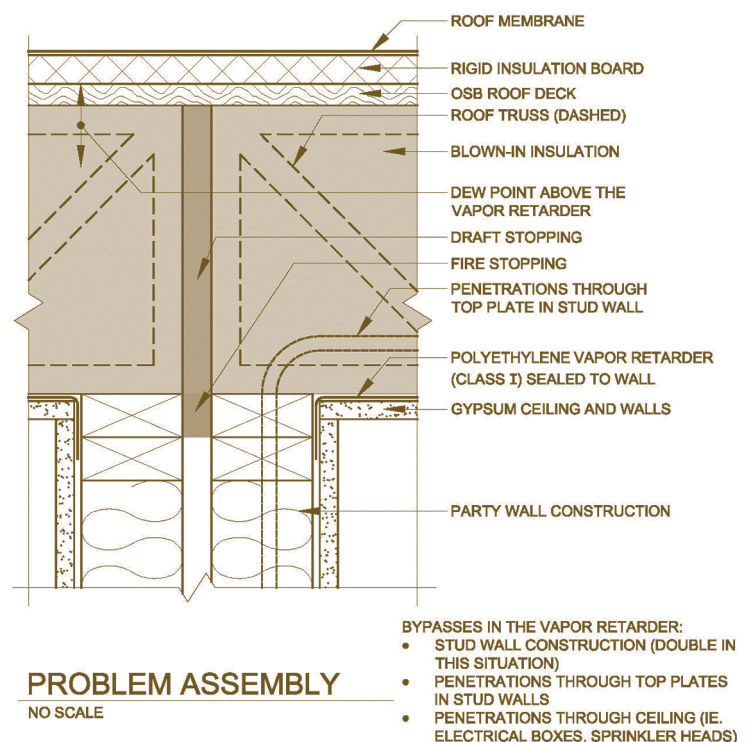
These buildings had similar nonventilated, low-slope roof assemblies utilizing wood trusses with a polyethylene vapor retarder on the bottom of the trusses covered with a gypsum ceiling. Blown-in fiberglass or cellulose insulation filled the truss space from the ceiling to the bottom of the roof deck. Oriented strand board (OSB) of ½-in. thickness was installed over the trusses as the roof deck. Rigid board insulation was installed over the OSB, followed by the roof membrane, which was a gravel-surfaced, built-up roof in one case; a ballasted EPDM single-ply membrane on another; and a mechanically fastened TPO single-ply membrane on the third (*Figure 1*).

Figure 1 – Problem assembly.

Perhaps the motivation to design an assembly as shown in Figure 1 would be to minimize the insulation costs related to the energy code requirements of recent years. While the amount of insulation installed exceeds the code requirement, the material and labor to install it were less than a code-compliant insulation installed above the roof deck. Filling the truss space with noncombustible insulation also provided the opportunity to eliminate the need for firestopping and draftstopping as noted in the 2000 International Building Code (IBC) in force at the time these buildings were constructed.

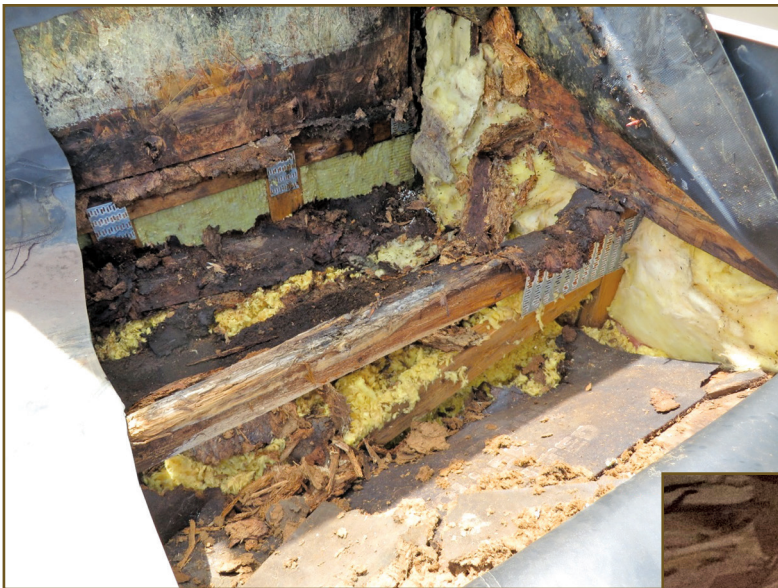
Invasive inspection openings made into the roof assembly revealed the OSB decking was severely deteriorated in many areas, such that it could not support the roofing materials above. The top portion of the top cord of the wood trusses was also wet and rotted in some cases. The steel tie plates of the trusses were corroded. Framing lumber at the exterior walls in the truss space was also wet.

Figure 2 – Rotted deck collapsed into truss space revealing rotted top chord of truss and corroded tie plates.

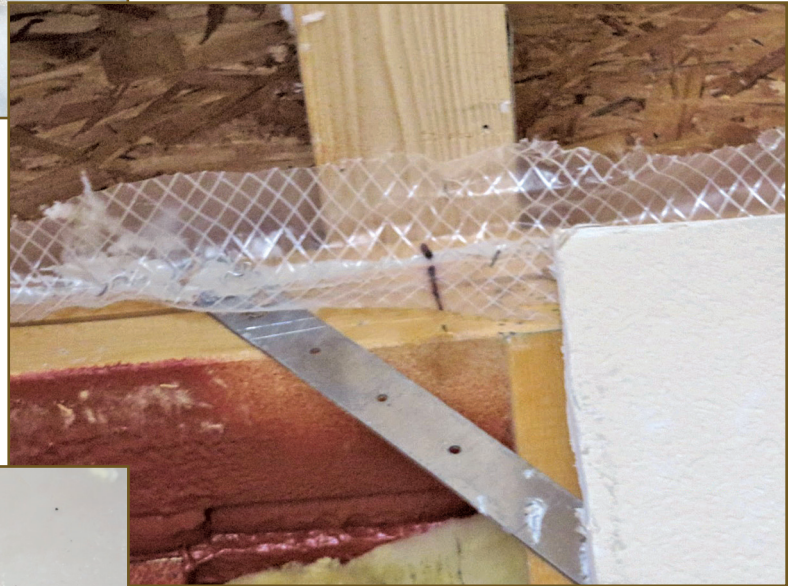
Figure 3 – Vapor retarder bypass at partition and party walls.

The investigations found many bypasses in the vapor retarder that would allow the warm, moist interior air to migrate into the truss space (Figures 2-5). The party walls between apartment units, which were a double-stud wall

construction, interrupted the continuity of the vapor retarder.

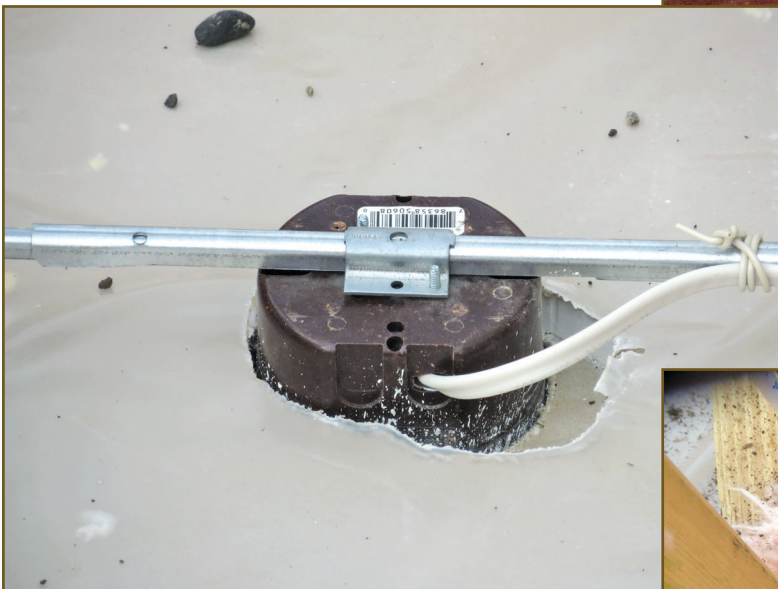
Figure 4 – Vapor retarder bypass at ceiling light electrical box.

Likewise, any interior partition walls resulted in a discontinuity in the vapor retarder at the ceiling. This was exacerbated by the penetrations through the top plate of the wall by plumbing stacks and wiring. Penetrations through the ceiling, such as sprinkler heads and electrical boxes for light fixtures, were also found not to be sealed to the vapor retarder.

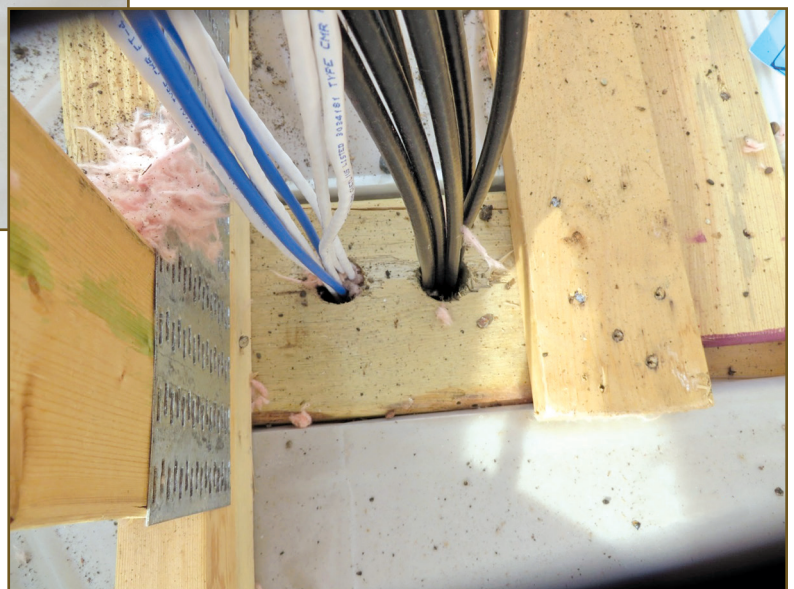
Figure 5 – Vapor retarder bypass through top plate of partition wall.

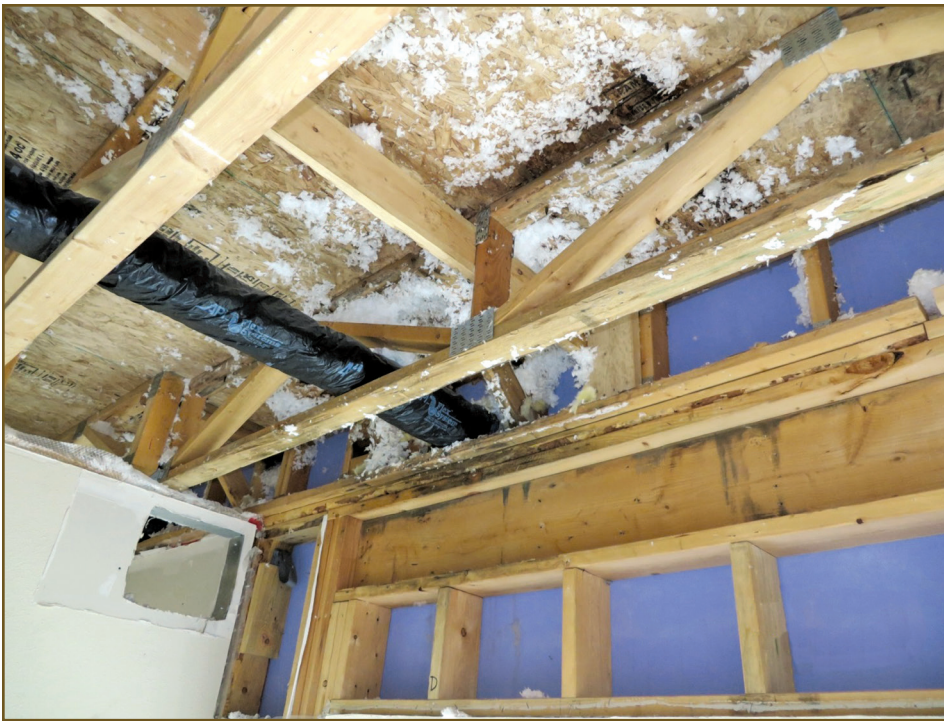
Figure 6 – Leaky dryer and bathroom vent ducts in truss space.

Two of the buildings had ducts from bathroom and dryer vents running through the truss space (Figure 6). Some of these ducts were not well sealed at the joints, which introduced very moist air directly into the space where condensation was most likely to occur.

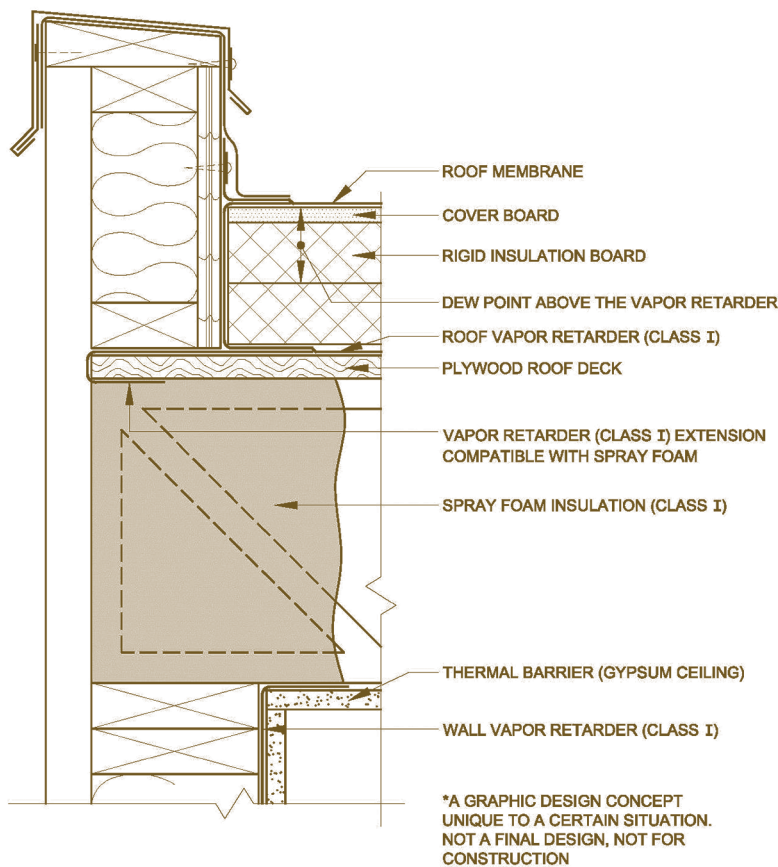
A GENERAL RECOMMENDATION FOR A ROOF SYSTEM AND PARAPET DETAIL*

A more constructible approach would be to install a vapor retarder on the roof deck level (Figure 8). Some insulation could be installed in the truss space, but most of the insulation would need to be installed above the vapor retarder so that the dew point

occurs above the vapor retarder. Insulating above the roof deck with rigid board insulation would be more expensive than insulating with blown-in insulation in the truss space. However, eliminating condensation is less expensive than costly repairs after the fact.

Installing the vapor retarder at the roof deck level affords a much better opportunity for achieving a complete vapor retarder. This would be a relatively easy way to provide continuity across party walls and to seal penetrations. The vapor retarder must also be continuous from the roof to the exterior walls. This might be accomplished by using spray foam insulation within the

truss space at the exterior walls.

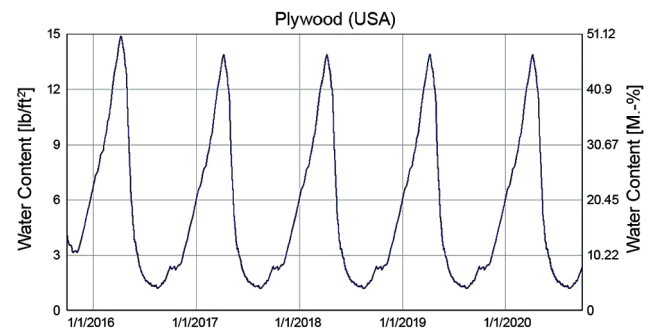
Figure 7 – Hygrothermal model graph of the roof deck in the roof assembly shown in Figure 1.

Figure 7 is the hygrothermal model graph of the roof deck in the roof assembly shown in Figure 1, assuming the presence of vapor retarder bypasses, over a five-year period. The water content of the roof deck exceeds 19% for about 40% of the year, peaking in April. Calculating the dew point using traditional methods by selecting temperature and humidity conditions in January may not have shown the potential problem of excessive moisture in the system that peaks in April. The moisture damage to the roof deck, as observed in the field, strongly correlates to the hygrothermal model results.

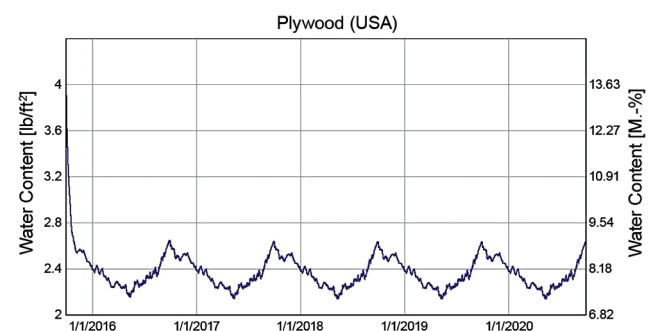
Figure 9 – Hygrothermal model graph of the plywood roof deck in the roof assembly shown in Figure 8.

Figure 9 is the hygrothermal model graph of the plywood roof deck in the roof assembly shown in Figure 8. This shows the moisture content of the plywood roof deck staying below 19% and actually drying out over time from its initial peak moisture con-

tent at the time of construction. Anecdotal observations of roofs similar to this design in place for 20 years or more substantiate the hygrothermal model results.
