# Expansion Joint Curve/Valley Intersection on Metal Roofing:

## A CASE STUDY

By Christopher A. Payne, RRC, CDT

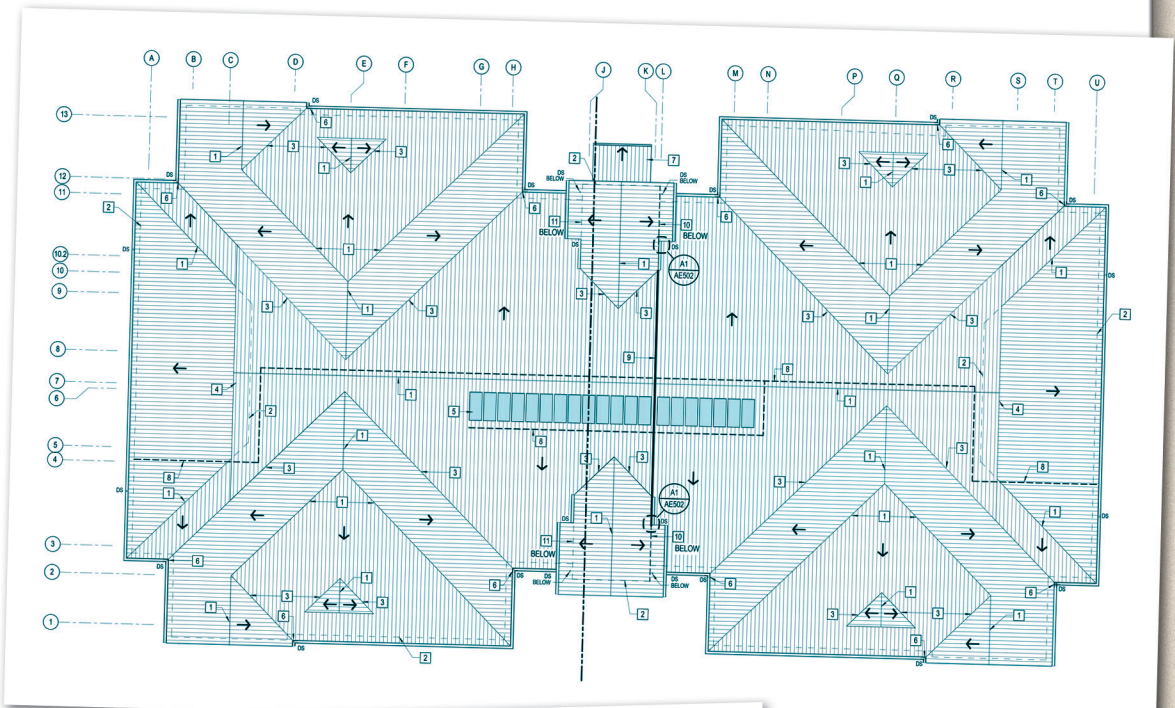
Figure 1 – Roof plan (expansion joint curb runs just right of center, parallel to the main roof slope).

ed across the roof, parallel to the panels of the main roof slope, but also intersecting two dormer valley flashings and sidewalls. The roof plan may be viewed in *Figure 1*. A close-up section of the expansion joint curb may be seen in *Figure 2*. The expansion joint intersection with the dormer valley occurred in two places on opposite sides of the building, both mirror images of one another. The project architect made an attempt to conceptualize the expansion joint flashing above and below the valley flashing, but struggled with how to deal with the actual transition of the expansion joint curb to the valley, then into the sidewall expansion joint and flashing on the wall below the valley. *Figures 3 and 4*

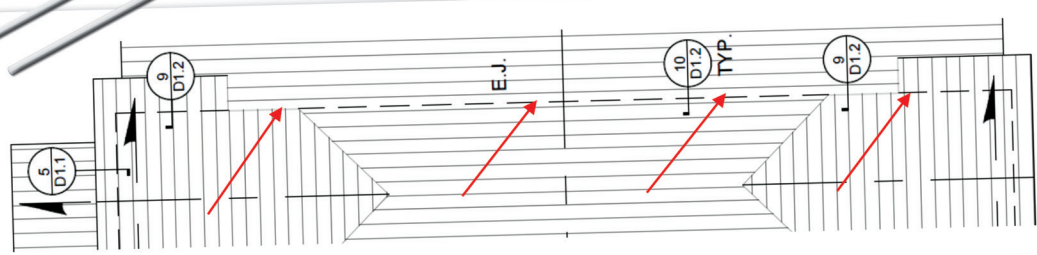
Figure 2 – Expansion joint curb (noted as segmented line and delineated by red arrows).

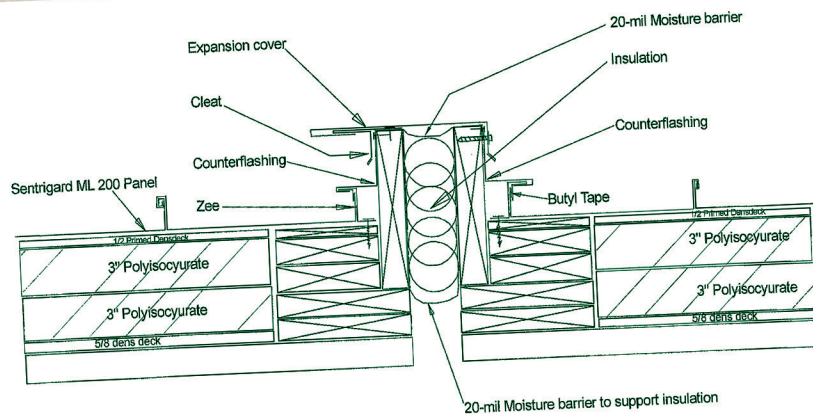
Figure 3 – Section through expansion joint curb.

show the details in the shop drawings.

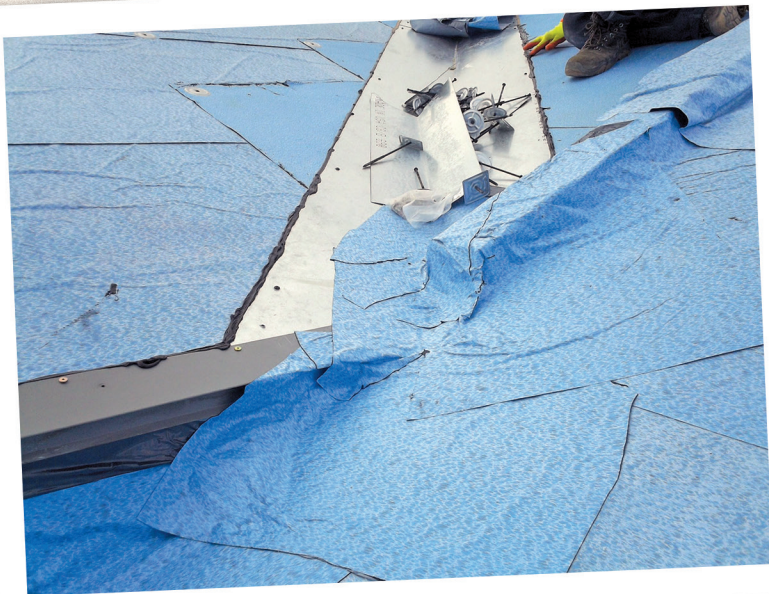
*Figure 5 – Expansion joint valley intersection prior to panel and flashing installation.*

When it came to the actual valley intersection with the expansion joint curb, it was necessary to allow for expansion and contraction of the sheet metal flashing in six different directions, yet keep the flashing system weathertight. *Figure 5* shows the intersection. *Figure 6* illustrates the first attempt of the roofing contractor to flash the condition, while *Figure 7* was the architectural detail from the original plans and specifications. This detail was the same as saying, “Roofers: Figure this out because we don’t know how to do it.”

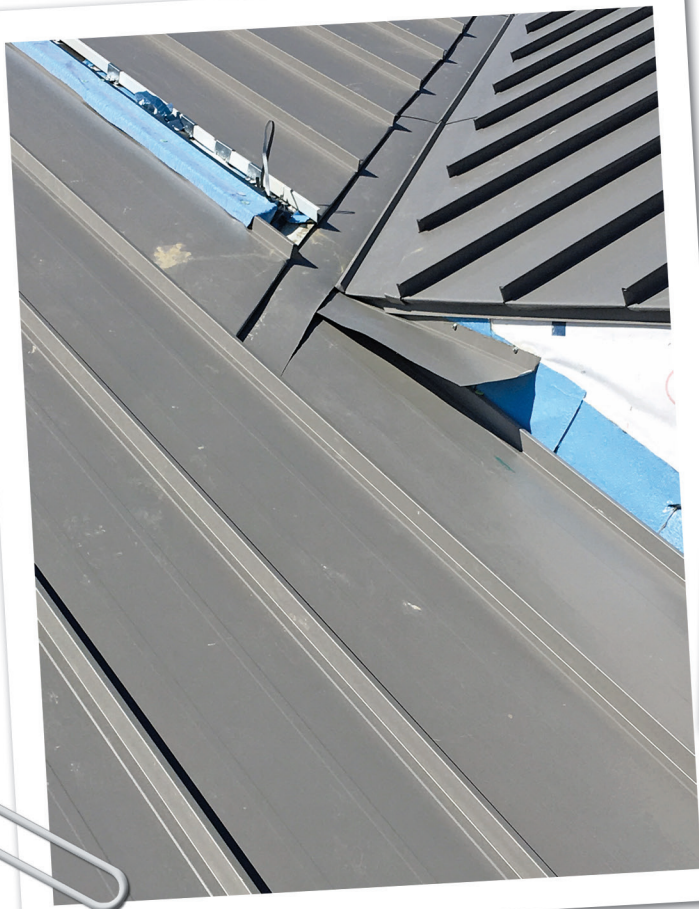
*Figure 6 – Temporary expansion joint; temporary valley flashing.*

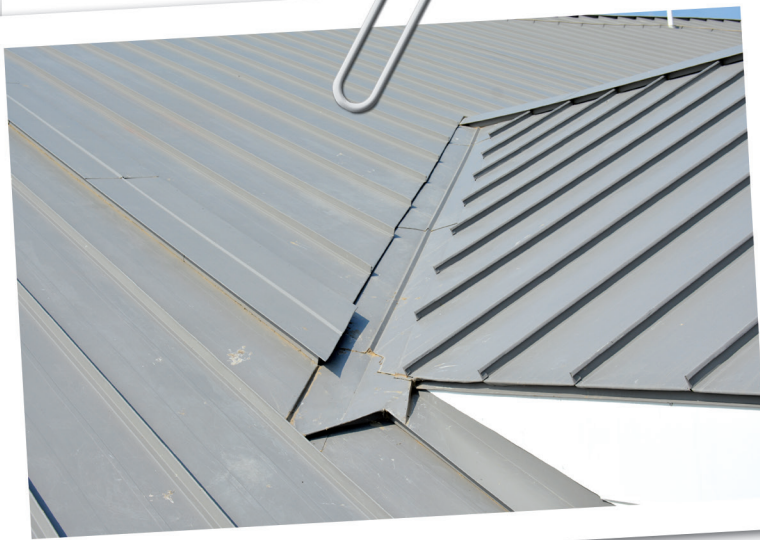
Figure 10 – Completed expansion joint/valley intersection (north side).

this problem would have been to move the building expansion joint and subsequent curb over at least 24 in. away from the valley. Unfortunately, the transition was never even thought about or discussed until the building was constructed and it was too late. Figures 10 and 11 show the successful integration of the standing seam roofing and flashing materials as they were ultimately constructed and installed.

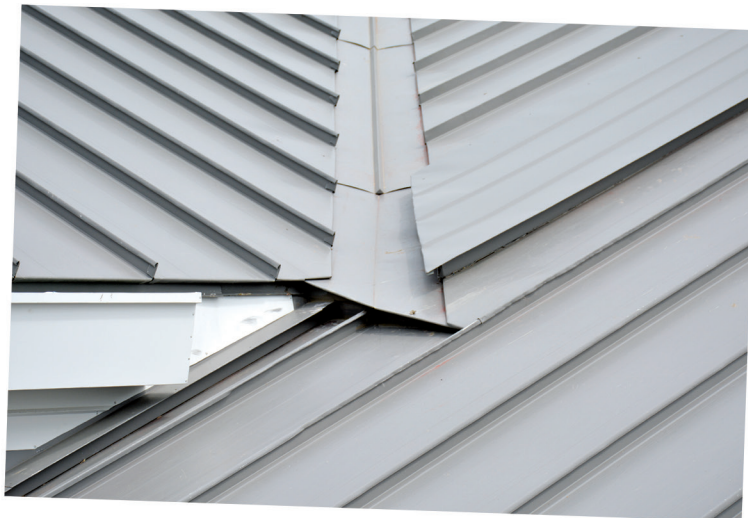
Figure 11 – Completed expansion joint/valley intersection (south side).
