BUILDING ENVELOPE TECHNOLOGY SYMPOSIUM

**EVERYONE LOVES A POOL,
BUT WHAT'S LURKING BENEATH THE SURFACE?**

EVERYONE LOVES A POOL, BUT WHAT'S LURKING BENEATH THE SURFACE?

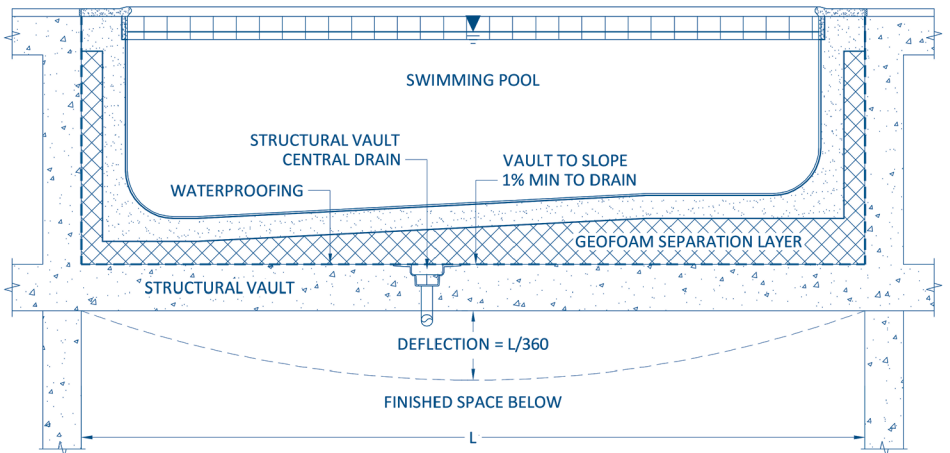
Figure 1 – Illustration of pool slab with uniformly spaced structural support deflection.

port elements. This span distance will suffer some vertical deflection between the supports, and the amount of vertical deflection is wholly dependent on the distance the slab spans (*Figure 1*). The deflection is often slight and invisible to the naked eye, but in many cases, the deflection is sufficient to induce structural cracking in a swimming pool. Often, the columns supporting the slab are not uniformly spaced beneath the swimming pool. *Figure 2* illustrates non-uniform support beneath the pool, creating eccentric loading, which will create differential deflection of the slab and cause the pool to lean in one direction. If eccentricity

Often, the building structural engineer designs concrete slabs with an anticipated deflection of $L/360$, where L equals the span length between the supports (ACI 318, immediate deflection due to live load). For example, a 20-ft.-wide rooftop swimming pool with wall supports located directly beneath the swimming pool walls, can be expected to suffer 0.7 in. of deflection at its center. This amount of deflection is more than sufficient to develop cracks in a pool structure.

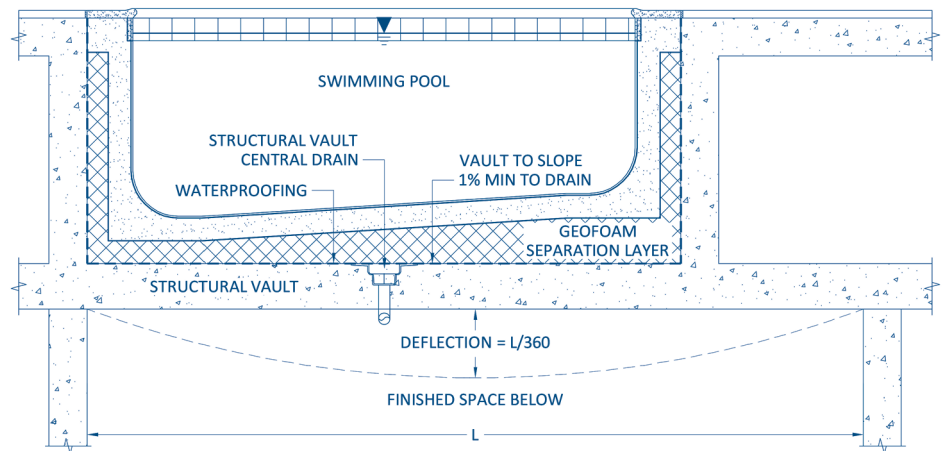
Figure 2 – Illustration of pool slab with eccentrically spaced structural support. This condition shows differential deflection of a vault, causing racking and twisting of pool shell.

exists in both directions, the pool can rack or twist—a far more serious structural condition. This deformation not only increases the risk of structural cracking, but also results in a pool that is not level. Rim flow pools with deck-level gutters can be very problematic, as they require the rim to be perfectly level for proper operation.

additional structural support—including a stiffer slab, beams, columns, or walls—can be installed to reduce the span length and the resulting vertical deflection. The design of the swimming pool support structure should be planned to provide uniformly spaced support under the pool and thereby eliminate differential deflection.

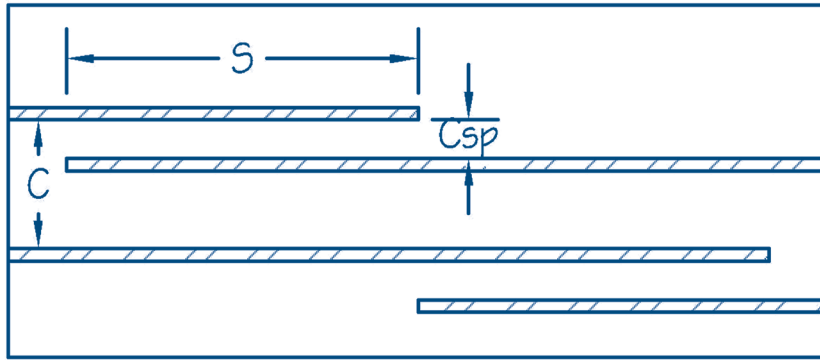
SHOTCRETE REINFORCEMENT: NON-CONTACT LAP SPLICE

S: LAP SPLICE LENGTH - VARIES, SEE PLANS

C: CLEARANCE - 2½" MIN FOR #5 BARS AND SMALLER
6 bd FOR #6 BARS AND LARGER

C_{sp}: SPLICE CLEARANCE - 2" MIN

Figure 3 – Non-contact lap splice method.

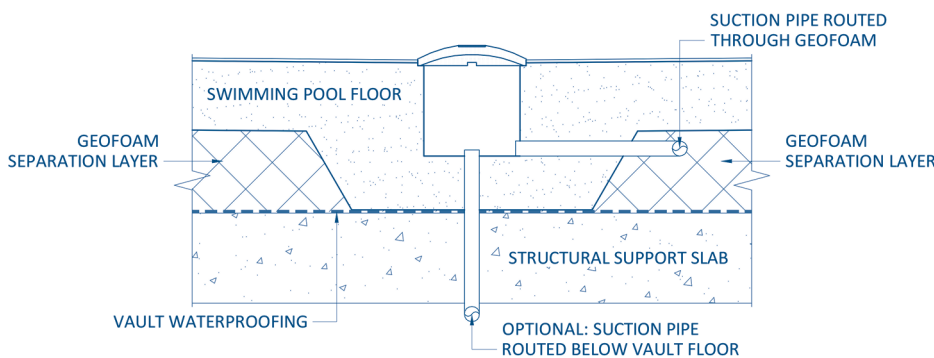
Figure 4 – Piping penetrations should be routed either through the geofoam or beneath the slab. Never embed piping through the pool structure.

A rebar schedule consisting of #5 bars at 5 in. on-center is the maximum reinforcement schedule the building code allows in shotcrete/gunite construction without building and testing preconstruction test panels. Many rooftop pools are specified with this reinforcement schedule. In order to reduce shadowing behind the rebar and maintain the utmost structural integrity, it is important to use the non-contact lap splice method to tie all reinforcement (Figure 3). Furthermore, all plumbing pipes should be routed either through the geofoam separation layer or beneath the structural slab (Figure 4). Plumbing pipes should never be embedded in the gunite/shotcrete swimming pool shell because the pipe creates a thin structural section at the pipe location where cracking can develop.

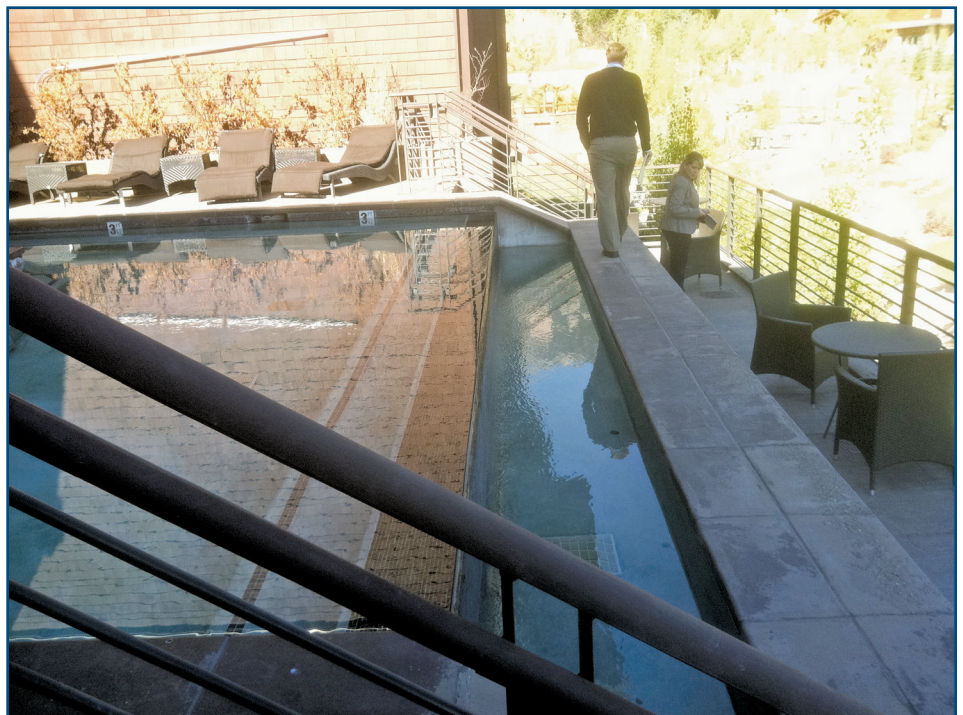
A new Wyoming ski lodge that incorporated a rooftop spa was constructed in 2009. The 300-sq.-ft. spa was 3 ft. deep and included a 26-ft.-long vanishing edge (Figure 6). The spa was located on the third-floor balcony and was built over a ballroom/banquet room. The spa was constructed inside a concrete vault, and the vault received a comprehensive waterproofing and drainage system similar to the recommendations herein. The interior surface of the vault was waterproofed with an approved water sealant product, and the entire vault

Figure 6 – Spa with vanishing edge built on third-floor balcony.

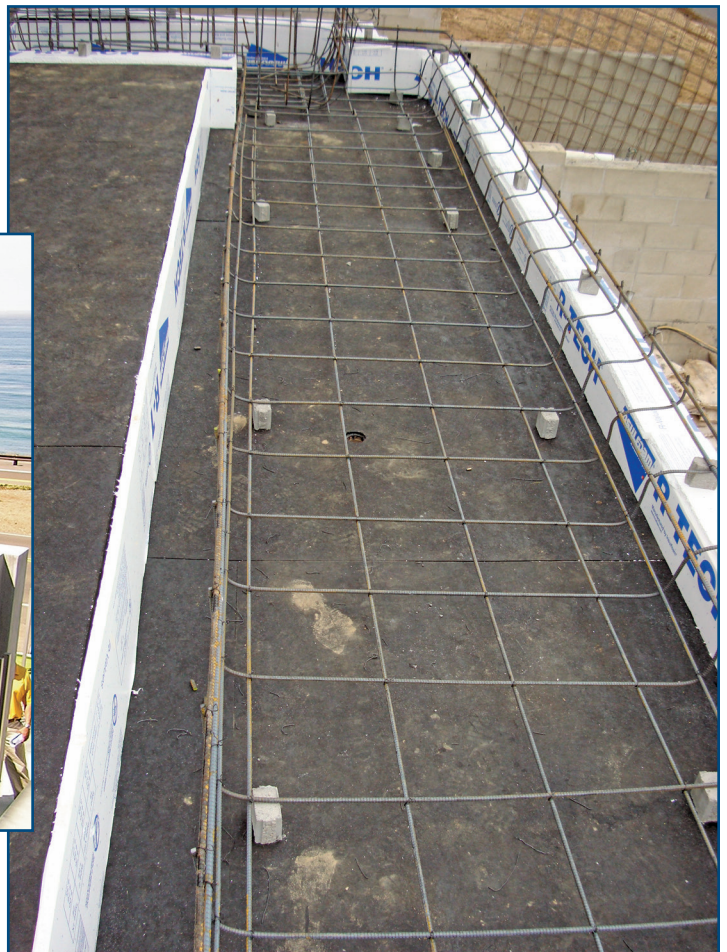
Figure 9 – Geotextile drainage composite laid flat.

This vanishing-edge rooftop swimming pool (Figure 8) was constructed at a beachfront residential home in San Diego, California. The pool was constructed over a pool equipment room, garage, and finished living space. The pool was underlain by a geotextile drainage composite and included foam insulation as a separation layer. However, waterproofing of the structural slab was insufficient, and the geotextile drainage composite was laid flat (Figure 9) so that accumulated water would not drain to the inlet. The pool structure was also under-reinforced.

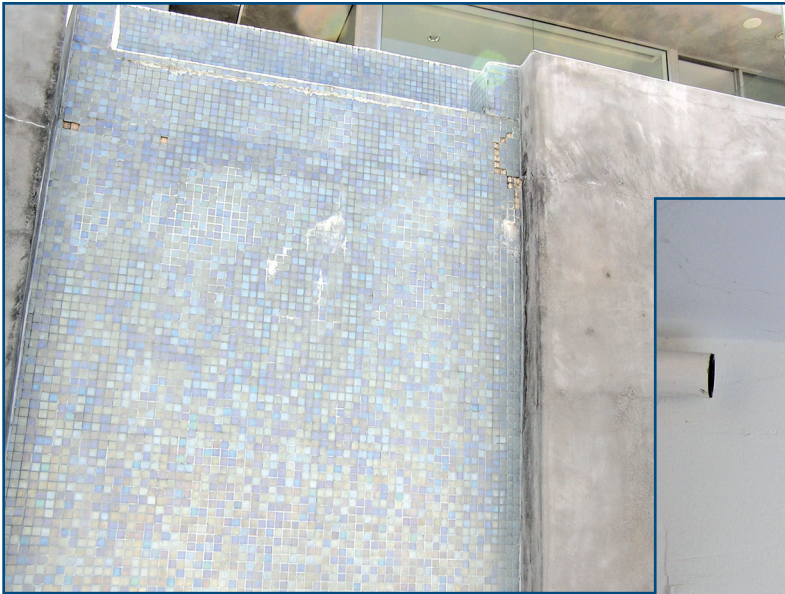
Figure 10 - Efflorescence and tile delamination due to water intrusion.

When the pool ultimately developed a leak, the water collected in the drainage layer had no ready means of egress. What resulted was a multitude of water penetrations into both interior and exterior spaces. Significant water intrusion with efflorescence developed in the exterior foundation walls, mosaic tile delaminated due to the water pressure, and water intrusion entered interior spaces, causing flooding, mold, and damage (Figures 10 through 13).

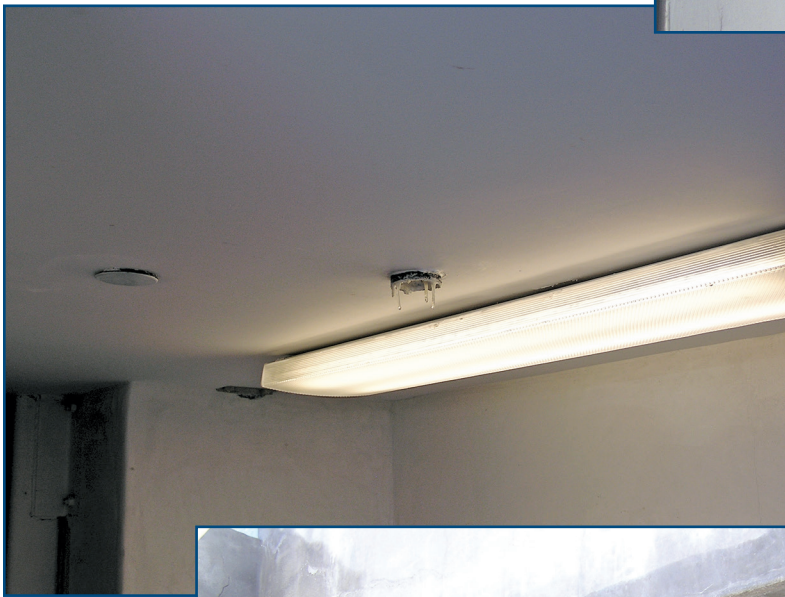
Figure 12 - Water leaking through residence utilities. Note the formation of stalactites from chronic leakage. The swimming pool is directly above this finished living space.

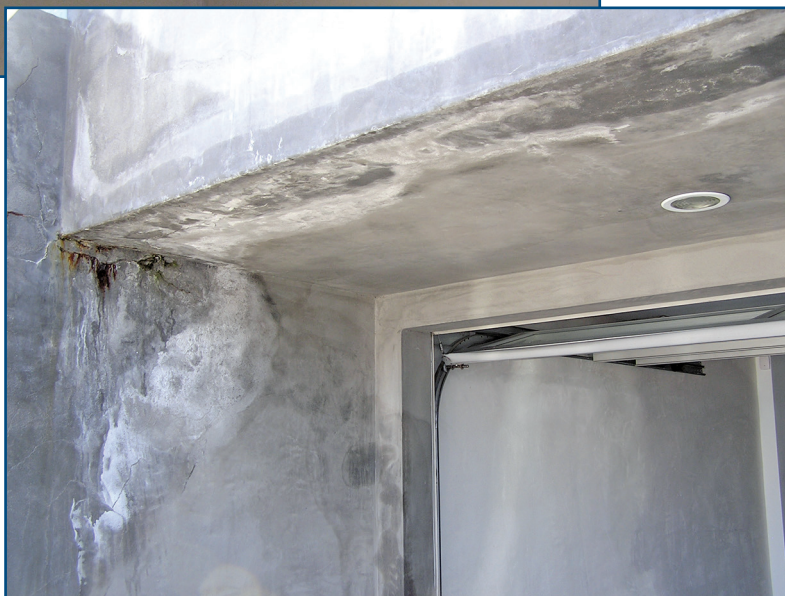
Figure 13 - Exterior leaking, efflorescence, structural cracks, and rust.

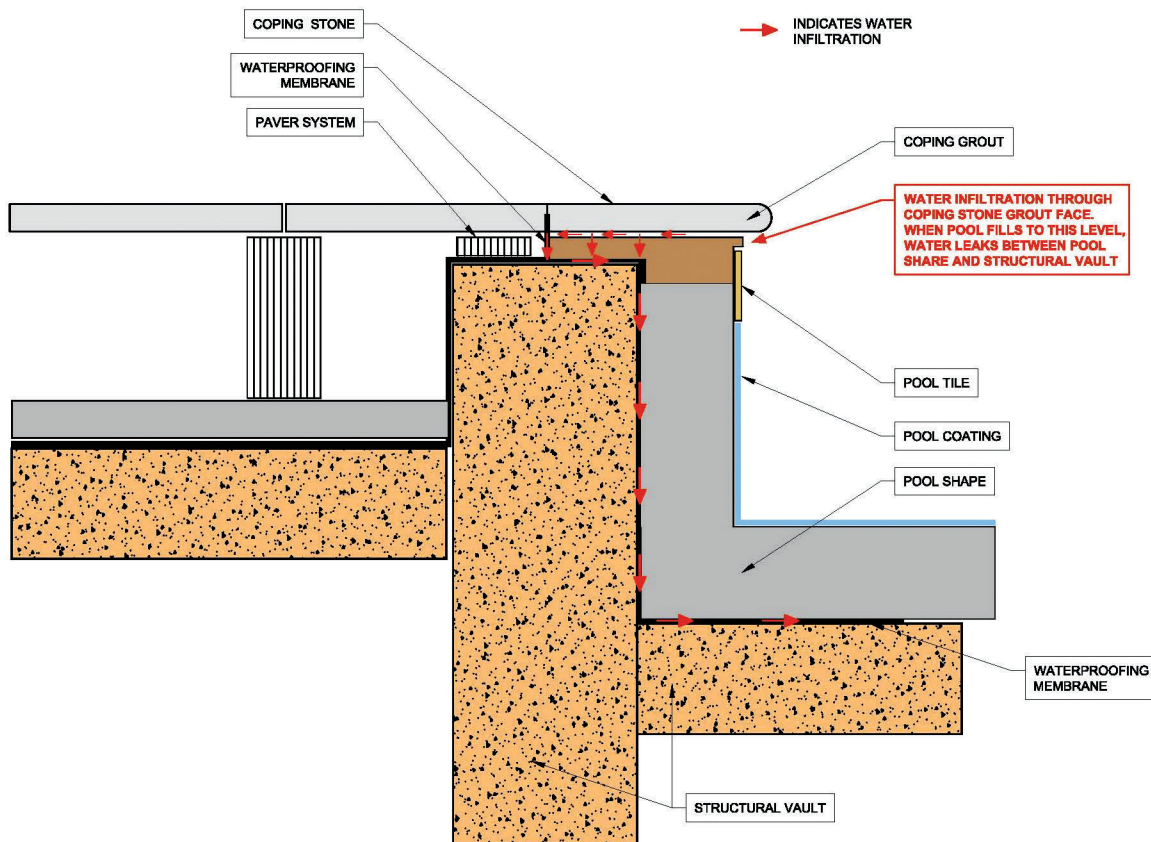
Figure 16 – Pool construction showing water infiltration.

overflow system in place to control the water level of the pool. The pool was filled to just below the top edge of the copingstone under the assumption that excess water would leak through the front mortar joints on the bottom of the copingstone (*Figure 16*). Once the pool was filled above this mortar joint, the measured leak volumes increased substantially in a short period of time. The level of the pool lowered from the center of the copingstone to just below the mortar joint of the pool tile overnight.

The coping stone was removed, and it was discovered that the waterproofing was not continuous, resulting in water infiltration at the intersection of the pool wall and the

vault wall beneath the coping cap. Following the discovery, a continuous waterproofing system was applied beneath the coping stone, resulting in a significant reduction in the moisture intrusion experienced in the parking garage.
