31ST RCI INTERNATIONAL CONVENTION AND TRADE SHOW

MOISTURE MIGRATION: CAUSES AND CURES

BRIAN P. CHAMBERLAIN

CARLISLE CONSTRUCTION MATERIALS

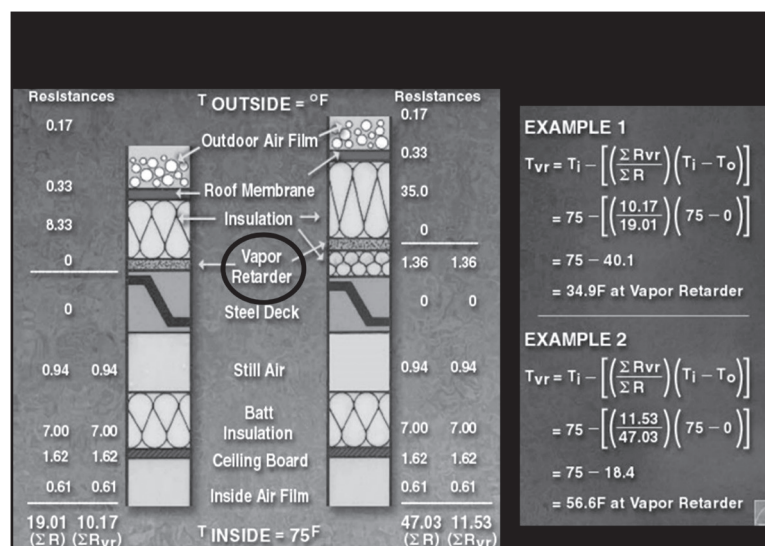
Figure 1 – ASHRAE dew point calculations.

Determining if a vapor barrier is necessary can get complicated mathematically. The American Society of Heating, Refrigerating and Air-Conditioning Engineers (ASHRAE)³ (Figure 1) and Oak Ridge National Laboratory (ORNL)⁴ have methods explaining how this can be determined.

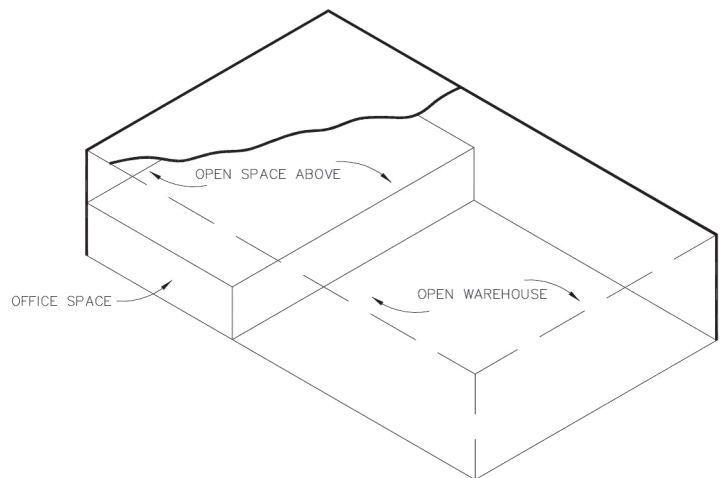
Figure 3 – New construction office/warehouse.

A developer saw the opportunity to build an office/warehouse in a northern climate. He has no idea who the end-user will be. The designer of record specified an office inside one area of the open warehouse. The designer knows that the inside warehouse area will have the same RH as the exterior RH, so he determines there will be no vapor drive, so a vapor barrier is necessary. The office space might need to be addressed with a vapor barrier at the walls and ceiling, but not the warehouse. The building is built, and the developer finds a buyer (Figure 3).

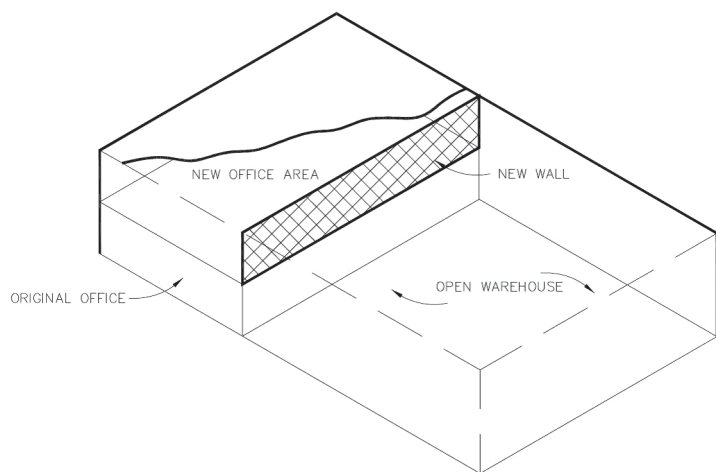
Figure 4 – Addition of new office space.

Once the building is purchased, the new owner sees the open space above the office as a place to add more office area. He has it renovated so the upper area is enclosed, using the original interior wall and extending it up to the structural deck. The owner decides to heat the new office space with gas heat, which is hot and humid pumped air, for the comfort of the employees (Figure 4).

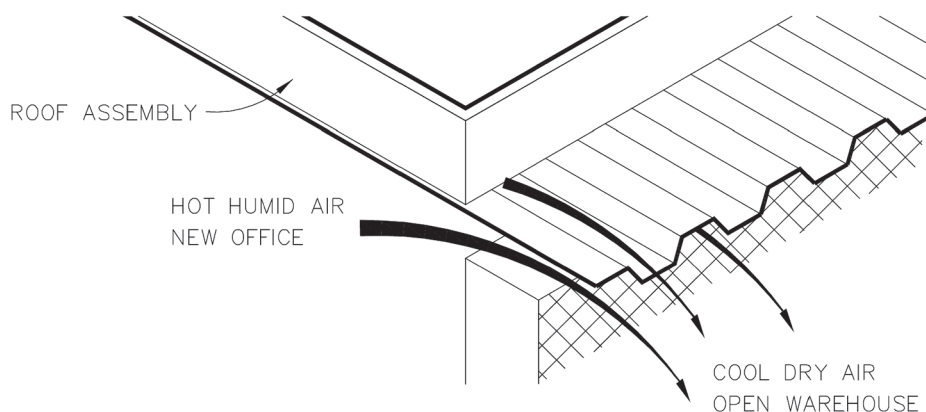
Figure 5 – Moisture migration from office to warehouse.

The result was that the hot humid air from the new office space migrated not only into the roofing assembly, causing condensation, but also migrated down the flutes and entered into a portion of the warehouse (Figure 5).

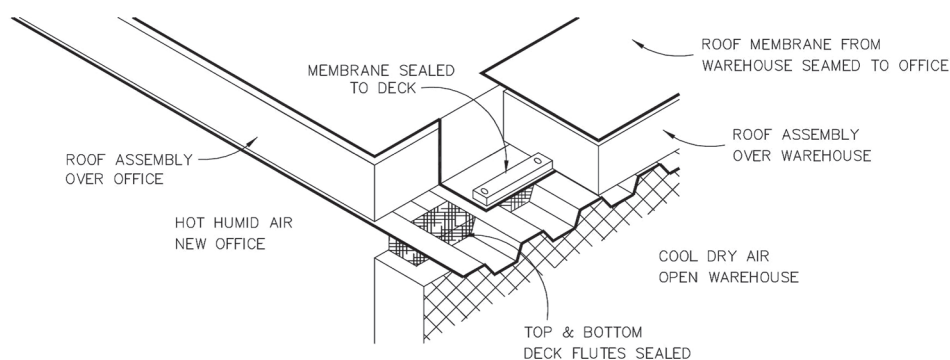
Figure 6 – Detail correction.

The correction of this issue with the roofing system and the interior was filling the flutes from underneath the deck and the top. This involved removing a section of the roofing membrane to expose the deck

and then seal any possible airways into the warehouse (Figure 6). Due to cost, the roof over the office space was switched to a black membrane to assist in mitigating the condensation under the membrane to avoid complete removal of the existing roofing assembly.

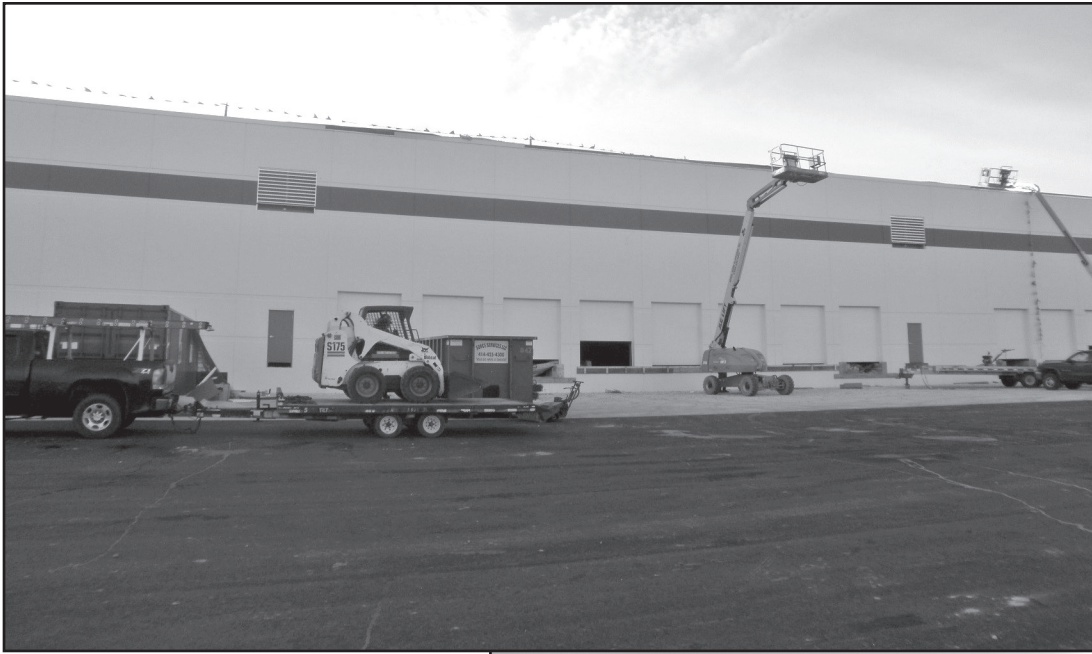
Figure 7 – New roofing assembly being installed.

A scenario has been reported and documented as follows. After the exterior walls and roof deck of a warehouse were put up, the contractor was asked to install the roof system. Since this was a warehouse, the designer of record decided a vapor barrier was not necessary, so none was included. The contractor saw no reason to wait, so he completed the roof assembly quickly (Figure 7). Soon after, the schedule for the pouring of the concrete floor on the interior started (Figure 8).

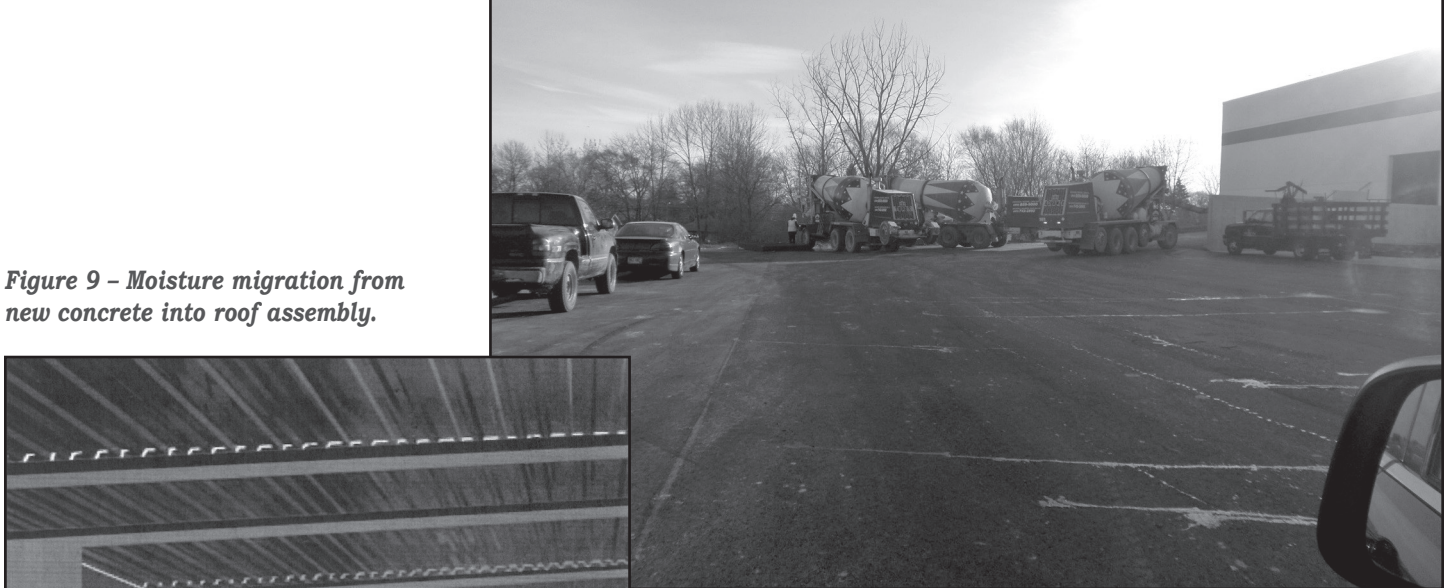
Figure 9 – Moisture migration from new concrete into roof assembly.

Since the roof assembly has insulation installed directly on the deck, the deck is kept warm from the interior, so the vapor moisture bypasses this location through joints and openings and continues up into the roof assembly, looking for a point to condense. This location ends up being the underside surface of the exterior membrane (Figure 9).

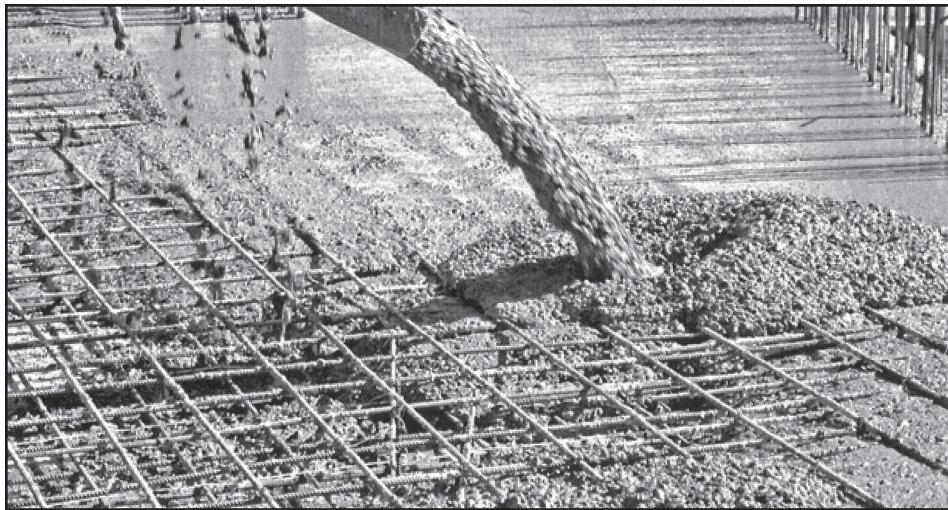
Figure 10 – Pouring of concrete deck.

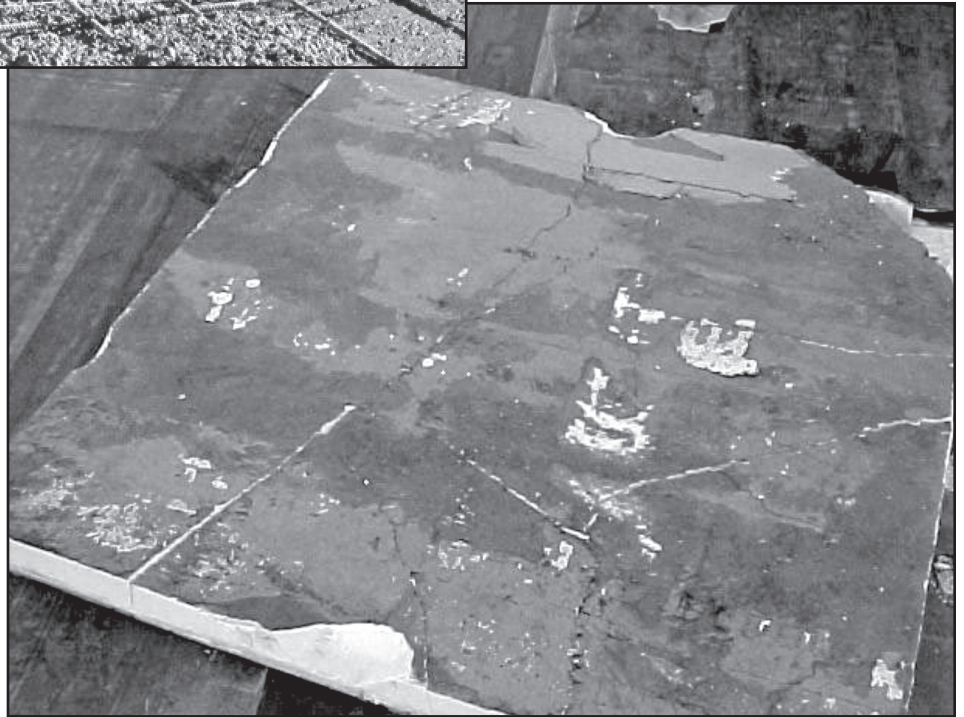
Figure 11 – Roof damaged from condensation.

Twenty-eight days is a concrete industry standard curing period and is generally sufficient to achieve a structurally sound substrate and a dry surface for the roof assembly. But while the exterior surface of the concrete deck may be “dry to the touch” for proper adhesion, there is a possibility of moisture being trapped within the concrete either from the original pouring process or from a weather event. The trapped moisture through natural vapor drive conditions (depending on the time of year) could be driven upward as a vapor and condense directly under the primary membrane. If excessive moisture condenses within the roof assembly, this moisture might harm the insulation (Figure 11) and possibly affect the long-term wind uplift resistance of the system.

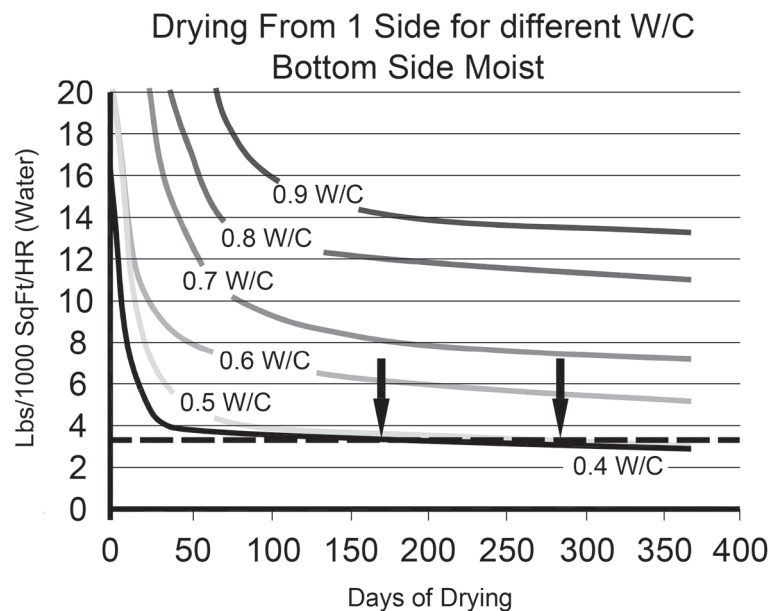
Figure 12 – Four-inch-thick concrete at constant room temperature and RH of 60%.

The chart in Figure 12, from Karnare’s “Concrete Floors and Moisture,”⁵ shows how many days it would take to reach the acceptable level of 3 lbs./1,000 sq. ft./hour based on different water-to-cement ratios. The study shows the best case ratio is over 150 days. Most are over a year in duration.

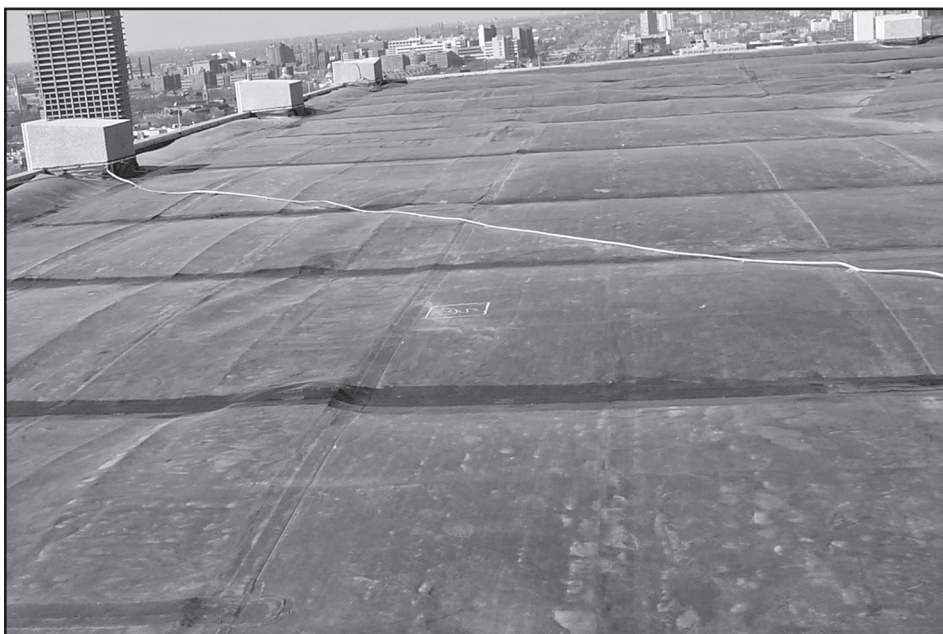
Figure 14 – Floating adhered membrane assembly.

systems either were installed with fasteners to hold the insulation in place (including the plastic that was used as a vapor barrier), or they had been adhered with a flood coat of asphalt. Asphalt installed in this fashion can be used as a vapor barrier. It was not until the industry started to use two-part urethane adhesive applied in ribbons as an option to adhere insulation to concrete decks without a vapor barrier that the issue emerged. As the moisture from the concrete migrated into the roof assembly between the ribbons, the moisture condensed. Sometimes the moisture would flow back to the deck surface during the spring and summer, where it would saturate the paper facer of the polyisocyanurate. The roof assembly would delaminate from the bottom, causing the roof assembly to float (Figure 14).

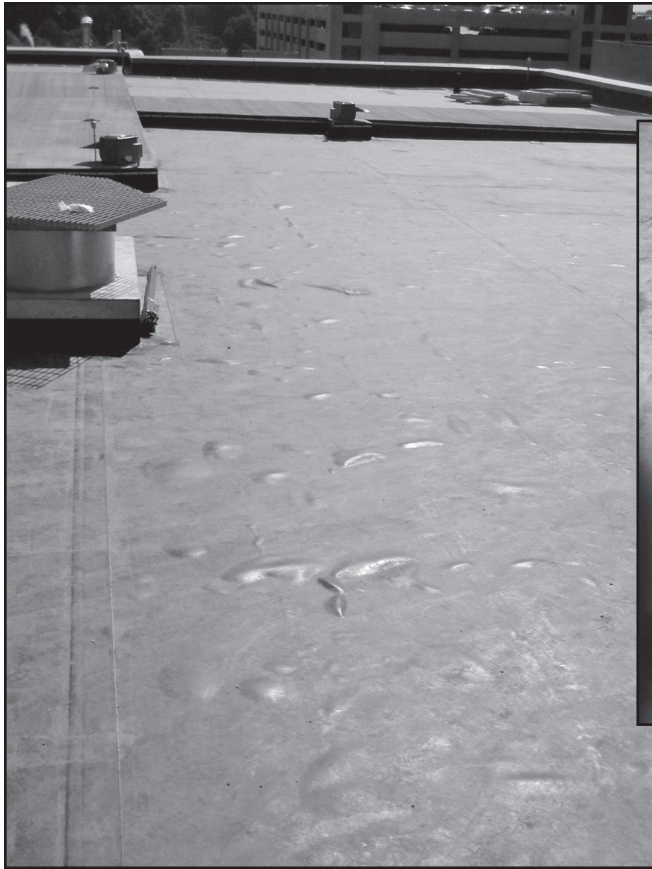
Figure 15 – Membrane coming loose.

In a very short period of time, it was found that this roof was not adhering, and many areas had become loose (Figure 15). When the contractor cut open the loose areas, condensation was found under the membrane (Figure 16).

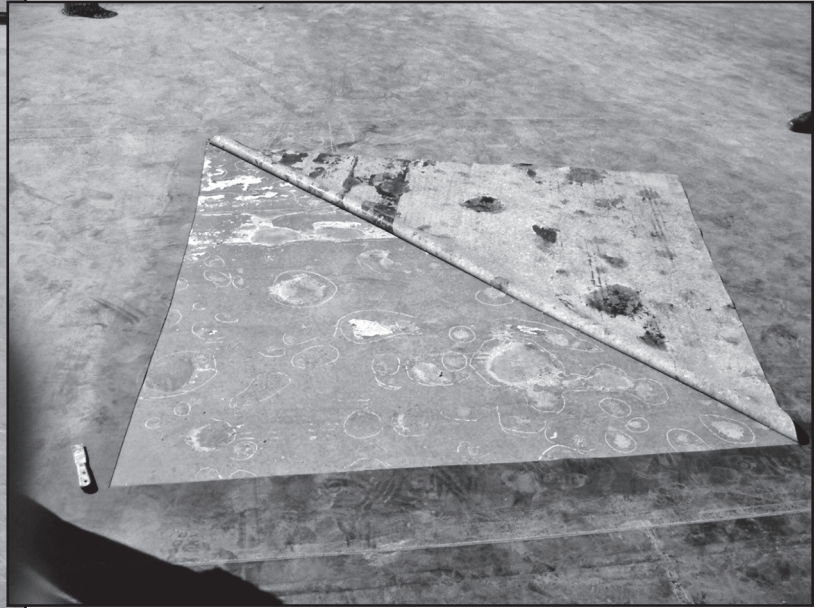
Figure 16 – Membrane losing adhesion because of moisture.

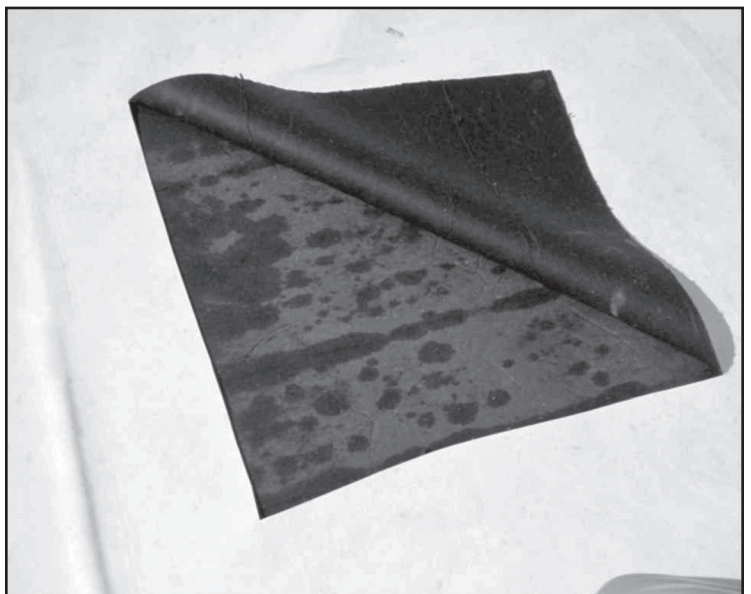
Figure 17 – Inter-ply failure of insulation facer from condensation.

In other cases, condensation damage was not discovered until much later, when the moisture had migrated into the adhered roof membrane assembly during the winter and condensed under the membrane, saturating the top paper facer of the polyisocyanurate, weakening the facer’s physical structure. Later a wind event occurred, and because of the weakened nature of the paper facer, delamination of the membrane was discovered. Upon investigation, it was recorded that paper facer was found on the membrane and on the insulation. This is what is referred to as an “inter-ply failure of the facer,” which has always been a strong indication of moisture infiltration (Figure 17).
