BUILDING ENVELOPE TECHNOLOGY SYMPOSIUM

EXTERIOR-STAIR WATERPROOFING: ASSEMBLING THE PUZZLE

SIMPSON GUMPERTZ & HEGER INC.

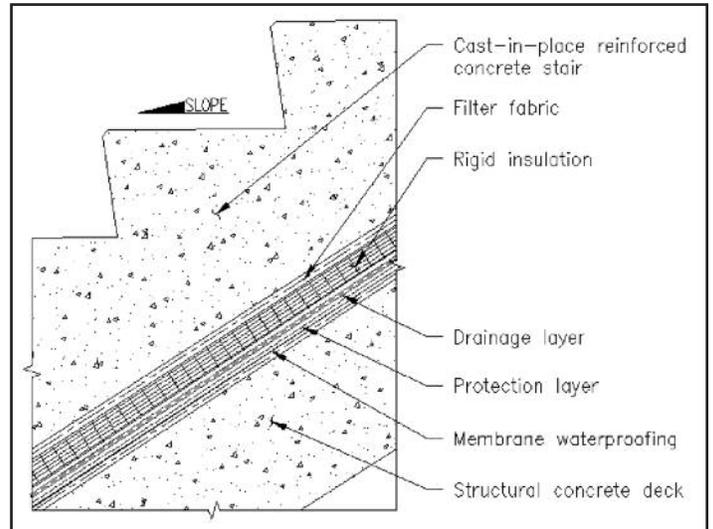
stair assemblies that consist of the following components, from interior to exterior (or from bottom to top). See *Detail 1*.

- Structural deck
- Waterproofing membrane with protection layer
- Drainage layer
- Insulation
- Filter fabric
- Overburden

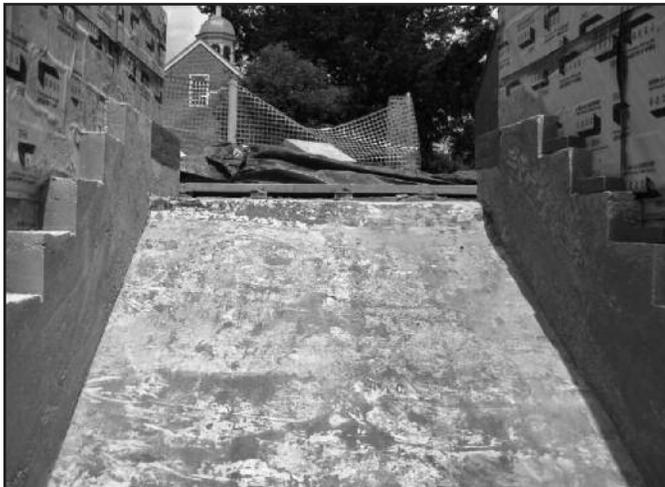
Elevated concrete stair decks are generally configured with either a uniformly sloped concrete slab (*Photo 1*) or a stepped concrete deck (*Photo 2*). Regardless of the deck configuration, the membrane should be applied to a reasonably smooth, dry, and properly sloped surface.

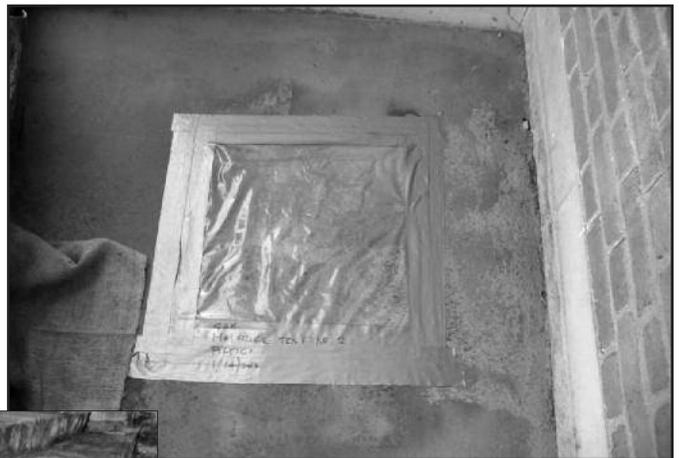
waterproofing system should include a membrane level slope of one-quarter in per ft to provide reliable membrane-level drainage (Photo 3). Slopes lower than one-quarter in per ft provide little margin for error in concrete placement or to accommodate long-term deflection, provide less-reliable drainage, and thereby reduce the durability of the waterproofing assembly. Stepped structural decks should include

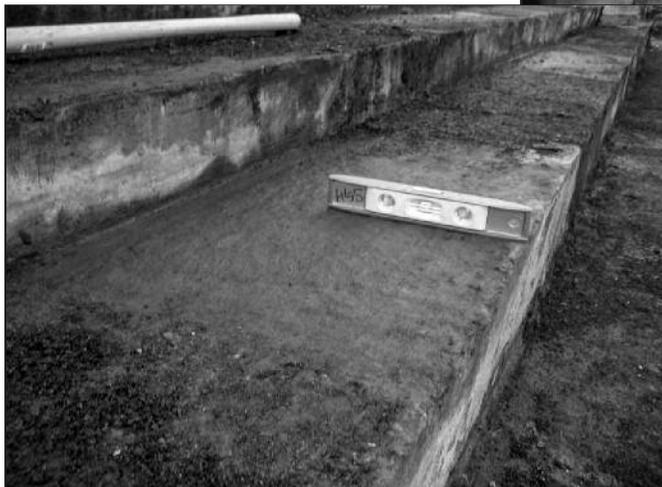
sure of concrete moisture that looks for condensation on the deck or a plastic sheet sealed to the deck (*Photo 4*), while ASTM F2170 is a quantitative measurement of the moisture within a concrete deck. The former is a rather unsophisticated measurement that is easy to perform in the field but may provide misleading results, while the latter is a more scientific test, but it requires specialized equipment to conduct.

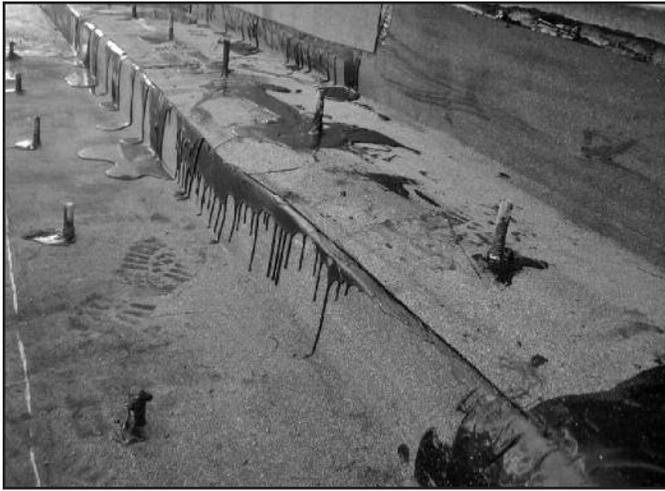
a minimum of 8 in above the walking surface of the stairs to raise the transition out of the “wet zone” (*Photo 6*). Lower transitions can be damaged in service and may allow water to overtop and bypass the transition details. The installation of these transitions well above the “wet zone” of the stair assembly is critical to successful performance of the stair waterproofing. Stair membranes typically should terminate with a mechanical attachment to the rising wall to prevent detachment and require metal through-wall flashing integrated with the wall waterproofing to counterflash the top edge of the membrane and direct water onto the stair surface away from the membrane termination. Wall-to-stair transition details should also include provisions such as a removable metal skirt and protection plates to facilitate future membrane removal and replacement without requiring extensive removals or damage to the rising building walls.

Rising Walls and Curbs. Transitions between stair waterproofing and rising building walls or curbs are critical to provide a continuous and watertight building envelope. Reliable transitions should extend

attachment to the rising wall to prevent detachment and require metal through-wall flashing integrated with the wall waterproofing to counterflash the top edge of the membrane and direct water onto the stair surface away from the membrane termination. Wall-to-stair transition details should also include provisions such as a removable metal skirt and protection plates to facilitate future membrane removal and replacement without requiring extensive removals or damage to the rising building walls.

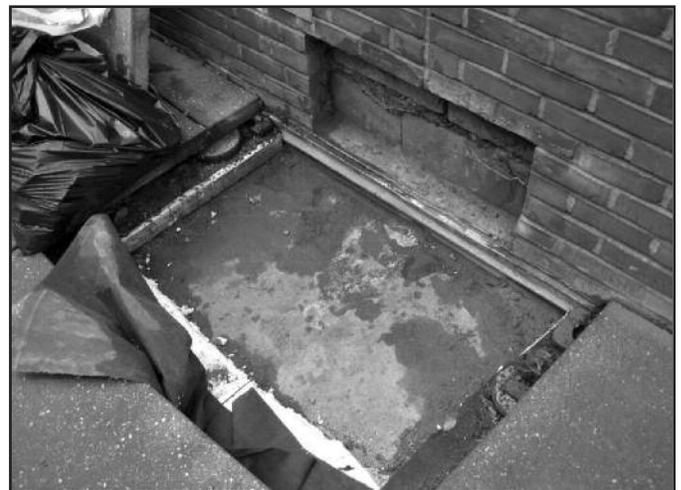
Protection Layer. Stepped concrete substrates can create problems with the installation of protection layers and drainage board. The protection layer must be installed so that it does not deduct from the slope of the stairs and does not allow standing water at overlap sections (*Photo 7*).

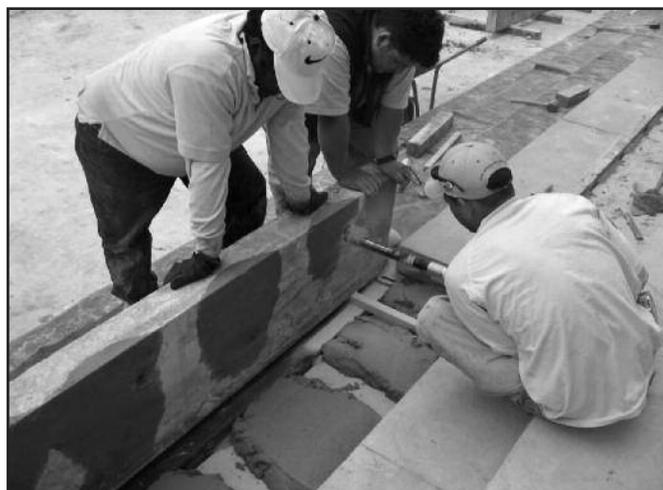
(see below), the mortar beds below the overburden should be spaced at approximately 12 in o.c. to provide a path for water to exit (*Photo 8*). Channels should run continuously on both the vertical and the horizontal surfaces of the concrete substrate. Where possible, we recommend the installation of a drainage layer in combination with drainage channels to provide optimal drainage and reduce the risk of efflorescence staining (see below).

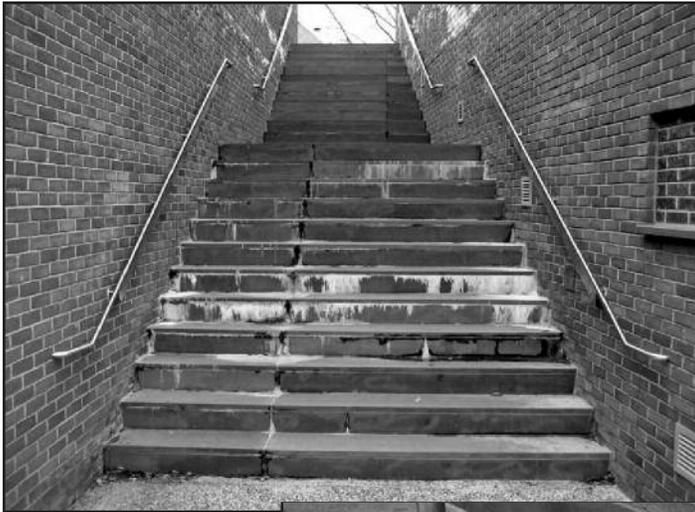
Staining and Efflorescence. On some recent field investigations, we noted significant efflorescence and staining on both the vertical and horizontal faces of the treads (*Photo 9*). Water travels through the mortar beds, dissolves soluble constituents, and deposits them on the exterior faces of the stairs as efflorescence. Drainage channels in the mortar-setting beds and drainage layers can provide a pathway for water flow and help prevent efflorescence or washout of the setting beds.

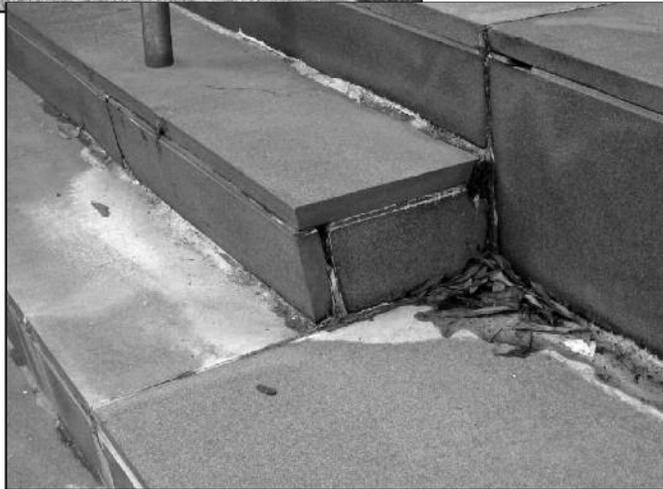
Loss of Attachment of Treads and Risers. Lack of or loss of tread and riser attachment can create an unstable surface. Washout, deterioration, and freeze-thaw damage (described above) of the mortar bed are common causes of loose treads and pavers (*Photo 10*). The designer should provide mechanical anchors or dowels to attach the pavers to the structural deck to prevent this phenomenon.

Freeze-Thaw Damage. Freeze-thaw damage from expansion of trapped water frequently plagues stone overburden assemblies with poor drainage. Water trapped within the assembly freezes and thaws with temperature cycles. This often leads to accelerated deterioration of the mortar bed.

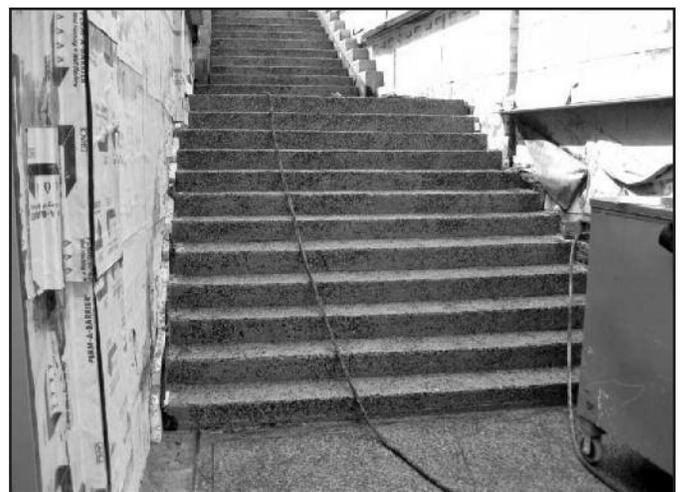
Contractors frequently form and pour concrete stairs directly against the waterproofing assembly (*Photo 11*). The construction of concrete stairs is composed of one monolithic pour or several pours with limited cold joints. Limiting cold joints helps to limit opportunities for water to penetrate the wearing surface. The exposed face of the cast-in-place stairs becomes the walking surface. Concrete is available in a variety of colors and finishes. However, the aesthetic appearance of cast-in-place concrete tends to be less desirable for certain applications (i.e., stairs on a monumental structure). Concrete stairs must be designed by a structural engineer to resist anticipated loads, account for thermal and differential movement, and address other environmental factors and are often continuously reinforced.

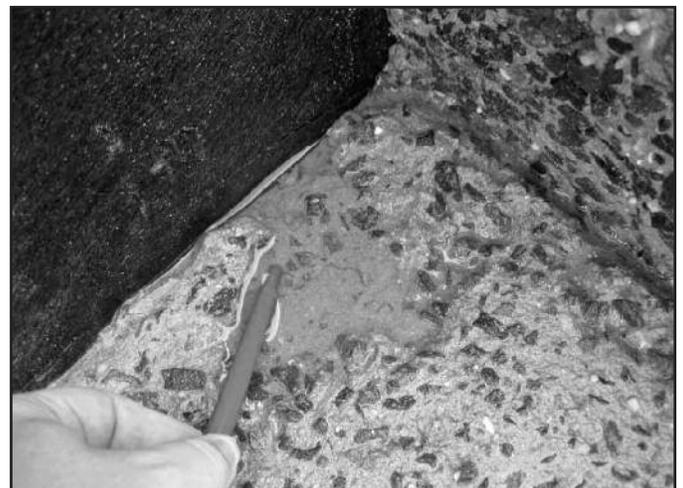
remove the paste with a high-pressure power washer with the following results (see *Photo 13*):

- Washout of paste and aggregate from several stair nosings
- Washout of paste and aggregate from the face of several risers
- Washout of paste and aggregate from the face of several treads

The project called for concrete stairs with an exposed aggregate finish. The contractor placed the stairs on a hot day during the summer. The concrete began to set rapidly while the contractor screeded and troweled the surface of the stairs. The contractor applied a retarder to the surface of the forms and the stair treads and returned to the site the following day to strip the forms and remove concrete paste to expose the aggregate. Due to the rapid set at the placement temperature, the paste was difficult to remove with a wire brush and low-pressure water as specified in the contract documents. The contractor decided to

The rapid set and finishing method utilized resulted in stair riser height variations that did not meet code requirements. The contractor removed and replaced the concrete stair overburden to meet code requirements and provide the specified finish. The time and expense of this overburden replacement could have been avoided with careful planning to place the concrete during conditions that would allow proper finishing.
