BUILDING ENVELOPE TECHNOLOGY SYMPOSIUM

THE DESIGNER'S DILEMMA: MODERN PERFORMANCE EXPECTATIONS AND HISTORIC MASONRY WALLS

BRADFORD S. CARPENTER, PE, LEED AP

SIMPSON GUMPERTZ & HEGER INC.

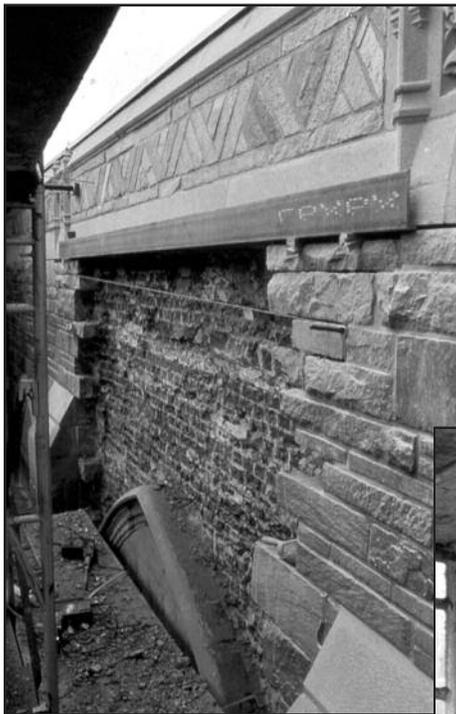
Figure 1 – View of stone masonry removal during a rehabilitation project to allow for the installation of dedicated waterproofing above window openings in an historic mass masonry wall.

These measures should include a careful survey of the exterior, combined with selective demolition and water testing to identify the sources of bulkwater penetration and allow for the design of appropriate repairs. Rehabilitation of the exterior wall system to address deterioration and damage to the original masonry materials, including repointing mortar joints and replacing cracked and damaged masonry elements, is the first step in improving the water penetration resistance of the system.

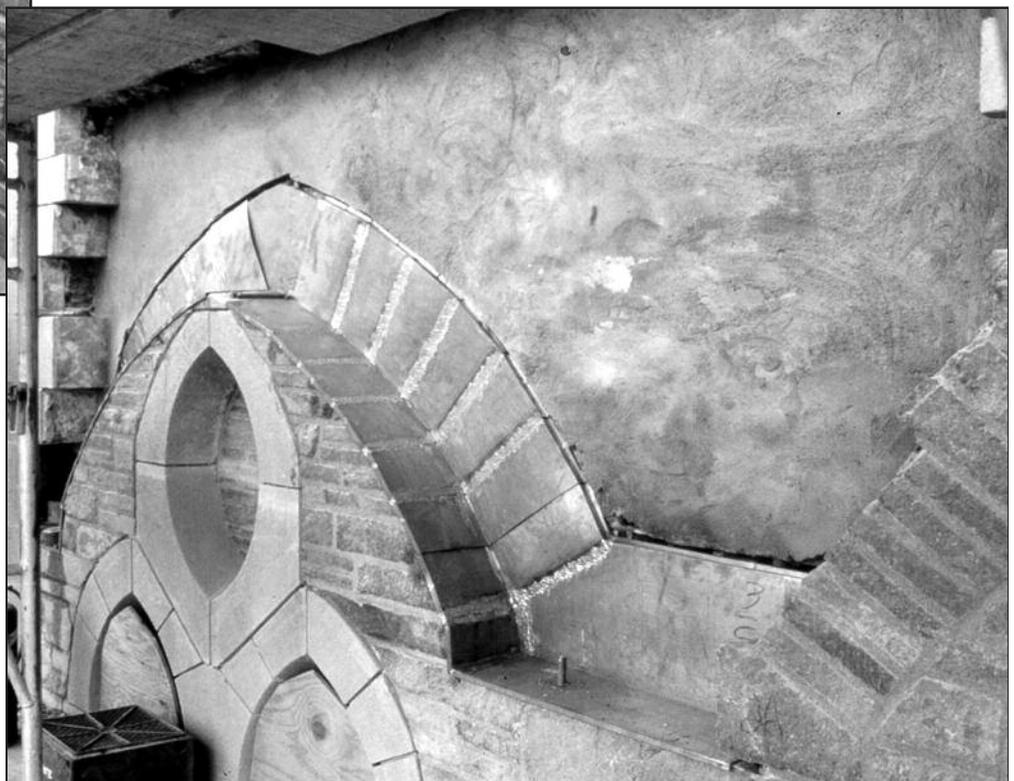
Figure 2 – View of dedicated waterproofing and flashing installation in an historic mass masonry wall assembly during a rehabilitation project.

In some instances, such as brick, stone, or other unit masonry construction, deficiencies in the original design can be addressed during rehabilitation, including detailing provisions that were overlooked or omitted in the original construction (Figures 1 and 2). These may include tried-and-true measures, such as adding through-wall flashings at wall openings, parapets, and railings and covering the sky-facing masonry materials with metal flashing. The addition of these measures offers reasonably predictable benefits that can be verified readily through the application of water testing. These measures, when correctly designed and executed, offer few drawbacks to the function of the masonry wall assembly. Water testing of completed repairs can provide a reasonable assurance of proper installation and efficacy of the repairs.

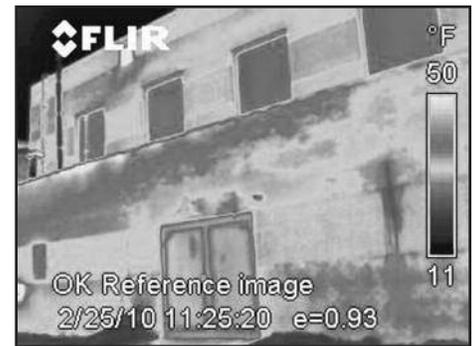
Figure 3 – View of a thermal image of a masonry building with window openings and a metal door. Note the higher temperatures are darker (reds and yellows in full color), indicating heat loss through the window glazing and frame metal door as well as the lower parapet in the photo.

Infrared thermography is another tool for identifying air leakage paths or thermal inefficiencies in the building envelope. The infrared camera produces images that show the temperatures of building materials at an instant in time (Figure 3). Anomalies in the temperature (i.e., cooler places) denote possible air leaks or a lack of thermal insulation. Additionally, infrared thermography can be used to validate improvements in the air barrier performance by taking comparative images before and after differential air tests on the assembly. The results of these

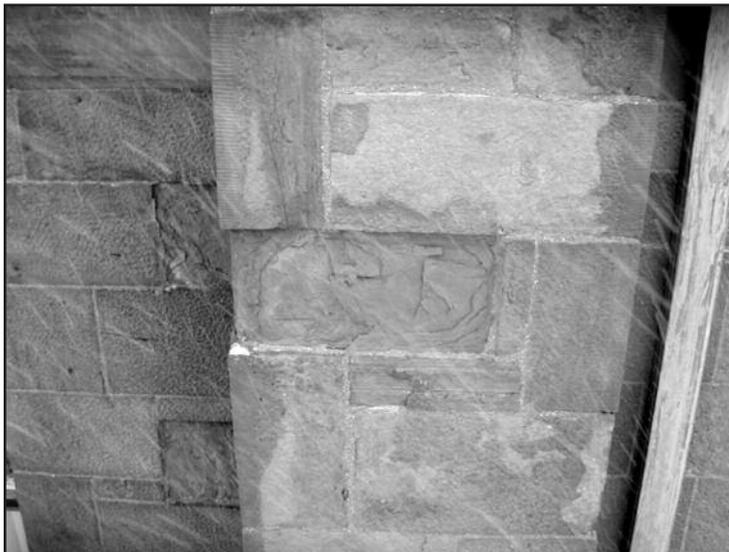
Figure 4 – View of stone masonry deterioration from freeze-thaw following the installation of thermal insulation on the building interior.

nity to dry. Masonry that is allowed to experience more thermal fluctuations in concert with exposure to water is at an increased risk of freeze-thaw damage that can degrade even the most robust masonry systems (Figure 4). The reduced masonry temperatures not only allow for more cycles below freezing but also drive the location of the freeze line farther into the masonry construction, away from the deliberate location of the most durable masonry materials and into the less durable backup materials. For example, the collar joint between granite masonry cladding and the brick masonry backup is typically filled with grout. Granite has a relatively high freeze-thaw resistance, whereas more absorptive materials, such as mortar/grout and brick masonry, have less resistance and can deteriorate more rapidly with exposure to increased freeze-thaw cycling and decreased material temperatures.

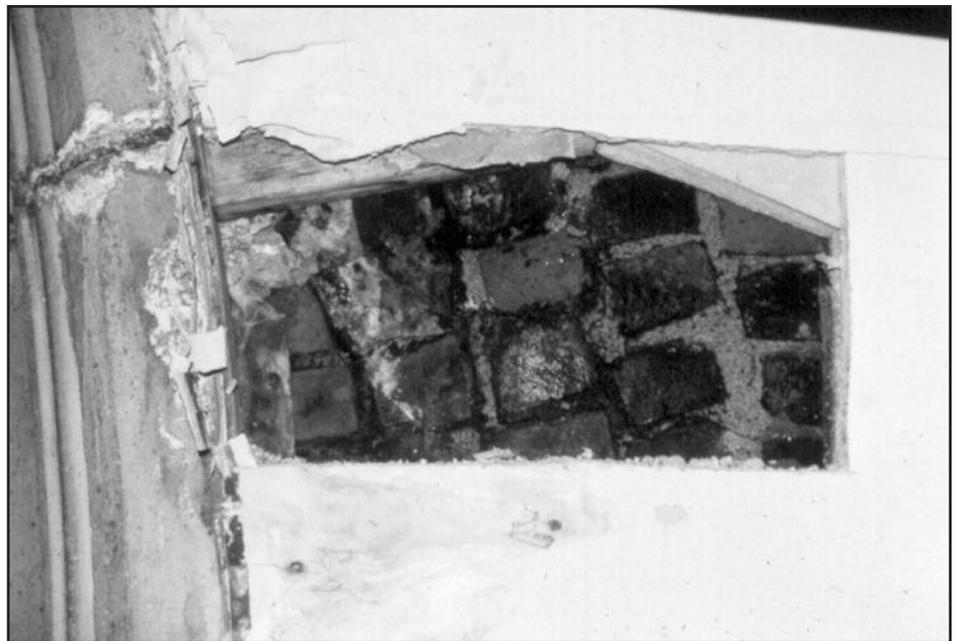
Figure 7 – View of moisture accumulation and masonry damage on the interior face of an historic masonry-wall system following the installation of extruded polystyrene (XPS) insulation behind the interior plaster finishes during a recent rehabilitation project.
