Improper Use of Self-Drilling Tapping Screws in Stucco Cladding

By Lonnie Haughton and Bobby Whitworth Jr., REWC

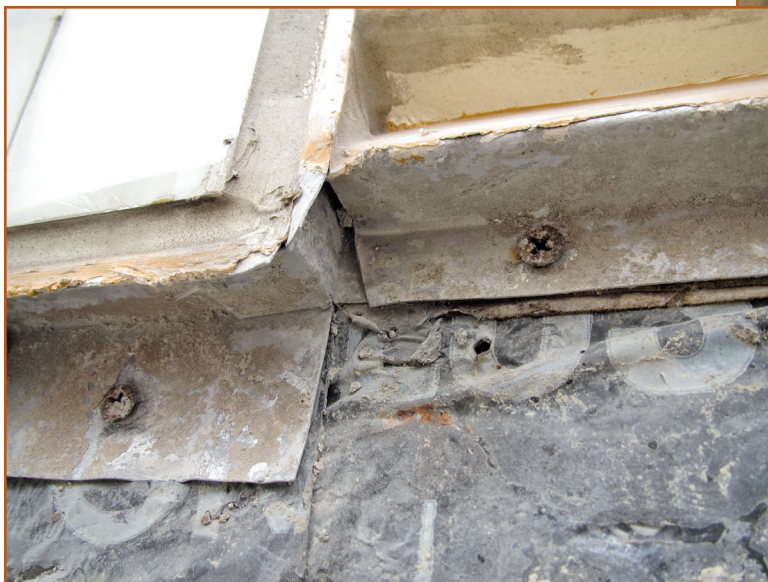
Consider a large wood-framed, stucco-clad school building constructed circa-2009 in a small coastal town in Northern California. The structure is highly exposed to storm winds blowing in from the Pacific Ocean. As evidenced by *Photo 1*, building envelope failures have resulted in extensive deterioration and fungal growth within weather-exposed wall assemblies.

Photo 1 – Building envelope failures at this school building have resulted in extensive deterioration and fungal growth within weather-exposed wall assemblies.

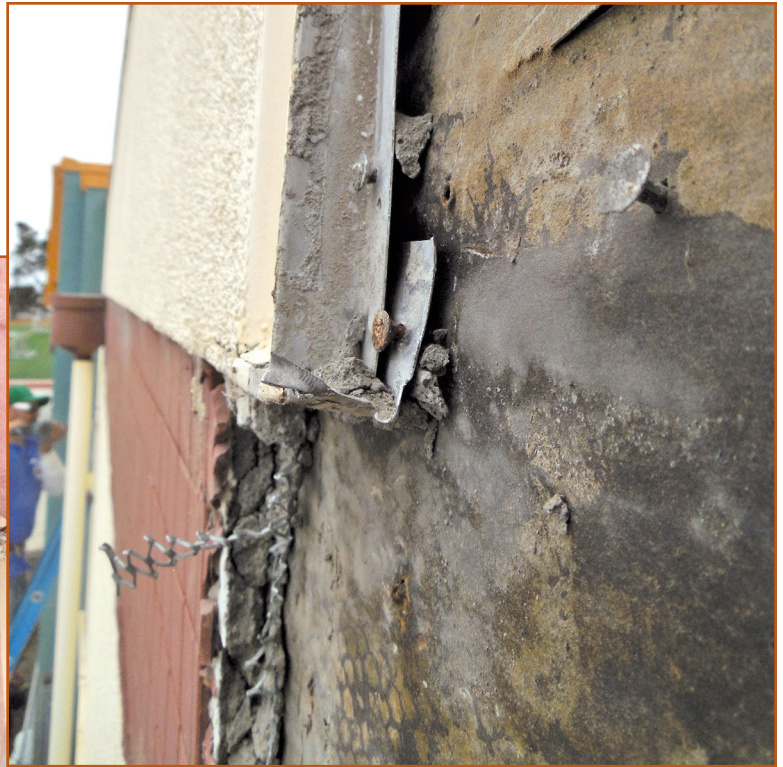
Photo 4 – The bugle-headed self-drilling tapping screws sit proud of the vertical reveal and the horizontal casing bead.

tersunk to accommodate the shape of the bugle head.)⁷ As documented with *Photos 2* and *4*, bugle-headed fasteners simply cannot fit flat to metal bases and accessories.

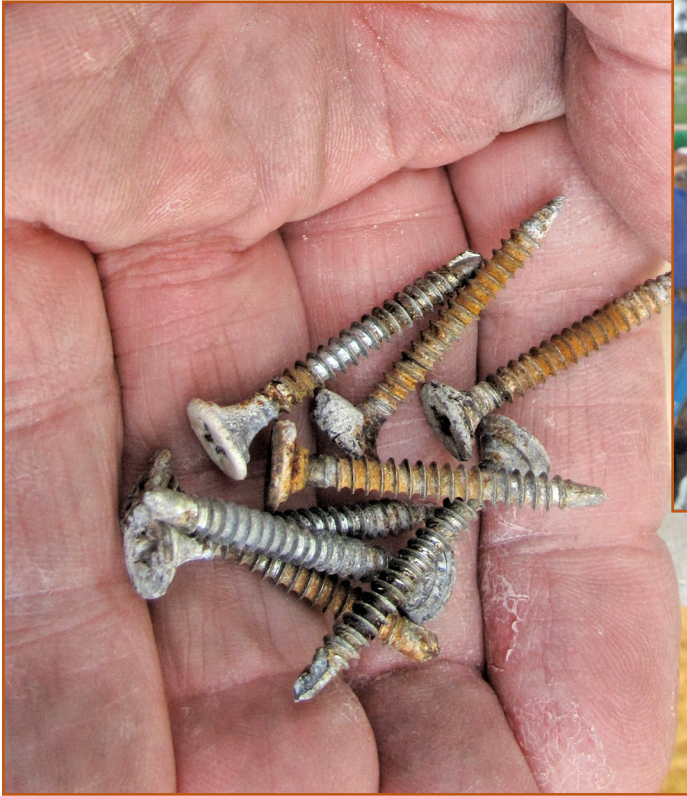
Photo 3 – Self-drilling tapping screws are equipped with hardened tips that resemble a drill bit. These 1¼-in. bugle-head fasteners had “the ability to drill their own hole” through the stainless steel components shown in Photo 2.

- **Self-drilling tapping screws**, most often used with thicker (up to ½-inch) steel sheets, have case-hardened tips (see Photo 3) that serve as a drill bit. In a single operation, self-drilling tapping screws have: “the ability to drill their own hole and form or cut their own internal mating threads without breaking.”³

graphs of as-built conditions at this building. For example, per *Photo 3*, the stucco installer used self-drilling tapping screws (typically intended for use with metal stud framing) at all elevations of the wood-framed building. We found no sharp-pointed screws.

- 1) Are not appropriate for use with wood stud framing
- 2) Are prone to improper “spin-out”
- 3) Fail to provide an adequate thread-mated structural bond with the wood studs
- 4) Generally tend to unduly damage the wood framing, sheathing, and asphaltic building paper
- 5) Fail to tightly interface with the stainless steel accessories
- 6) As evidenced by the stained/corroded screw threads seen in *Photo 3*, often are installed in a manner that pro-

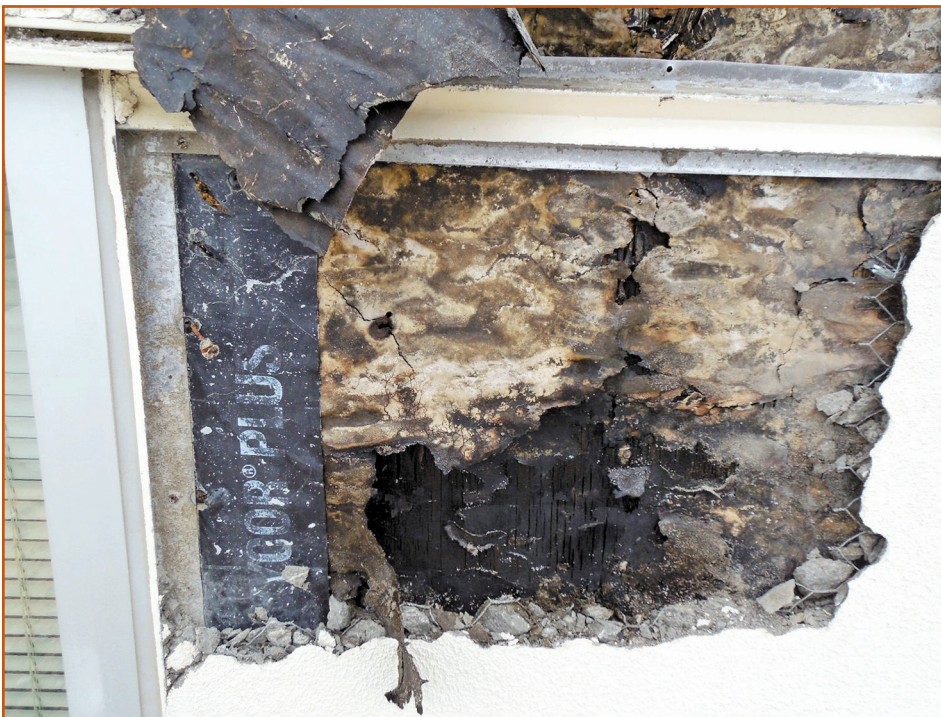
Photo 5 – Water infiltration through the exposed fasteners exacerbates resulting damage at the stud framing and sheathing.

Further, as indicated by *Photos 3 through 5*, we saw that the exposed, poorly secured tapping screws provided direct routes for damaging water infiltration through the building paper into the wood sheathing and studs.

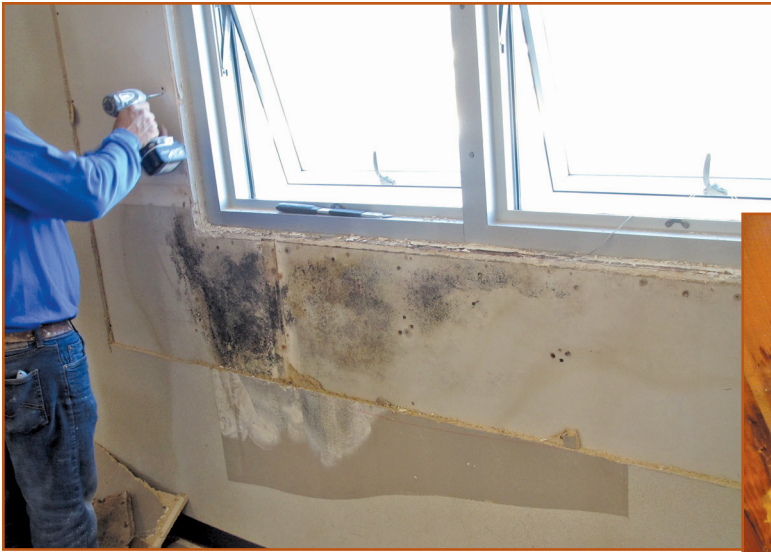
Photo 6 – Wet, degraded (and fungal-contaminated) gypsum wallboard layers were exposed below an upper window.

1. Our destructive investigation below an upper floor window exposed wet, degraded gypsum wallboard (see *Photo 6*). Removal of these fungal-contaminated panels confirmed our preliminary assessment that

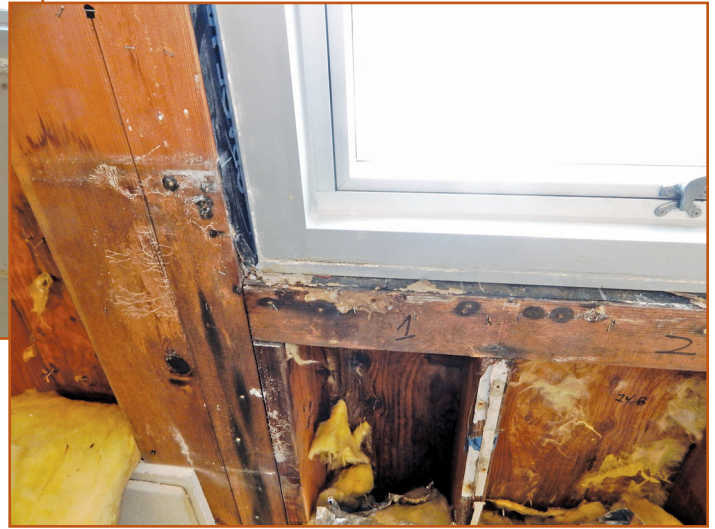
Photo 7 – Removal of the degraded wallboard revealed severely damaged framing and sheathing.

the wood framing and sheathing at this jamb-sill corner would also be wet and decayed (per *Photo 7*).

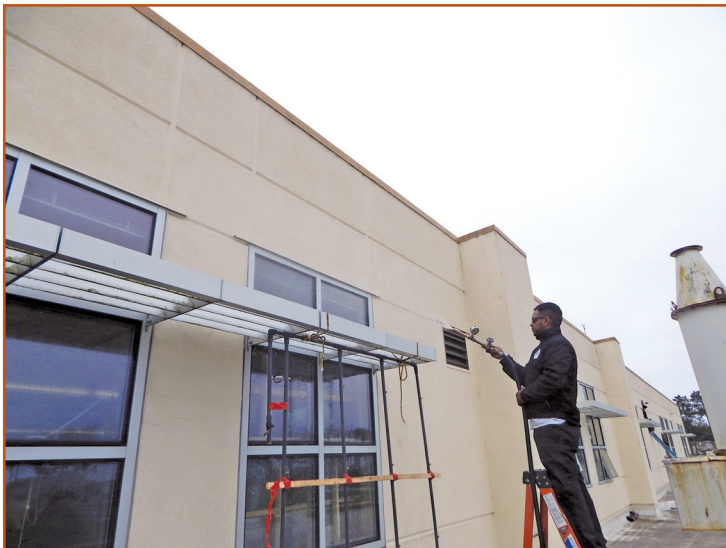
2. Our first step toward tracking the origin of this leakage was to water-spray test the bottom two-thirds of this aluminum storefront window assembly. (Note in *Photo 8* the standard ASTM E1105¹⁰ spray rack positioned below the awning framework.) No interior leakage was observed during this water test.
3. However, upon then spraying the upper right corner of this window (see *Photos 8 and 9*) with a pressure-calibrated nozzle (per test procedures established in industry stan-

*Photo 8 – AAMA nozzle testing at the upper right corner (see *Photo 9*) of this window produced interior leakage at the sill.*

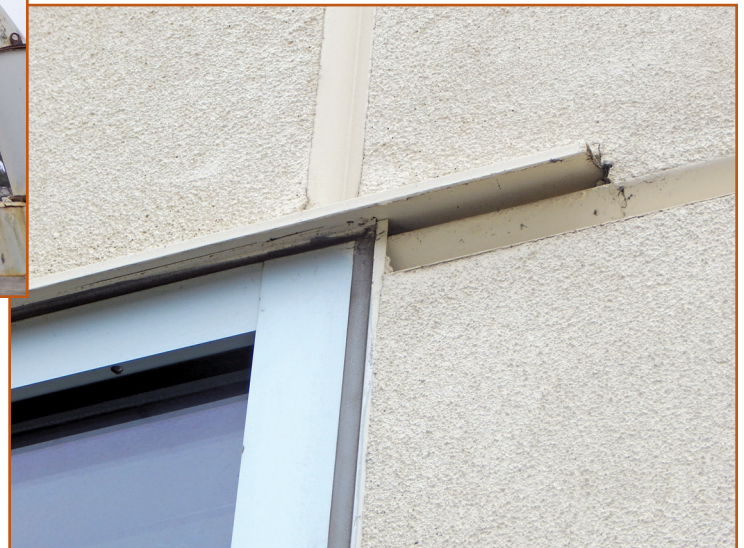
*Photo 9 – Nozzle spray testing (see *Photo 8*) at this corner of the window frame rapidly caused interior leakage at the sill.*

standard AAMA 501.2¹¹), we quickly were able to replicate a steady flow of interior leakage at the windowsill.

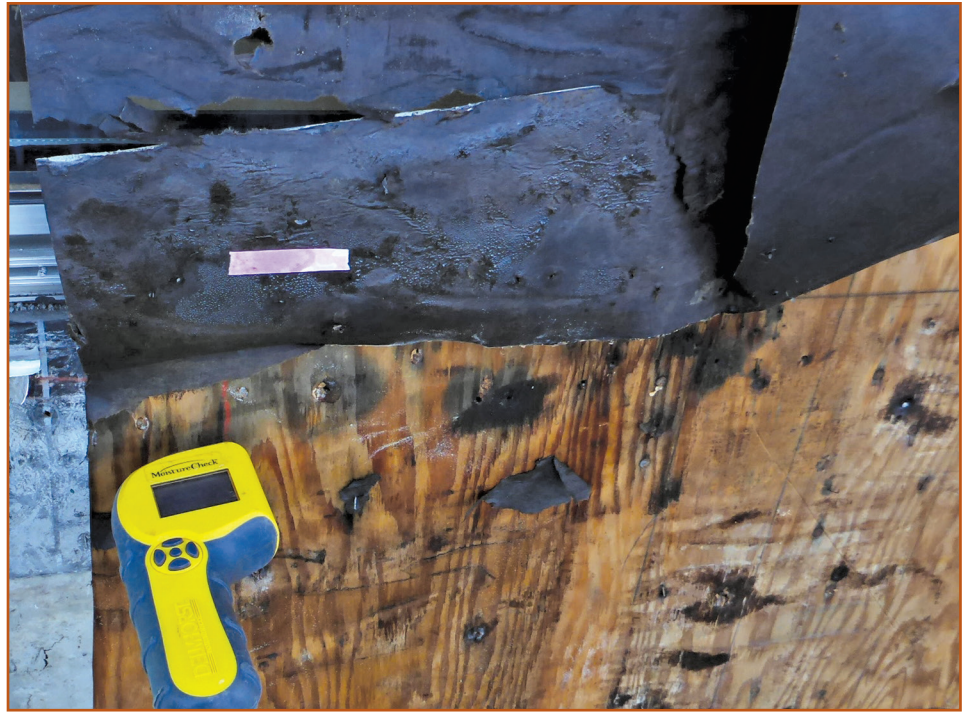
4. Our crew then removed stucco cladding below the exterior sill, revealing deteriorated plywood sheathing and free water (remnants from our water-spray testing) behind the building paper, per *Photo 10*. (The water-finding test paper¹² seen in this photograph turns red when in contact with free water.)
5. We then removed additional sections of stucco (*Photos 11 and 12*) in order to trace this water trail up the wall (behind the two layers of building paper) toward the window head. We discovered (per *Photos 13 and 14*) that the water trail continued under the horizontal stainless steel reveal, which was loosely set with self-drilling tapping screws and nails. (Note in these photographs the ripped and deteriorated building paper, which provides the infiltrated rainwater immediate access to the surface of the plywood sheathing.)
6. *Photos 15 and 16* conclusively estab-

Photo 10 – Water-finding test paper turns red when in contact with free water.

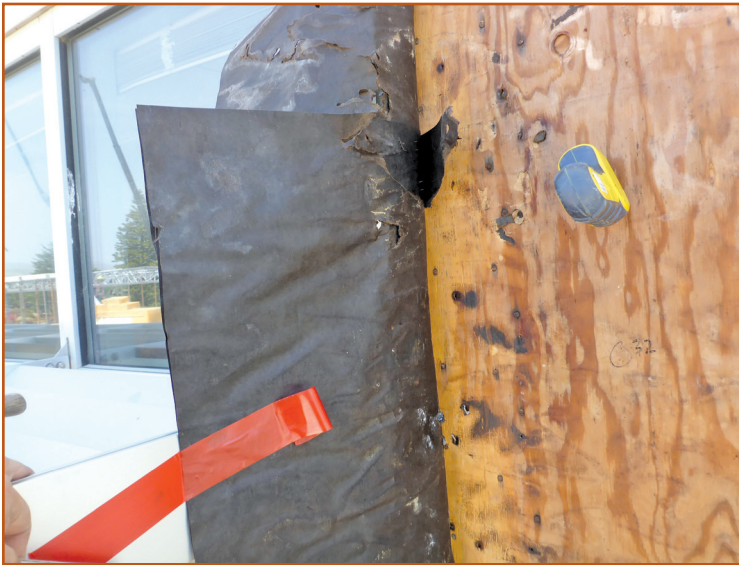
Photo 11 – We traced the water trail up the wall toward the window head (see Photo 12).

In short: Our step-by-step investigation demonstrated that rainwater flow off these horizontal components at the window head (*Photo 16*) drained behind the stainless steel reveal (*Photo 15*), then migrated through the ripped/damaged building paper (*Photo 14*) and continued down the sheathing (*Photos 11 and 12*), eventually collecting at the jamb-sill corner (*Photo 10*), then migrating inward, leaving a swath of decay, deterioration, and fungal growth (per *Photos 6 and 7*) in its wake.

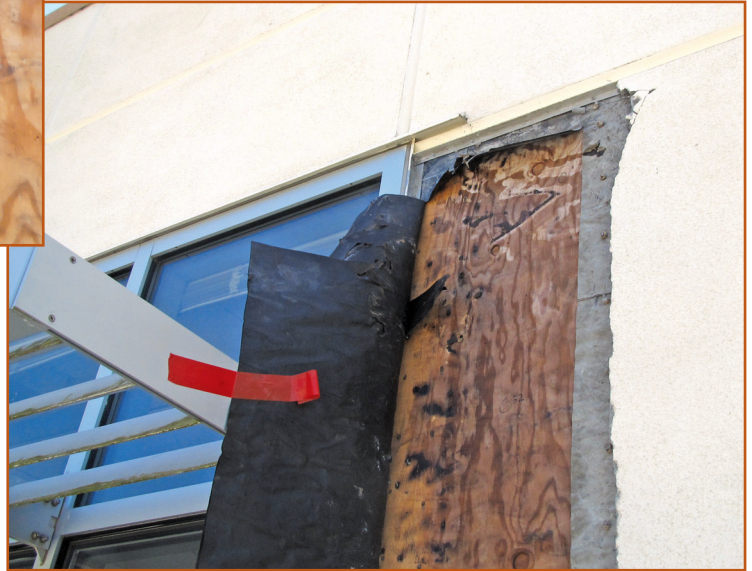
Photo 12 – We continued to trace the water trail up the wall toward the window head.

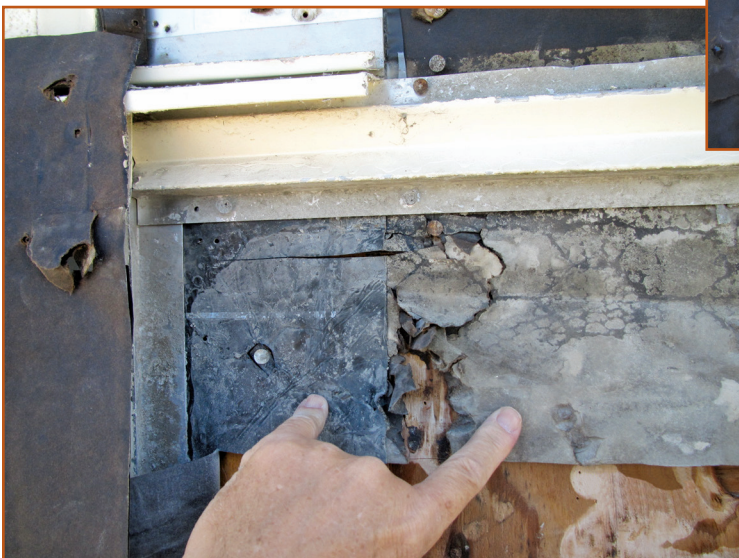
Photo 14 – The two layers of ripped and deteriorated building paper correspond to the corroded tapping screw above.

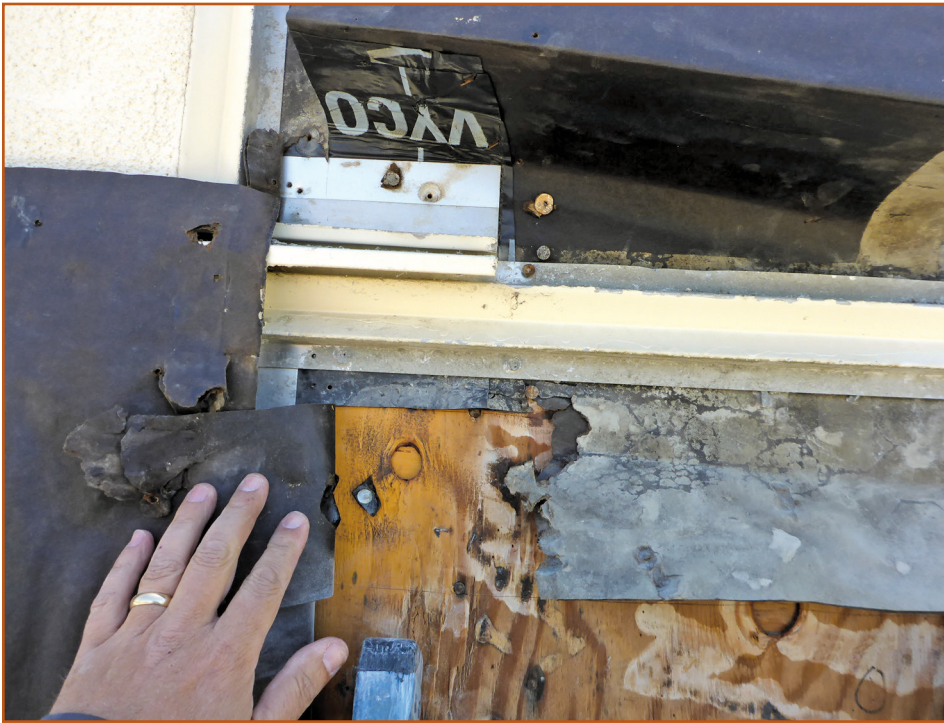
lished that the origin of the leakage, damage, and fungal growth seen in the preceding photographs was rainwater drainage off the ends of the

horizontal head flashing and stucco casing bead (aka, “J mold”) accessory positioned above this storefront window.

Photo 15 – The trail of water damage leads directly to the head flashing and J-mold accessory above the horizontal reveal.

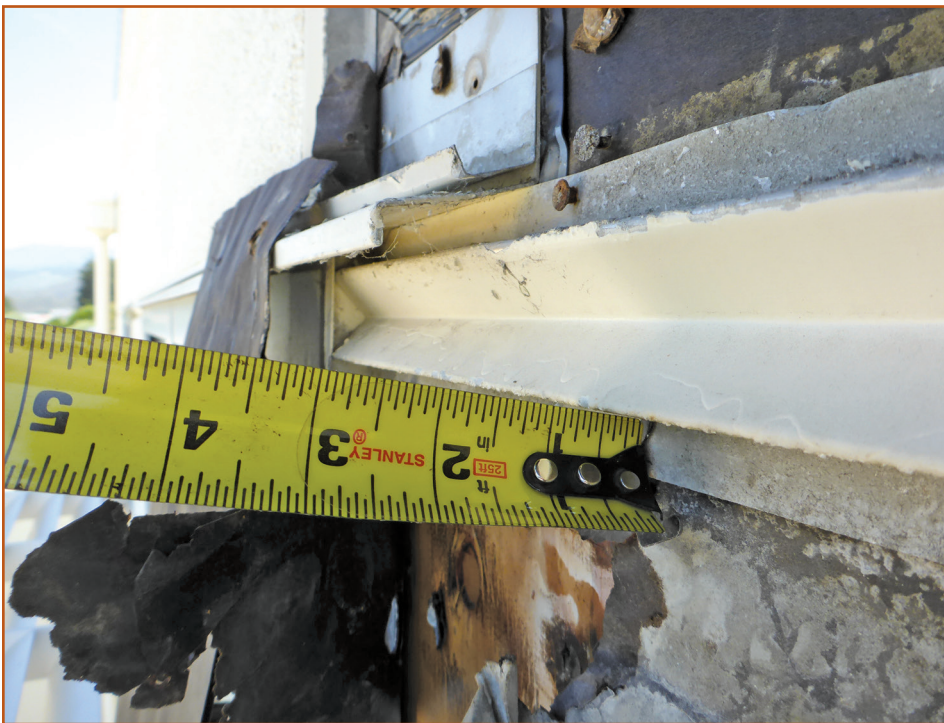
The linchpin of this entire deleterious water-intrusion process was the improperly installed self-drilling tapping screw projecting from the horizontal reveal in *Photo 16*.

Photo 16 – The linchpin of this entire deleterious water-intrusion process was the improperly installed self-drilling tapping screw projecting from the horizontal reveal.

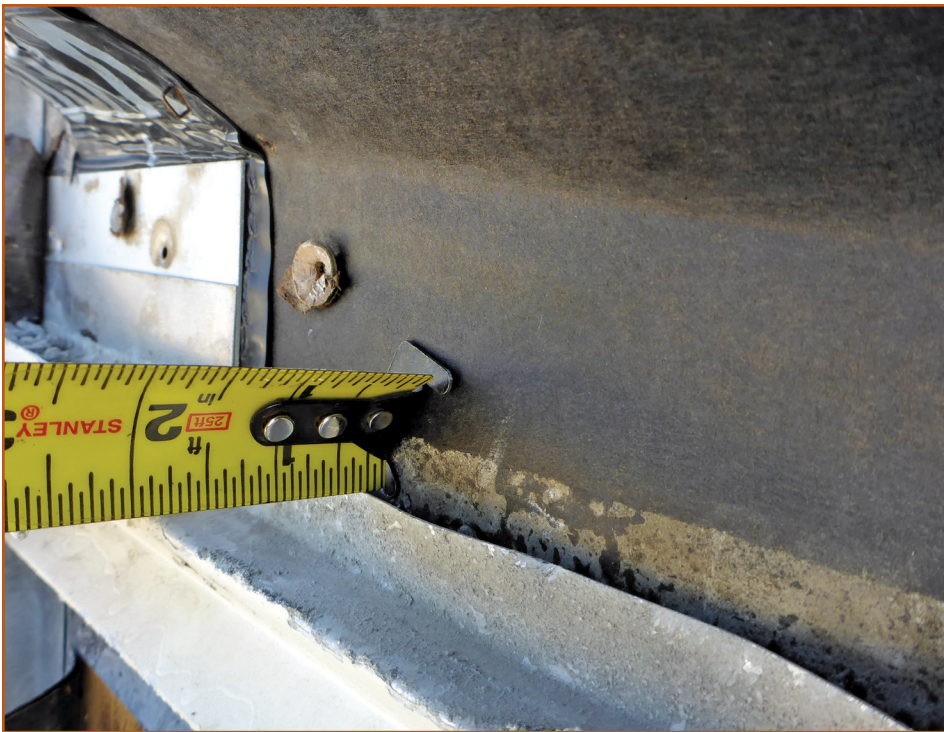
7. Finally, *Photo 17* confirmed that rainwater drainage off the ends of the horizontal head flashing and stucco J mold had immediate access to the ripped/deteriorated building paper behind the loosely set stainless steel reveal.

Photo 17 – Rainwater drainage off the head flashing and J-mold accessory had immediate access behind this loosely set reveal.
