Waterproofing ICF Foundations:

Two Steps Forward, Three Steps Back

By David Campbell,
RWC, AIA, GRP

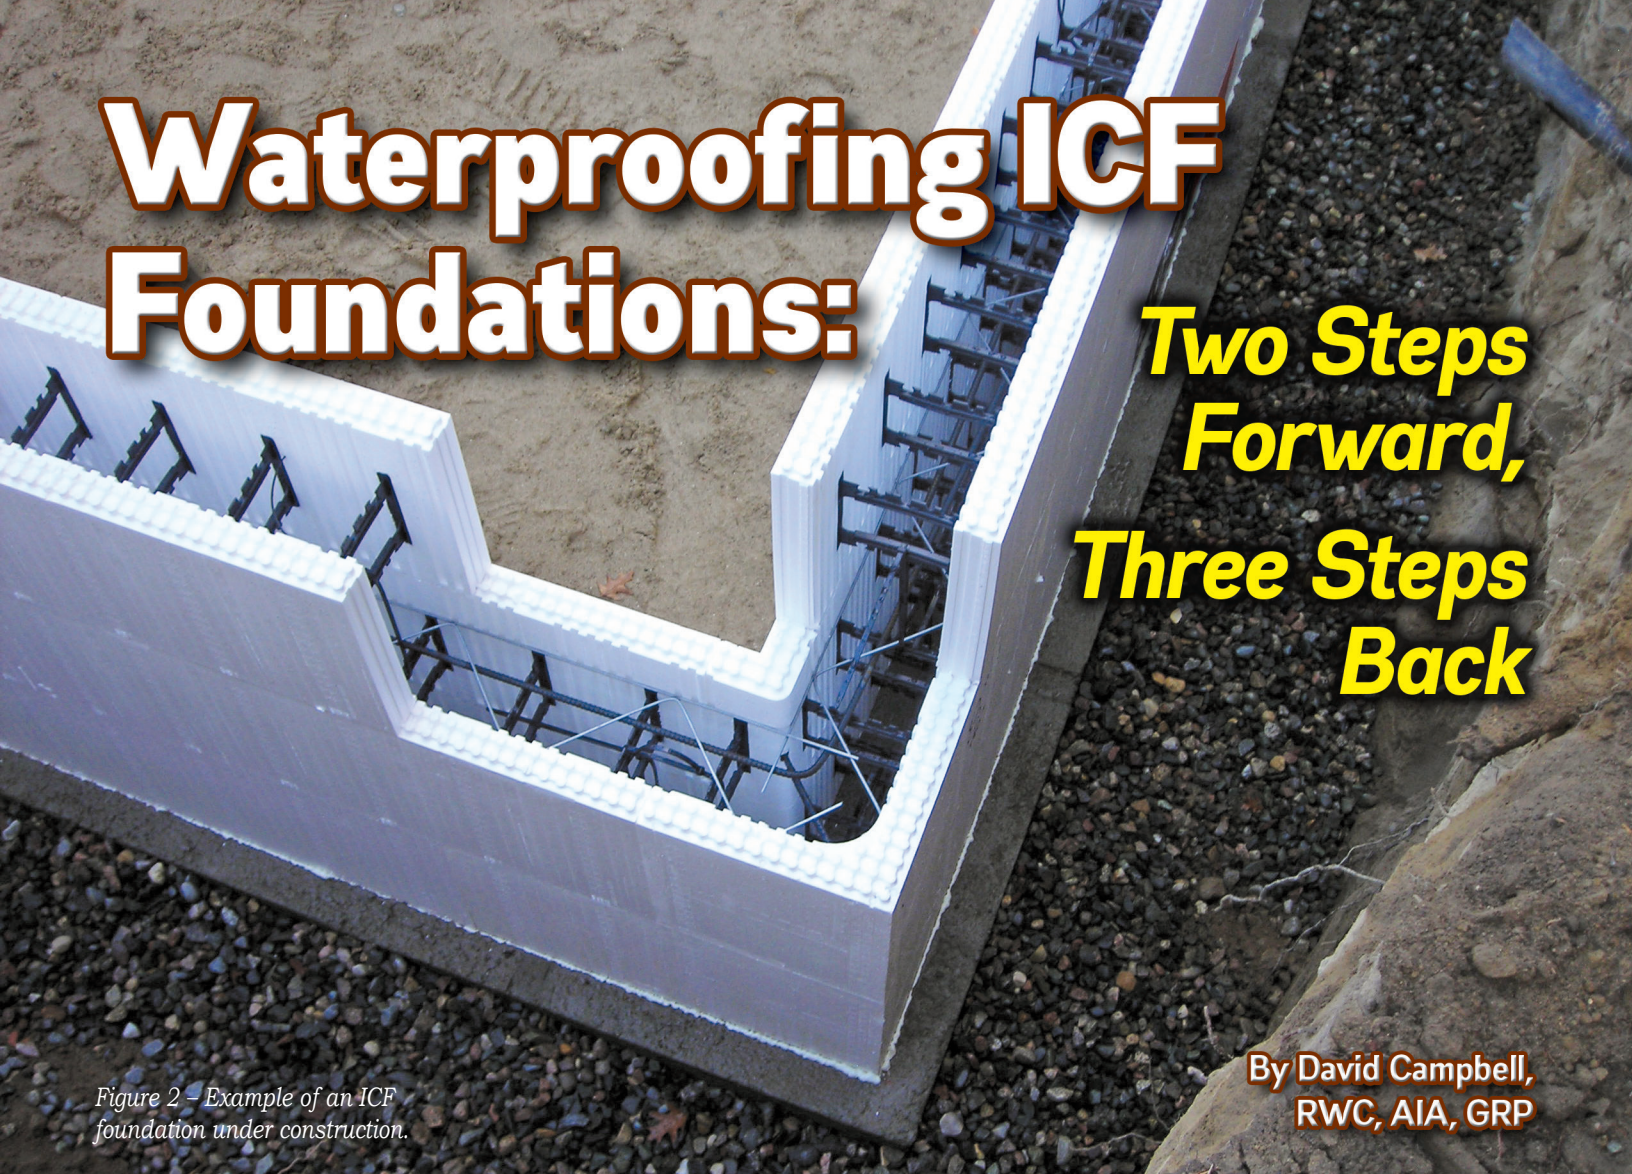
Figure 2 – Example of an ICF foundation under construction.

ICF cast-in-place concrete walls are a relatively new below-grade building practice (Figures 1 and 2). Basically, ICF enables the contractor to construct a

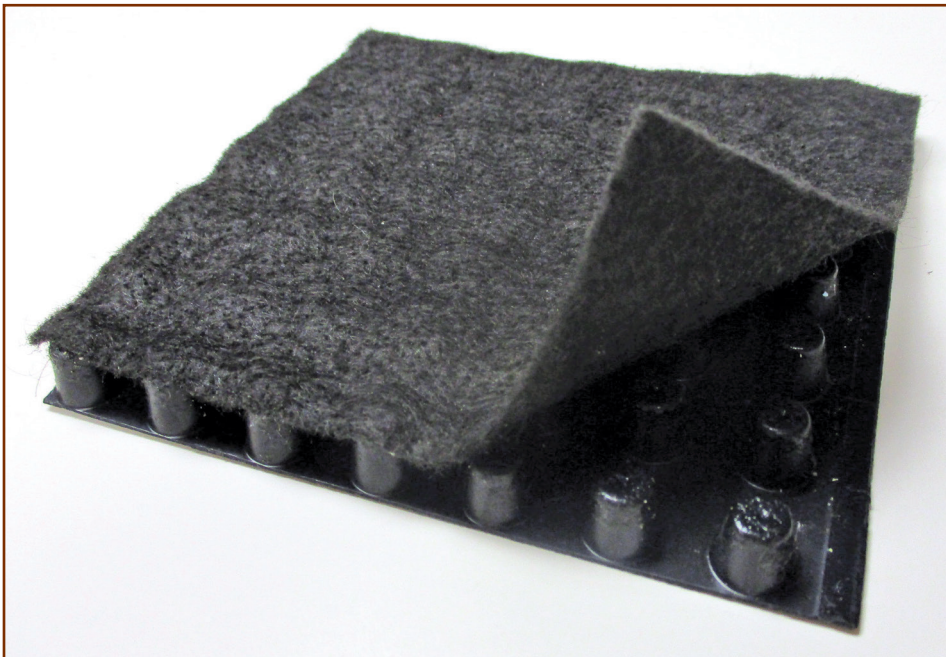
Figure 4 – Composite drainage sheet.

When a composite drainage sheet (CDS) (Figure 4) is used in conjunction with an ICF system, it can only be placed between

the waterproofing and the backfill. Since the factory-attached filter fabric component of the CDS is in direct contact with the backfill, the fabric component is susceptible to tearing caused by the drawdown effect of the backfill being compacted in lifts. As a result, the torn filter fabric allows mud and other fines into the core space of the CDS and renders the product useless over time.

In addition, the same drawdown effect can also damage the waterproofing if the CDS is adhered to it, which is usually the case. With the CF foundation approach, the CDS would be installed inboard of the insulation and not in direct contact with the backfill. In addition, a sacrificial slipsheet could be installed between the insulation and the backfill in order to prevent the drawdown effect from damaging any of the installed products.

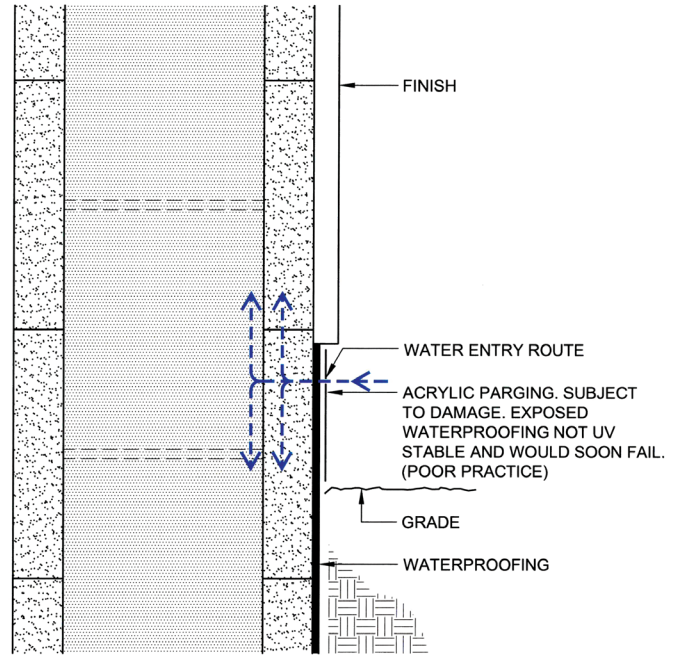
Figure 6 – ICF grade-line termination detail.

Having to install the waterproofing over the insulation makes the critical grade-line termination detailing very difficult. This puts the waterproofing in an unprotected and vulnerable location, which is difficult to make watertight for long-term performance. Figures 5 through 8 are redrawn versions of various grade-line details found in the researched ICF manufacturers' installation manuals. In my opinion, they all show a

profound ignorance of what is required in the real world to keep water from getting behind the membrane near grade for the life of the structure.

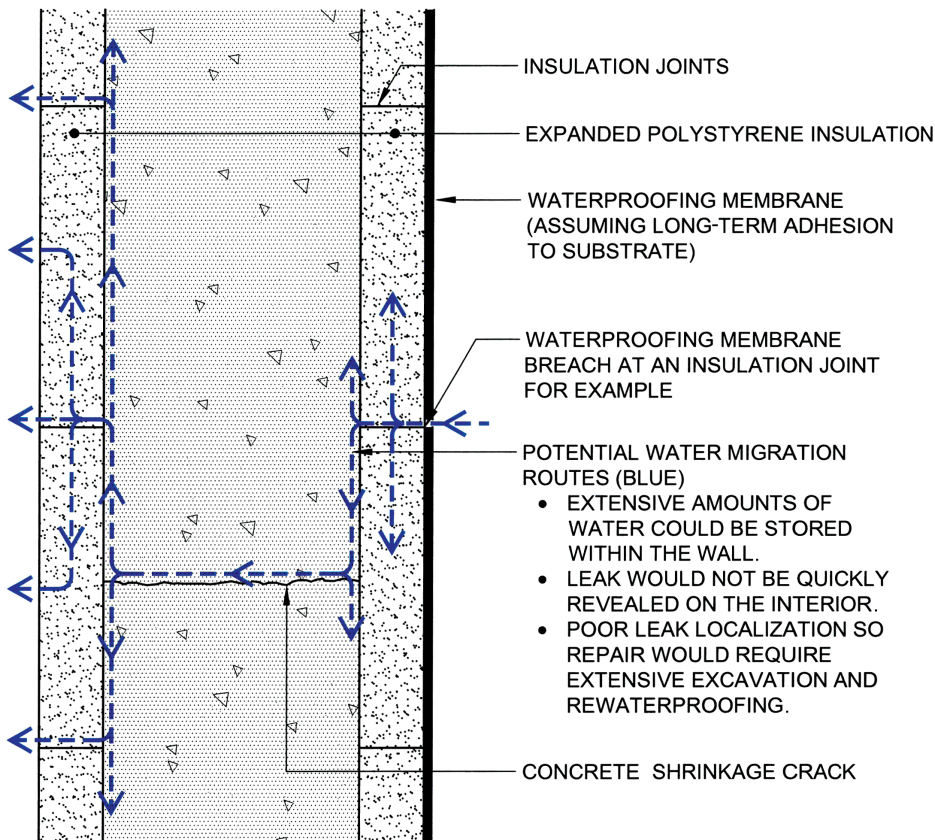
Figure 9 – Potential water migration routes within an ICF foundation.

membrane must be applied to the exterior side of the exterior EPS insulation board, since the board is acting as a permanent form. This means that if the membrane should ever develop a breach, penetrating moisture could be stored between the EPS joints (exterior and interior sides), within the EPS insulation, between the EPS and the concrete (exterior and interior sides), and within the concrete shrinkage cracks themselves (Figure 9). This would represent a significant amount of water that would be stored within the wall. The waterproofing,

As revealed in Figure 9, the various routes that penetrating water could travel within the wall are extensive. It could conceivably take years for the penetrating water to navigate through everything until it was finally revealed on the interior. If the interior side were finished with furring and gypsum board, it could take even longer. During this delay between the time that the membrane is breached and when the water appears on the interior, an extensive amount of moisture could be deposited within the wall long before it becomes apparent that there has been a waterproofing breach.
