TILED SHOWER WALLS ARE COMPARABLE TO CLAD EXTERIOR WALLS

By Lonnie Haughton; David M. Field, AIA;
and Jared Orozco

shower walls at a residential condominium complex in San Francisco.

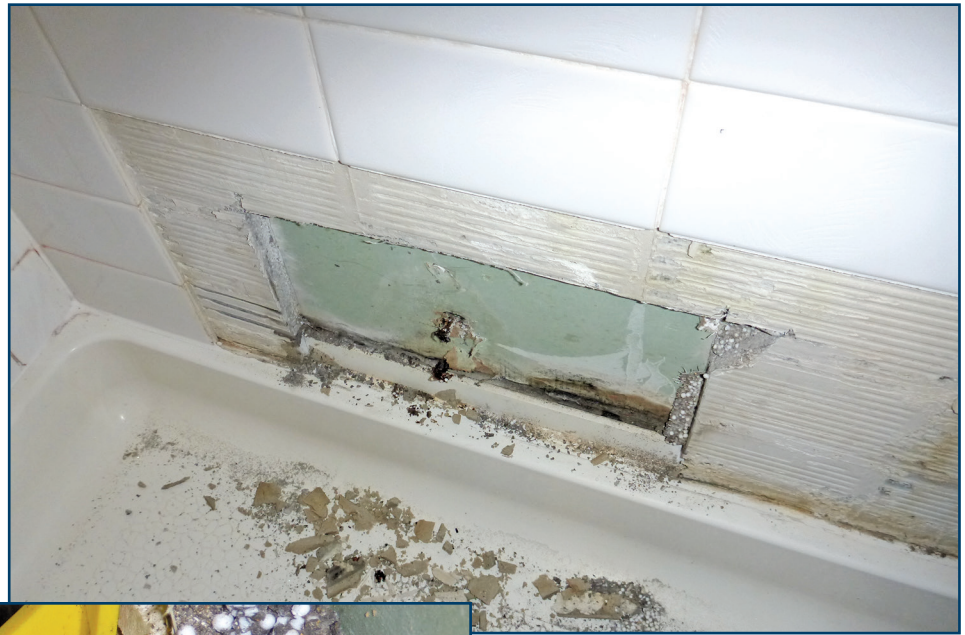
Figure 2 – Deterioration behind the loose tiles extended to the gypsum wallboard behind the CBU panels (see Figure 3).

tiles were adhered with a thinset bond coat to a cement board underlayment (CBU) installed atop gypsum wallboard (Figure 2).

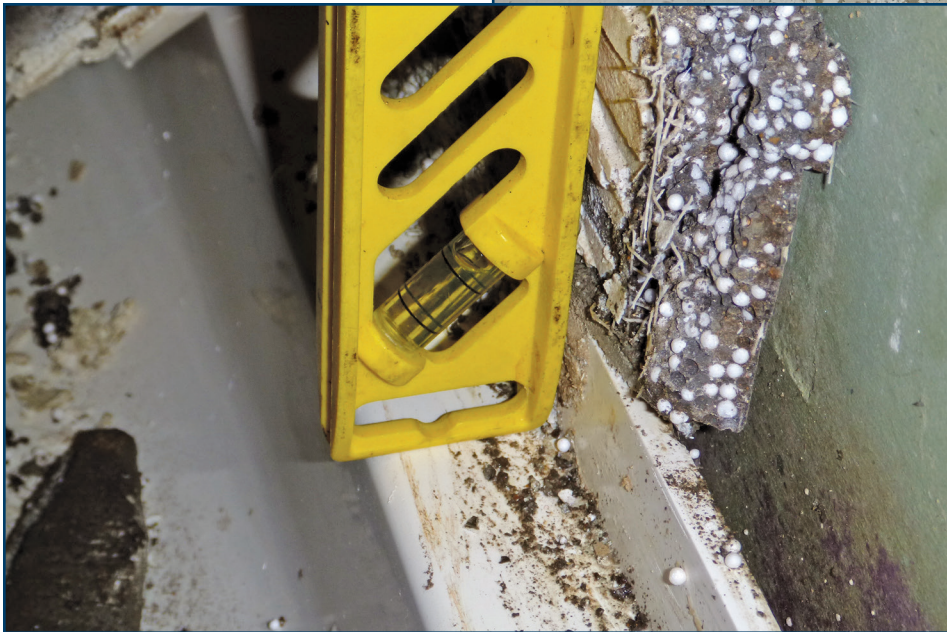
Figure 3 – Per TCA methods B412 and B415, the CBU panel should overlap this vertical flange in a water-shedding manner. (These TCA details also depict an asphaltic or polyolefin “membrane” behind the CBU – also overlapping the flange.)

At all inspected locations, the installer terminated these CBU panels directly at (or as much as ¼ inch above) the vertical flanges (Figure 3) that project upward from the fiberglass shower pans and tub units. In contrast with these as-built conditions, industry standard methods B412 and B415, published by the Tile Council of America (TCA),⁵ show the CBU panel overlapping the vertical flange in a water-shedding manner similar to that seen at exterior lap siding and shingles.

Further, the TCA details prescribe placement of a protective “membrane” (also overlapping the vertical flange) behind the CBU. This asphaltic or polyolefin sheeting

Upon completion of our initial assessment phase of these ceramic-tiled shower walls, two generally consistent deficiencies had been identified, per *Figure 3*: 1) poorly grouted and non-lapped CBU-to-flange transitions, and 2) the absence of the TCA-required (and architect-specified) protective sheet membrane behind the CBU panels. Further, issues of poor quality control (improperly packed grout and the practice of setting the ceramic tiles to skinned-over mortar) by the installer appeared likely to be intrinsic to the complex.

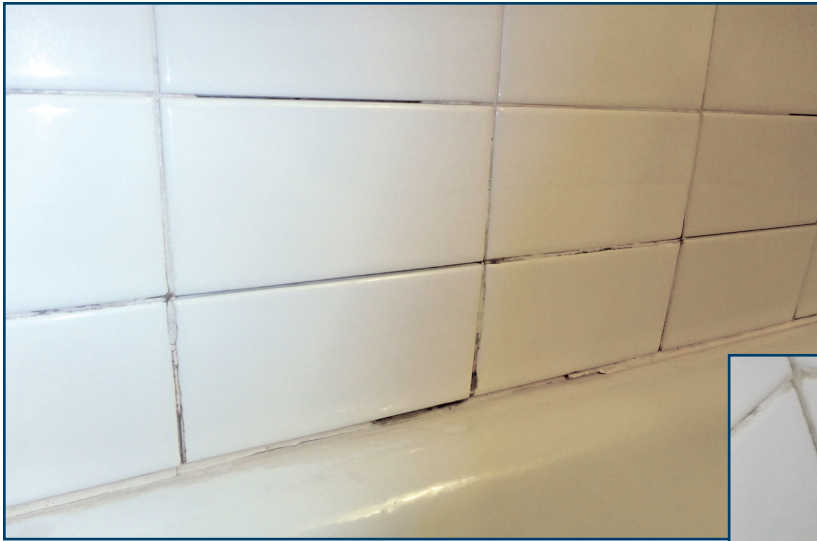
Figure 4 – Ceramic tiles at this tub-shower unit were loose. Multiple sections of the grout were deteriorated or missing.

After our initial visual surveys and preliminary testing, we concluded that the most likely source of the water damage seen in multiple bathrooms was leakage at loose shower tiles and those that exhibited deteriorated and missing grout (Figures 4 and 5). Due to the tile installer’s failure to install the secondary protective membrane recommended by TCA, this water leakage then migrated through the poorly grouted, non-lapped CBU-to-flange transitions into the wood-framed walls.

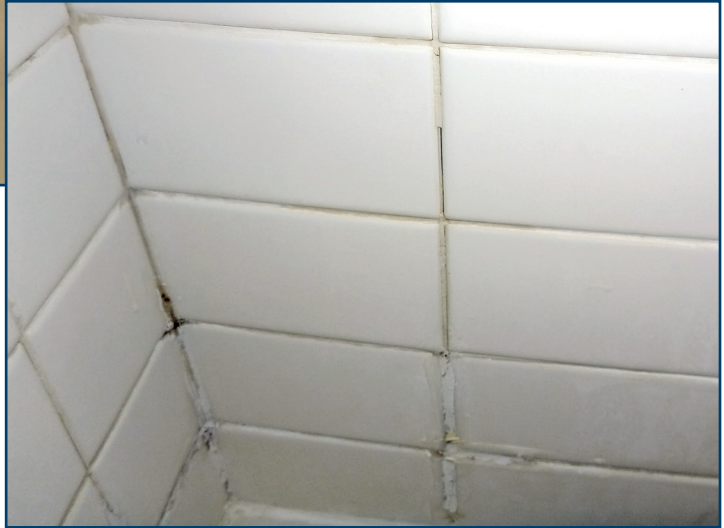
Figure 5 – At many shower walls at all three buildings, many of the grout joints were failing or missing.

Further, Orozco reported that the many grout failures observed at all three buildings were indicative of poor quality control and inconsistent workmanship, including: 1) failures to properly “pack” the grout into the joints, 2) improperly mixed grout, and/or 3) grout packed after cement hydration had started.⁹

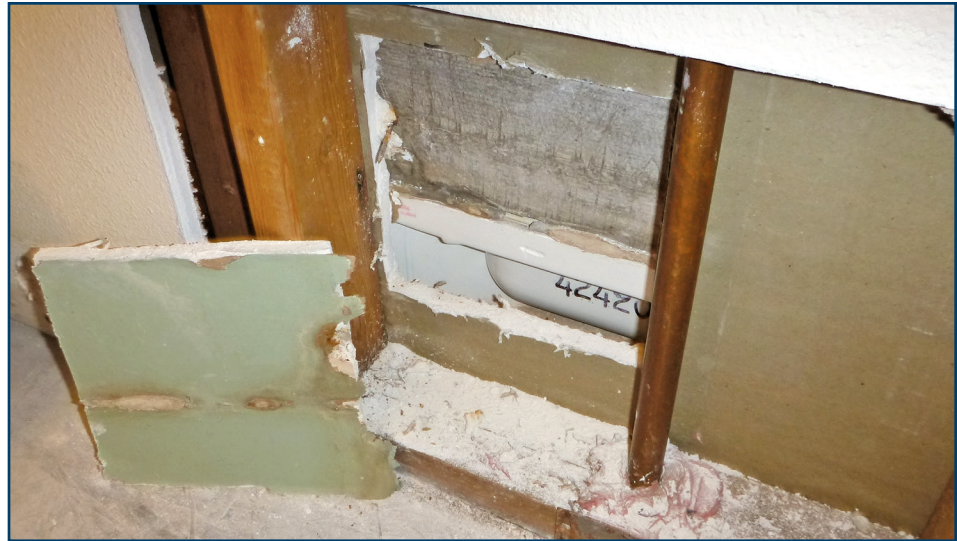
Figure 6 – Purposeful supplemental testing confirmed limited and localized water damage within this wall assembly.

As an example, the shower enclosure in *Figure 6* had been selected for sampling because it did not exhibit obvious external clues and evidence of hidden damage. In a manner that is fully consistent with the above-cited guidelines of ASTM E2128, the team’s “cognitive” assessment process at

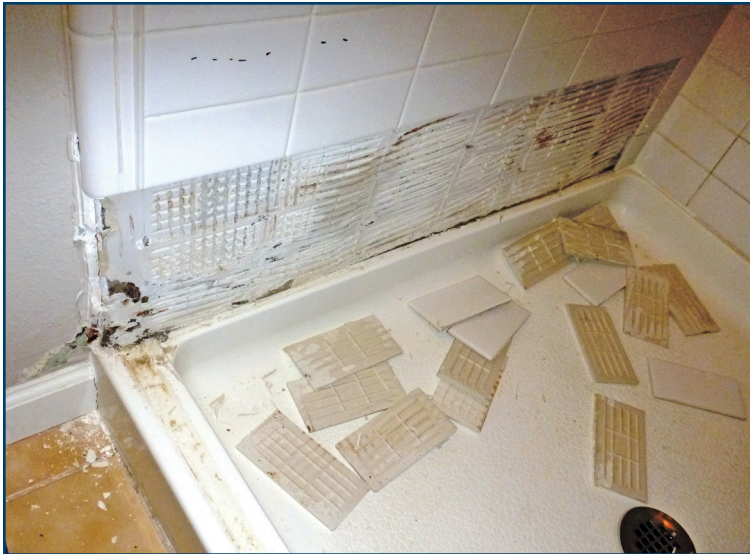
Figure 7 – Supplemental testing (at this purposefully selected shower) confirmed widespread water intrusion and extensive damage under loosely bonded ceramic tiles.

Similarly, as documented at *Figure 7*, team members removed intrinsically loose tiles at a shower wall where they expected (based upon external evidence) to expose severe damage and decay due to water infiltration through the failed grout joints. As evidenced by *Figure 8*, the mislapped CBU-to-flange transition was also exacerbated by the absence of the TCA-required protective membrane layer behind the CBU.

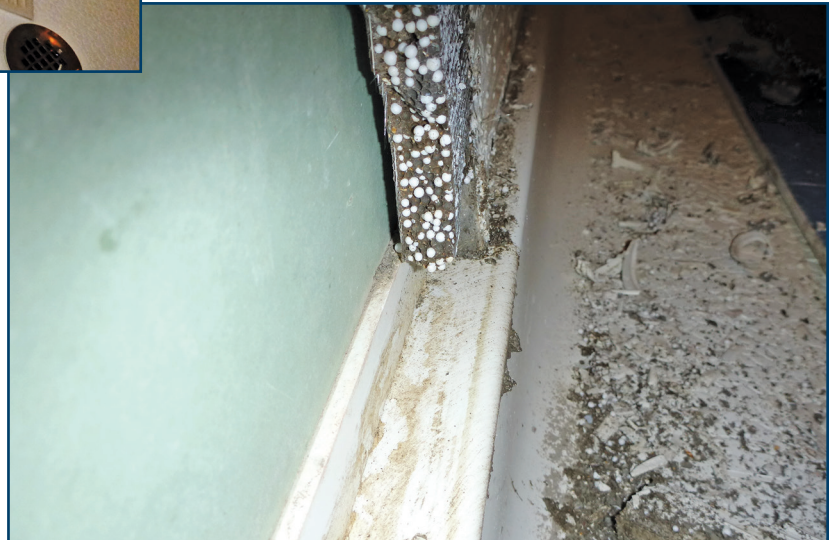
Figure 8 – As expected, the CBU panel was not properly lapped over the vertical flange.

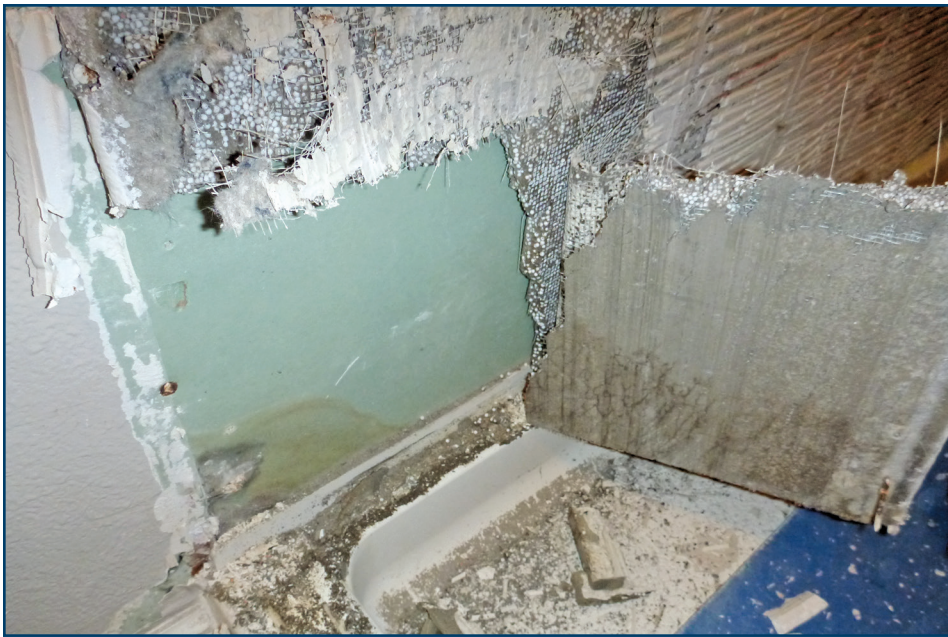
Figure 9 – Leakage and deterioration extended to the unprotected gypsum wallboard behind the CBU.

Per Figure 9, it was confirmed that leakage through the mislapped (and poorly grouted) CBU-to-flange transition can “wick” upward (via capillary action) at the back side of the CBU panel, promoting deterioration and fungal growth at the unprotected gypsum wallboard.

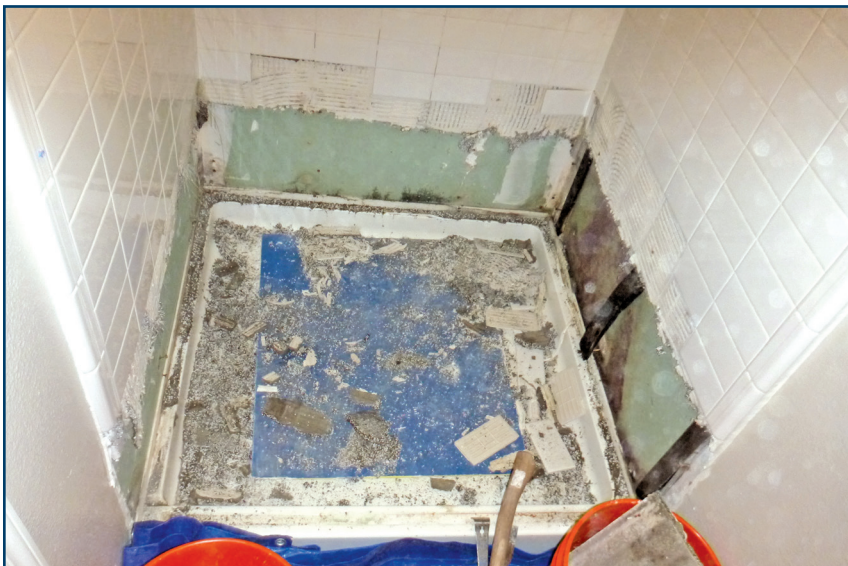
Figure 10 – Water infiltration at the CBU-to-flange transitions had damaged all walls at this purposefully selected shower.

Additional removal of loose tiles at this shower confirmed (per Figure 10) that the internal water damage within these walls was not limited to just their base-wall transitions to the fiberglass shower pan. Further, removal of this pan exposed a fully destroyed subfloor assembly (Figure 11).

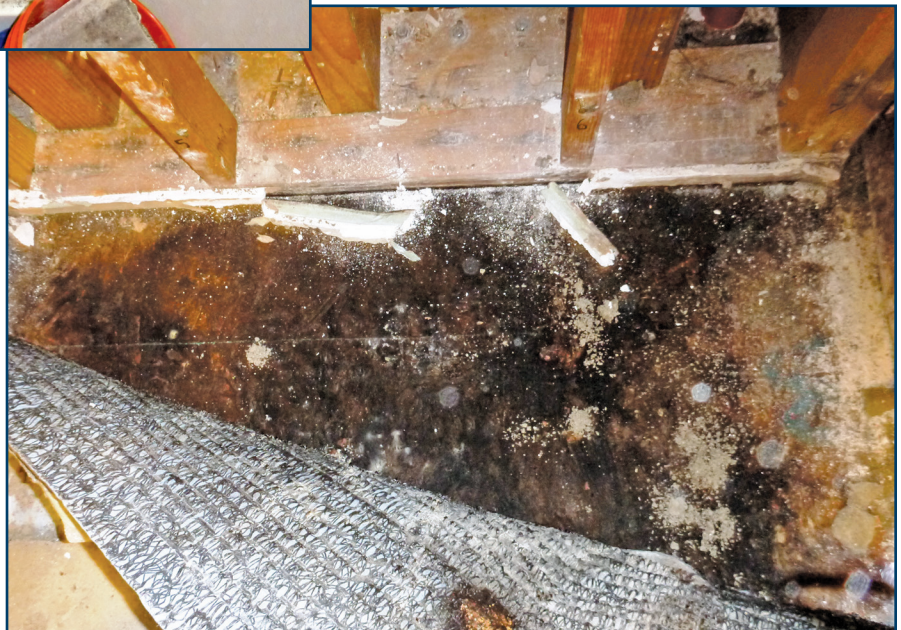
Figure 11 – The subfloor system below the fiberglass shower pan was also found to be severely damaged.

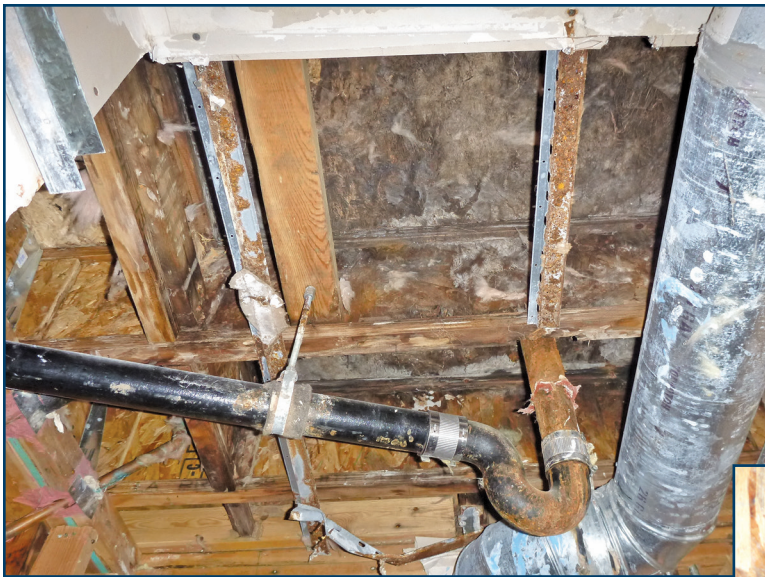
Even then, it was only after exposing the dramatic damage conditions depicted in Figures 12 and 13 (showing the underside of the same failed subfloor) and Figure 14 (revealing severe multi-floor decay and structural impairment within this shaft enclosure) that the remarkable extent of the

Figure 12 – Viewed (looking up) from below, structural damage resulting from the CBU butt joint leakage was severe.

1. At all (100%) of the shower and tub-shower enclosures, remove and replace existing ceramic tiles, CBU panels, and fiberglass pans in compliance with tile industry standards, as specified in the original contract documents. Inspect all exposed wall, ceiling, and subfloor materials for evidence of internal water damage.
2. For budgeting purposes, assume 45% of these tiled enclosures also would require remediation of minor-to-moderate internal damage within their wall, ceiling, and/or subfloor assemblies.
3. Further, assume that at an additional 9% of the inspected shower enclosures, the internal damage would prove to be sufficiently extensive and severe (e.g., *Figure 10*) to necessitate multi-floor structural repairs within these shafts, including substantial replacement of structural framing and floor joists.

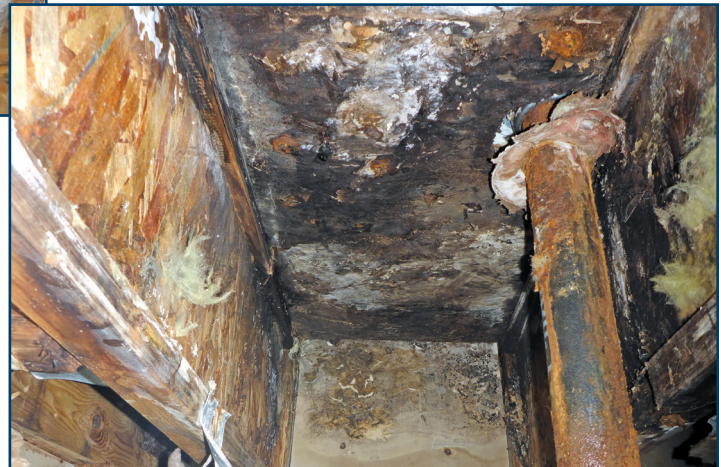
Figure 13 – The CBU butt joint leakage had destroyed the subfloor system and the underlying floor joists.
