ADDING AIR BARRIER AND THERMAL IMPROVEMENTS TO EXISTING FACILITIES

BY BRIAN H. NEELY, AIA, CDT, BECx^{PSM}

This article was previously published in the Proceedings of the 31st RCI International Convention and Trade Show in March 2016.

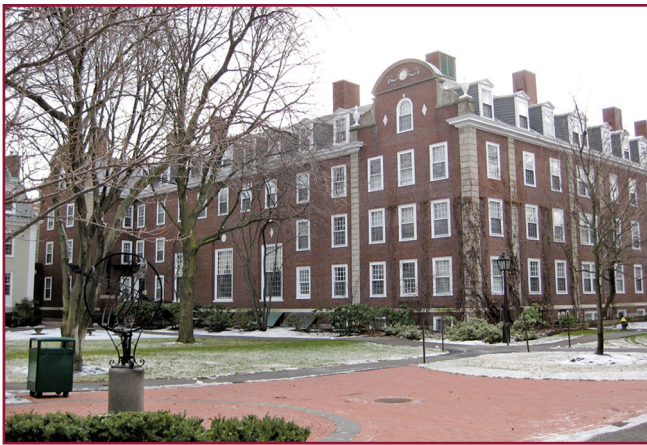
Figure 1 – Typical solid masonry wall dormitory.

The unrenovated wall assembly consisted of solid load-bearing masonry composed of an exterior wythe of brick masonry (Figure 1), an approximately 7-in.-thick terra cotta infill, and interior plaster walls.³ The construction represents a fairly common transitional-period, load-bearing wall system that undergoes consistent wetting and drying cycles. As there were no vapor barriers in the system, the wall was able to seasonally adapt and dry from the interior or exterior of the assembly (depending on which side was heated), limiting the potential of condensation and frost inside the walls. The WUFI simulation indicated that the overall water content of the system was undergoing a consistent wetting and drying cycle. Over the five-year analysis period, the water content of each of the materials, as well as the overall water content of the assembly, decreased. While this type of wall system is not optimal in terms of energy efficiency, it performs hygrothermally well over time and has a good track record when maintained.

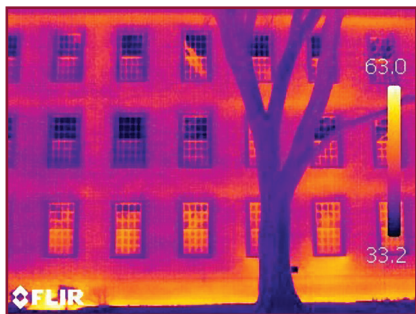
Figure 2 – Infrared image of SPF-insulated building. Note thermal bridging from uninsulated interior walls and floor slabs.

The addition of an air barrier in a solid masonry wall system (to which insulation is added) is recommended to minimize the water vapor transport through exfiltration air through the wall. Although closed-cell SPF insulation can act as a vapor barrier, the thickness of SPF applied in this case was not sufficient for it to function as a complete vapor barrier, allowing some inward drying potential (Figure 2).

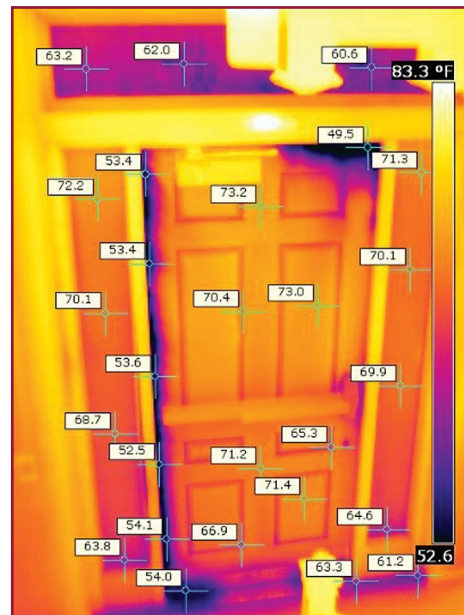
Figure 3 – Infrared image of air leakage at a door showing up to a 22°F temperature change due to poor weatherstripping.

which could result in air exfiltration and moisture infiltration at these areas (Figure 3). Furthermore, WUFI assumes that the masonry/terra cotta wall to which the SPF was applied is in “perfect” condition and any defects such as cracked or spalled brick, mortar deterioration, etc., have been repaired. The integrity of the exterior masonry wall system is important as the lack thereof could increase the bulk-water accumulation within the masonry wall and potential for freeze-thaw damage due to the change in the temperature gradient as a result of the added insulation.

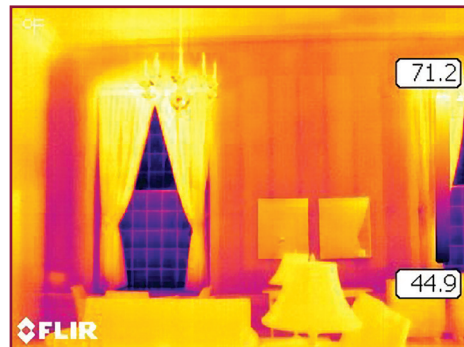
Figure 4 – Infrared image of interior space. Note thermal bridging of metal studs that bypass batt insulation.

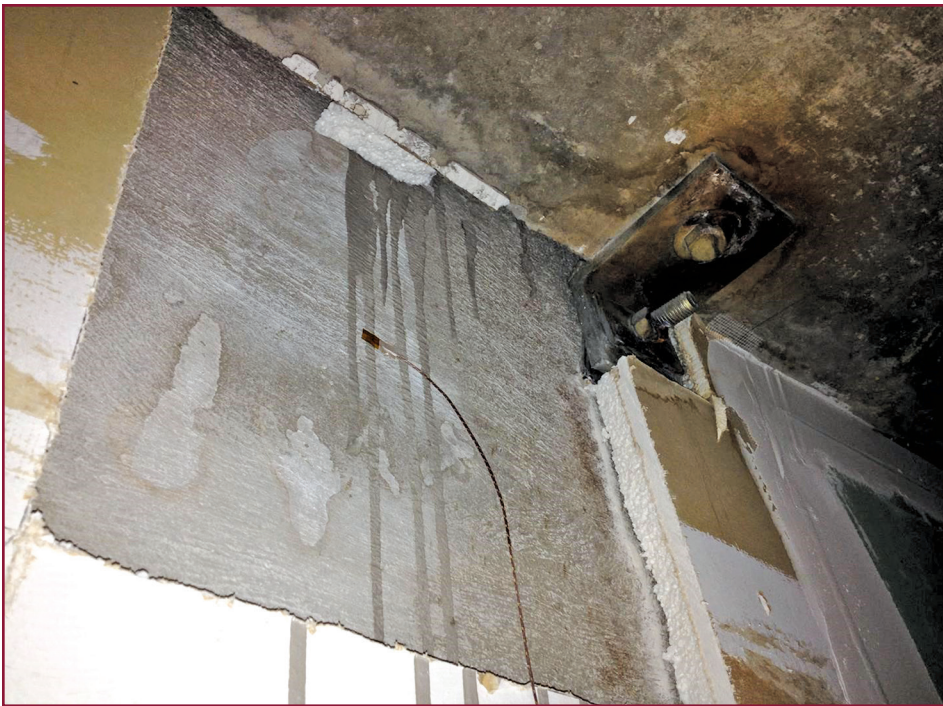
Figure 5 – Locations of thermal data logger probes.

1. Interior surface of the precast concrete panel
2. Interior surface of the interior gypsum wall board
3. Surface of the steel support angle for the precast panels at the floor above

With the assistance of single-point data loggers, the interior conditions were found to range from 67.8°F to 71°F, with relative humidity (RH) ranging between 42% and 55%. Exterior temperatures ranged from 14°F to 24°F. The data logger analysis was performed using a battery-powered digital thermometer data logger meter. These meters display and store temperature readings from the thermocouple temperature probes that are attached to various surfaces and exterior wall components. Figure 5 shows where the thermal probes were placed:

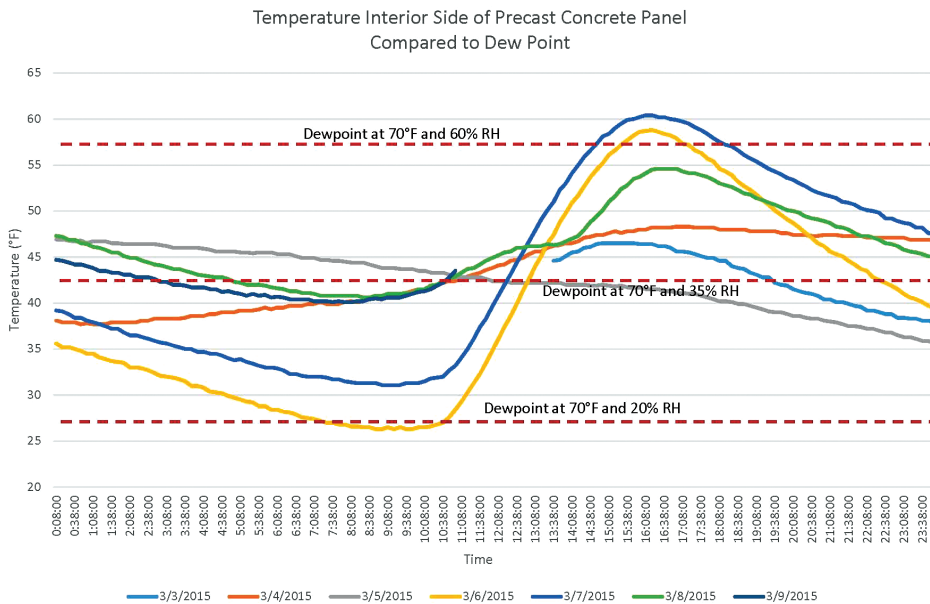
Figure 6 – Temperatures on the interior side of precast concrete panel compared to dew point.

Figures 6 and 7 chart out the temperatures logged. As shown in these graphs, the temperature readings of each of the probes fluctuated along the same ranges as the exterior temperatures. Note that

the exterior temperatures are taken from the Logan International Airport Weather Station, approximately five miles from the site. The graphs clearly show that the temperature of the interior surfaces of the precast concrete panels exhibited temperature readings that followed closely to those of the exterior temperatures. The difference in temperature between the exterior and the interior side of the precast panels ranged from approximately 20°F down to 5°F. It is worth mentioning that the most significant condensation was occurring in a suite on the north side of the building, but the temperature data loggers were performed from a suite on the south side due to room usage. On March 6, 7, and 8, the temperature peaks recorded are due to solar heat gain experienced on the south elevation.

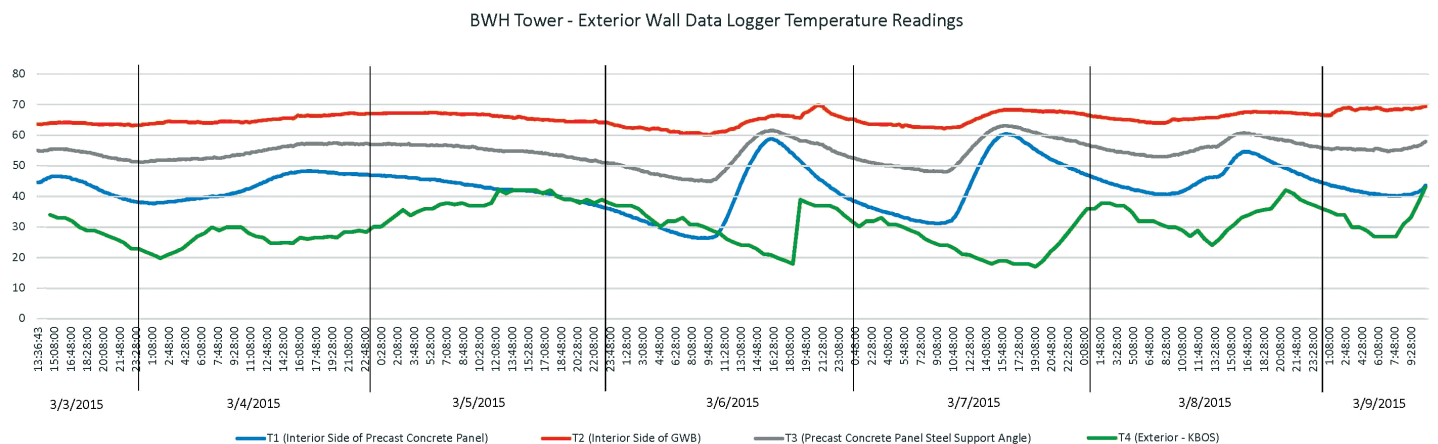
Figure 7 – Exterior wall data logger temperature readings.

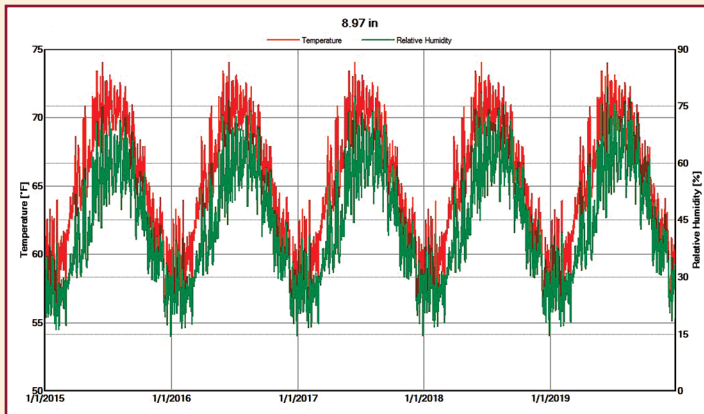
Figure 8 – Temperature and humidity readings at the interior surface of the expanded polystyrene insulation.

At the interior face of the insulation, the RH passes 80% briefly (Figure 8). Typically, if the humidity surpasses 80% for prolonged periods of times, corrosion of metal framing can occur. While the model did not indicate this being an issue, it was in close proximity to a dangerous range where risk could be increased if the vapor barrier was not completely continuous and allowed additional moisture within the system. Figure 9 indicates the interior gypsum wallboard surpassed 70% RH, a trigger point for mold growth during the summer months.

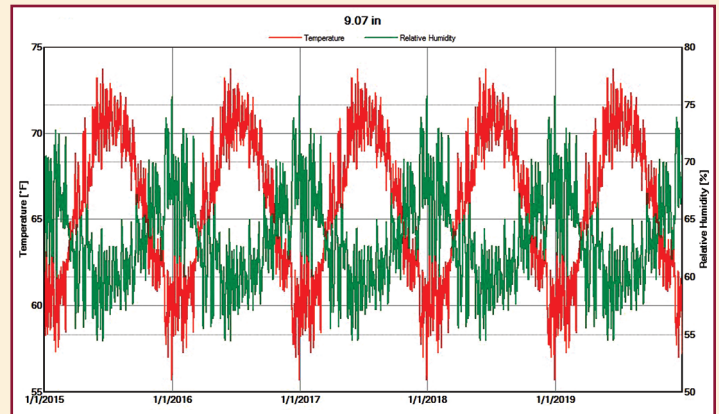
Figure 9 – Temperature and humidity readings at the interior surface of the gypsum wallboard.

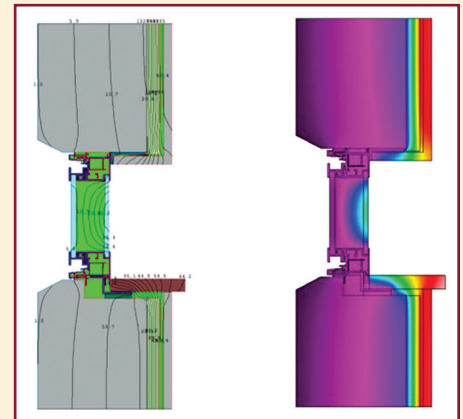
Figure 10 – Two-dimensional image of existing (modified) wall assembly.

The wall assembly modeled in Figure 10 had the existing nonthermally broken aluminum windows within the existing exterior wall construction with prior interior modifications. The assembly consisted of the following components, listed from the exterior:

- 8-in.-thick precast concrete panels
- 2-in. mineral wool insulation, with periodic vertical furring strips
- Vapor barrier (noted to be noncontinuous and open at penetrations)
- 5/8-in. gypsum wallboard, painted

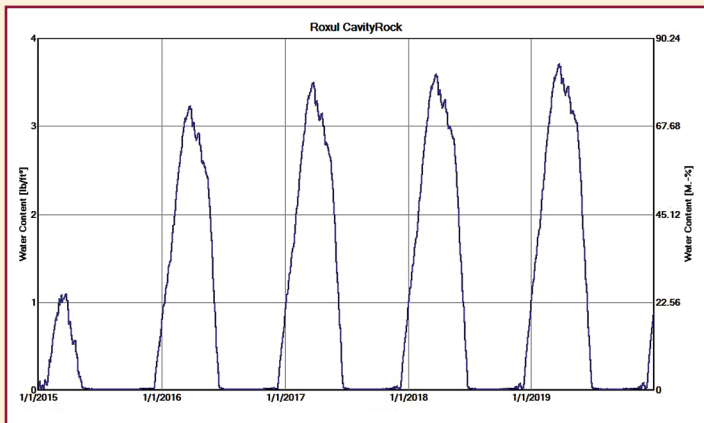
Figure 11 – The graph shows the increasing moisture content of the mineral wool each winter.

finishes and vapor barrier, the wall assembly collected significant moisture content each winter (Figure 11). Figure 12 indicates a significant period of time that condensation can occur (areas indicated by 100% RH each winter) at the interior concrete surface. This includes potential condensation within the mineral wool and metal framing layer.

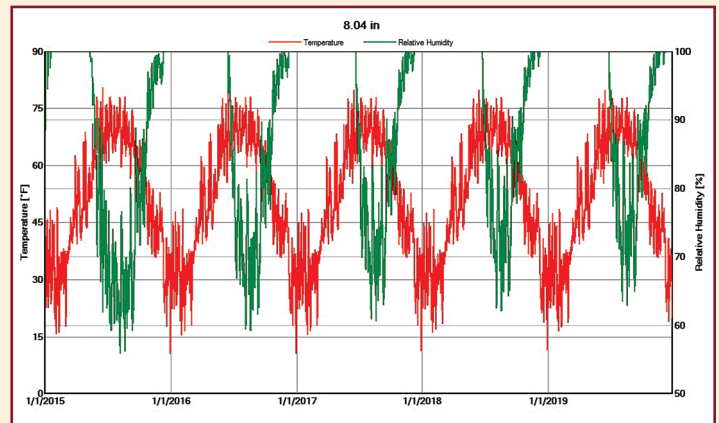
Figure 12 – Temperature and humidity readings at the interior surface of the concrete wall. Condensation occurs when the green line tops out at the 100% RH mark.

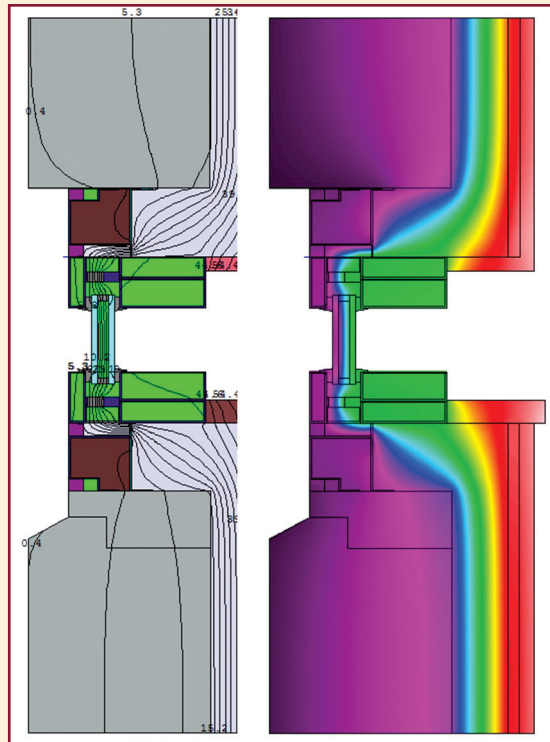
Figure 13 – Two-dimensional image of the existing exterior precast concrete panel wall with new interior spray-applied foam (SPF) insulation, new curtainwall assembly, and new interior finishes.

The wall assembly modeled in Figure 13 has a new thermally broken aluminum curtainwall system with the wall construction consisting of the following components, listed from the exterior:

- 8-in.-thick precast concrete panels
- 2¼ in. SPF
- ½-in. gypsum wall board (painted) on 2-in. metal studs, set minimum 1½ in. off face of precast

The new SPF insulation installed to the interior surface of the precast concrete panels provided a thermal barrier between the conditioned interior and the concrete wall panels. Since the product was spray-applied, it could be installed continuously around existing objects and uneven surfaces. One item of concern was the depth of the metal studs. The greater the offset, the less thermal bridging was caused. While modeling the SPF assembly in Figure 14, at ¾ in. of thickness, there was still the potential for RH above 80%, which could cause corrosion of metal items. At a depth of 1½ in., the chance for corrosion was reduced

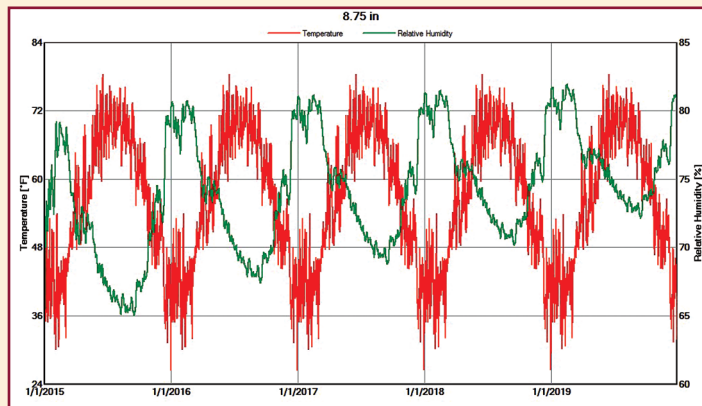
Figure 14 – Temperature and humidity ¾ in. into the SPF. Note several RH readings over 80%.

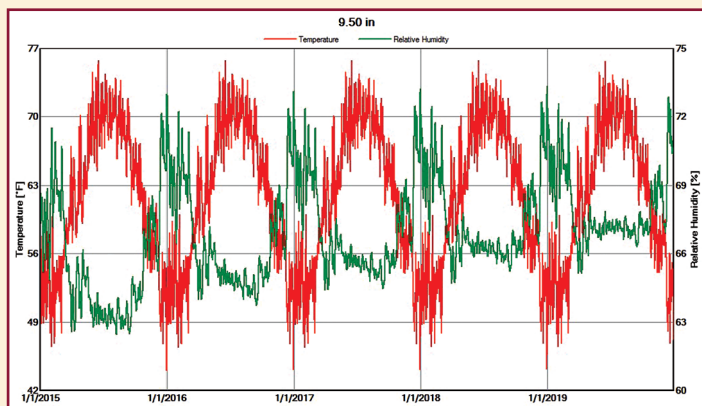
Figure 15 – Temperature and humidity readings 1½ in. into the SPF. Note no RH readings over 80% and very few over 70%.

(Figure 15). Therefore, we recommended an offset of 1½ in. for the metal studs. The humidity continued to moderate moving towards the interior surface of the room (Figures 16 and 17).

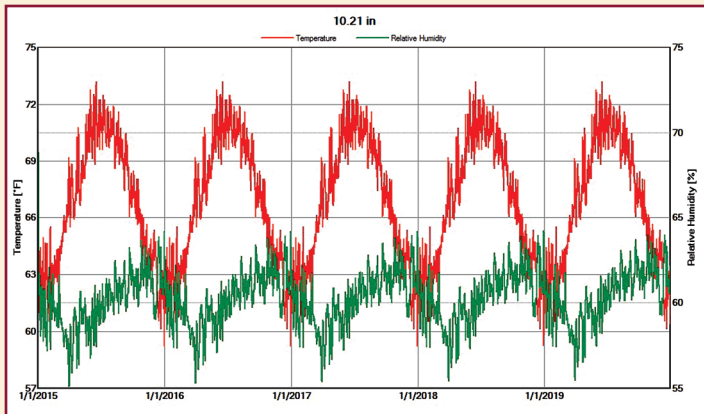
Figure 16 – Temperature and humidity readings at interior face of the SPF. Note low RH readings close to baseline interior RH.

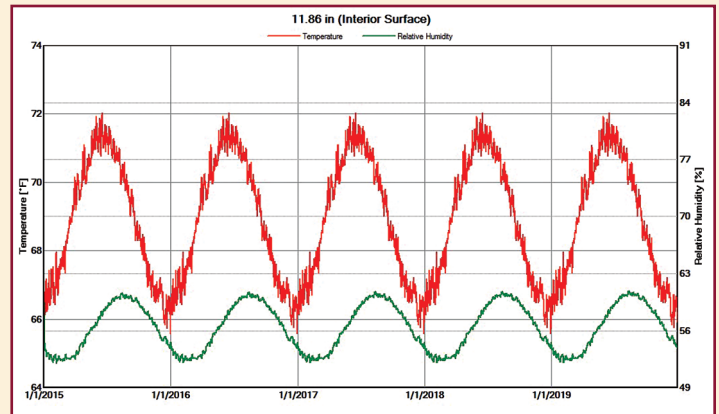
Figure 17 – Temperature and humidity readings at interior face of the gypsum. Note low RH readings close to baseline interior RH and temperatures close to baseline interior temperature range.

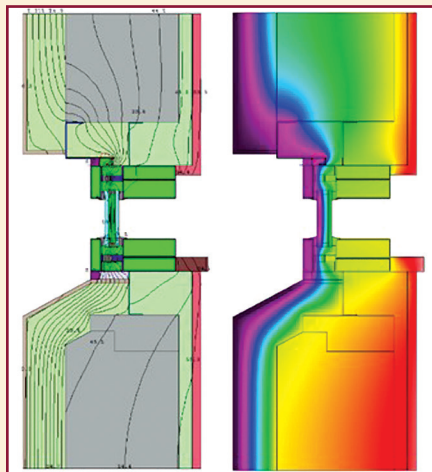
Figure 18 – Existing exterior precast concrete panel wall with new exterior EIFS, new curtainwall assembly, and new interior finishes.

The wall assembly modeled in Figure 18 had a new thermally broken aluminum curtainwall system with the wall construction consisting of the following components, from the exterior:

- 3-in. exterior insulated finish system (EIFS)
- 8-in.-thick precast concrete panels
- Periodic vertical furring strips
- ½-in. gypsum wall board, painted

Figure 18 represents a new thermally efficient curtainwall assembly installed within the existing punched opening of the precast concrete panel construction. Additionally, a new EIFS had been installed on the exterior surface of the precast concrete panels, and finishes installed on the interiors. EIFS was modeled due to lack of complexity, but a similar exterior insulated cladding system would be expected to perform much the same. Note the thermal conductivity and temperature differentials are now moved towards the exteriors instead of the interiors (Figure 19). When installing an exterior-insulating system, the thermal and moisture issues are shifted out to the exterior insulation

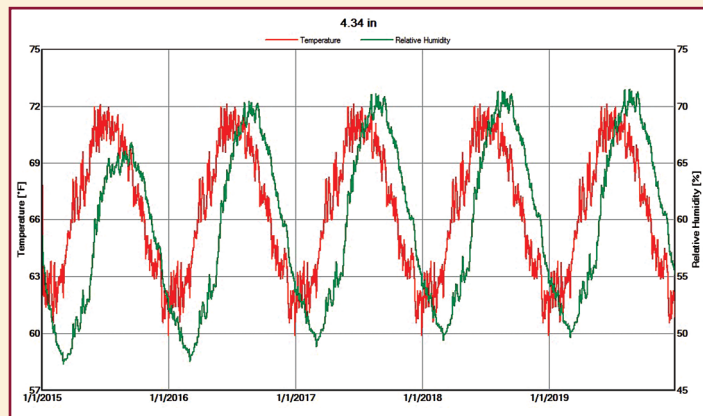
Figure 19 – Temperature and humidity readings at the exterior surface of the precast concrete panel. Note the range of the temperature and RH closely mimics the interior set temperatures.

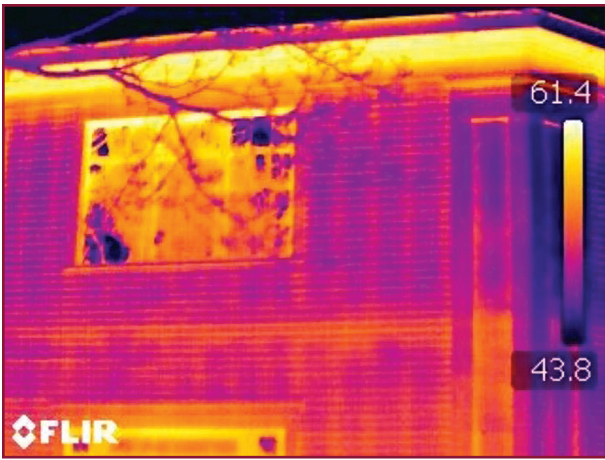
Figure 20 – Infrared image highlighting the thermal bridging caused by the metal studs.

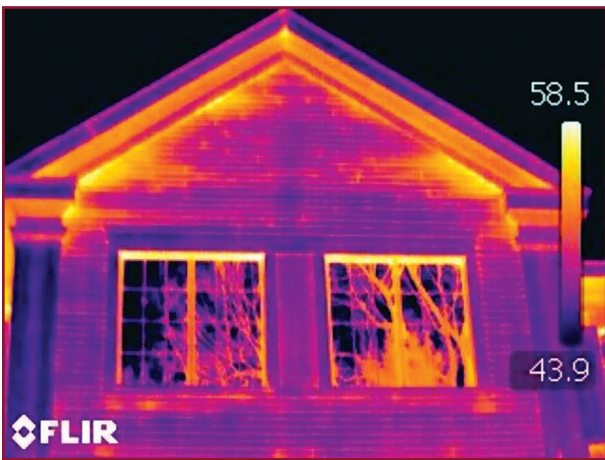
Figure 21 – Infrared image indicates air leakage.

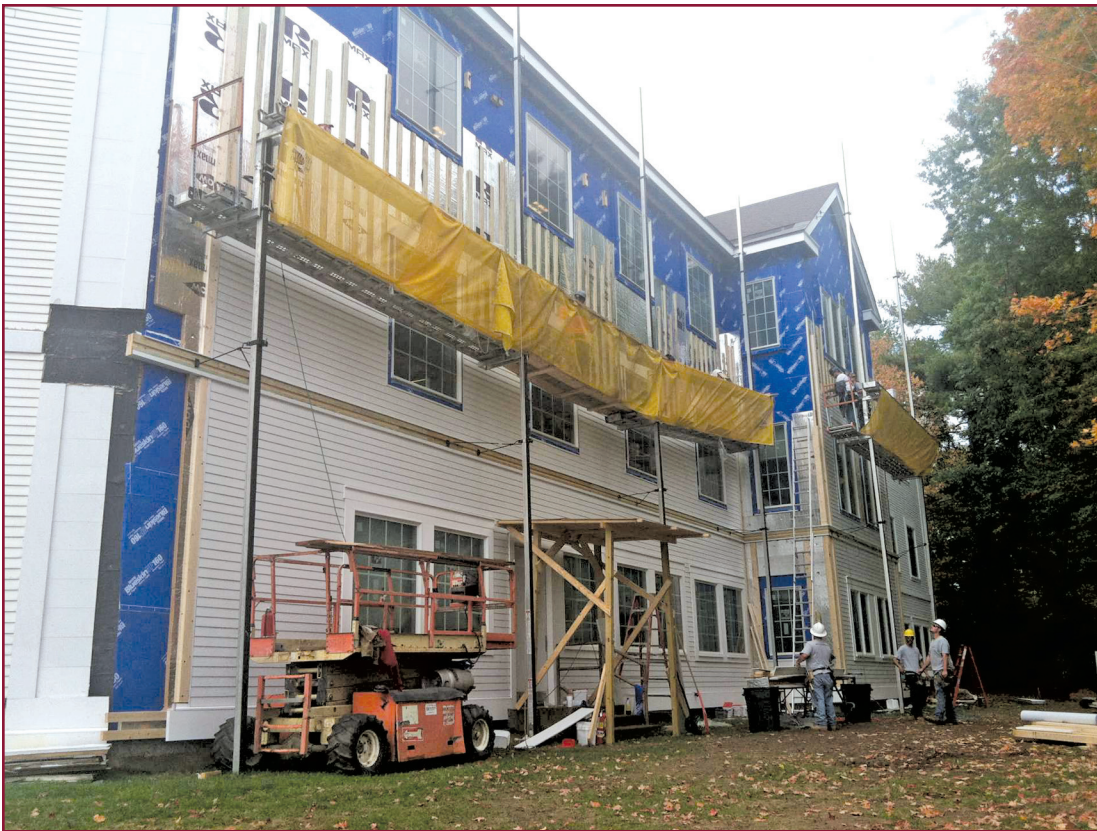
Figure 22 – Exterior wall assembly under construction.

On a recent project involving an international corporation’s headquarters, the exterior siding was found to be in poor condition and near the end of its useful life. During the design phase, an infrared (IR) survey indicated significant air leakage and thermal bridging (Figure 21). To address these issues, the proposed wall assembly included a vapor-permeable air barrier, exterior continuous insulation, and a fiber cement wallboard to replicate the traditional New England clapboard style of the original building (Figure 22).

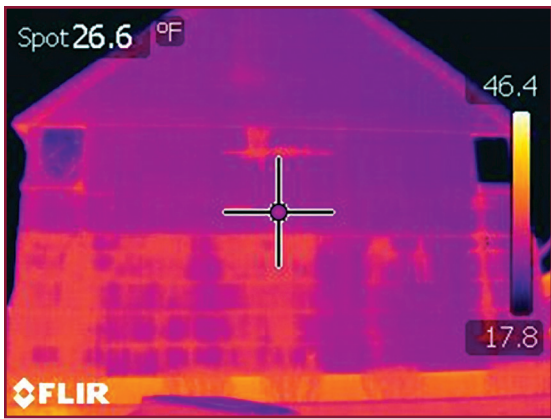
Figure 23 – Infrared image indicating wet and damaged EIFS.

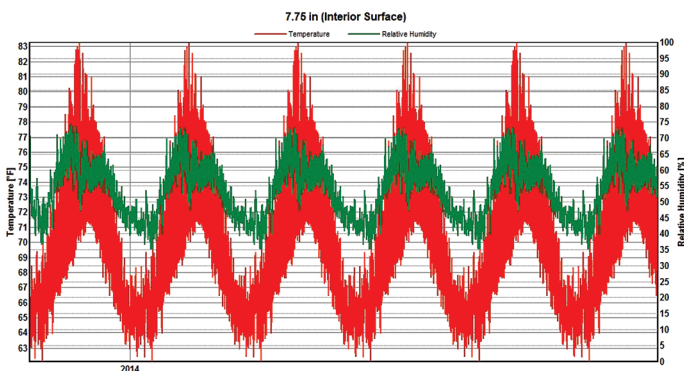
Figure 24 – Temperature and humidity readings at the interior gypsum sheathing at the existing wall assembly.

The EIFS wall had a higher interior RH range of 35% to 73%, while the proposed wall assembly was 35% to 67%. It should be noted that the real failure of the existing wall assembly was due to poor detailing and poor installation. Several details allowed the flow of bulk water behind the EIFS cladding, which acted as a partial vapor barrier. The moisture deteriorated the OSB sheathing and foam adhesive, leading to the blow-off of the exterior finish, which initiated the project. During construction, further damages were uncovered, including significant deterioration of wood-framing members and mold growth on the sheathing and fiberglass batt insulation.

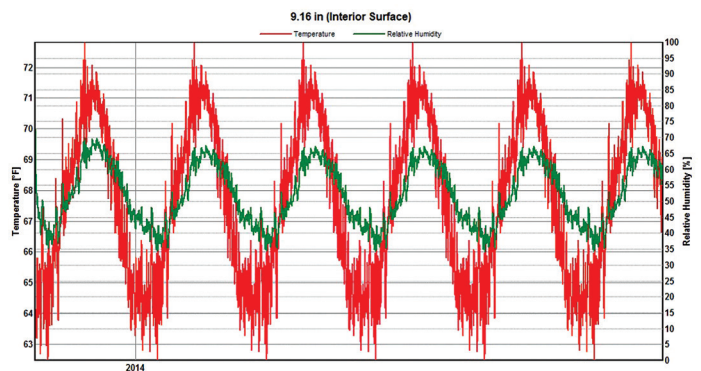
Figure 25 – Temperature and humidity readings at the interior gypsum sheathing at the proposed wall assembly.

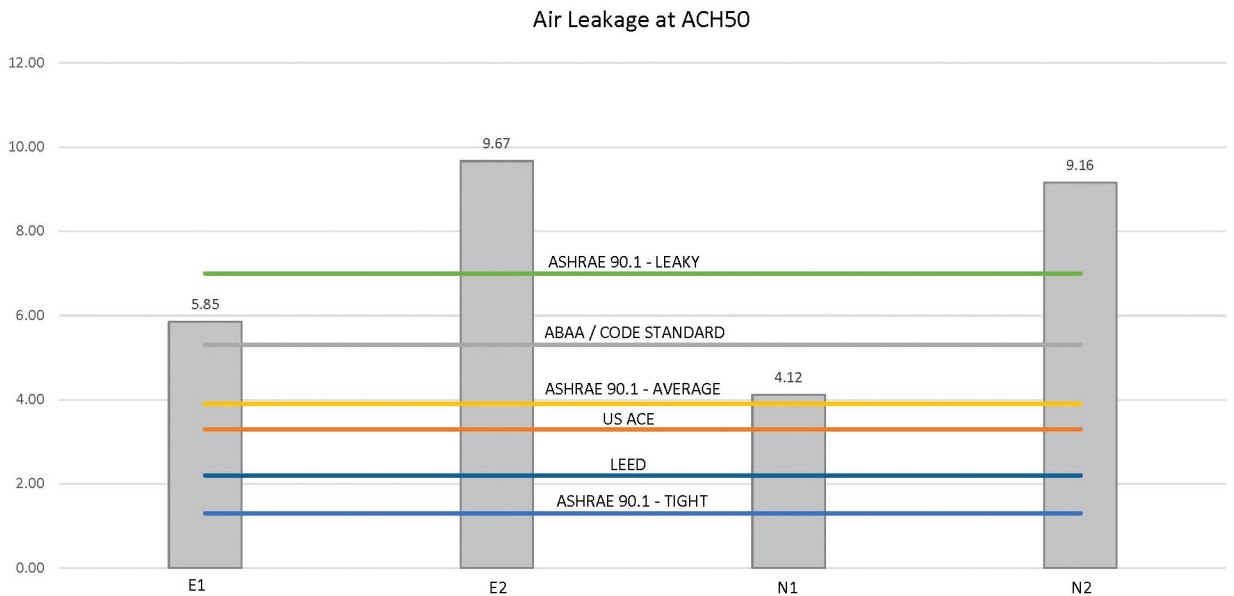
Figure 26 – Graph of industry air change levels and test results.

Society of Heating, Refrigerating and Air Conditioning Engineers (ASHRAE). ASHRAE indicates that buildings with “average” air leakage have an approximate ACH50 of 3.9, “tight” of 1.3, and “leaky” of 7.0 or higher. Unit E2 had a calculated ACH50 of 9.67, which, by ASHRAE standards, is considered “leaky.” Blower-door testing confirmed that the addition of an air barrier to the exterior walls was able to reduce air leakage to an ACH 3.80, which is just below “average.” Figure 26 shows how the ACH50 values recorded during testing compare to ABAA, USACE, and ASHRAE standards.
