# MISCONCEPTIONS OF WIND DAMAGE TO ASPHALT COMPOSITION SHINGLES

BY CARLOS R. LOPEZ, PHD, PE;  
JONATHAN S. GOODE, PHD, PE;  
AND SCOTT R. MORRISON, PE

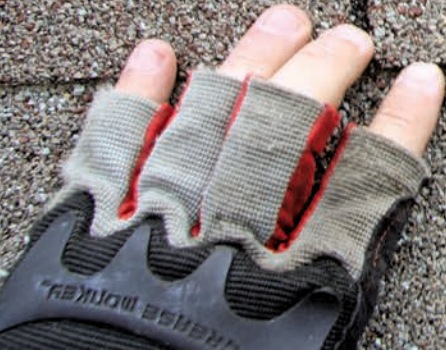
Figure 2 – Creased shingle tab.

This progression will tend to flip and crease or tear the shingle. The wind forces cause the shingle to flutter and bend such that further creases may develop (*Figure 2*). Eventually, if the wind force is strong enough, the tabs or shingle sections break off and are carried downwind (*Figure 3*). This is particularly the case in areas of the roof that are exposed to higher wind forces (e.g., eaves, hips, ridges, etc.). Failure typically occurs at the top of the exposed section, just below the butt end of the overlying shingle.

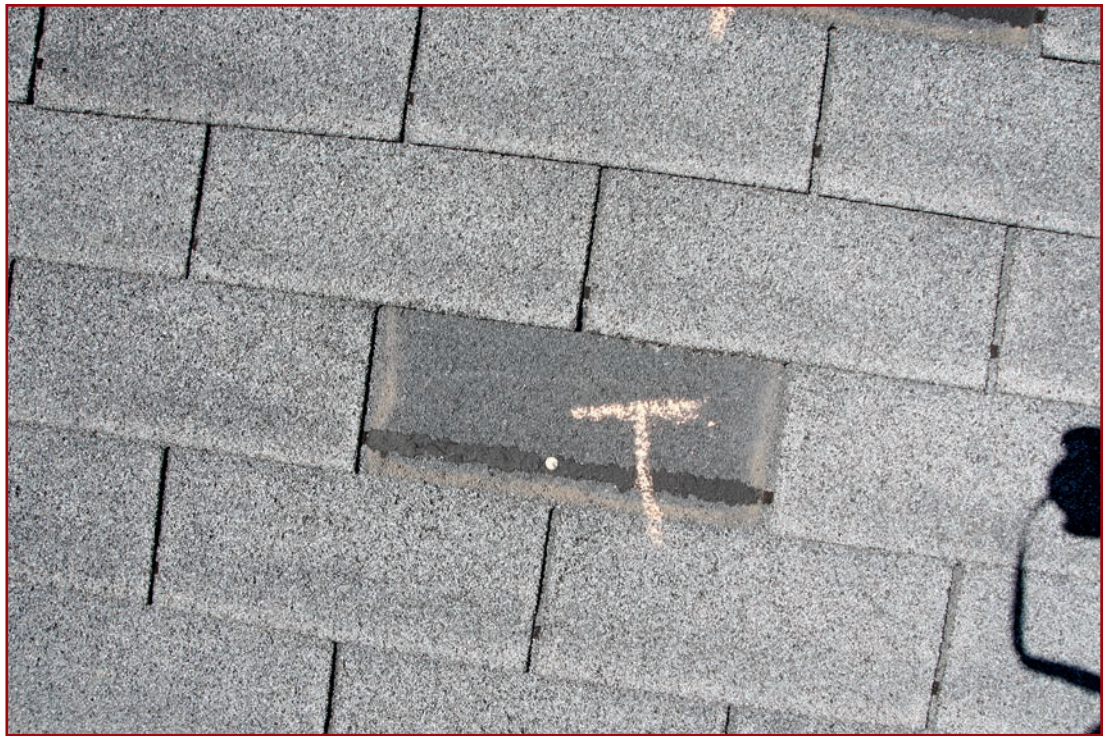
*Figure 3 – Torn shingle tab.*

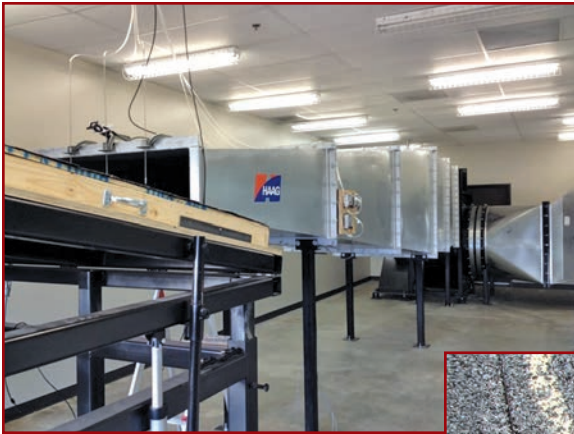
Figure 4 – Haag wind simulator.

A recently completed test performed by Haag Research/Testing (HRT) documented the mechanisms by which shingles are damaged by wind. HRT employed a wind simulator (*Figure 4*) capable of producing wind speeds up to 175 mph and compliant with ASTM D3161, *Standard Test Method for Wind-Resistance of Steep Slope Roofing Products (Fan-Induced Method)*. Post-test inspection of all shingles that unbonded during the testing revealed that, at a minimum, creases were present. Shingles utilized in this test were not weathered, but were placed on the test assembly days before the test. In the new, pliable shingles tested, the creases required very close inspection and tactile manipulation (i.e., placing hand pressure from underneath the shingle) of the granular surface to observe the crease; nonetheless, they were present and observable.

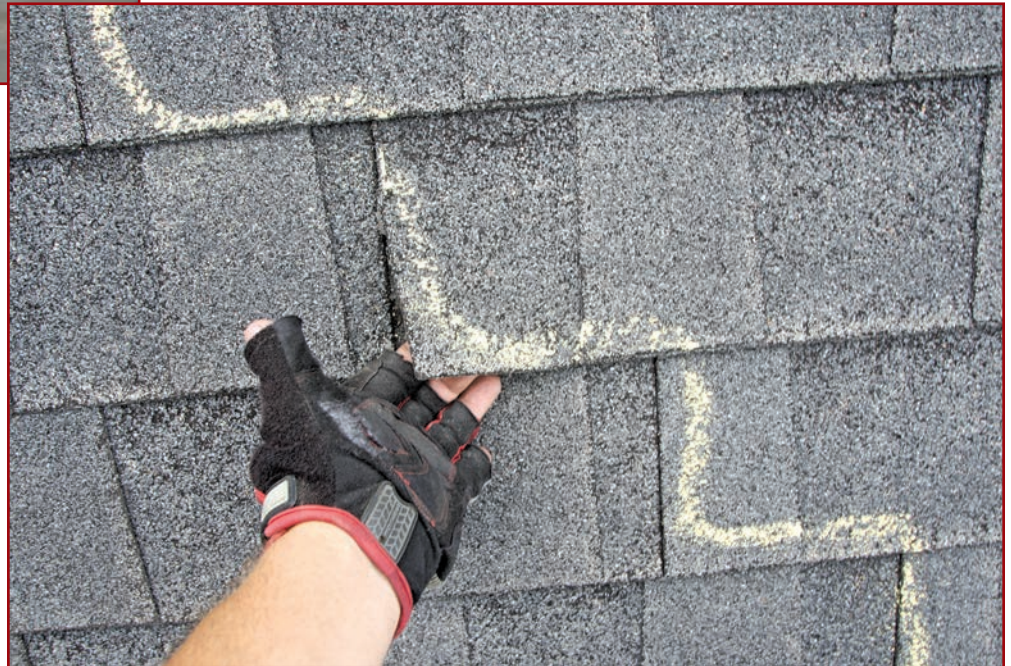
Figure 5 – Unbonded diagonal pattern of shingle overlaps.

Cyclic thermal expansion and contraction, for example, will yield a pattern of unbonded shingle overlaps extending up-slope diagonally, reflecting the pattern in which these shingles were installed (*Figure 5*). A similar pattern is often observed with shingles installed in a straight-up pattern, referred to as “racked.” An unbonded pattern of shingle tabs in a racked installation is commonly referred to as zippering (chalk lines in *Figure 6* show the nonbonded shin-

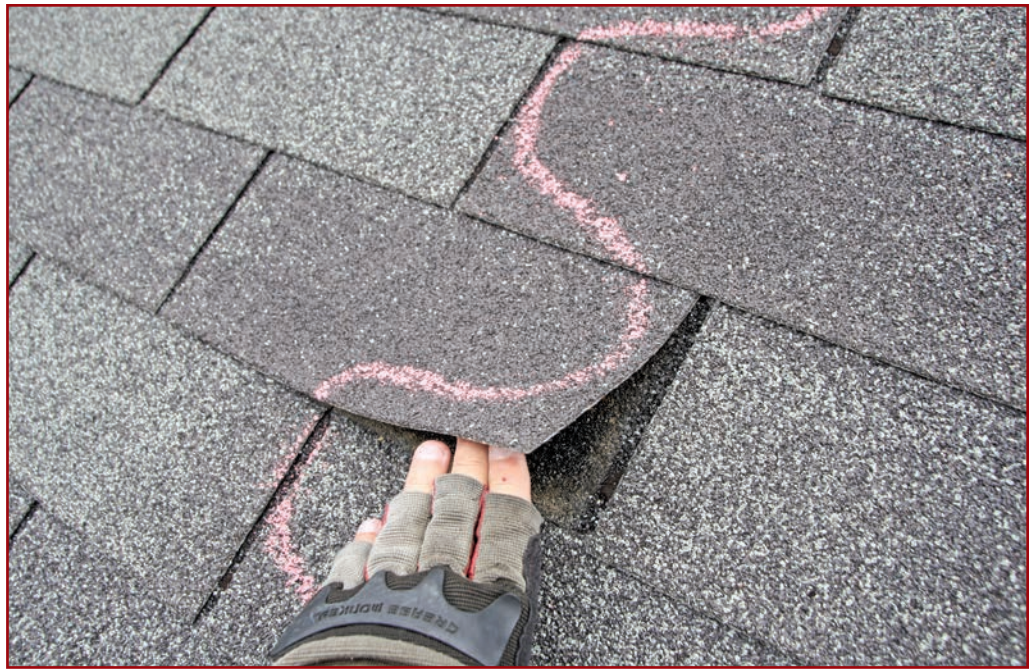
Figure 6 – Unbonded racked pattern of shingle overlaps.

gle portions). These unbonded overlaps will not vary in direction or increase/decrease in areas of the roof where wind uplift would
