“Value-Engineered” Waterproofing Errors

By Lonnie Haughton, MCP, LEED AP, CDT

THE PROJECT

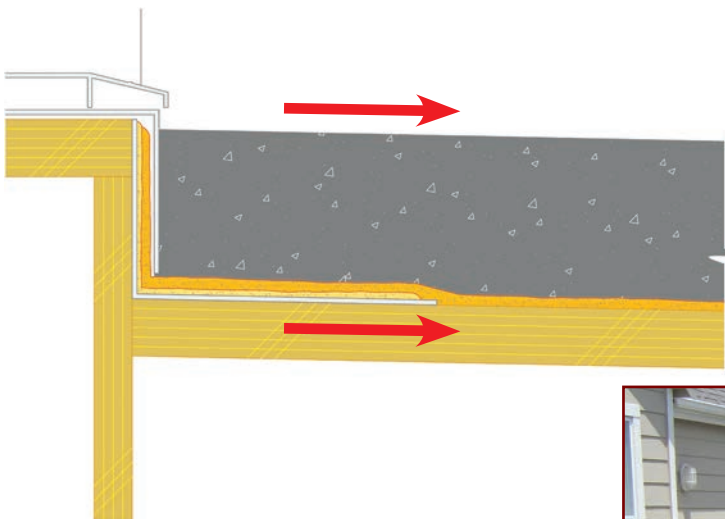
Figure 1 – Upper-story tenants at this apartment complex are served by 3000 lineal feet of wood-framed elevated walkways.

Consider a 160-unit, three-story, wood-framed residential apartment complex south of San Francisco. The upper apartments are served by the wood-framed elevated walkways seen in *Figure 1*, capped with 1½-in. engineered wood decking, a fluid- and spray-applied waterproofing/flashing system, and a concrete walking surface. The architect’s original design called for the framing to be tapered to the exterior, thereby providing positive slope-to-drain at both the waterproofing layer and at the concrete walking surface, as seen in *Figure 2*.

As evidenced by Figures 1 and 5, a complex layout of elevated walkways (totaling 3,000 feet long and 19,200 square feet in area) wrapped around the 104 upper-story units at this facility. Clearly, the architect's original plan (per Figure 2: providing positive slope for walkway waterproofing drainage by individually cutting a taper into

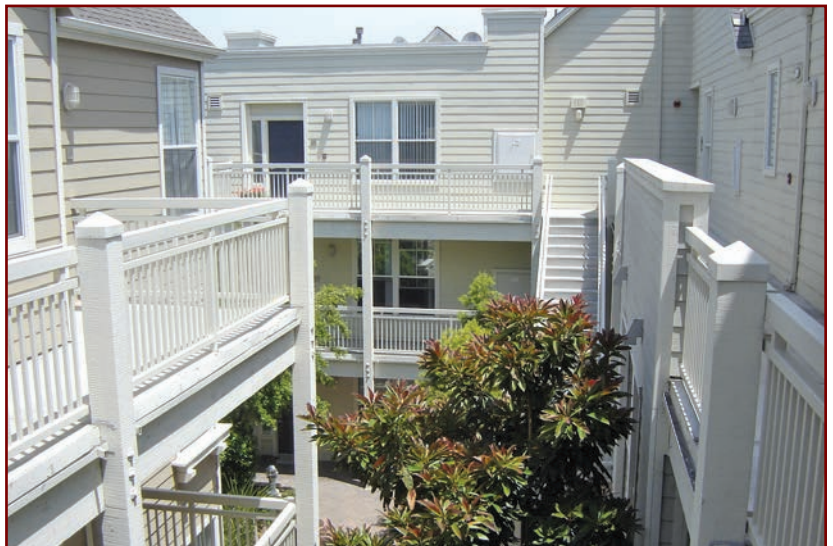
Figure 2 – The architect’s original design called for positively sloped framing, decking, waterproofing, and concrete that served to drain rainwater toward the exterior edges of these elevated walkways. (Litigation exhibit by Andrew D. Trias.)

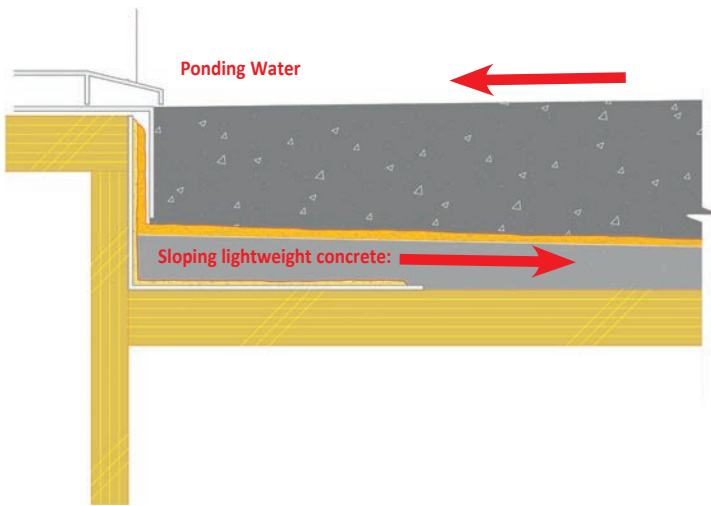
Figure 3 – The as-built proposal instead provided sloping lightweight concrete under the waterproofing membrane. However, this alternate design produced negative slope, ponding water, and locally severe framing damage below the concrete walking pad. (Litigation exhibit by Andrew D. Trias.)

Instead, the contractor proposed installing a layer of wire-reinforced, sloping lightweight concrete (see *Figures 3 and 4*) under the fluid-applied waterproofing membrane as an alternate method of providing the positive slope sought by the architect. The value-engineered cost savings would be tremendous.

Unfortunately, during the entire course of construction, both the architect and the contractor failed to recognize that due to: a) the additional thickness of the lightweight concrete and b) the additional height that was inherent in not tapering the wood framing per the original plans, the outside elevations of these concrete walkways were being raised significantly in relation to the already-fixed height of the apartment entry doors (compare *Figures 3 and 4*.)

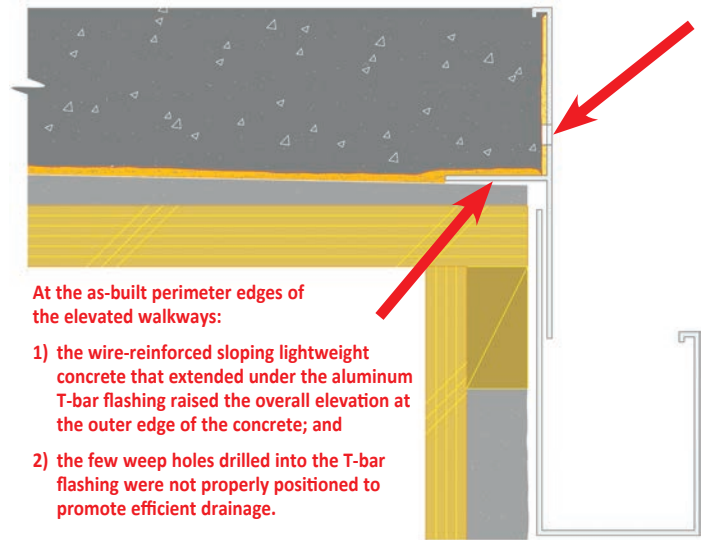
Figure 4 – Sloping lightweight concrete extending under the 2-in. aluminum T-bar flashing at the outer edge served to raise its overall height. Additionally, the relatively few weep holes drilled into this metal flashing were not properly positioned to promote efficient drainage of the waterproofing membrane. (Litigation exhibit by Andrew D. Trias.)

Additionally, note in these two figures (also see *Figure 4*) that the few weep holes that had been drilled (post construction) into the perimeter aluminum T-bar flashing were not properly positioned to promote efficient drainage of the waterproofing membrane; trapped water eventually leaked down through various as-constructed flashing and membrane deficiencies, attacking the heavy glue-laminated wood structural beams and columns below.

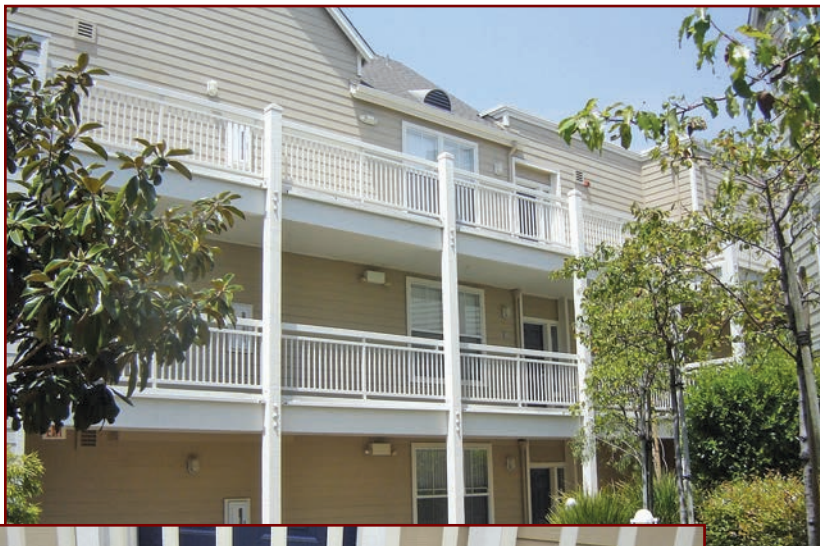
Figure 5 – Elevated walkway posts and beams were manufactured from glue-laminated Alaskan yellow cedar.

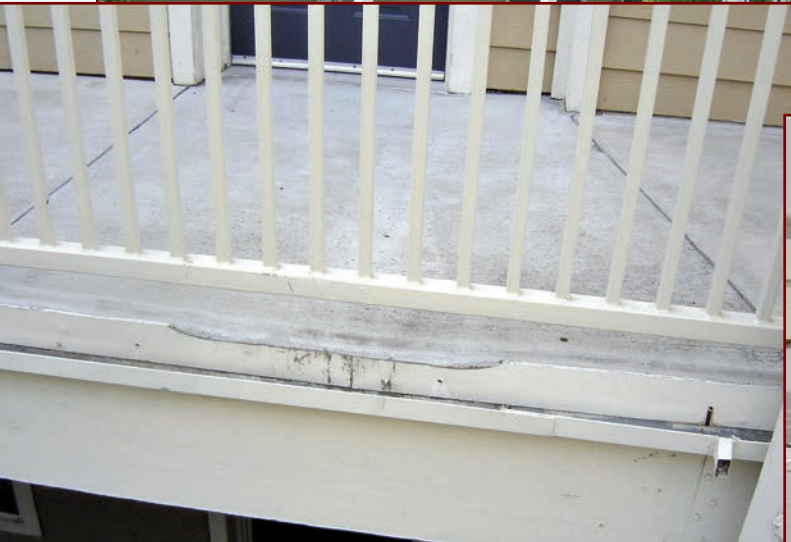
Figure 7 – The relatively few weep holes drilled into the T-bar flashing were not properly positioned (see Figure 4) to promote efficient drainage of the waterproofing membrane.

By not taking into account the predetermined elevations of these door thresholds, the architect and contractor allowed the as-built walkways to be negatively sloped toward many of these entry doorways. Later, as seen in *Figures 6 and 7*, the owner's maintenance personnel responded to interior flooding through these poorly crafted thresholds by literally grinding out portions of the outer edge of the metal T-bar flashing and concrete in order to provide drainage relief for areas of particularly troublesome rainwater ponding.

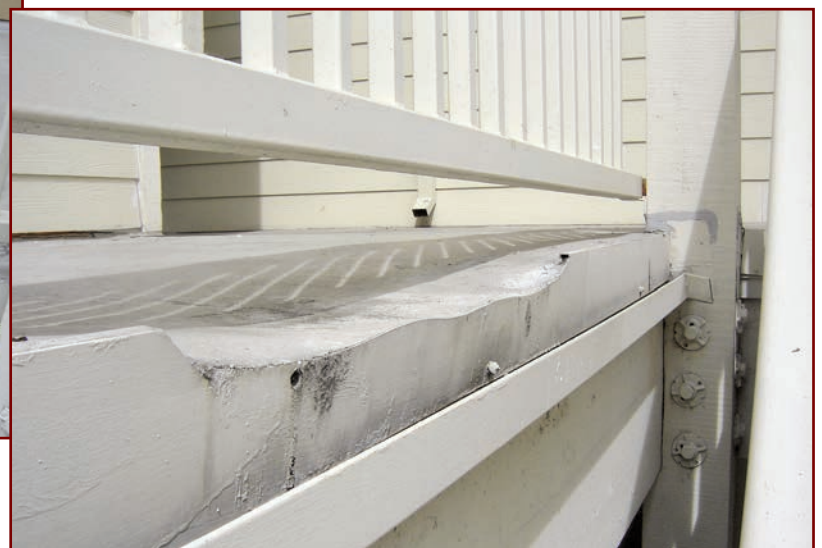
Figure 6 – Maintenance staff had carved out numerous portions of the outer edge of the T-bar flashing and concrete in order to provide drainage relief for areas of particularly problematic ponding.
