# ROOF DECKS

# A to Z

## Part XII: Board Sheathing

By L.D. Hogan, RRC, FRCI, PE

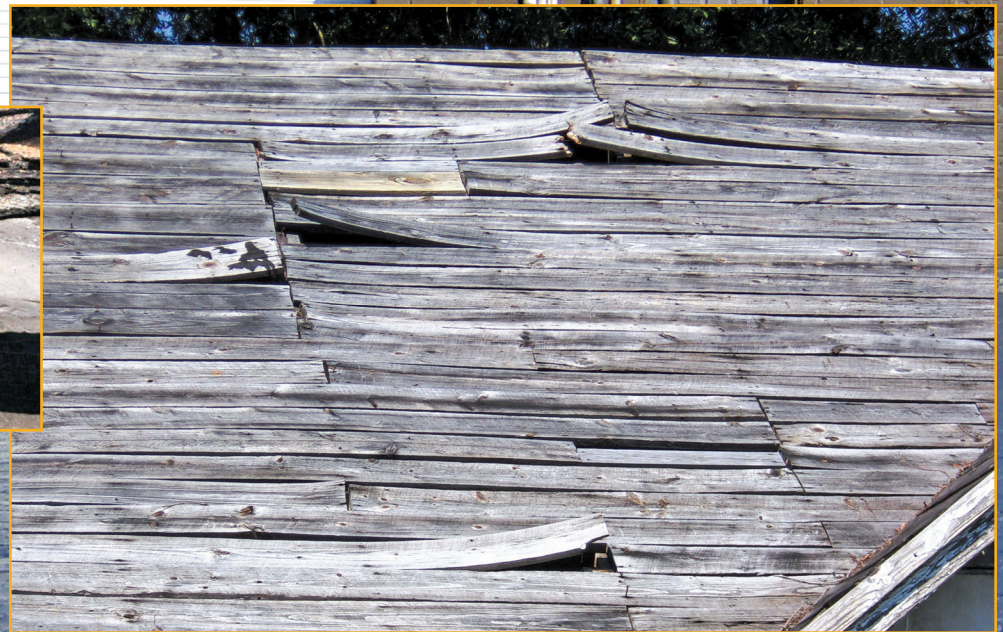
*Figure 2 – Left exposed for much longer than appropriate, this deck has distorted in response to cycles of wetting and drying. Now, much of it will require repair before a covering can be applied.*

decking can sometimes be challenging. *Figure 2* depicts one such instance where a deck was left exposed for much longer than appropriate. This deck has distorted in response to cycles of wetting and drying; now, much of it will require repair before a covering can be applied.

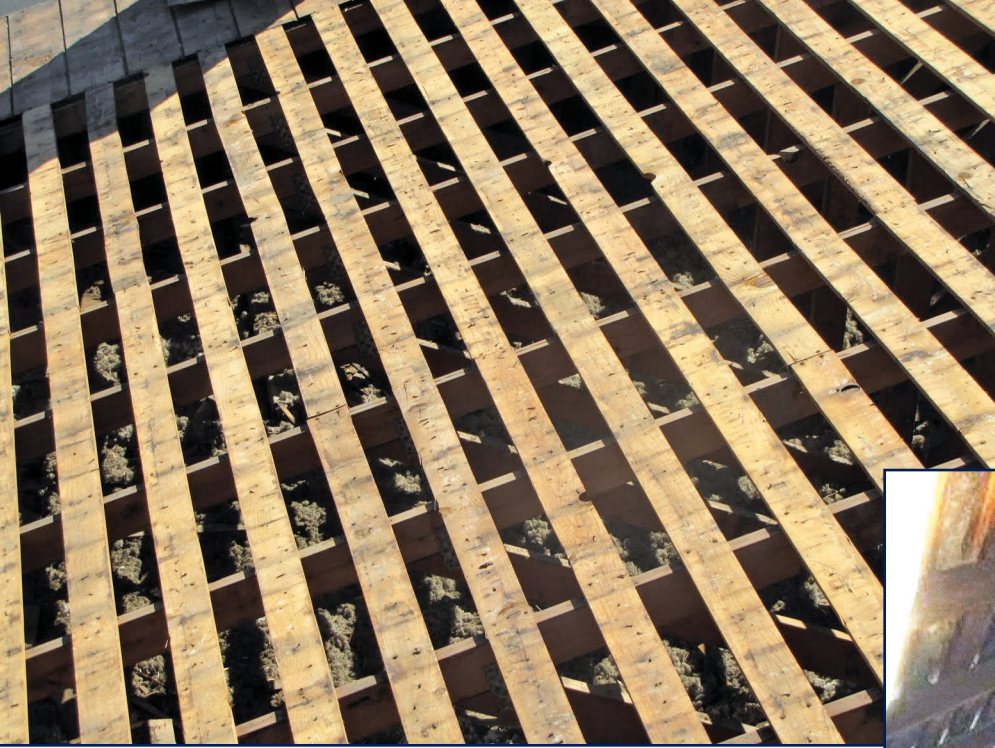
Figure 4 – Spaced decking (also known as skip sheathing) may be found below wood shakes, slate, and tile.

may be encountered as well. Also known as “skip sheathing,” this arrangement may be found below wood shakes, slate, and tile (Figure 4).

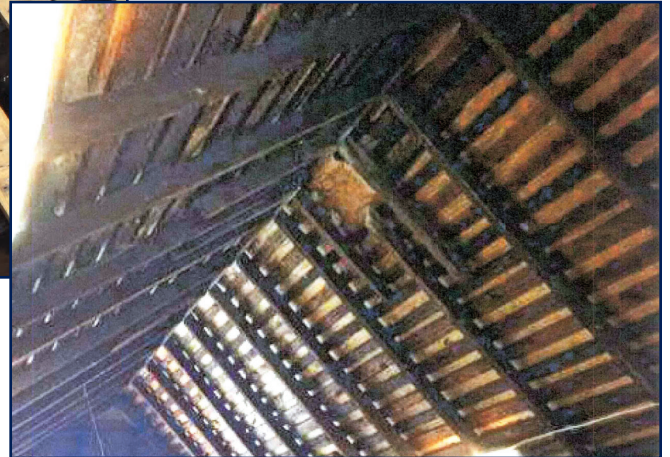
Figure 5 – This spaced decking on an old church was later topped with OSB sheathing. Only when attic access was gained did the skip sheathing become recognized.

OSB. Although topside fastening is mostly “blind,” some care can be taken to find support joists and engage new sheathing edges to the supports. *Figure 5* depicts spaced decking on an old church that was later topped with OSB sheathing. Only when under-deck access was finally gained did the original skip sheathing become known (the attic door opening was very small, with few individuals ever attempting entry). With the deck overlay alternative discussed here, there may sometimes be a structural loading consideration. This will hinge on matters of rafter/support type and spacing, slope, potential for rooftop snowdrifts, etc. Accordingly, the decision to overlay should include proper scrutiny of likely loading scenarios.

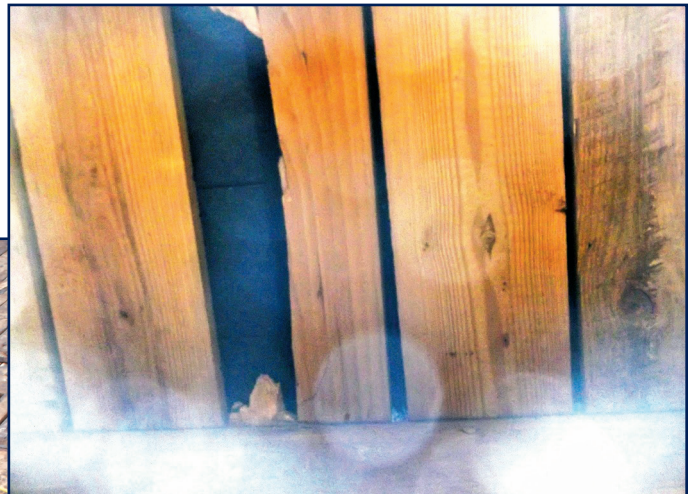
Figure 7 – This newer roof had been installed with little thought given to proper deck repairs.

When individual planks are replaced, it is advised that the new members be situated across several supports. Just as with plywood or OSB, board sheathing provides some lateral stability for the framing, and small plank fractions are not as sturdy as longer elements that span multiple supports. *Figure 7* depicts a newer roof that had been installed with little thought given to proper deck repairs; this merely postpones a correct remedy for the next roofing team.

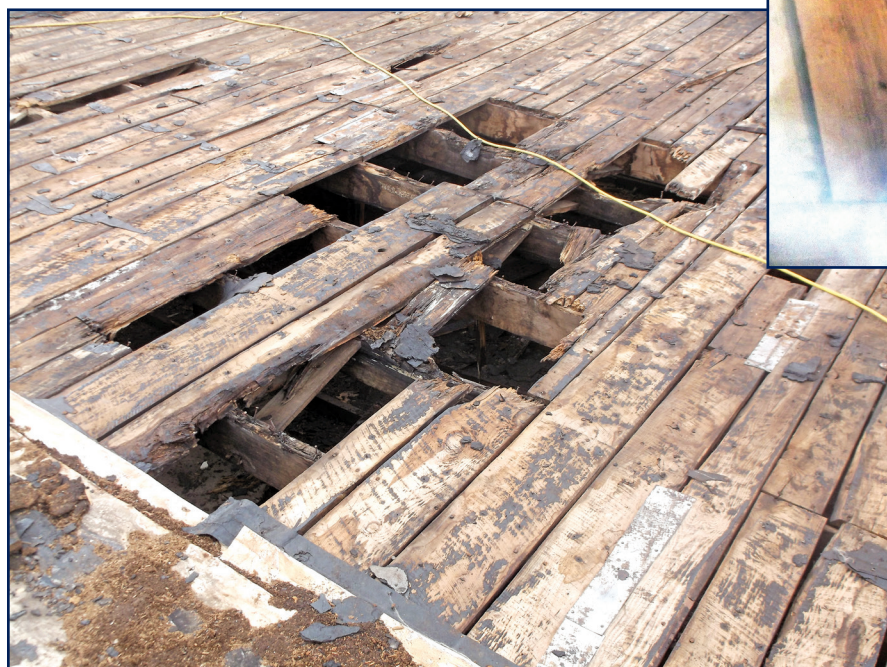
Figure 6 – Old board sheathing decks will commonly need repairs before the new covering can be installed. The effort deployed in carrying out such repairs is well worthwhile.

Old board sheathing decks will commonly need repairs before the new covering can be installed (*Figure 6*). The effort in carrying out such repairs is well worthwhile.

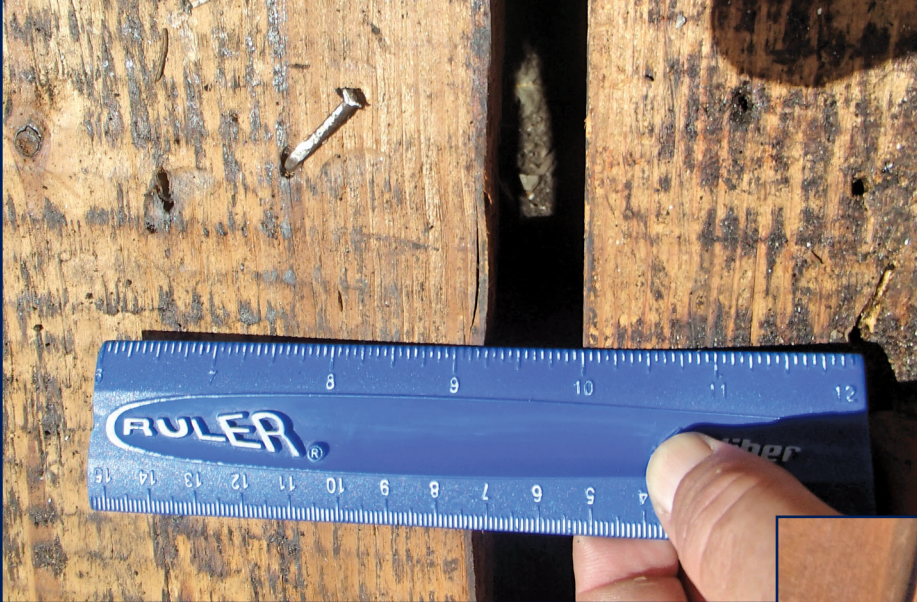
Figure 8 – Wide decking gaps are problematic for reroofing projects. Usually occurring in older structures, the gaps can create fastening problems (i.e., greater likelihood for nails to occur in the plank joints).

Often found in older structures (*Figure 8*), the wide decking gaps create the likelihood for nails to occur in plank joints. Heavier underlayment can be deployed, but over time, there will probably still be sagging of underlayment

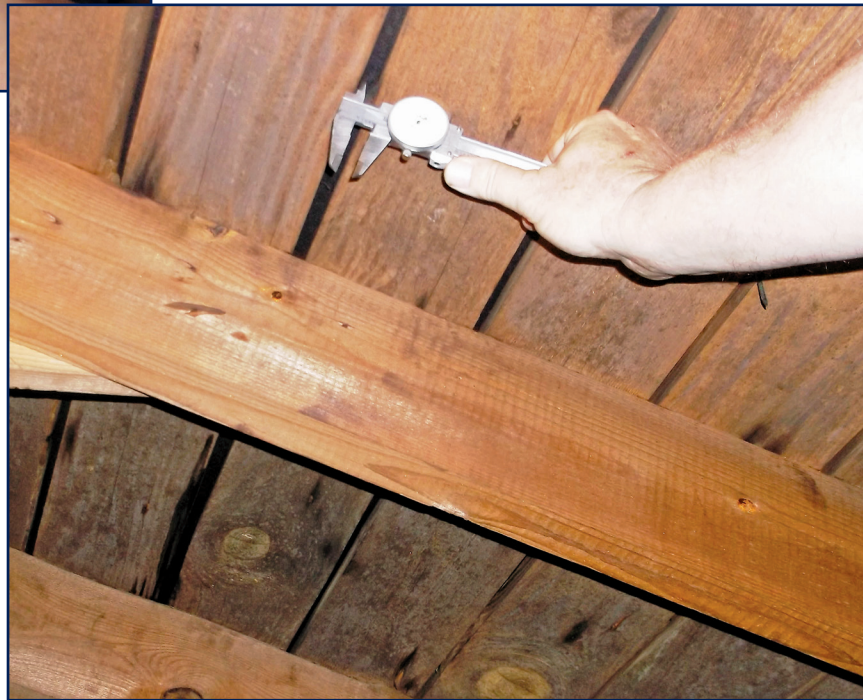
Figure 9 – Fastening that does not engage the plank sharply reduces wind resistance, frustrates the installing mechanic, and reduces rooftop production. Shingle manufacturers are aware, and a figure of ¼ in. is the increasingly familiar limit for gaps in order for warranties to be honored.

into the void, and eventual leakage will usually occur here first, especially at lower slopes. Fastening that does not engage the planks reduces wind resistance, frustrates the installing mechanic, and hinders rooftop production (*Figure 9*). When lightweight shingles are used, gaps exceeding ¼ in. may telegraph through and become visible. For shingle manufacturers, the figure of ¼ in. is the increasingly common gap limit allowed in order for warranties to be honored.

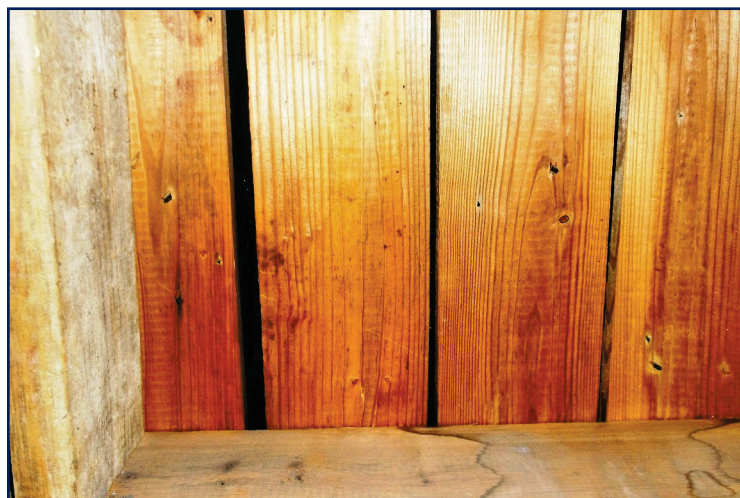
Figure 10 – Note that shrinkage of planks is seldom uniform. This occurrence will require a judgment call regarding the proper course of action.

As outlined earlier, wood shrinks as it dries—just like many other construction materials (*Figure 10*). Note that shrinkage of wood planks is seldom uniform. The occurrence of wide gaps will require a judgment call regarding the proper course of action (*Figure 11*). Note that if deck planks are 6 in. wide and a ⅛-in. gap is present between planks, there is a 9.4% chance that any random nail will occur in a joint opening; where joints are ¼ in. wide, there is an 11.1% chance for nails in a gap. That is a lot

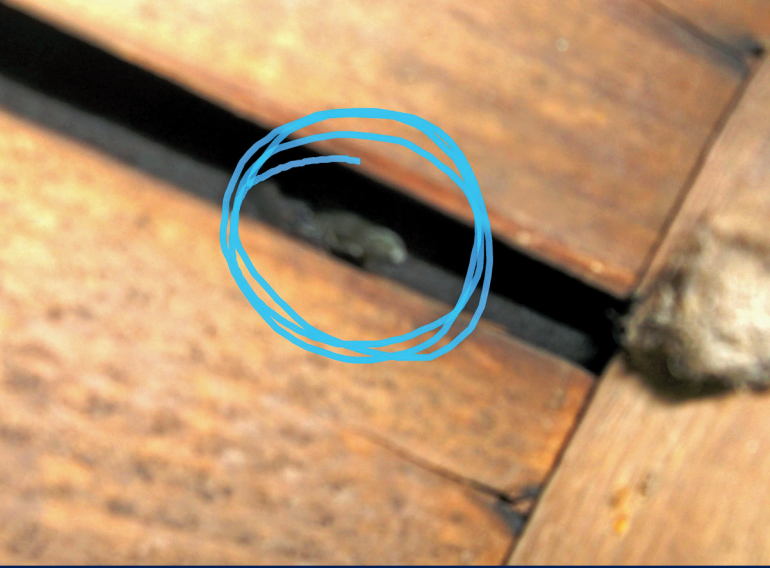
Figure 11 – If deck planks are 6 in. wide and a 1/8-in. gap is present between planks, there is a 9.4% chance that any random nail will occur in a joint opening. Where joints are 3/4 in. wide, there is an 11.1% chance for wayward nails.
