# Why We Need to Rethink the Business of Mid-Rise Wood Frame Student Housing

By Derek Hodgin, RBEC, RRO, PE, CDT

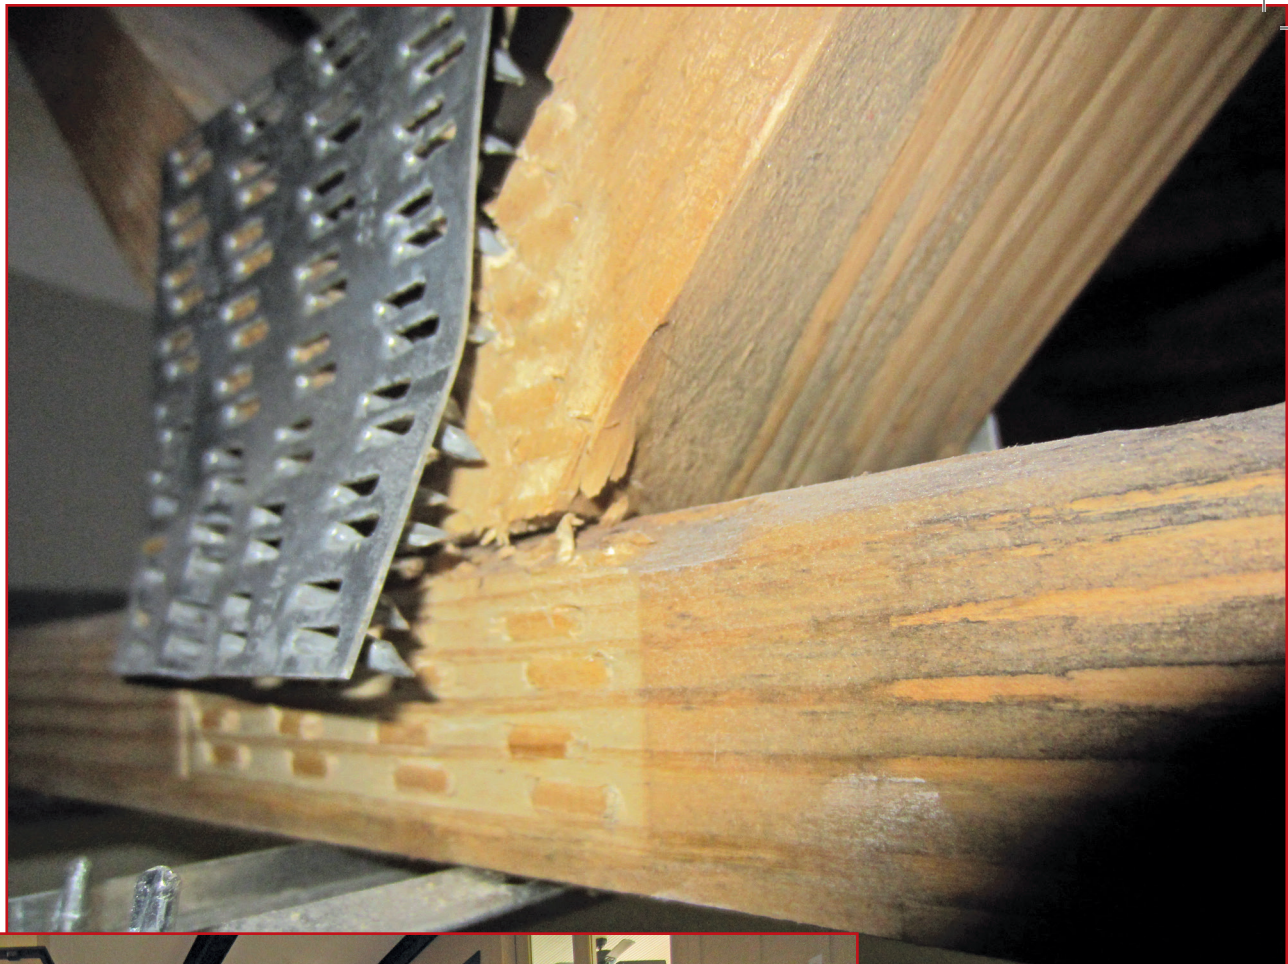
Figure 2 – View of damaged wood truss due to dynamic condition.

buildings. College students have much greater potential of generating dynamic loading conditions on floor framing due to dancing and deciding to “see what happens if we all jump together!” as reported in one of our floor collapse cases (Figure 2).

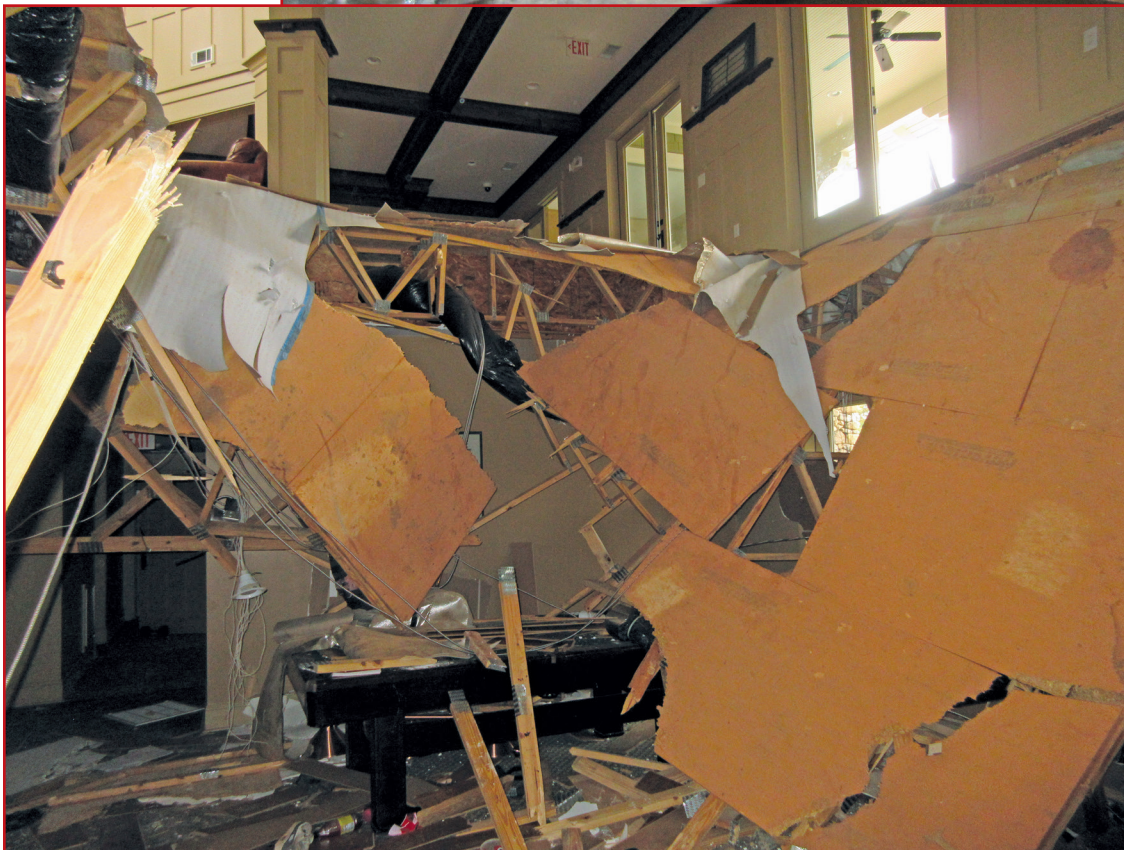
Figure 3 – View of collapsed floor framing.

Our firm has recently consulted on two collapses of wood frame floors and a collapse of a wood frame deck in student-occupied

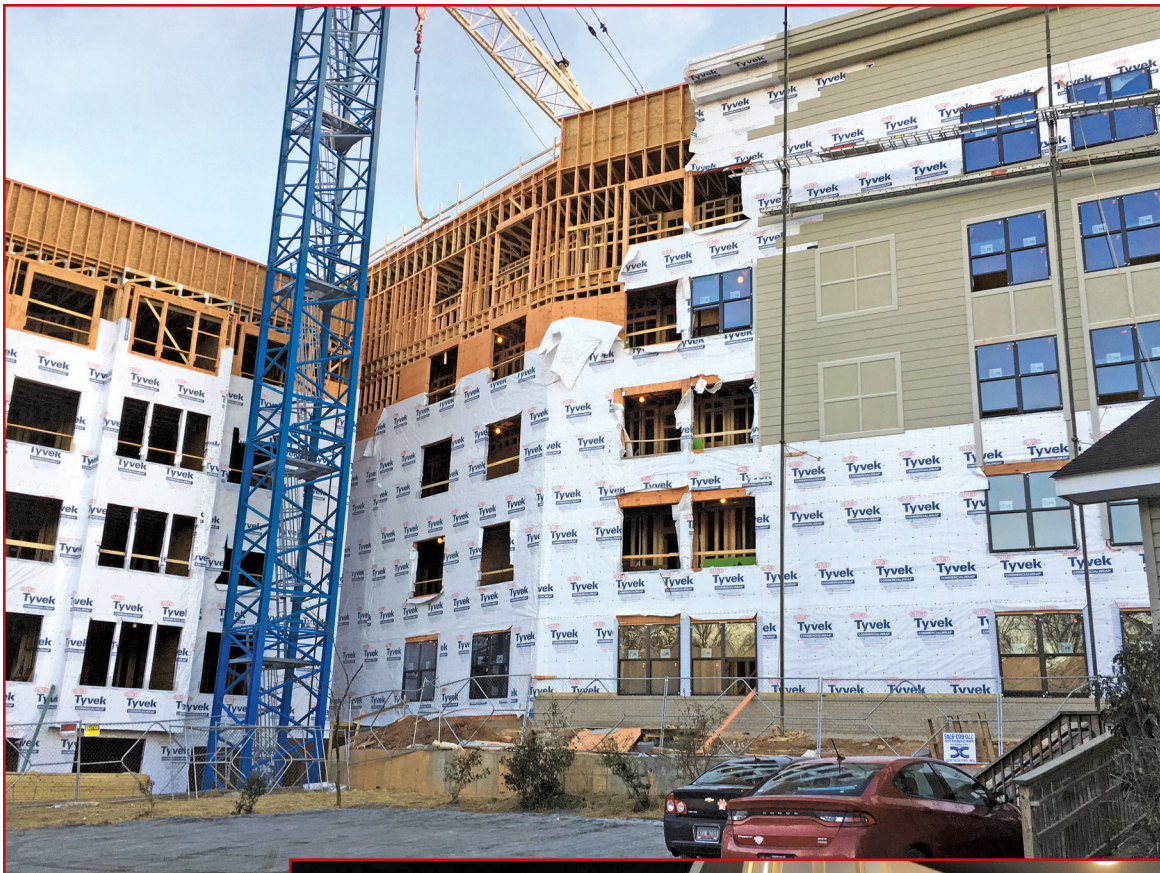
Figure 4 – View of a building in various stages of construction.

Another project trapped water in the exterior wall assembly due to rain events that occurred while the walls were in a variety of stages of completeness. Areas of incomplete weather-resistant barrier (WRB) served to trap and funnel water into the wall assembly, where it remained while the wall construction continued, with no efforts to dry out the wall (Figure 4).

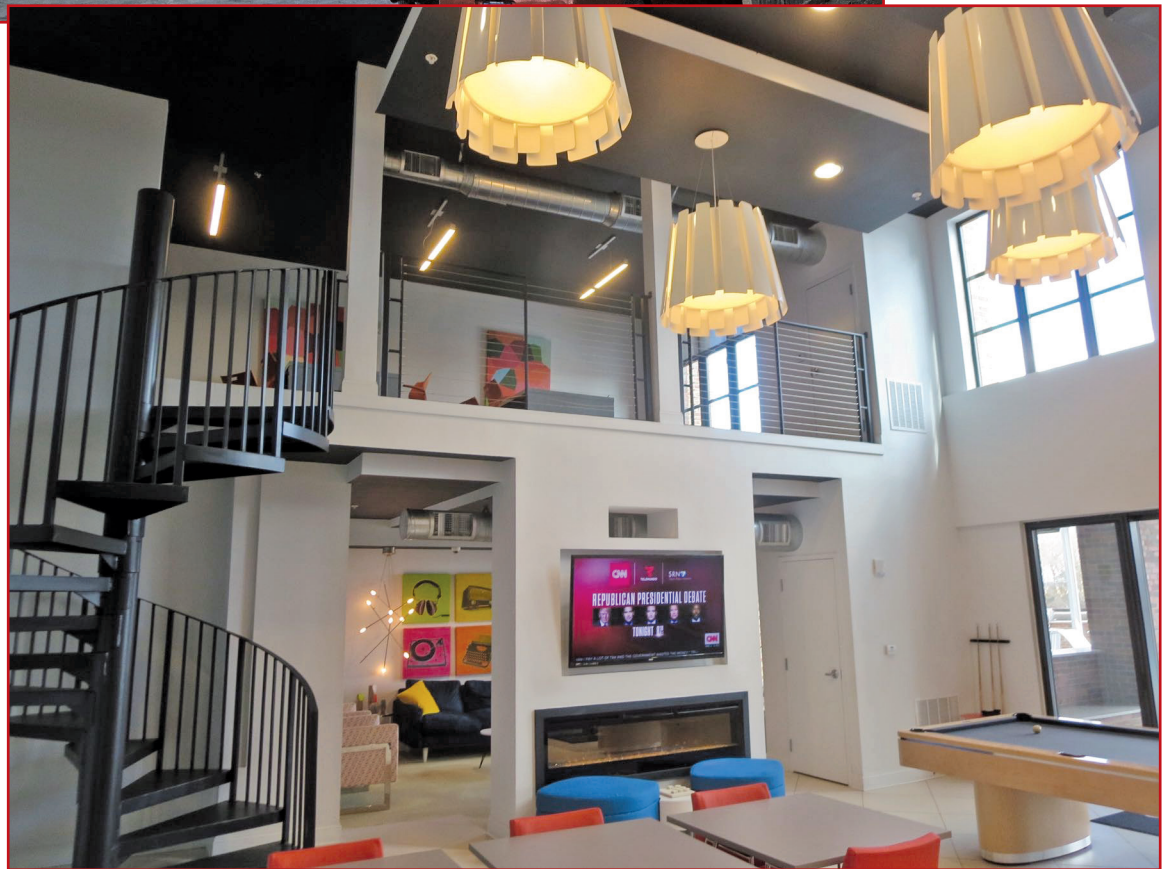
Figure 5 – View of the interior of student housing building.

there appears to be an all-out amenity war. It is no longer acceptable to only have a pool, lazy river, and fitness center. To attract more students, most current projects include volleyball, a DJ booth, hip communal spaces, frequent social functions, and an array of promotional giveaway gear fashioned in school colors (Figure 5).

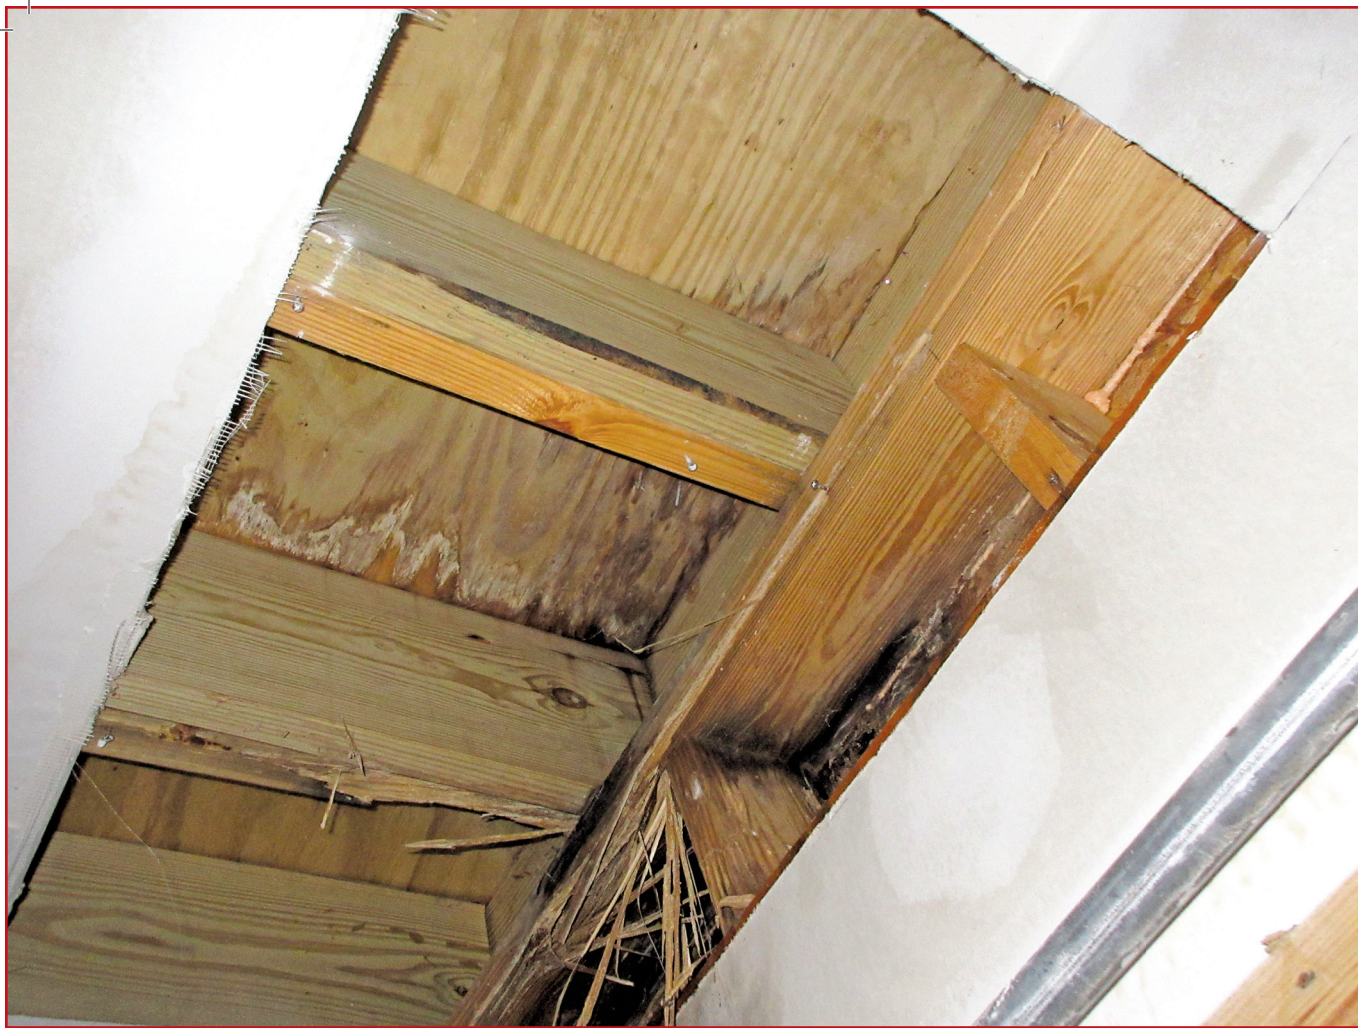
A recent example of a value engineering failure involved balcony waterproofing details. While the project plans depicted a well-known waterproofing system, a decision was made to replace the best-practices waterproofing system with a code-compliant waterproof coating over a flat wood balcony

Figure 6 – View of water damage at balcony.

subfloor and cover the waterproofing with a concrete topping slab. Significant water intrusion and rot were documented within five years after the project was completed. The balcony repairs that are now required will be significant. Fortunately, no one was injured or physically harmed by the resulting damages (Figure 6).

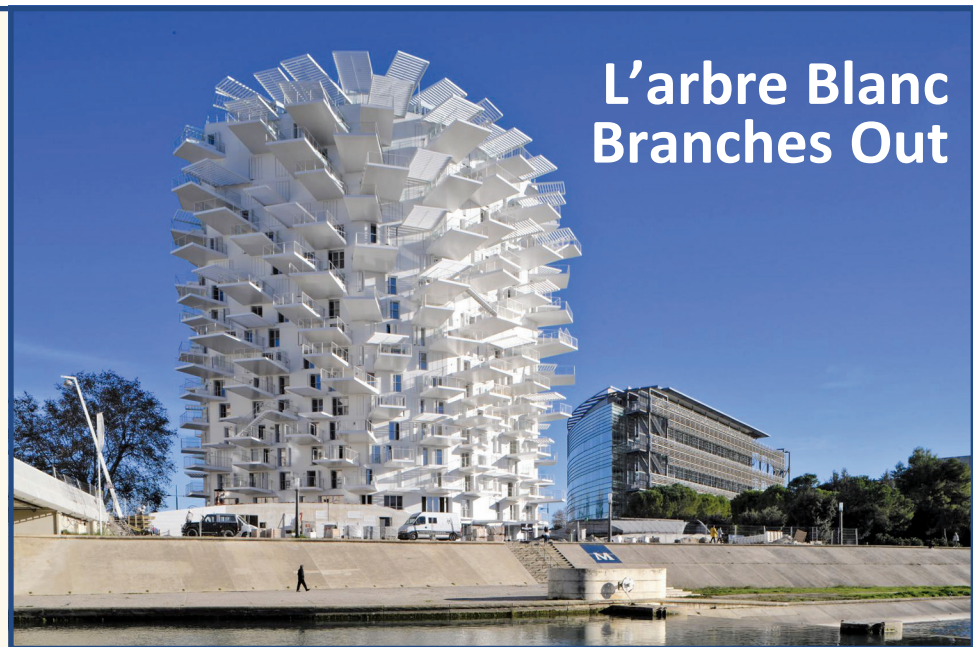
## L'arbre Blanc Branches Out

The kidney-shaped building has 113 luxury apartments—many with cantilevered balconies—some as long as 25 feet out from the building and formed of built-up welded sections and bolted to vertical steel H-beams fixed to the concrete floor slabs. Steel pergolas serve as sun-breakers above the balconies.

The reinforced-concrete column-and-slab structure and enclosing walls rely on faceted planes to bend around corners.
