Design Principles for Tower and Steeple Restoration

By Robert Fulmer

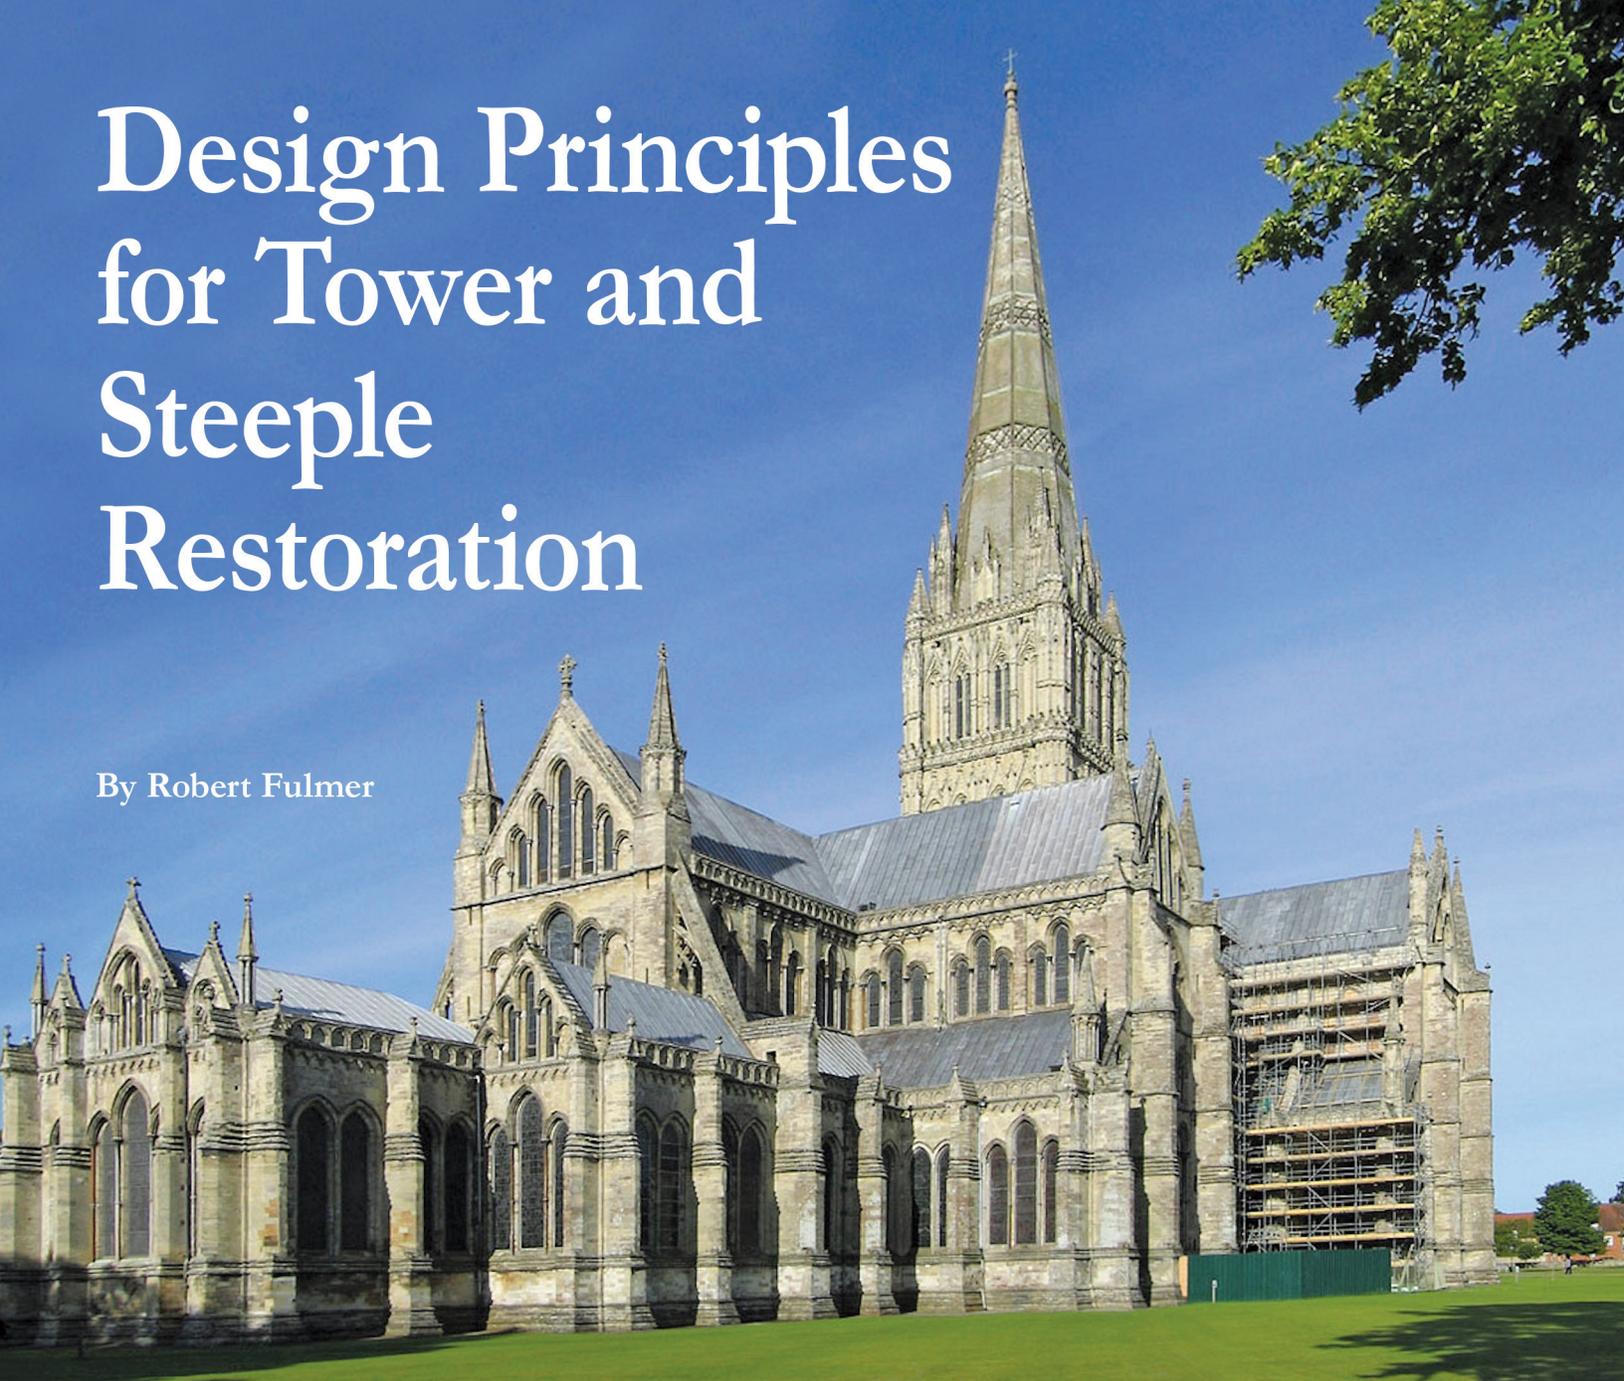
Figure 1 – Salisbury Cathedral, England, during a lead roof replacement.

also adapted from military watchtowers. See *Figure 1*.

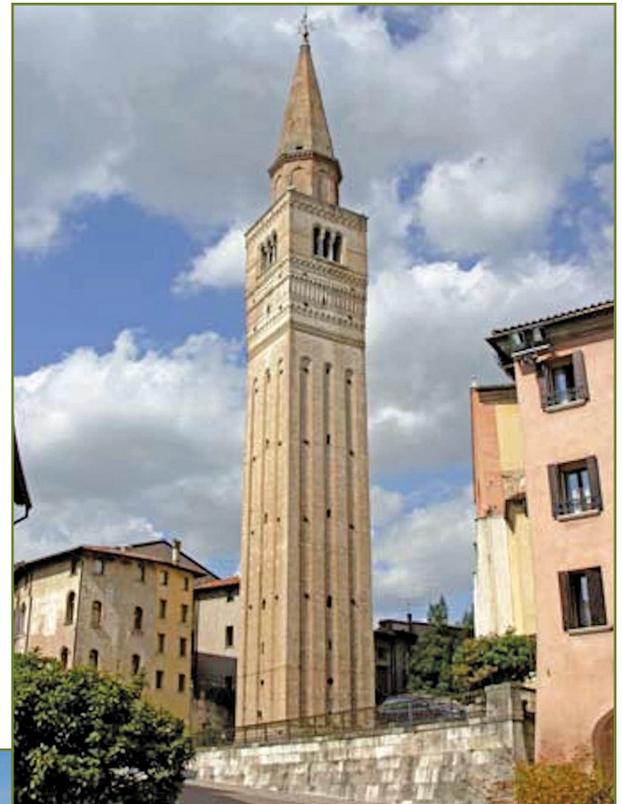
Figure 2 – Campanile, Cathedral of Pordenone, Italy.

Campanile: An early Italian architectural term for a (usually) freestanding bell tower, derived from “campa” (meaning bell). The earliest campaniles, dating from the 6th to the 10th centuries, were plain round towers with minimal ornamentation near the top. Square campaniles began to appear at the end of the 10th century. In the 19th century, that design inspired the tower at Westminster Cathedral (by J.F. Bentley, 1897). The revival of the campanile in the 19th and 20th centuries included installations at factories, country houses, blocks of buildings, markets, and academic structures as a bell or a clock tower. (See *Figure 2*.)

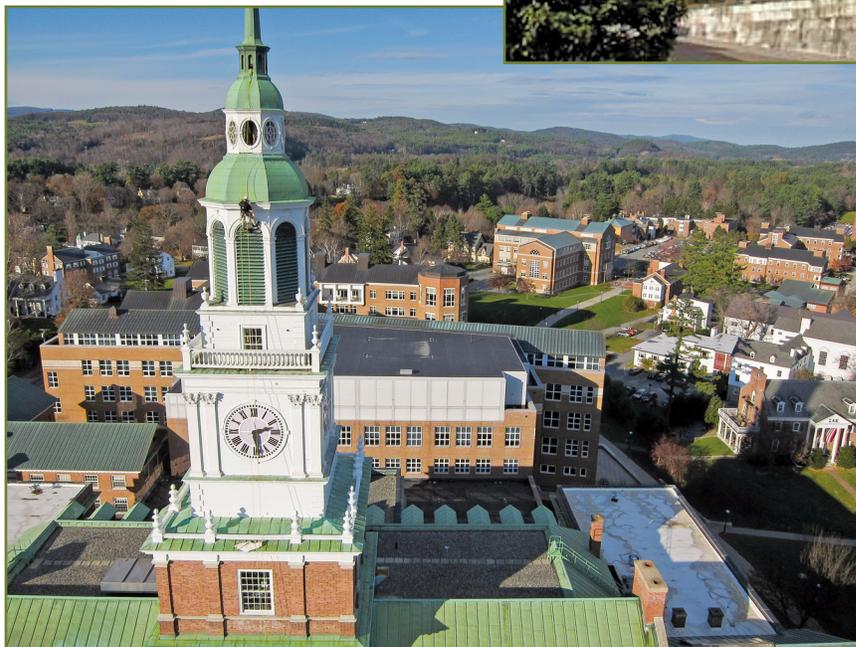
Figure 3 – Baker Tower industrial rope access inspection.

Whether in the schematic design phase or construction phase, the logistics of tower access can be challenging. Unlike the construction phase, the requirements for OSHA compliance are less onerous for design inspections. However, personal safety planning is obviously essential. The need to access the full height of a tower for inspection and actual construction significantly impacts both the cost and schedule of all tower projects. The trade euphemism of “everything costs more and takes longer when working at height” is a basic design principle to be kept in mind (*Figure 3*).

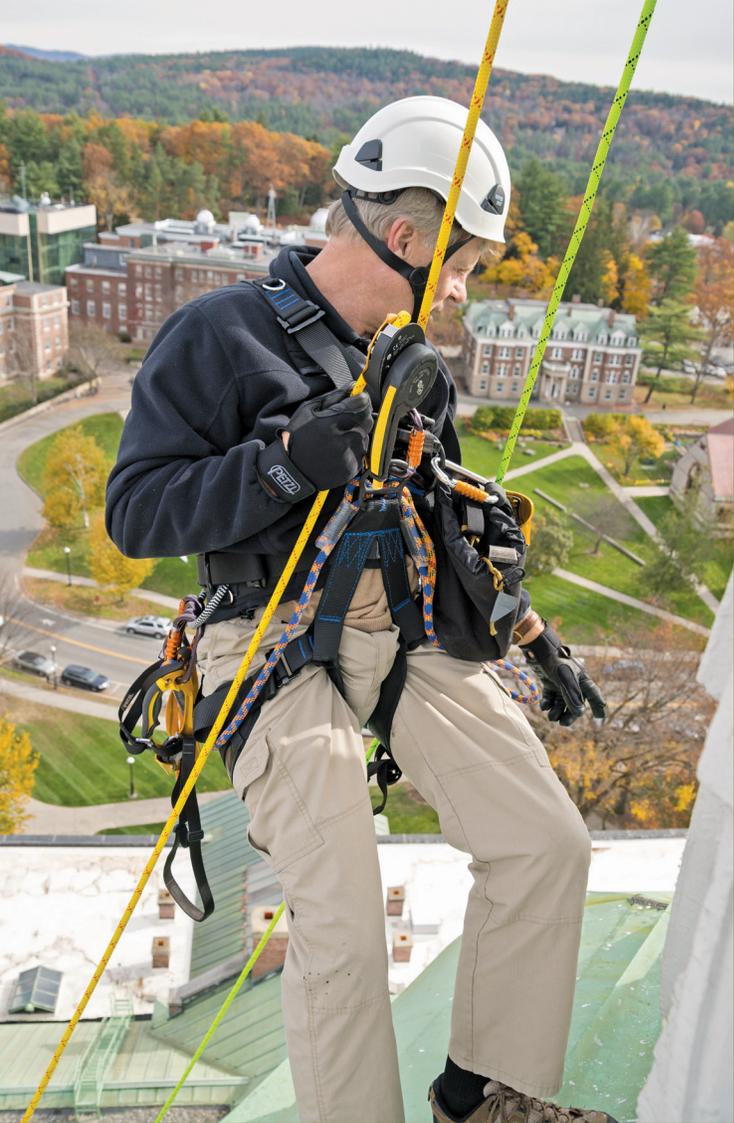
Figure 4 – Rope access enables forensic analysis and materials sampling.

With no mechanical access option and the prohibitive cost of staging erection for inspection, the author used an “industrial rope access” option to access the tower (Figure 4).

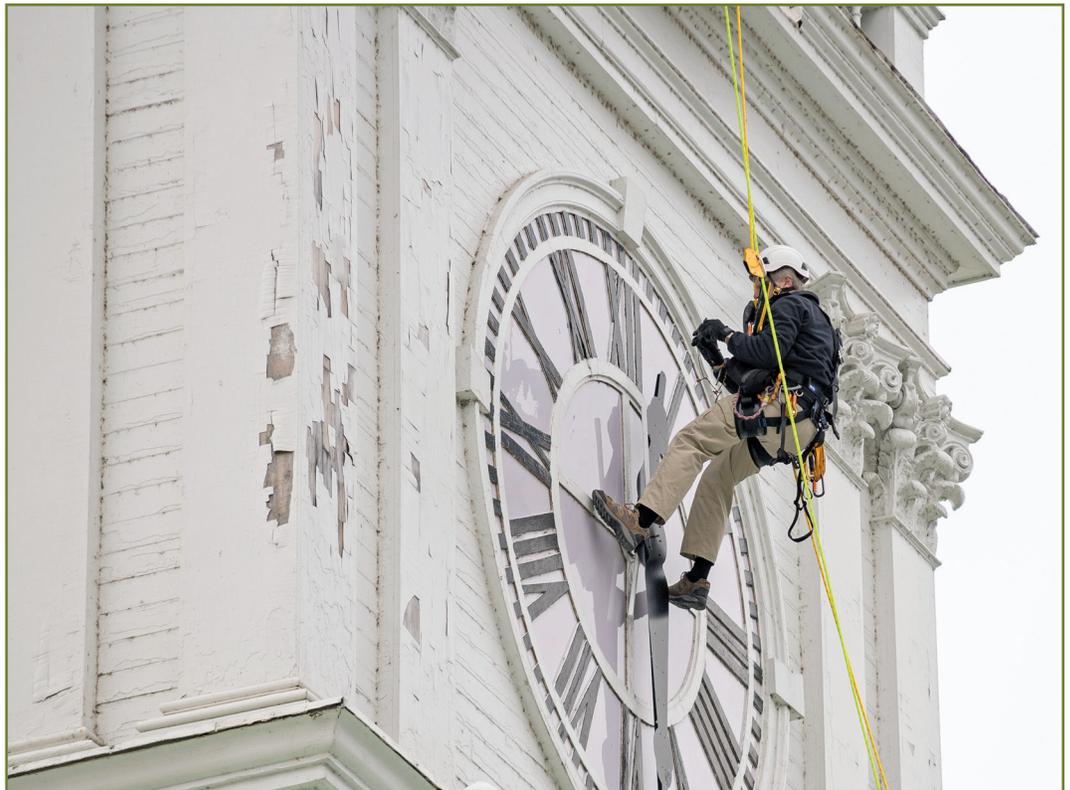
Figure 5 – Baker Tower building conditions survey.

At a minimum, the building conditions survey (Figure 5) should include the following elements:

- Determine the applicable code bodies to be addressed as a result of initial observations and concerns.
- Diagram all existing structural components in situ; include sizes, locations, configurations, truss structure, and timber species, quality, and grade (if applicable). Document any conditions of structural component stress, deterioration, or failure.

- Note all areas of water infiltration, along with any structural distress or deterioration within those areas.
- Record any previous repairs or modifications to the structure.
- Note any areas of “change of use” or potential increase of future loads on the structure.
- Document the existing condition of all tower envelope systems and collect material samples, both inert (i.e., timber frame component samples) and potentially hazardous materials that may require abatement.
- Note immediate or potential life safety concerns and possible remediation procedures to address those concerns.

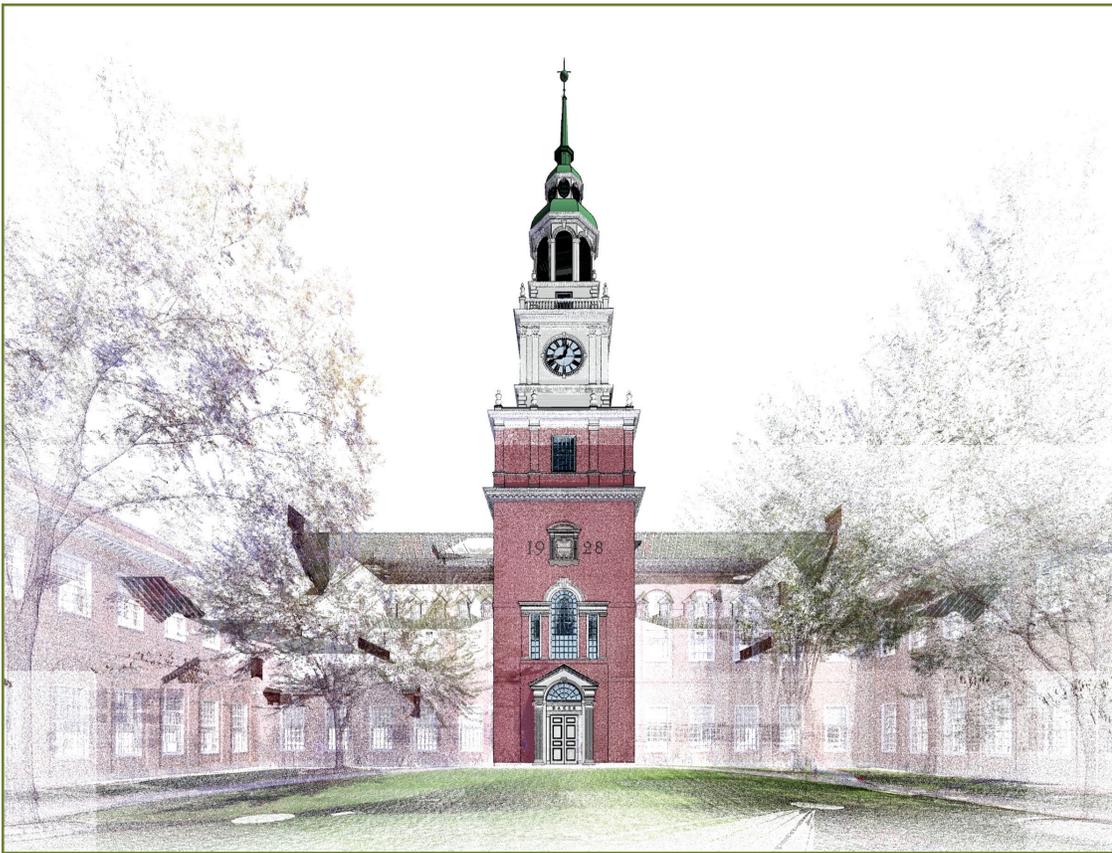
Figure 6 – Point Cloud rendering from a laser scan.

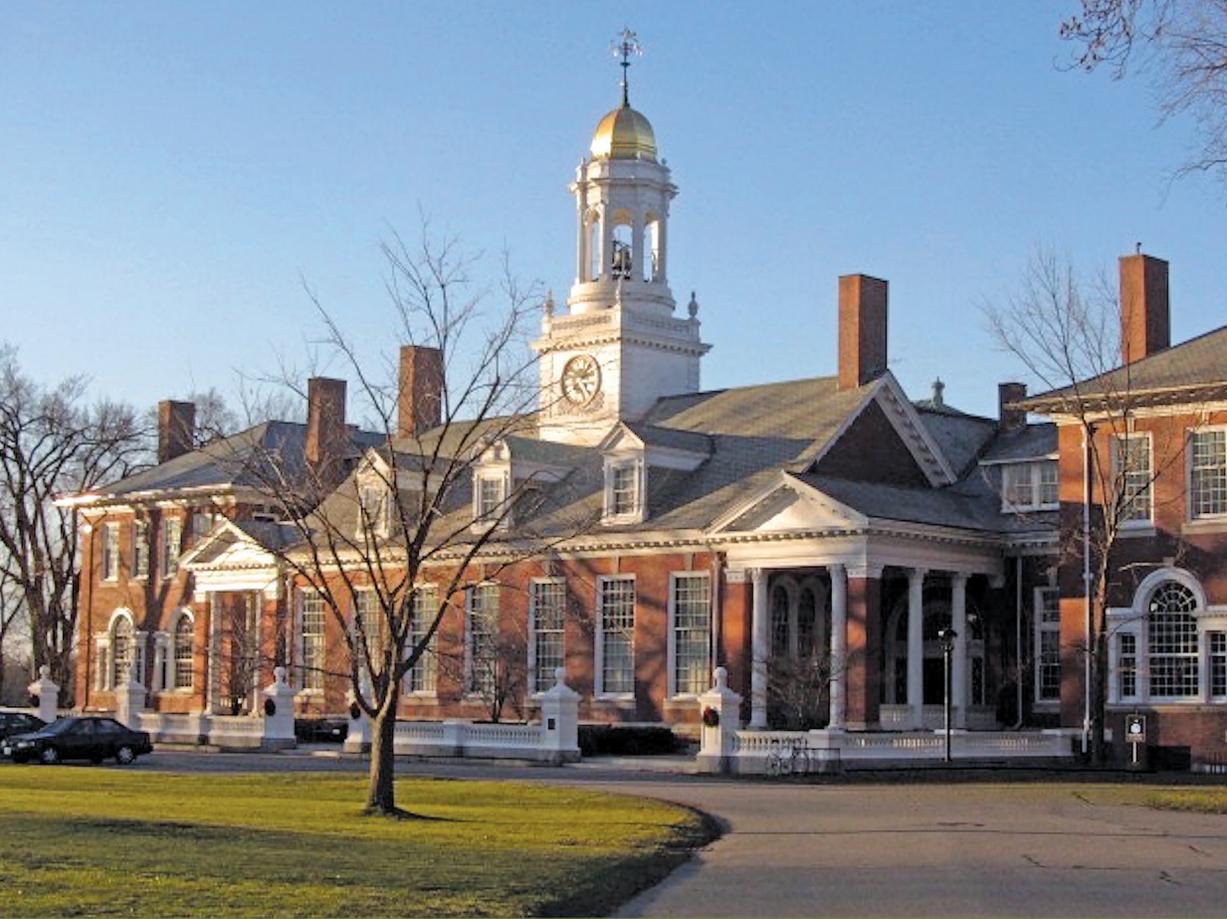
Figure 7 – Clock tower restoration, Groton School, Massachusetts.

The tower is positioned in the center of an academic classroom building. The structure was designed in 1898 by noted Boston architects Peabody and Stearns in the Classical Revival style and built in 1899. The tower stands approximately 150 feet above grade and is supported by a timber-framed structural support system, integral to a timber-framed roof truss system.

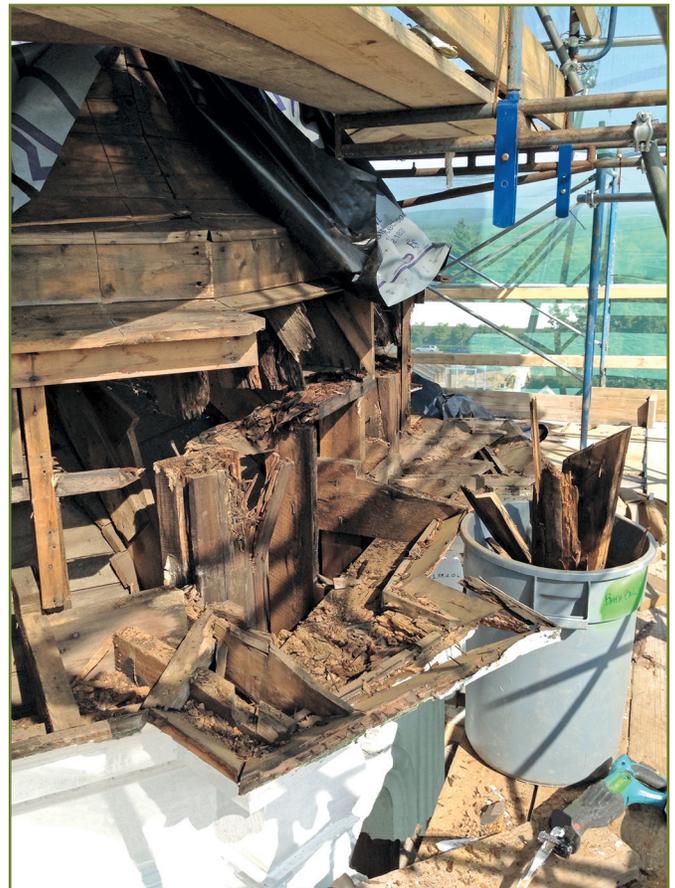
Figure 8 – Structural deterioration of the belfry dome.

During the SD process, a timber grade quality assessment inspection was conducted with removal of wood samples. While accessing the tower using the industrial rope access method, the author began to remove materials on the bell-level cupola roof and observed evidence of long-term water infiltration (*Figure 8*). Over time, water infiltration had substantially deteriorated several column support members. The author used ASTM D245 strength ratio analysis to estimate mechanical properties of the white pine timbers. Structural analysis of the steeple framing revealed overstresses under dead load alone. Extensive in-situ capacity augmentation was required throughout the steeple and adjacent scissor roof truss framing.

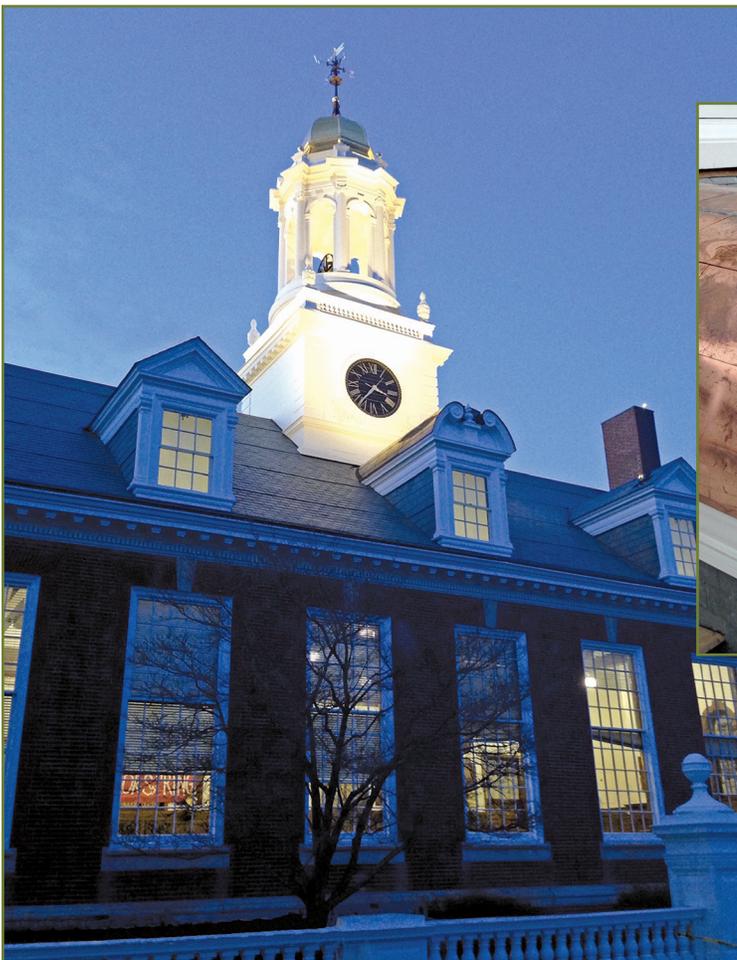
Figure 11 – Roof design to minimize view of tower lighting fixtures.

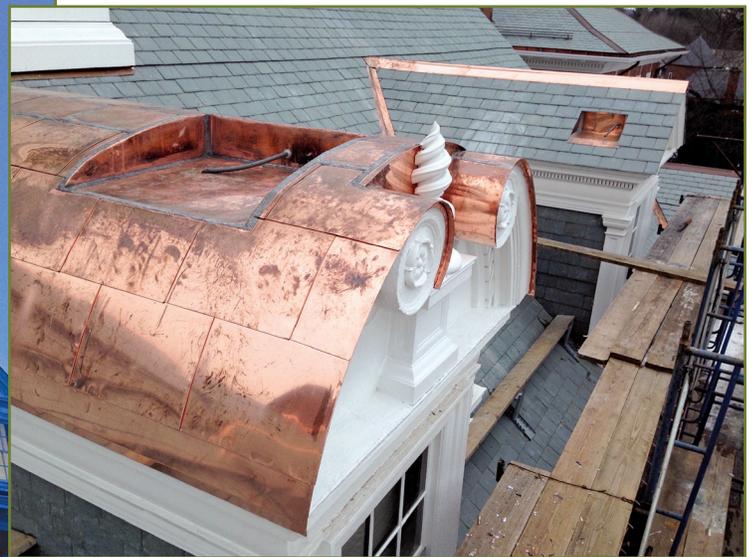
Figure 12 – Tower lighting mock-up in progress.

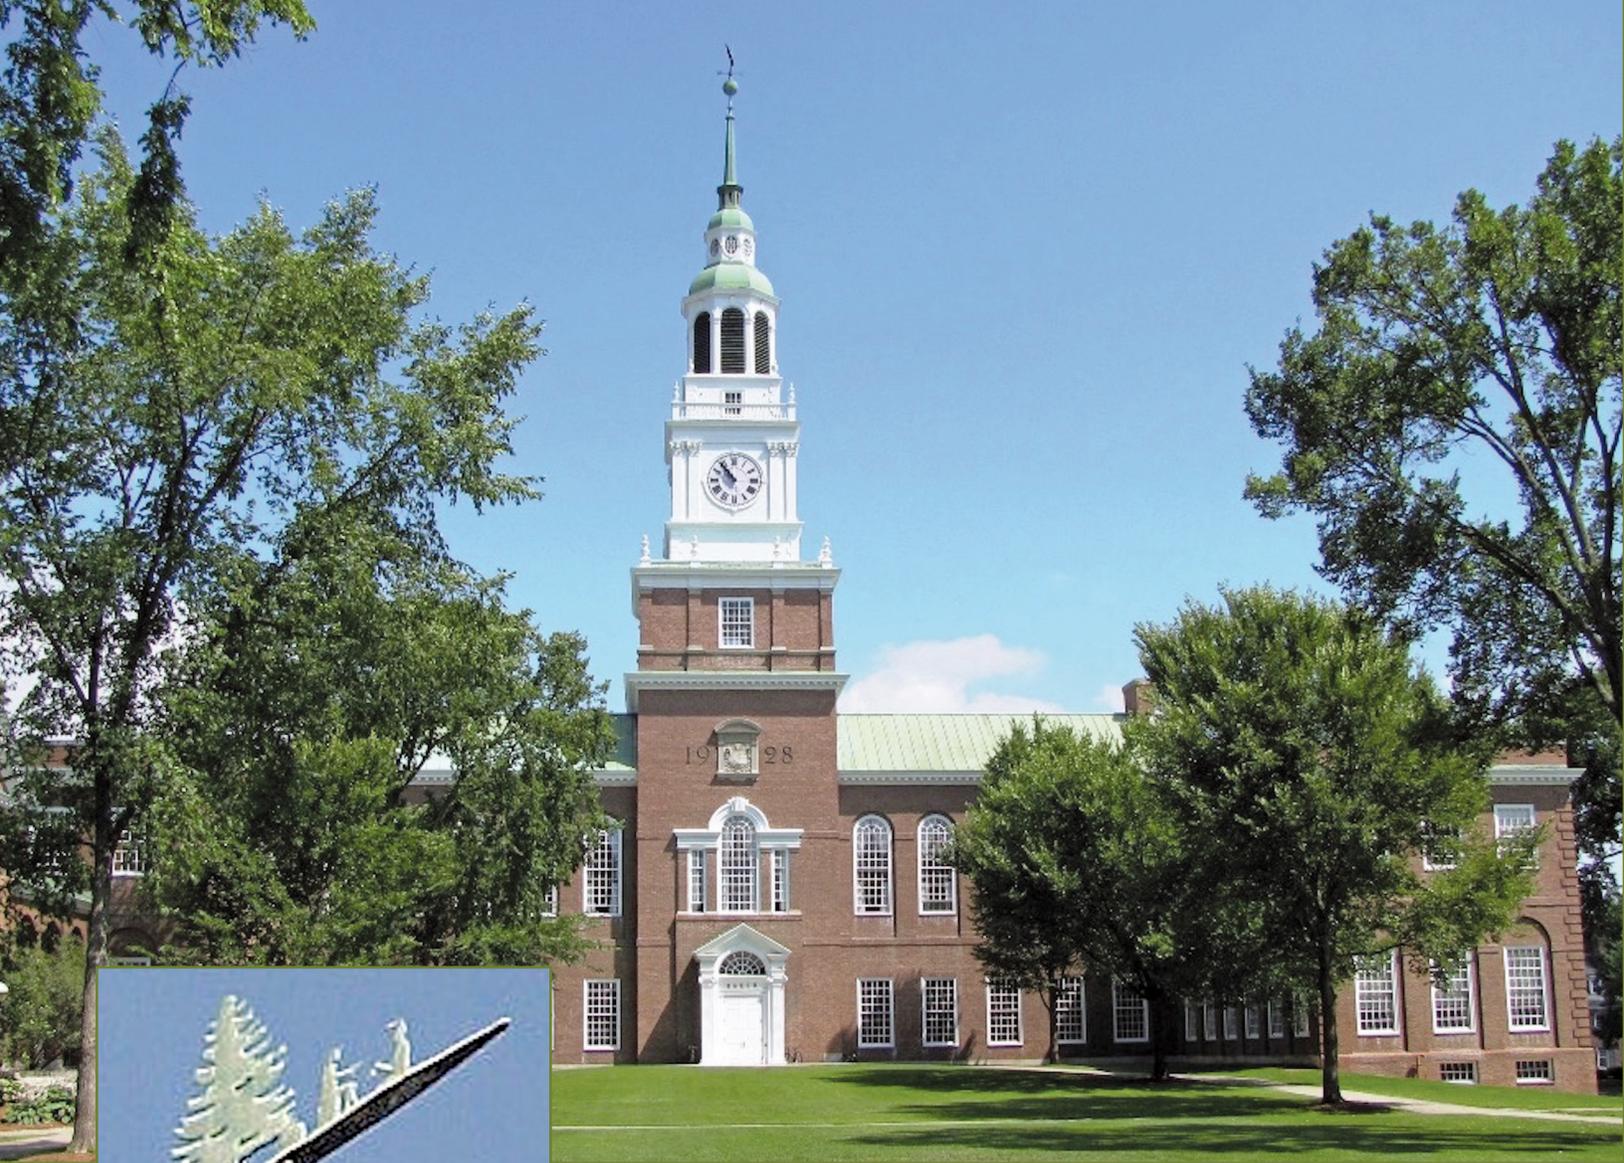
Figure 13 – Baker Library Tower, Dartmouth College.

Recently, Dartmouth College in Hanover, New Hampshire, requested a forensic building conditions survey and structural evaluation to serve as the basis for a schematic design of its iconic Baker Library tower as a precursor to restoration. The tower was designed by noted college architect Jens Frederick Larson to emulate the tower at Independence Hall in Philadelphia (Figure 13). The steel-framed structure was com-

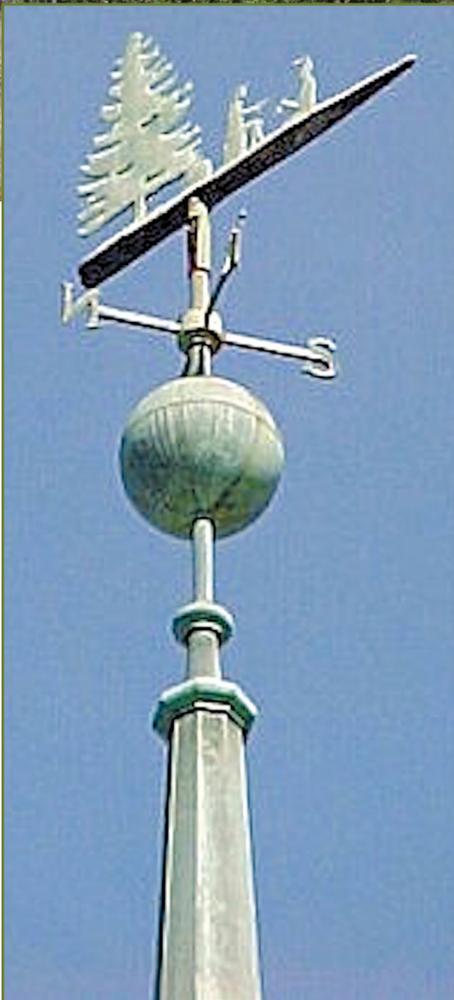
Figure 14 – Baker Tower weathervane, depicting Dartmouth’s founder, Eleazar Wheelock, in 1769, teaching a Native American.

The tower stands 200 ft. in height, with a weathervane mast (spire) extending 28 ft. above the weathervane cupola and supporting a weathervane that is 7 ft. tall and weighs 600 lbs. (Figure 14).

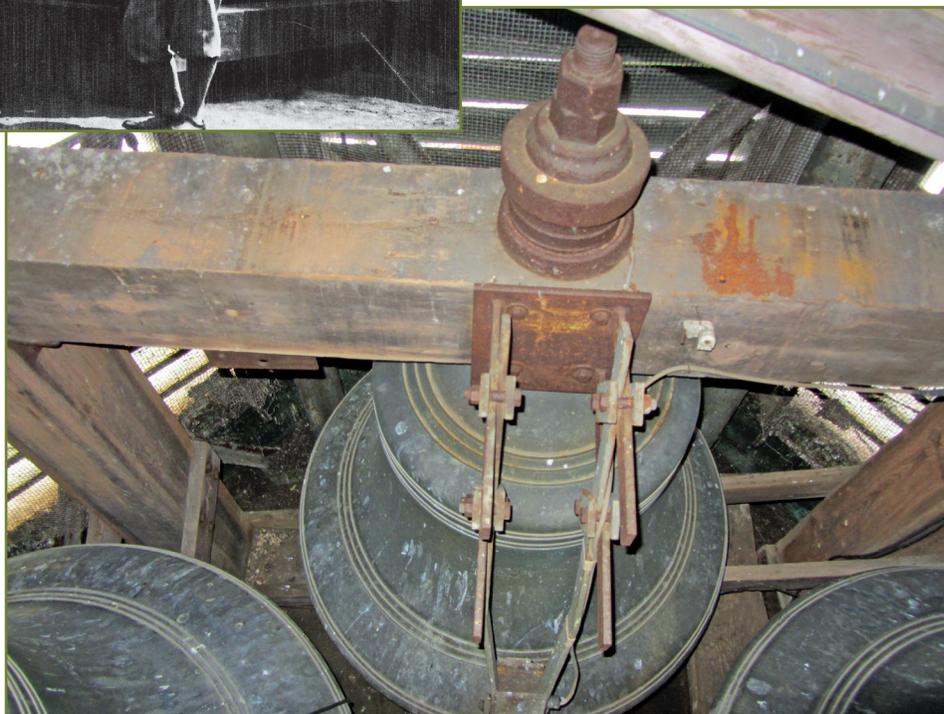
Figure 16 – Tower chime supports required in-situ capacity augmentation.

based on the inspection data and revealed that while under code-prescribed loads, most of the carriage components were within allowable stress limits for a full design load. The few timber-framed bell support system components that were overstressed provided capacity for 75% of the demand. It was then determined that in-situ capacity augmentation could be utilized to remediate the issues (Figure 16). Specifications for the bell restoration and structural scope of work were added to the project documents. Bell restoration and casting foundries are a "niche" trade and can be difficult to locate, requiring the designer to search outside of the U.S.
