PLAZA DECK WATERPROOFING DESIGN APPROACHES:

From Traditional to Modern

By CHARU CHAUDHRY, LEED AP

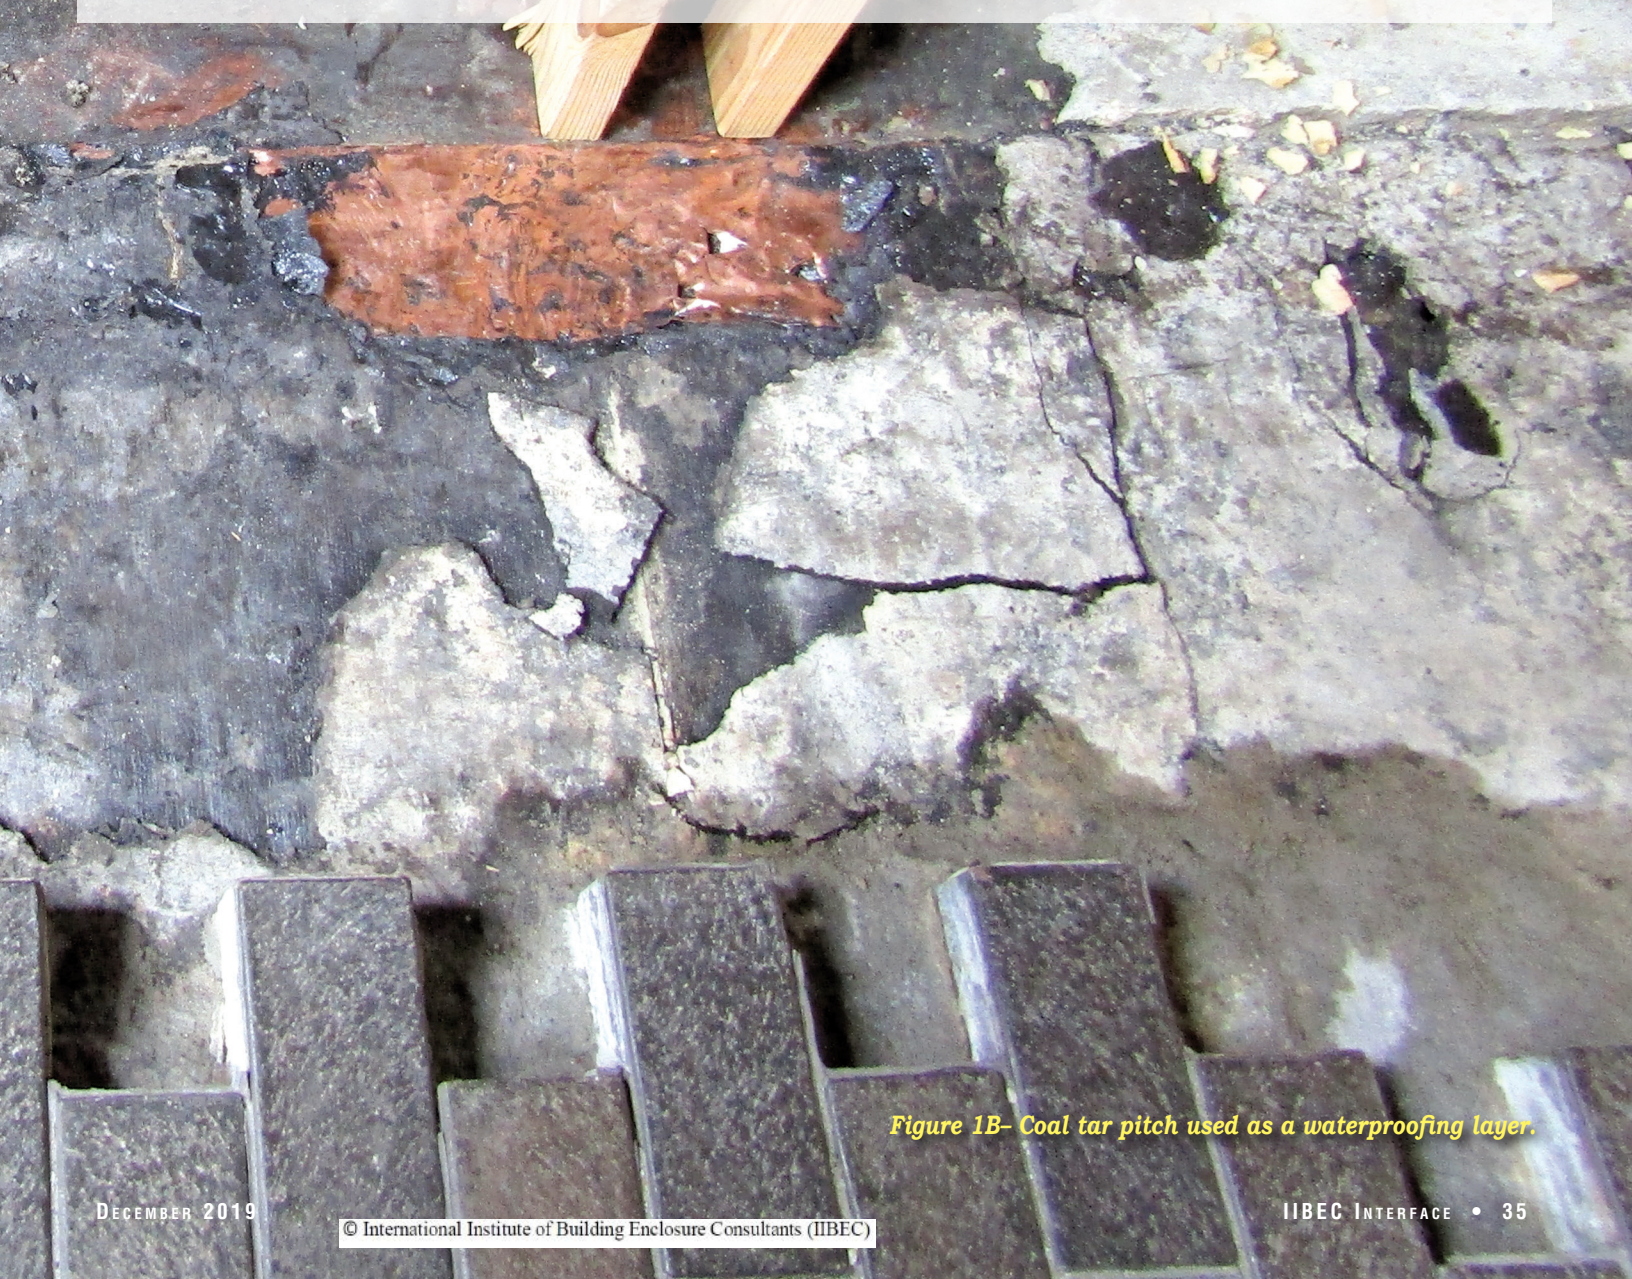
Figure 1B– Coal tar pitch used as a waterproofing layer.

Some early-period plaza constructions employed a coal tar pitch (on a concrete substrate) with a wearing surface just beneath the pavers. In the absence of a drainage layer (to laterally disperse the water), prolonged water ponding led to disintegration of the wearing surface and the waterproofing surface. Metal flashings were usually used in the assembly due to the inability of the coal tar pitch to be used in vertical applications.

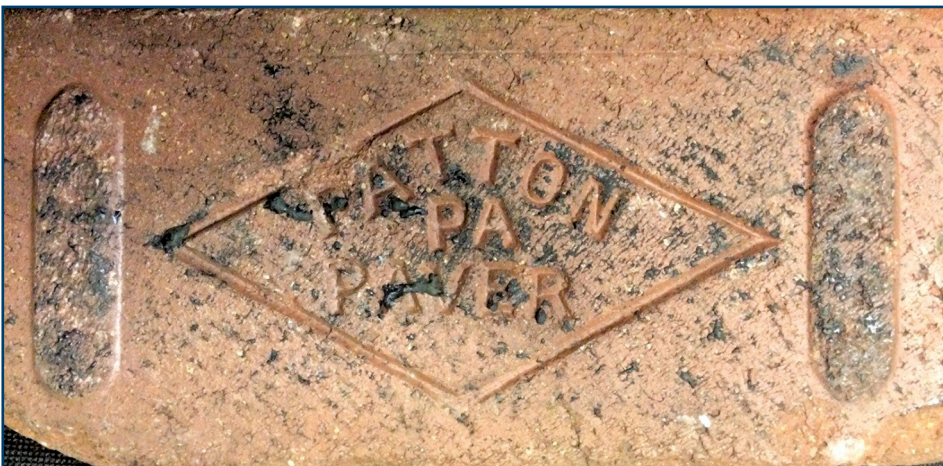
Figure 3 – Historic Patton Clay Works brick.

In 1996, the State Historic Preservation Office determined that the station met the criteria for inclusion in the National Register of Historic Places. Preservation of the historical features of the plaza was an important factor in the rehabilitation of the plaza. The historical brick was a clay pressure-molded unit manufactured by Patton Clay Works of Patton, PA, which was closed in 1968 and hence is no longer available to create replacement units (see Figure 3).

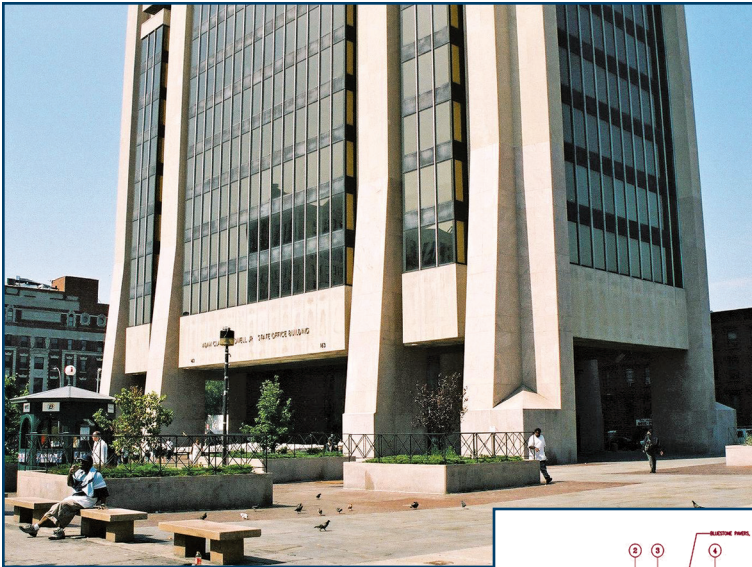
Figures 6A and 6B – Overview of the Adam Clayton Powell Plaza.

Built in 1967, the Adam Clayton Powell Plaza in New York, NY, is paved with sections of brick and stone paving over a sub-grade garage. Drains are located at the low points with the grates integrated with the plaza paving. A trench drain was situated along the south façade. The plaza is constructed of a concrete slab (which was flat); liquid asphaltic waterproofing membrane with an asphaltic protection board atop the concrete slab; tapered fill to drains; and a combination of bluestone flags, brick pavers, and granite planters. The bluestone pavers are 2½-ft. squares creating 5-ft. square grids. The red brick masonry was also laid in a pattern that is based on 5-ft. grids. There was setting bed material that ranged in thickness from ½ to 2 in. The brick pavers were set in a black bituminous setting bed. The bluestone flags were set in a mortar setting bed (see Figures 6A and 6B).

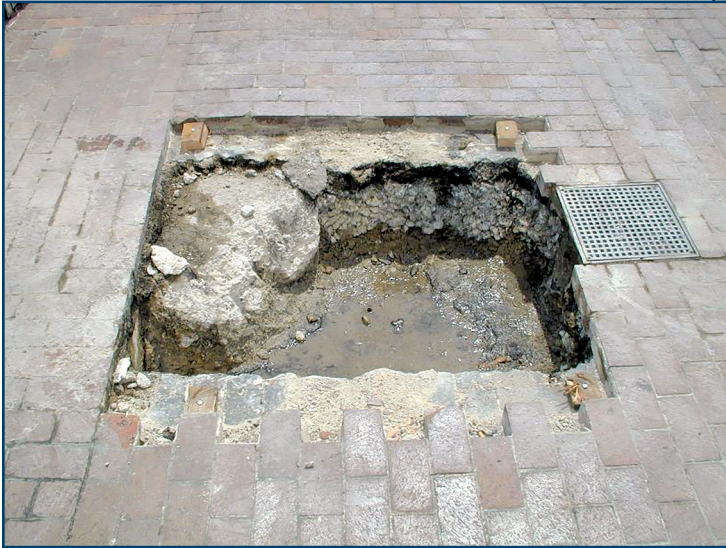
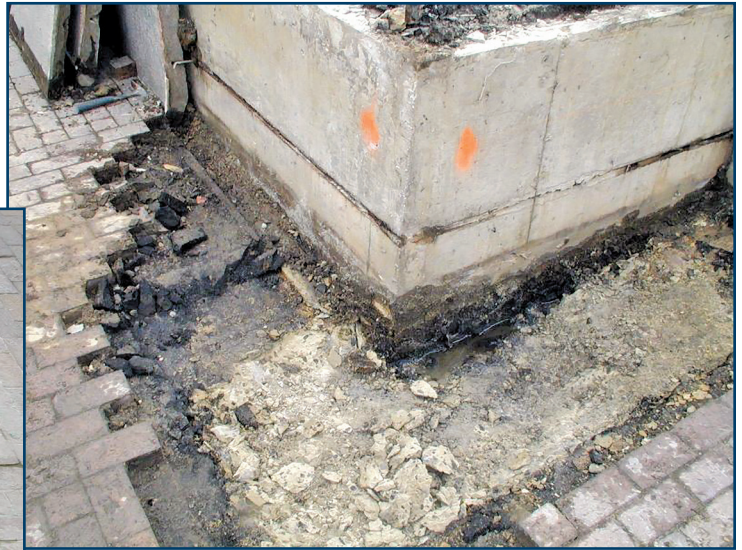
The most significant issues of the plaza were failure of the waterproofing membrane, lack of positive pitch to the drains at membrane level, failure of the paving materials, inadequate moisture management within the plaza assembly, lack of a proper expansion joint seal, and inadequate flashing at penetrations and intersections leading to large-scale leakage into the spaces below (Figures 7A and 7B).

Figures 7A and 7B – Existing conditions at Adam Clayton Powell Plaza.

Paving brick was tested in accordance with ASTM C902. Bluestone flagging was tested in accordance with ASTM C616. These standards are intended for the evaluation of new materials prior to construction, but they are relevant to this type of investigation for a comparative rather than absolute evaluation, particularly when evaluating the viability of retaining intact portions of materials that have failed locally.

Brick testing indicated that the existing brick failed to meet the requirements for saturation coefficient, which is an indicator of probable freeze-thaw performance. The brick also failed to meet the requirements for abrasion resistance, which is an indicator of durability. The standard has criteria for high, medium, and low abrasion resistance. The test results missed even the low-performance requirement by a wide margin. Bluestone testing indicated that the

existing stone was marginal with regard to absorption. In the wet condition tests, the stone failed to meet the test requirements for compressive strength, and it failed to meet the required values for modulus of rupture.
