# VALUE ENGINEERING GONE BAD:

## *A Refresher on How to Avoid Problems*

By Derek Hodgins, RBEC, RRO, PE, CDT

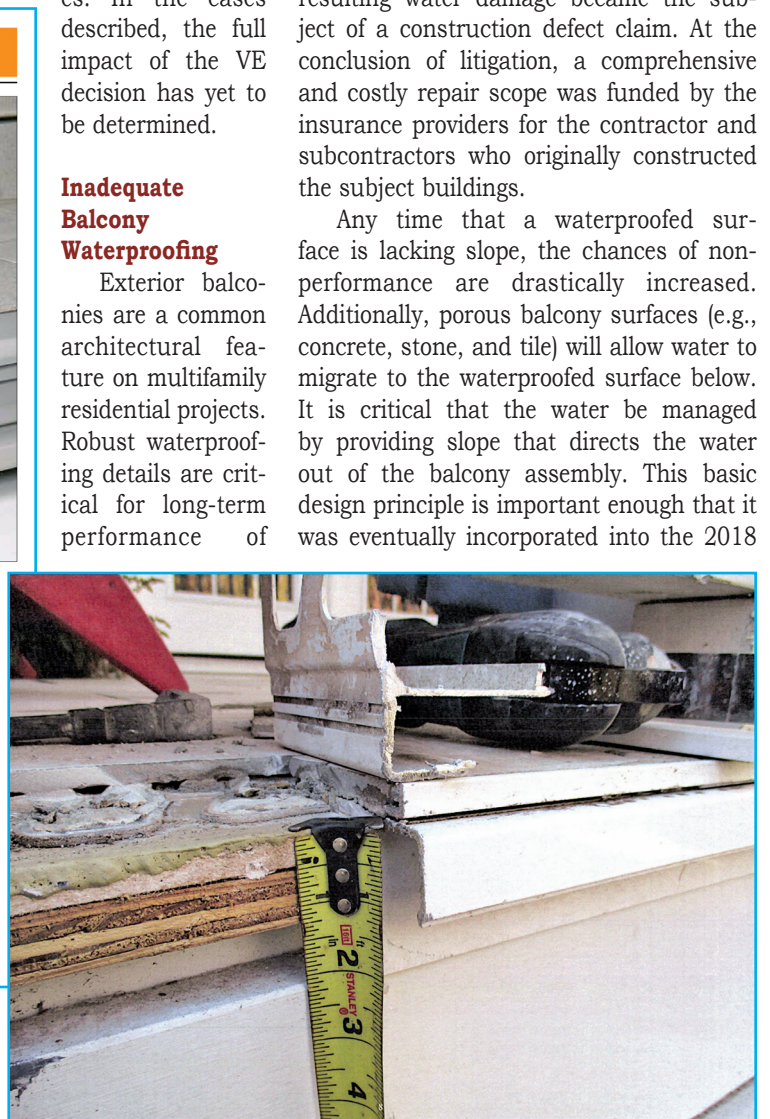
Figure 2 – As-built balcony details.

On a condominium project constructed circa 2013, a well-known balcony waterproofing system was specified on the architectural plans (Figure 1). The system included a sloped waterproofing surface over a wood-framed balcony, perimeter flashings, a drainage mat, and an elevated tile walking surface. At some point during the construction project, an improper VE process replaced the specified waterproofing assembly with a low- to mid-grade liquid-applied waterproofing product applied over the plywood with no slope and a tile surface that was intended to have a 1/8-inch-per-foot slope on the walking surface (Figure 2). The resulting water damage became the subject of a construction defect claim. At the conclusion of litigation, a comprehensive and costly repair scope was funded by the insurance providers for the contractor and subcontractors who originally constructed the subject buildings.

Any time that a waterproofed surface is lacking slope, the chances of non-performance are drastically increased. Additionally, porous balcony surfaces (e.g., concrete, stone, and tile) will allow water to migrate to the waterproofed surface below. It is critical that the water be managed by providing slope that directs the water out of the balcony assembly. This basic design principle is important enough that it was eventually incorporated into the 2018

1. The design concept was changed.
2. An accepted industry standard (i.e., sloping the waterproofed surface) was violated.

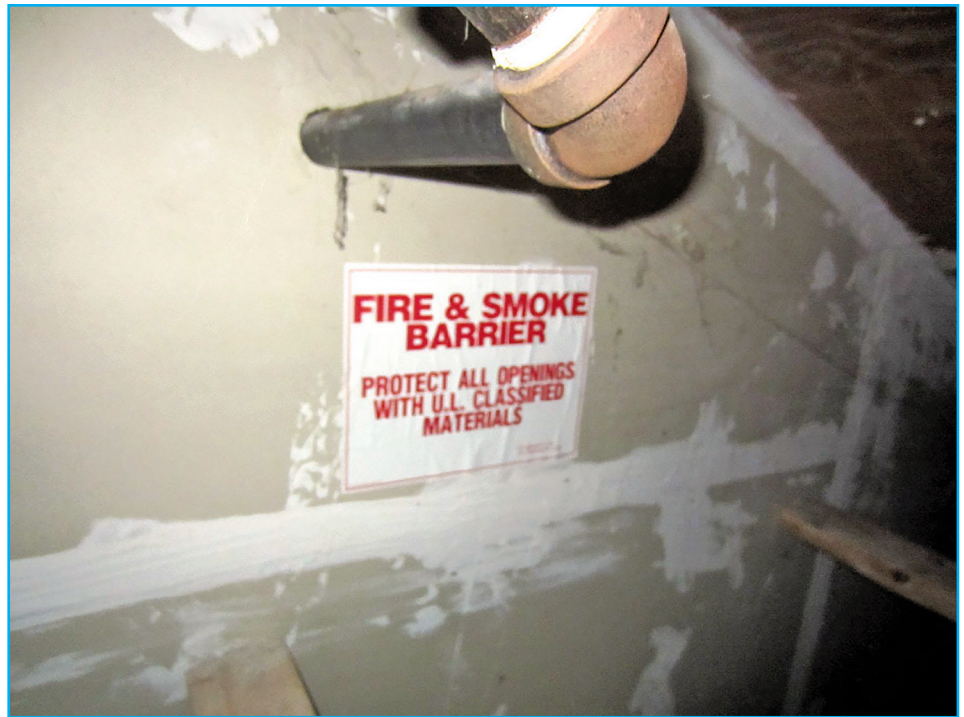
Figure 3 – Traditional Type-X gypsum panel used for fire resistance.

Traditionally, it was common to provide fire resistance using non-combustible materials such as Type-X gypsum panels (Figure 3) or pressure-impregnated fire-retardant

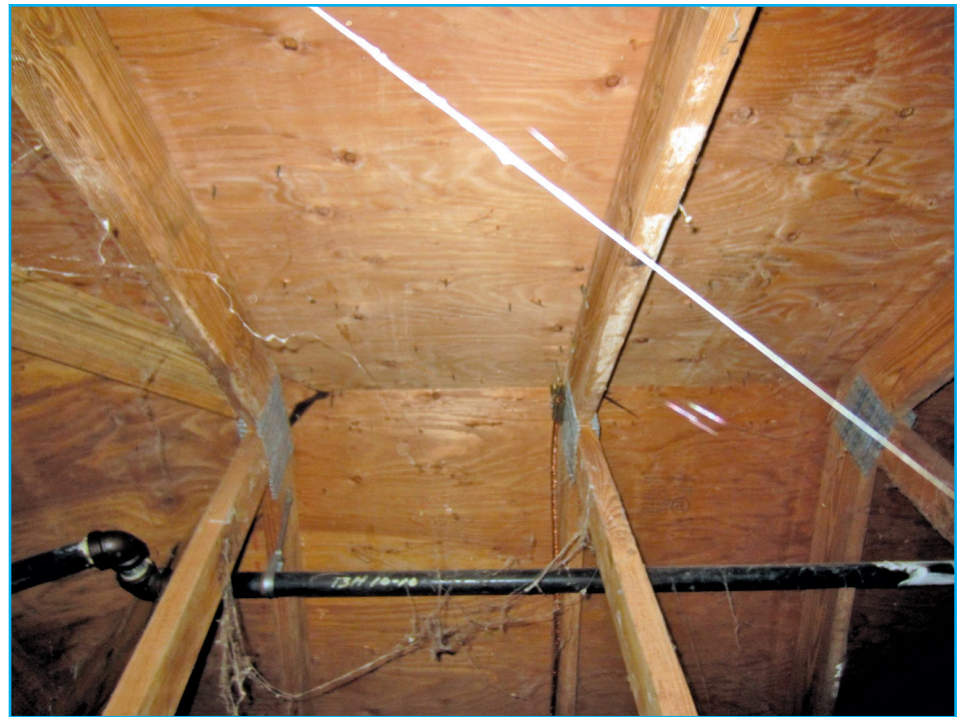
treatment (FRT) (Figure 4). There are now intumescent paints that are applied to the surface of combustible wood panels that claim to provide the same level of performance as traditional methods. However, at least in some instances, these claims have fallen short.

Figure 4 – Fire retardant-treated (FRT) plywood used for fire resistance.

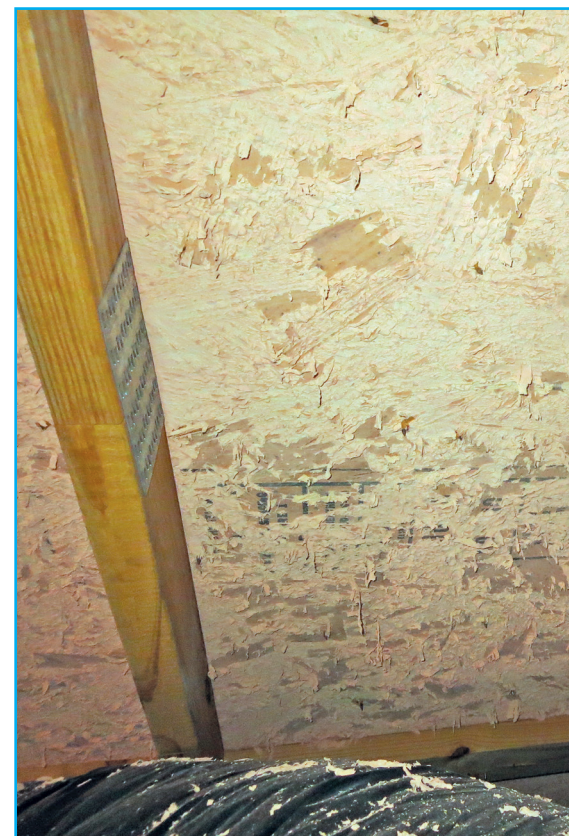
On a townhome project constructed circa 2008, an oriented strand board (OSB) roof deck with a thin film of intumescent paint was substituted for traditional methods of providing fire resistance. The use of the alternative product resulted in time and money savings during the initial construction of the project. The contractor relied on the claims made by the manufacturer regarding the adequacy of the product. The local authority having jurisdiction (AHJ) accepted a code evaluation report that appeared to support the claims made by the manufacturer. However, in a short period of time, the product experienced significant adhesion failure due to the heating of the wax content in the OSB roof deck (Figures 5 and 6).

During the investigation, it was determined that the product was never officially approved by the International Code Council (ICC). The code evaluation report associated with the product fell short of adequately evaluating the product for long-term performance and effectiveness. Research regarding the specific product revealed a troubled performance history marked with problems of durability. The repair scope proposed during the construction litigation process included the installation of Type-X gypsum board on the bottom of the OSB roof deck with the failing paint.

Figure 5 – Adhesion failure of fire-resistant paint.

1. A switch was made to an untested product and/or assembly.
2. The code evaluation report was not reviewed sufficiently to identify product performance shortcomings.

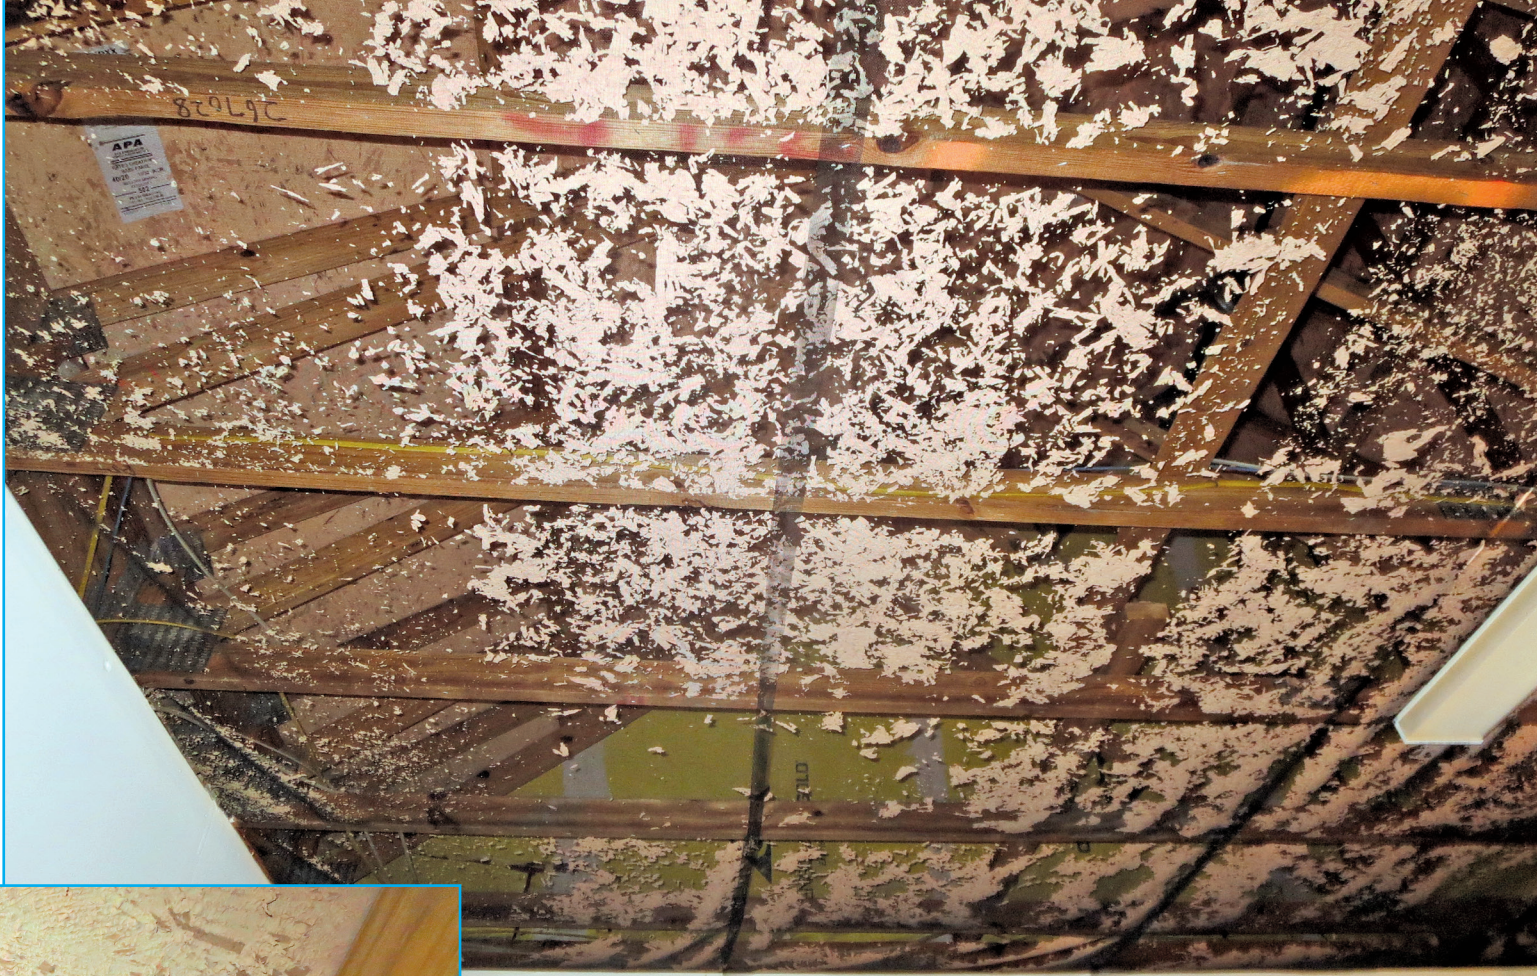
Figure 6 – Screen placed to catch fire-resistant paint shown falling from the OSB roof deck in Figure 5.
