"POTHoles" IN A MOD-BIT ROOF MEMBRANE

- LICHEN ATTACK

BY HARVEY FREEMAN, MNSAA, MRAIC

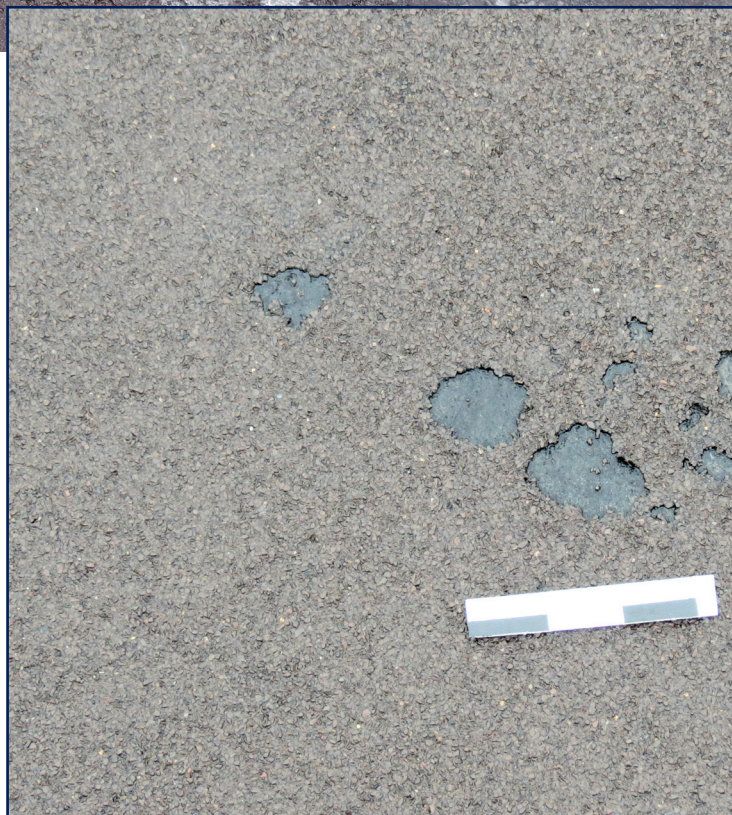
Figure 1 - This "pothole," where granules and the top layer of asphalt are missing, started the investigation.

The largest patches of missing granules were about four centimeters in diameter and did not resemble any kind of damage we had previously seen. This investigation was done in the early spring when Nova Scotia was in the middle of pothole season on the highways, and I decided to call these “potholes” because they were flat-bottomed depressions with straight sides. See *Figure 1*.

We had these potholes patched, and at the next several yearly inspections, no new potholes were observed.

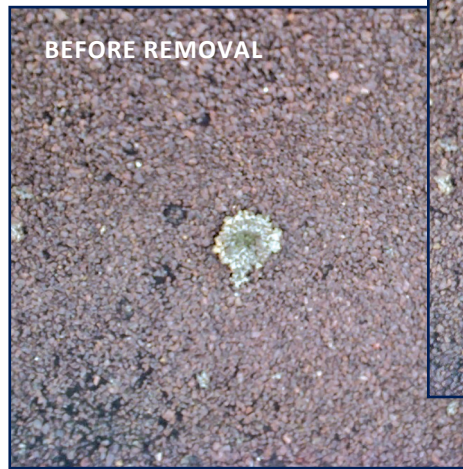
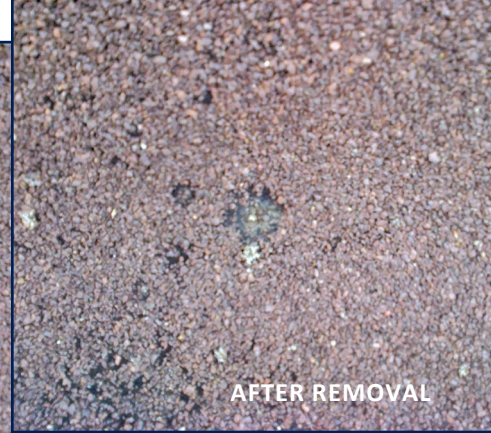
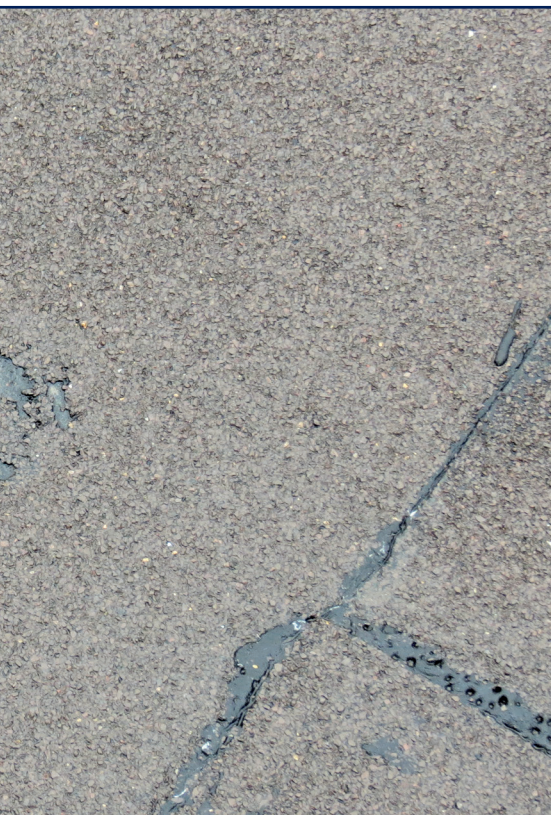
One person observed there were some random spots of very thin “vegetation” on the roof, and he pulled up some of this material. The granules and the top layer of the cap sheet asphalt came up with the vegetation. *Figures 2 and 3* show the before

Figures 2 and 3 – These photos were contributed by Tim Wrigley of IKO Industries. He lifted the lichen shown in the immediate right, and the granules and top layer of asphalt came away with the lichen, leaving the pothole shown in the far right.

and after conditions where this removal was done. The photos are not of excellent quality because he took them just to show me that it looked like the depressions were not a manufacturing defect.

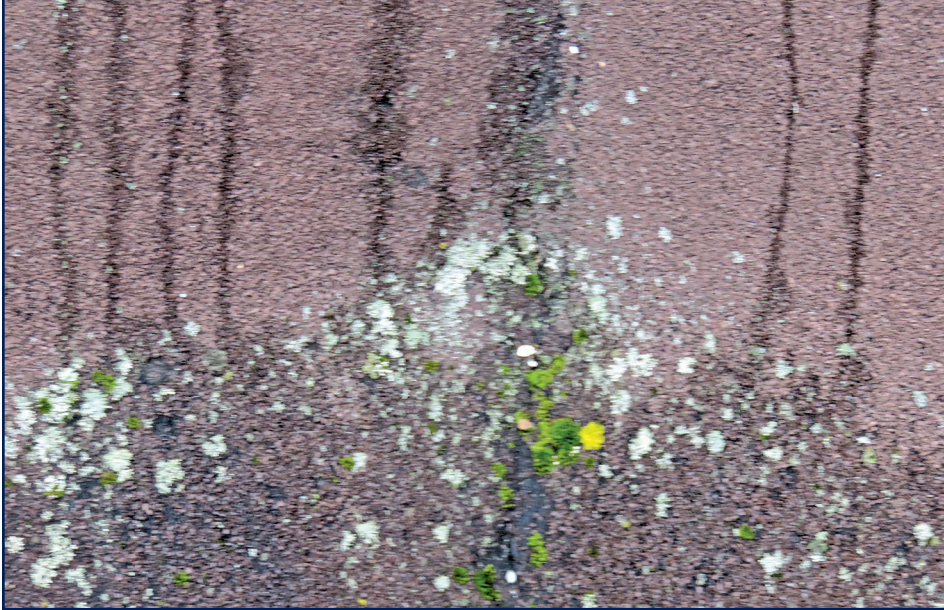
Figure 4 – David Richardson identified nine varieties of lichen in this patch.

Richardson took an interest in my quest for information and came to look at the roof and took samples. He reported that he found nine species of lichen in the area he sampled (Figure 4). Figure 5 is a close-up of one lichen. Richardson loaned me a book he had written some years ago, entitled *The Vanishing Lichens – Their History, Biology and Importance*. From the book I learned that there are more than 18,000 species of lichen in the world. Their rate of growth varies. The diameter of a lichen may grow from

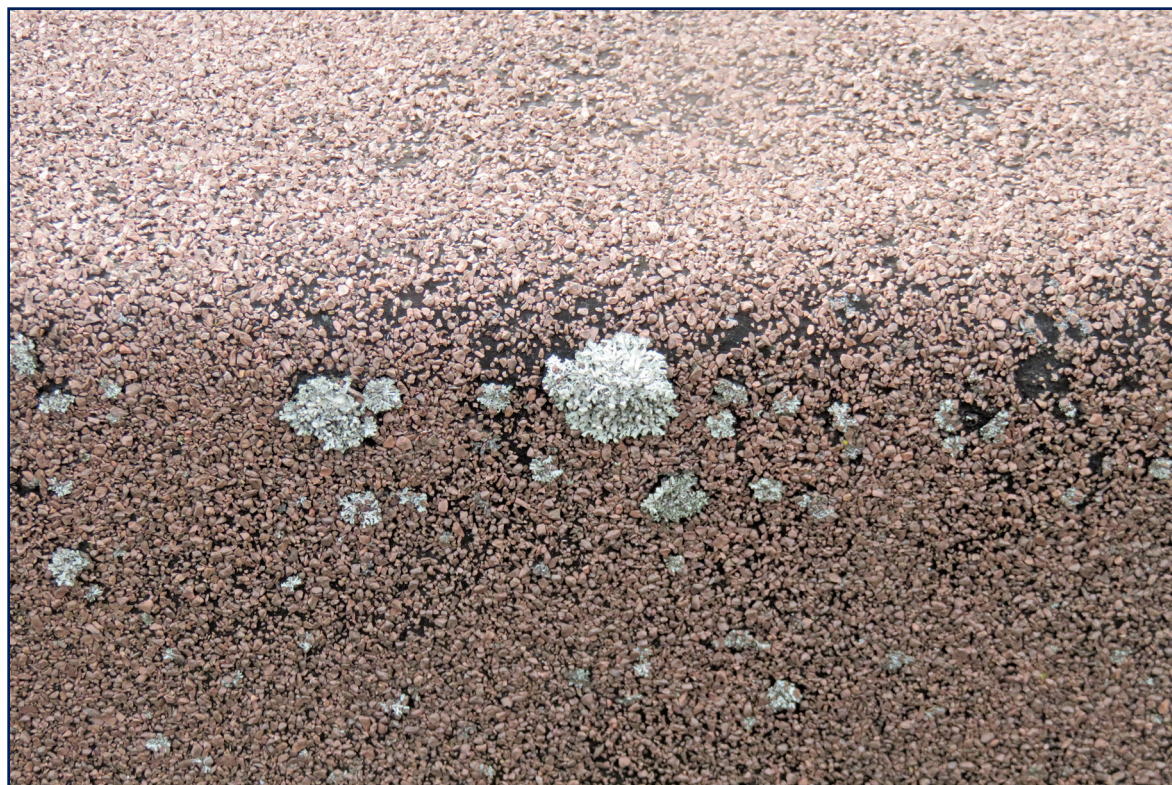
Figure 5 – A close-up of one patch of lichen. It does not look anything like moss.

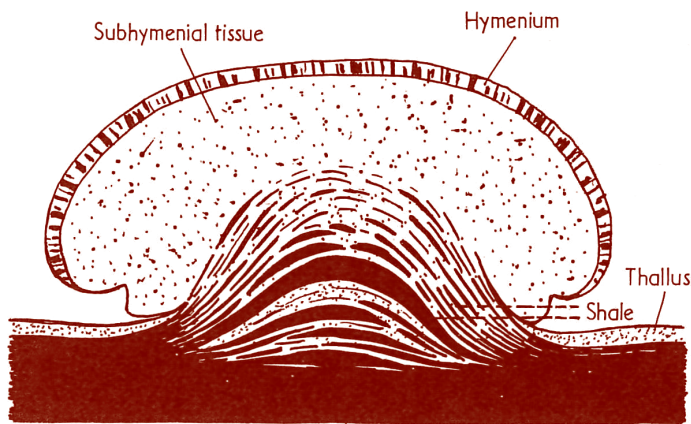
A drawing (Figure 6) with the descriptive caption from Richardson’s book details, in a general way, what I believe happened on our roof. The lichen pried up the top layer of asphalt and granules to the point that it separated from the roof surface, and the lichen was then blown away, leaving a cavity (pothole).

FIGURE 11. The action of lichens on rock. A semi-diagrammatic representation of a vertical section through a fruit body of *Lecidea* sp. This shows arching of the shale lamina beneath the lichen. The dotted mass represents the dense brown hyphal tissue

Figure 6 – This drawing and caption of a lichen acting on the surface of a stone is from David Richardson’s book.

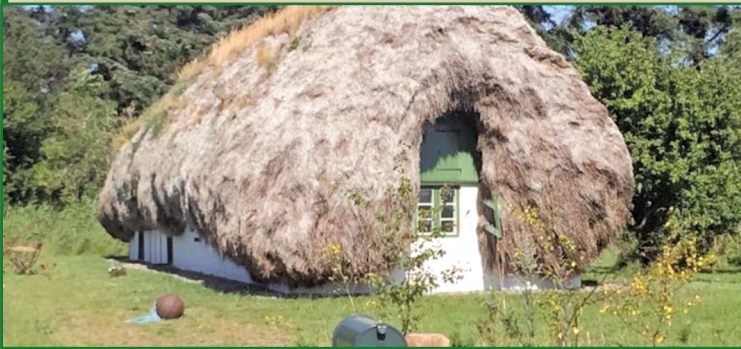
Old eelgrass-thatched roof in Laesø. Photo by Adam Schnack.

On the Danish island of Laesø, once known for its salt industry, there still exist dwellings thatched with seaweed, also known as eelgrass. The walls of the homes were made of driftwood. Since both the seaweed and the driftwood were saturated with salt water, they survived for centuries. The seaweed houses still standing there have been declared as one of North Jutland’s seven wonders.

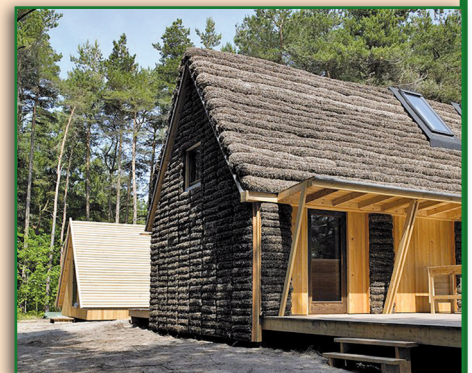
Recently, the Modern Seaweed House, a \$360,000 vacation home, was built in Laesø, incorporating seaweed-stuffed “pillows” on the building’s façade in the place of traditional shingles or clapboard. The algae was also stuffed into the light pine walls and serves as a replacement for mineral wool insulation. The ceiling is also padded with the same insulation. It was a collaboration between architectural firm Vandkunsten and Readania Byg, an organization that preserves Denmark’s historical properties. Designers estimate the exterior pillows could last 100 years or more.

Modern Seaweed House. Photo by Helene Hoyer Mikkelsen.
