The Most Common Problems with Residential Counterflashing

By Derek Hodgin, RBEC, RRO, PE, CDT

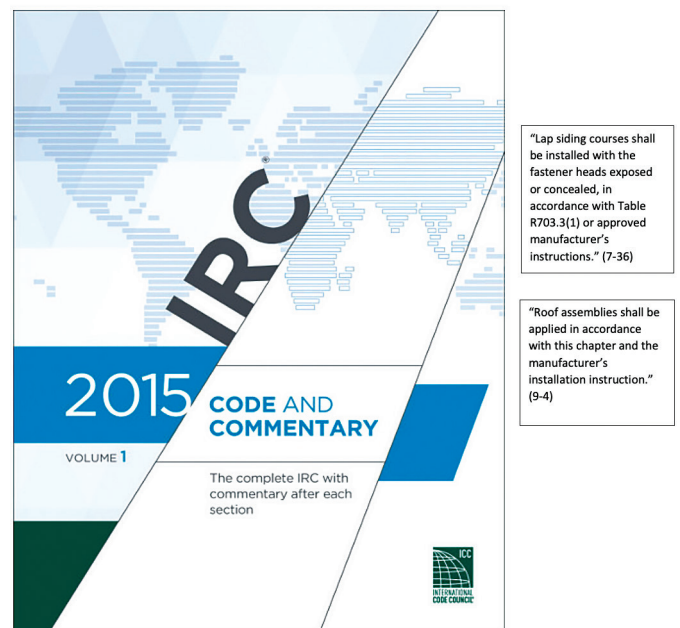
Figure 1 – Code requirements regarding manufacturer instructions.

Chapter 7 of the IRC includes requirements for exterior walls. The fiber cement siding section of the code requires that the contractor follow the siding manufacturer installation instructions. Chapter 9 of the IRC includes requirements for roof coverings. The composition shingle section of the code requires that the contractor follow the shingle manufacturer installation instructions. The specific references to the manufacturer instructions make them a code requirement, as if they were part of the code (Figure 1).

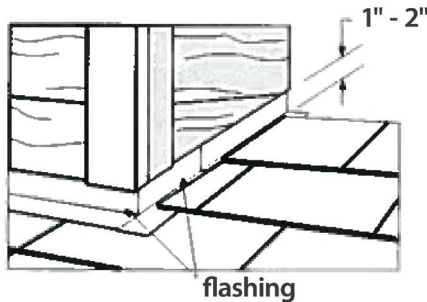
Figure 2 – Siding manufacturer detail.

Typical siding manufacturer installation instructions require the siding to be installed as much as 1 to 2 in. above the roof covering (Figure 2).⁴ Typical shingle manufacturer installation instructions require the vertical leg of the step and/or base flashing to be only 2 to 4 in. tall (Figure 3).⁵

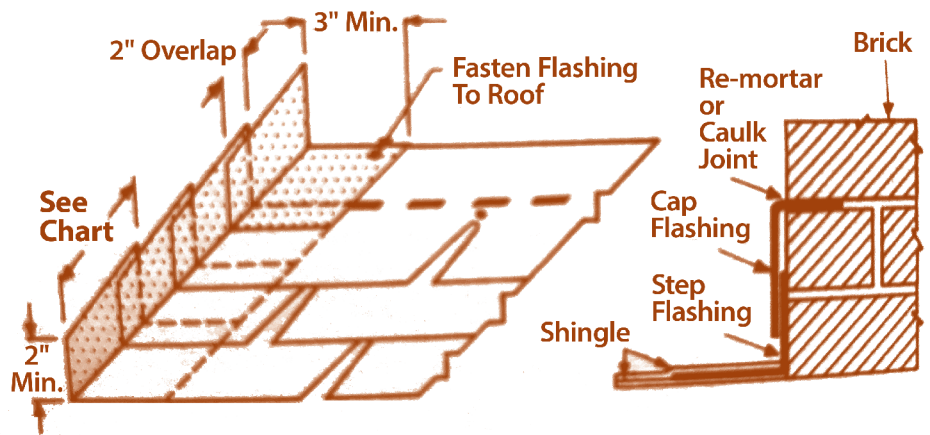
Figure 3 – Shingle manufacturer detail.

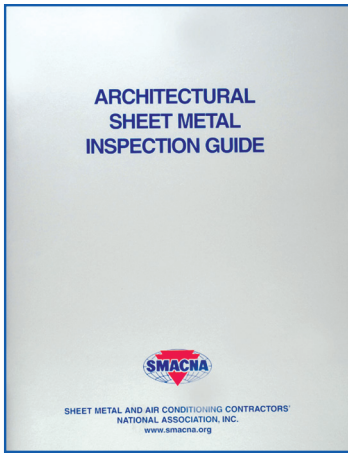
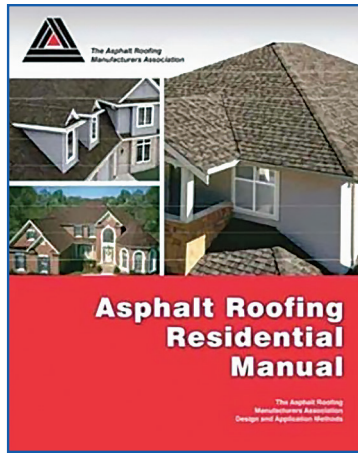
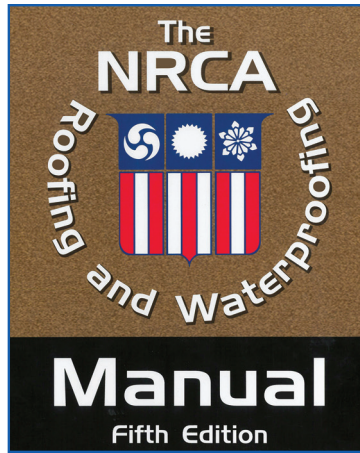
Figure 4 – Accepted industry standards.

Association (NRCA) *Roofing and Waterproofing Manual* provides Detail ASPH-2, which requires the vertical leg of step flashing to be 4 in. tall.⁶ The Asphalt Roofing Manufacturers Association (ARMA) *Residential Asphalt Roofing Manual* provides Figures 10-1a and b, which require the vertical leg of step flashing to be 5 in. tall.⁷ The Sheet Metal Air Conditioning National Association (SMACNA) *Architectural Sheet Metal Manual* provides a detail that requires the vertical leg of step flashing to be 6 in. tall.⁸ The NRCA, ARMA, and SMACNA manuals are not referenced by the building code, but they are considered to represent accepted standards in the roofing industry (Figure 4).

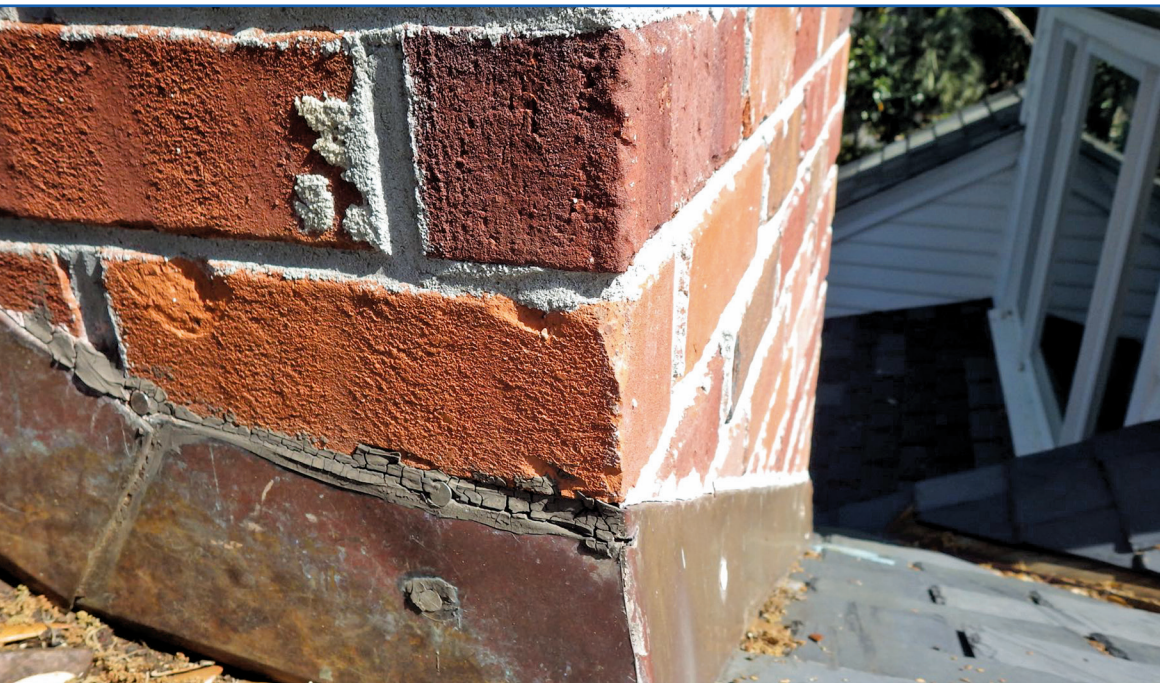
Figure 5 – Typical surface-mounted flashing.

The most common defect at this location is installing surface-mounted counterflashing on the side of the brick chimney (Figure 5). Sealant may or may not be installed along the top of the counterflashing. This detail will only be effective in rain events that are light and/or of short duration. It does not take a significant rain event to saturate the brick chimney sufficiently for water to migrate behind the counterflashing, potentially causing water damage to the roof deck, roof framing, or the interior of the building (Figure 6).

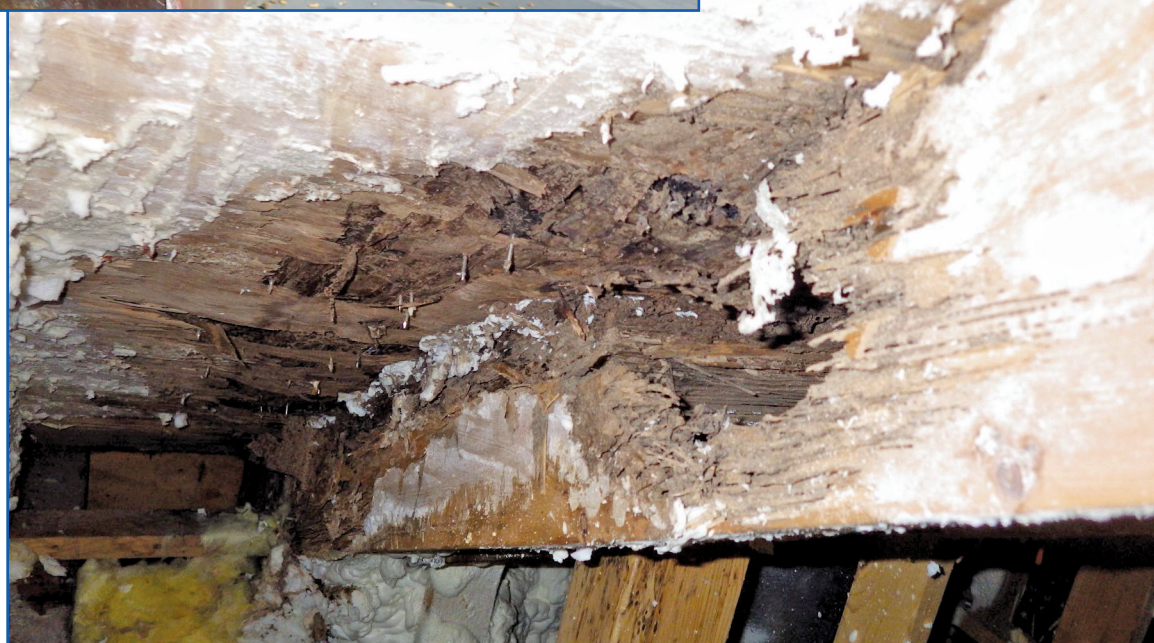
Figure 6 – Water-damaged roof deck at chimney.

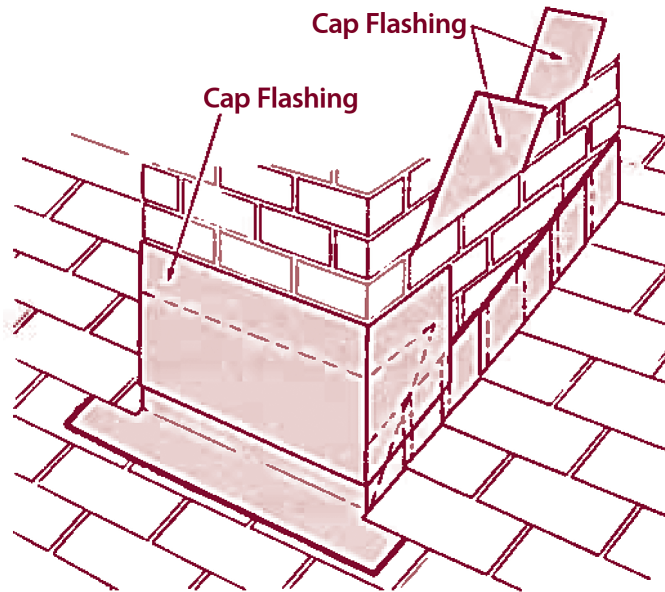
Figure 7 – Manufacturer counterflashing details.

ing and counterflashing (aka cap flashing) that is inserted into reglet(s) that are cut into the brick a minimum of 1-in. deep (Figure 7). Most instructions include details for “stepped” counterflashing that is set into reglets cut into horizontal bed joints, and continuous counterflashing that is set into a reglet that is cut parallel to the roof surface.⁵

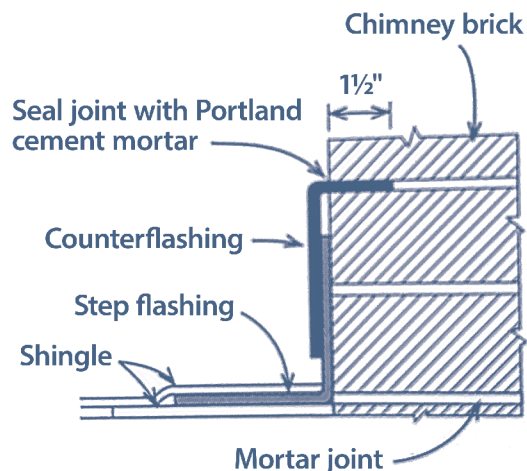
Figure 9 – Industry detail lacking “best practices.”

The ARMA manual devotes nearly five pages of text and details related to chimney flashing. Figure 10-14 shows the cross-section of the counterflashing details, while Figures 10-15 and 10-16 show isometric views of the installation of counterflashing around the chimney. Unfortunately, Figure 10-14 does not incorporate the “best practices” described above. Specifically: 1) the flashing is depicted to be inserted into a horizontal reglet, not sloped; 2) the counterflashing is depicted to be installed vertically, in contact with the step flashing, without a capillary break; 3) the counterflashing terminates without a hemmed drip edge; and 4) the minimum 2-in. overlap between the counterflashing and step flashing is not identified (Figure 9).

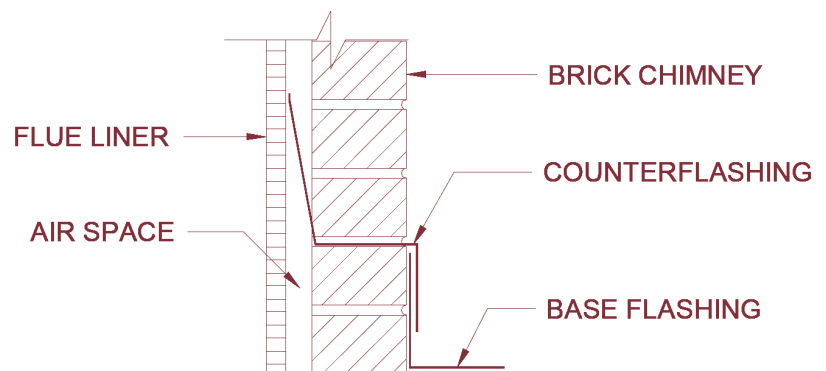
Figure 10 – BIA “Brick Brief” counterflashing detail.

The Brick Industry Association (BIA) Technical Note 19B – Residential Chimneys: Design and Construction¹⁰ includes Figure 7, showing a general isometric depiction of chimney counterflashing, with no specific details. The most current version of this Technical Note appears to be 1998. However, BIA published a July 2005 “Brick Brief” with the title of “Flashing Chimneys.”¹¹ Figure 2 of this two-page document depicts through-flashing, consistent with the 2006 version of the IRC, released a short time later (Figure 10). The details of the counterflashing lack “best practices” as described previously.

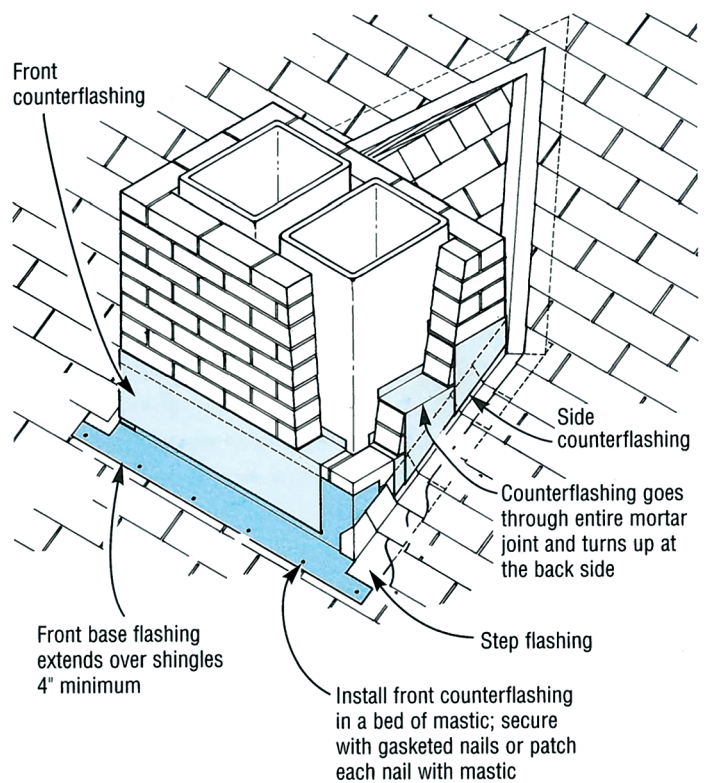
Figure 11 – JLC flashing detail.

base and/or step flashing to serve as counterflashing (Figure 11). This is the most robust solution, because water is able to penetrate completely through the outermost course (or wythe) of brick and still be collected and directed back to the exterior, just above the roof base and/or step flashing.

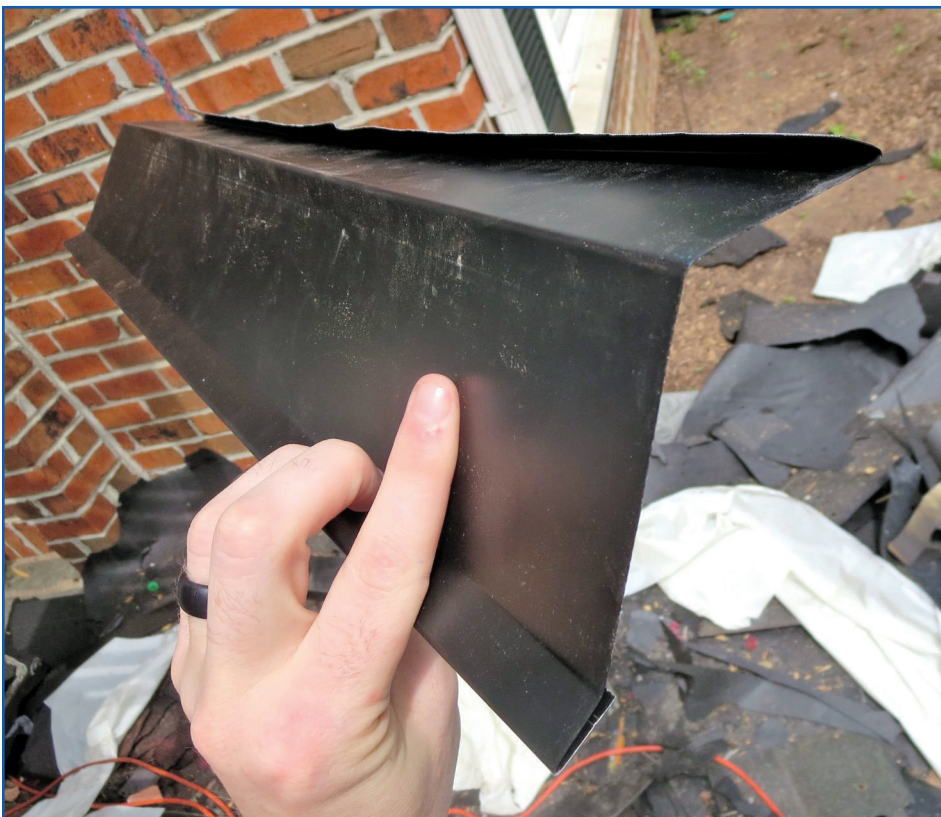
Figure 12 – Profile view of best-practices counterflashing.

Alternatively, the counterflashing could terminate into a deep reglet cut into the brick veneer. To improve the function of this detail, the reglet should be cut at an angle to drain water. Additionally, the edge of the flashing that is inserted into the reglet can be folded to create a compression fit, held in place with lead wedges and topped with a urethane sealant joint. The flashing should extend away from the chimney, past the base or step flashing, before taking a sharp bend downward to create a capillary break, an air space that will not allow capillary suction of water from below. The base of the counterflashing should include a hemmed drip edge to manage the water (Figure 12). The minimum depth of the reglet should be 1 in., but 1½ in. is preferred.

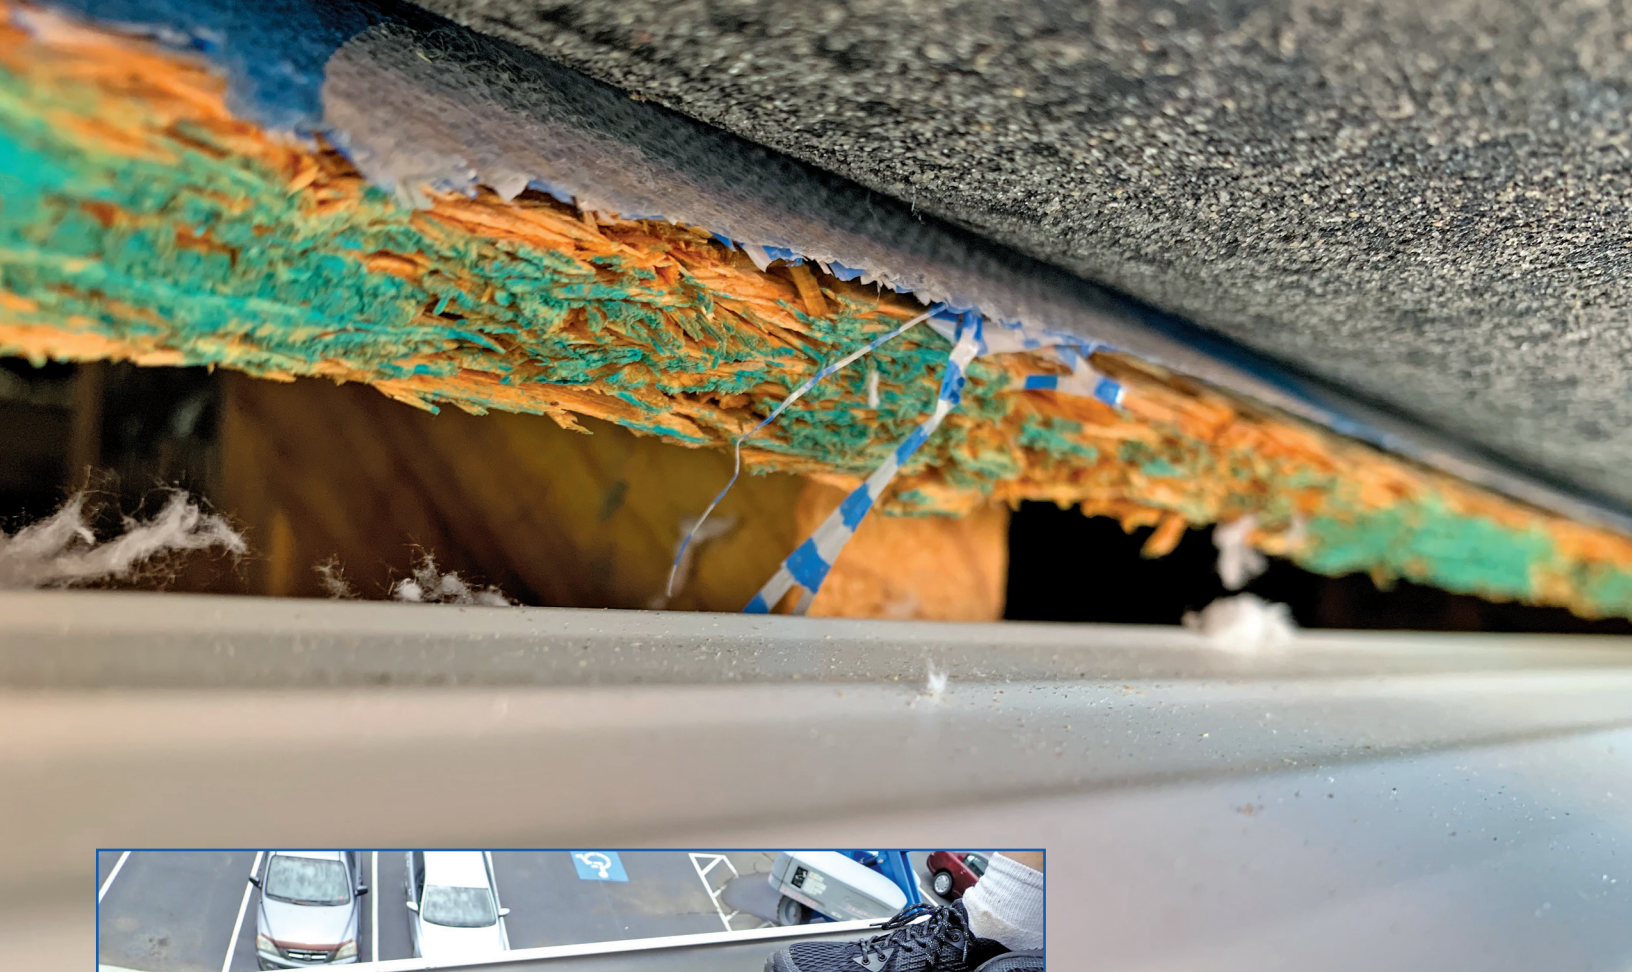
Figure 13 – Improper eave flashing.

roof underlayment and the metal drip edge, collectively referred to as the eave flashing (Figure 13). If the roof underlayment does not lap properly over the metal drip edge, water is potentially allowed to penetrate to the roof deck, fascia, and sub-fascia areas, which typically include untreated wood that is susceptible to water damage (Figure 14).

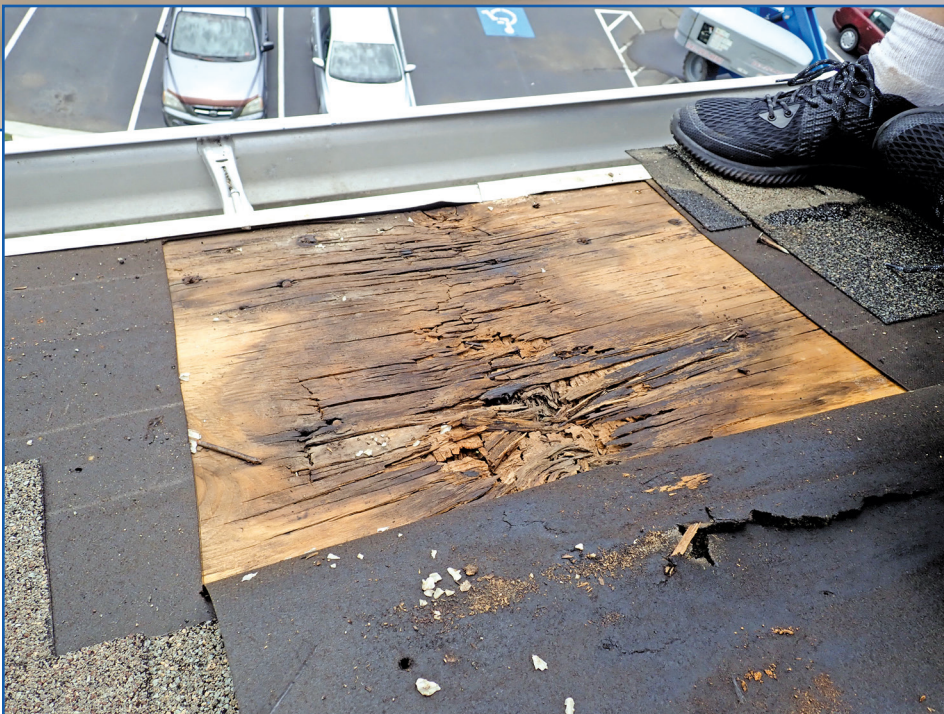
Figure 14 – Water damage at roof eave.

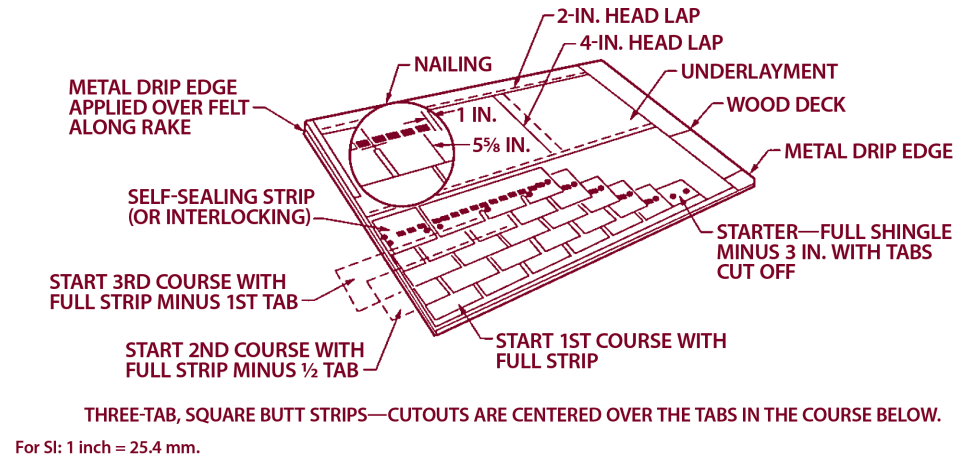
Figure 15 - Proper eave flashing.

Chapter 9 of the IRC includes Figure R905.2.2(1), which depicts the proper installation of a metal drip edge, underlayment, and asphalt roof shingles over a wood deck (Figure 15). The figure shows the metal drip edge properly integrated below the roof underlayment along the eave and over the underlayment along the rake.

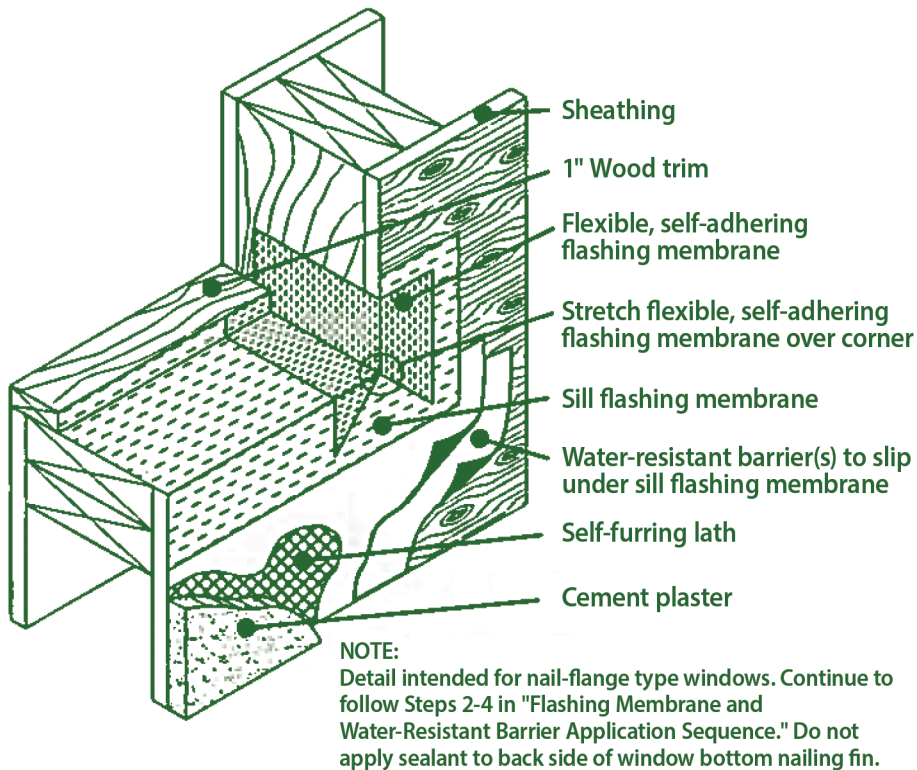
Field-Installed Sill Pan Flashing

Figure 16 – Proper integration of WRB layers at a window.

A contractor guidebook called *Builder’s Guide to Stucco, Lath & Plaster*¹⁸ is one of the few references that describe the need to properly integrate the two layers of WRB to keep the water on the outside of the outermost layer. Specifically, Figure 2-14 in this book indicates that the two layers of WRB are to be integrated behind the windowsill flashing, precluding the water from penetrating between the layers, as allowed by the code and WRB manufacturers (Figure 16).
