How Technology is Revolutionizing Complex Roofing Assessments

By Dan R. Parker, Jr. and Chad Zielinski, PE

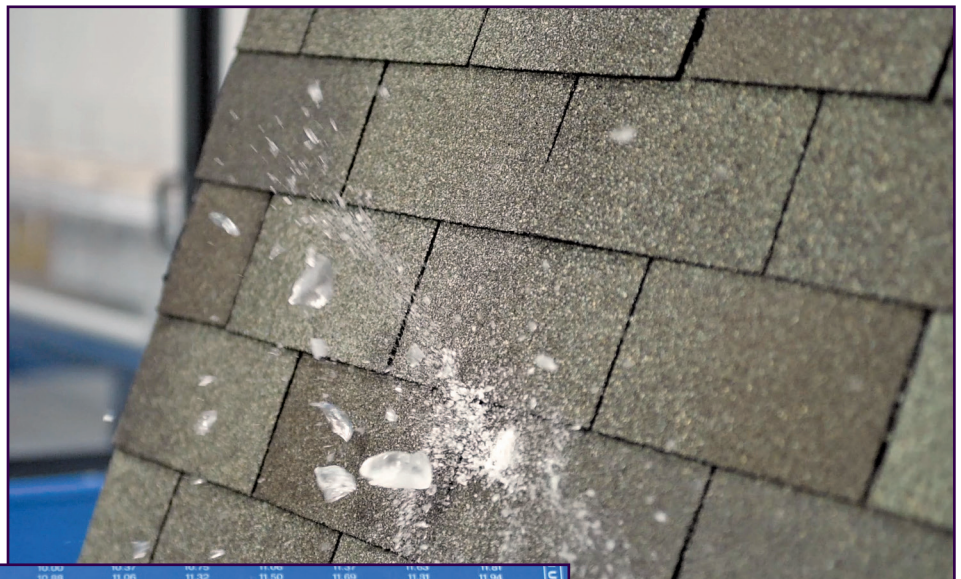
Figure 1 – Impact testing.

Regardless of the roof covering, samples are examined visually with both the unaided eye and under magnification to discern punctures, tears, or bruises typical of hailstone impacts (*Figure 1*). Bituminous roofing—including built-up roofing (BUR) and modified bitumen (mod-bit), as well as composition shingles—can be desaturated in a vapor degreaser (*Figure 2*) and their reinforcements extracted and examined for fractures or strained regions characteristic of hail. For instance, fractures (other than anvil strike types) initiate in the lowermost reinforcement and are longest in the lowermost reinforcement and progressively shorten in reinforcements above. Plastic single-ply membranes can be examined while backlit by high-intensity light. The light enables inspection of the reinforcement for fractures or strained regions within the plastic matrix without dissolving

Disagreements often arise regarding causes of marks in roofing, especially when the marks are claimed to be attributed to hail. To identify possible hail strikes in the lab, comparative impacts are made against roofing samples with simulated hail in accordance with ANSI FM 4473, *Test Standard for Impact Resistance Testing of Rigid Roofing Materials by Impacting with Freezer Ice Balls*. For this, roofing membranes are supported in the same way as they were in the field and impacted by various sizes of ice balls propelled at free-fall speeds that are equivalent to those of similar-sized naturally occurring hailstones. Qualitative comparisons are then made between the existing marks, reportedly caused by the naturally occurring hail, and those of the simulated hail—assessing sizes of marks as well as the patterns of the marks. Impacts also can be made to develop threshold sizes for hail-caused damage to roofing.

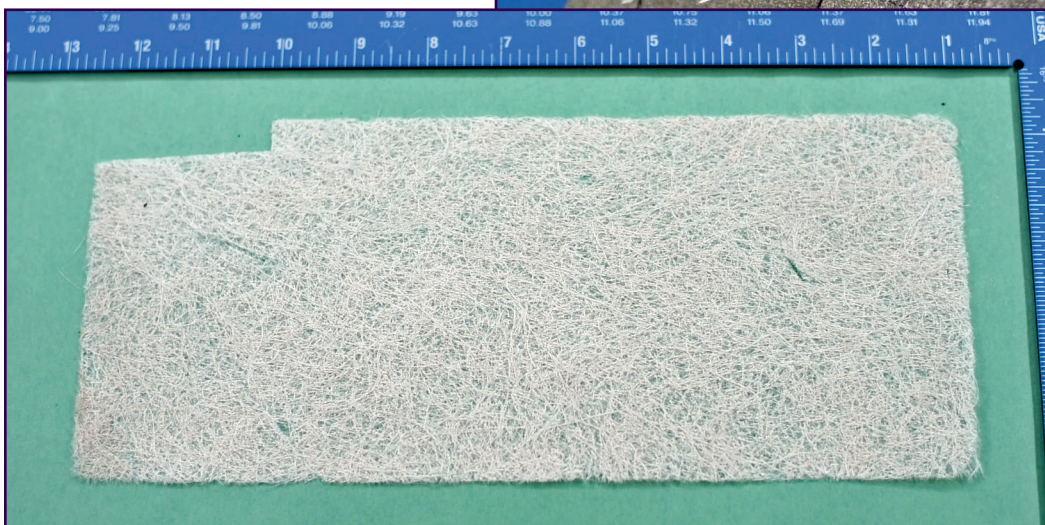
Figure 2 – Roofing membrane after being desaturated in vapor degreaser.

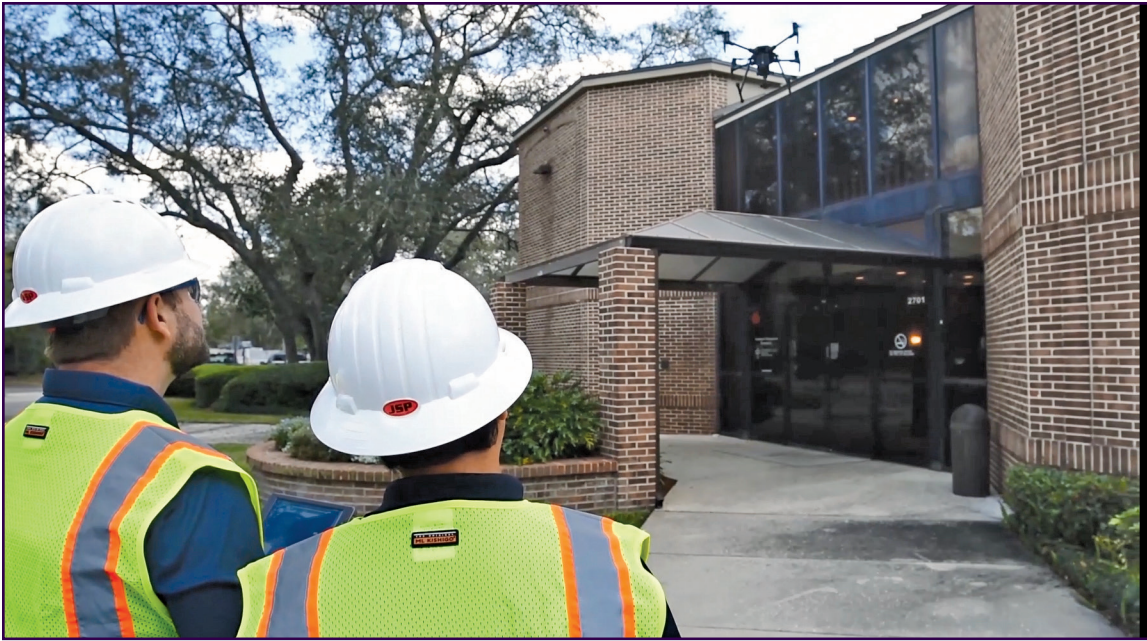
Figure 5 – UAV assessment.

UAV technology has advanced to the point that flying the UAV and capturing photographs/videos can be done after basic training on the equipment. However, in commercial use, a certification from the Federal Aviation Administration (FAA) for the UAV and a license for the pilot are required to lawfully operate one (Figure 5).
