Code Ambiguities and Minimum Standards

The importance of code clarity and readership

By Nick Warndorf

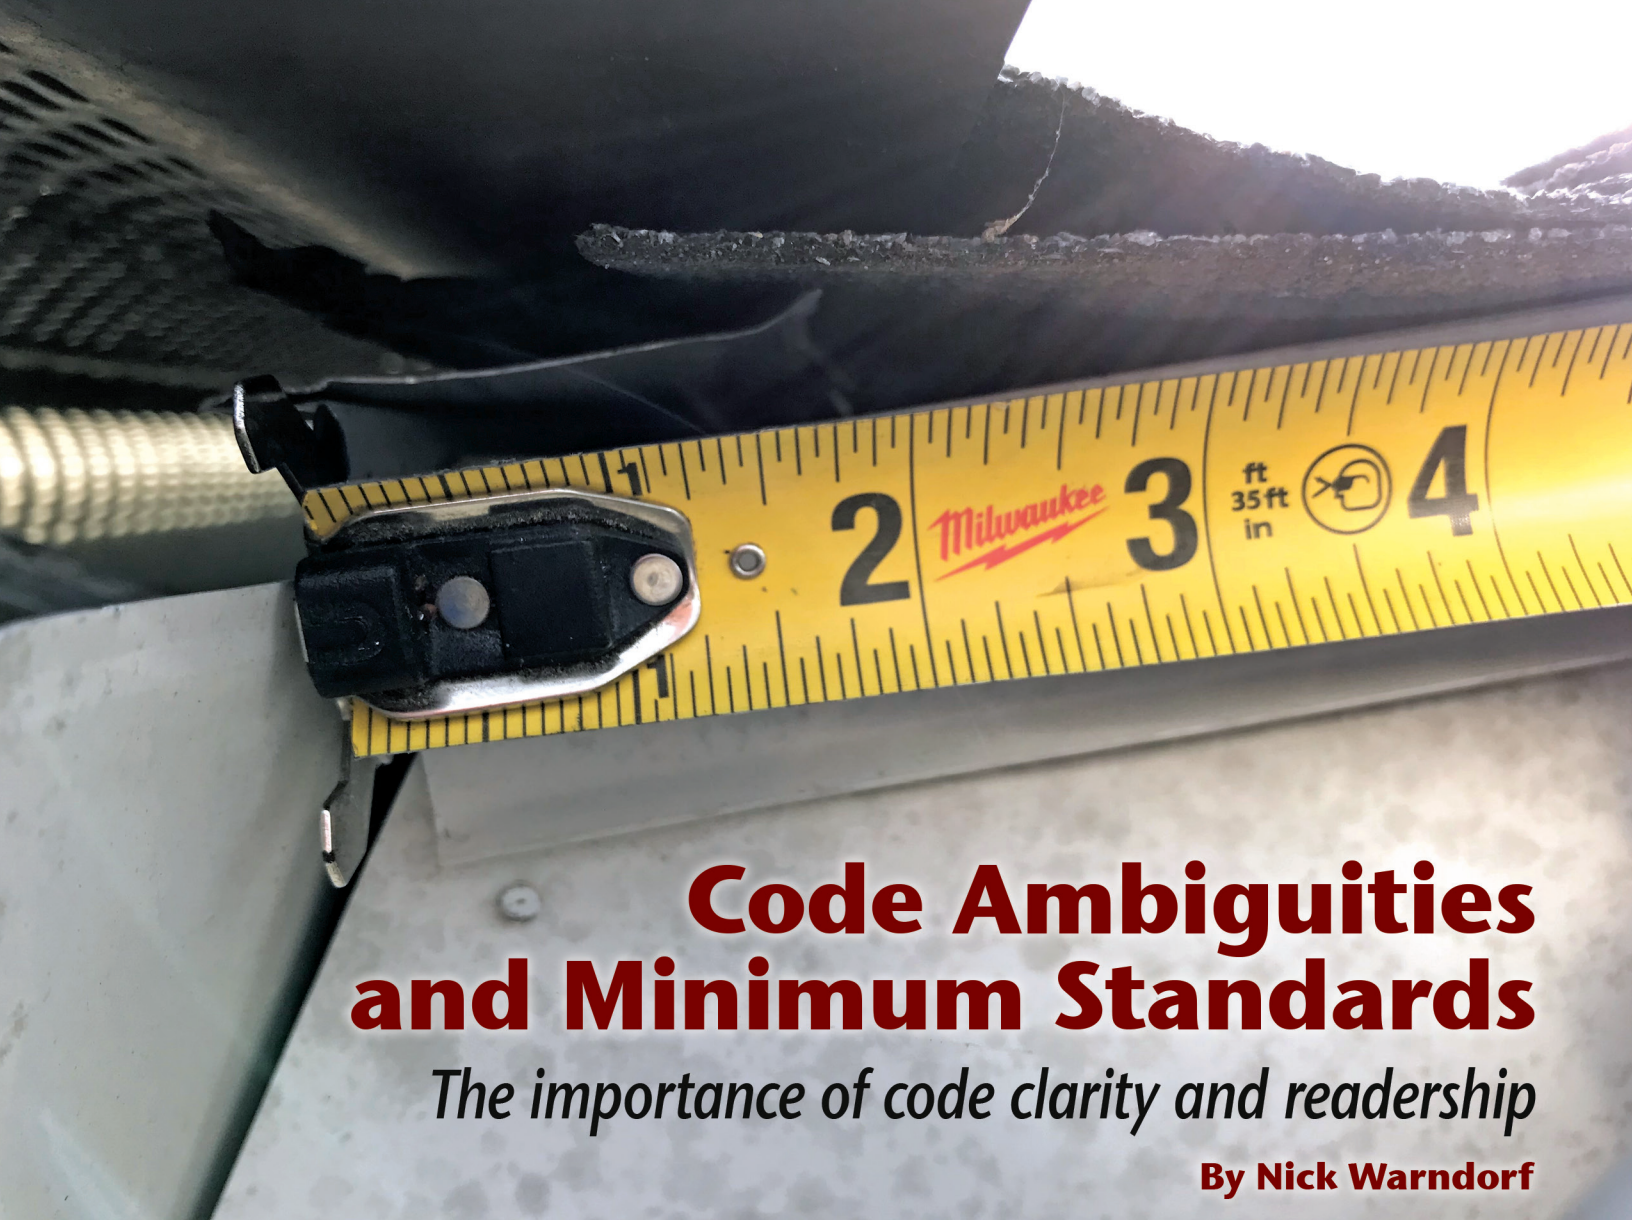
Figure 1 – Picture of drip edge measured at eaves.

tractors time and energy in customizing the metal work to the project as shown here in *Figure 1*. This is an image of a mass-produced drip edge found in most commercial supply houses with standard sizing.

In 2012 IRC section R905.2.8.5, we can see a standard, commercially produced drip edge that is less than the minimum-required 2-in. installation, primarily because the fabrication style or angle holds the drip edge off the fascia, preventing a 2-in. extension. Going further, the manufacturer of the drip edge must take the measurement from the end of the drip edge outside lip to achieve a full 2-in. measurement, which is about ¼-½ in. from direct contact with the eave.

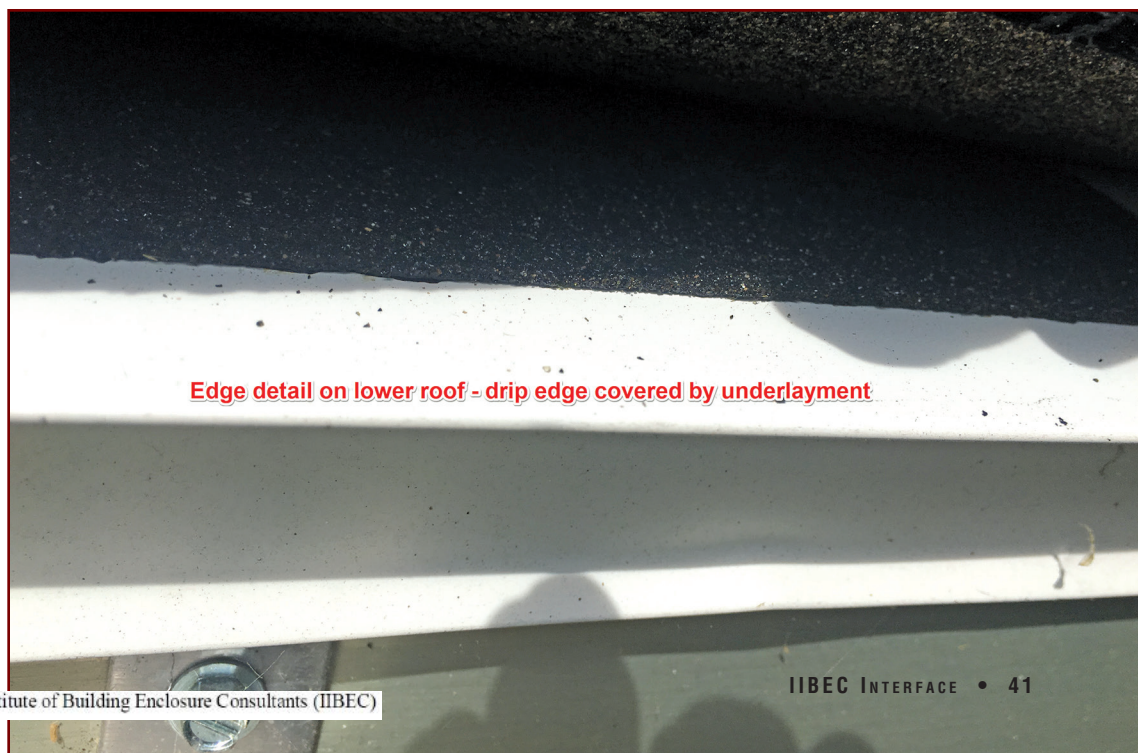
Figure 2 – Picture of underlayment over drip edge.

Edge detail on lower roof - drip edge covered by underlayment

The drip edge itself is almost always affected by the existing framing. There are often gaps between the roof sheathing and fascia that the drip edge must span in order to have a solid fastening surface. Lastly, if the specifications call for an ice and water shield at the eaves (common in steep-slope roof systems), there is no way to verify that the drip edge was installed with nails (not staples) after the underlayment is installed, nor whether it has been done correctly (*Figure 2*).

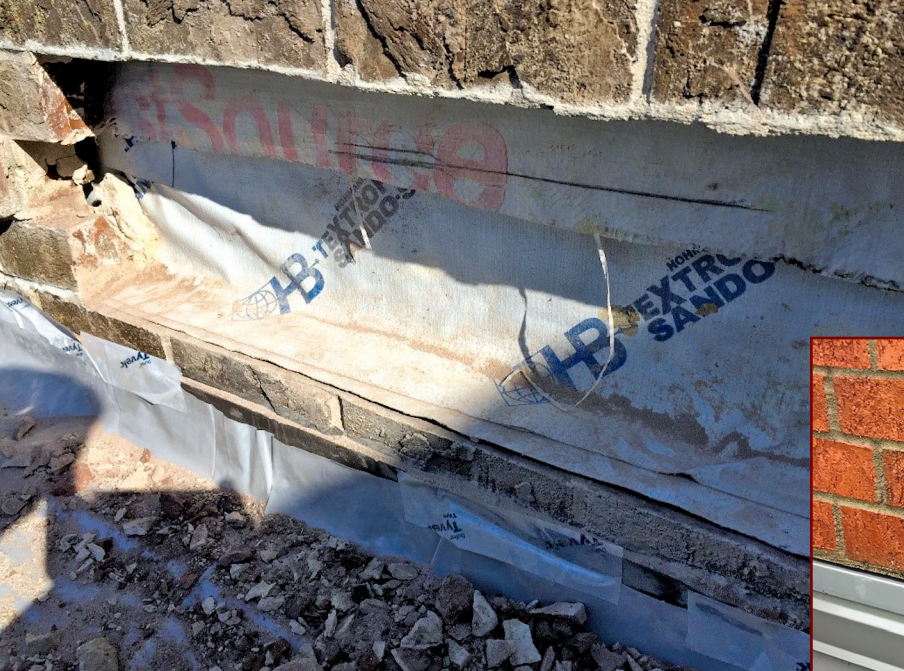
Figure 3 – Picture of failed through-wall membrane without through-wall metal.

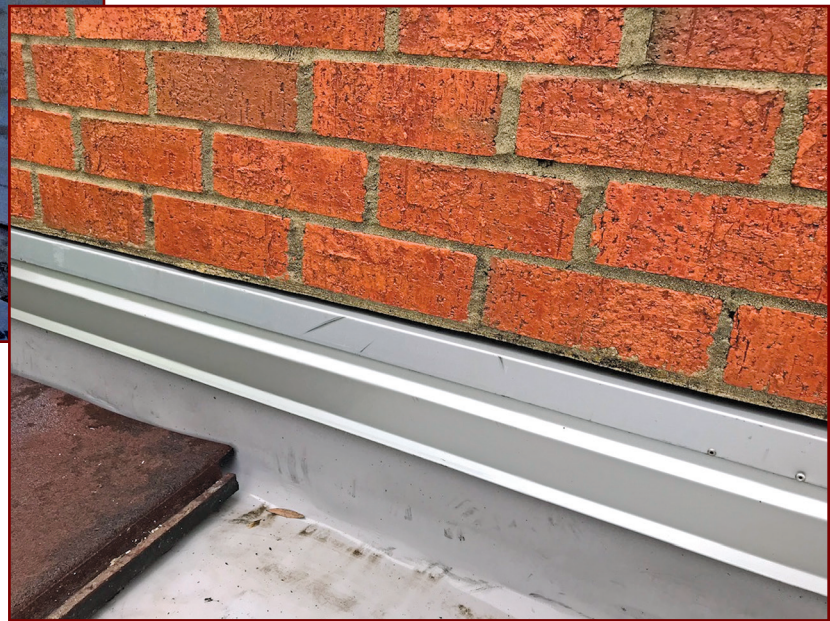
Figure 4 – Through-wall flashing.

Through-wall flashings are commonly investigated in residential consulting work, and yet they are still rarely understood by many repair crews and new construction project managers. We have worked with many masons over the years who have never incorporated copper through-wall flashing into their masonry installation—either because the plans didn't call for it or because the specification was for peel-and-stick WRB membrane in lieu of copper or stainless steel. The benefit of the latter specification is cost in both material and labor, but it is likely to cause much more costly problems later. Most chimney rebuilds start around the \$20,000 to \$30,000 mark, and that's assuming that there won't be any framing work as part of the scope. In these types of projects, the full extent of the damage is rarely known until you start taking things apart. *Figure 3* is an example of improper through-wall flashing using membrane rather than metal, which is just short of the brick exterior thereby defeating the design intent. *Figure 4* shows through-wall flashing that has an opening for drainage as intended, and *Figure 5*

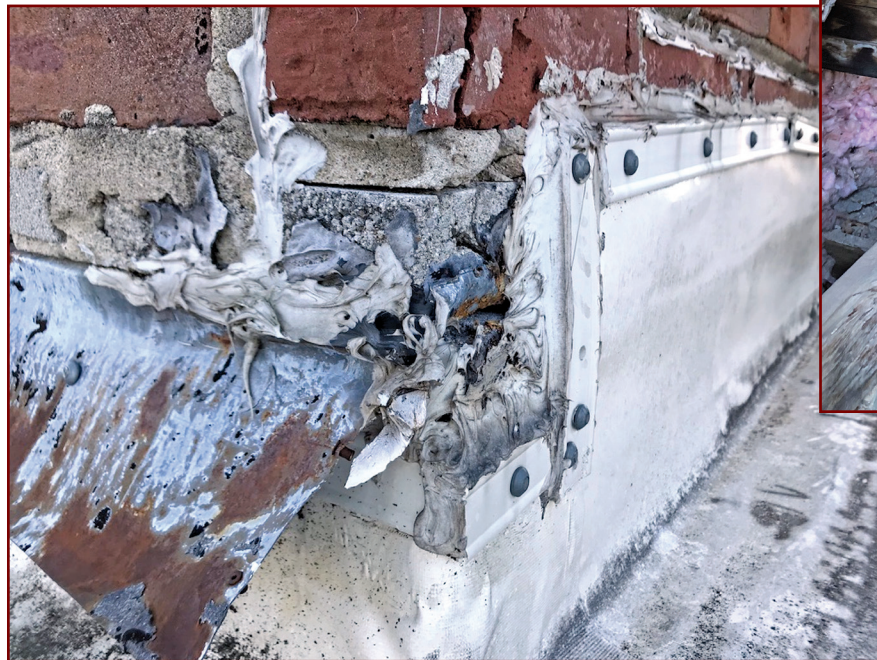
Figure 5 – Improper wall termination.

shows one of the most common conditions observed in single-ply membranes today, a termination bar over brick exterior (which is doomed to fail). *Figure 6* is a great example of the consequences of design and installation failure when proper attention to detail is not given.

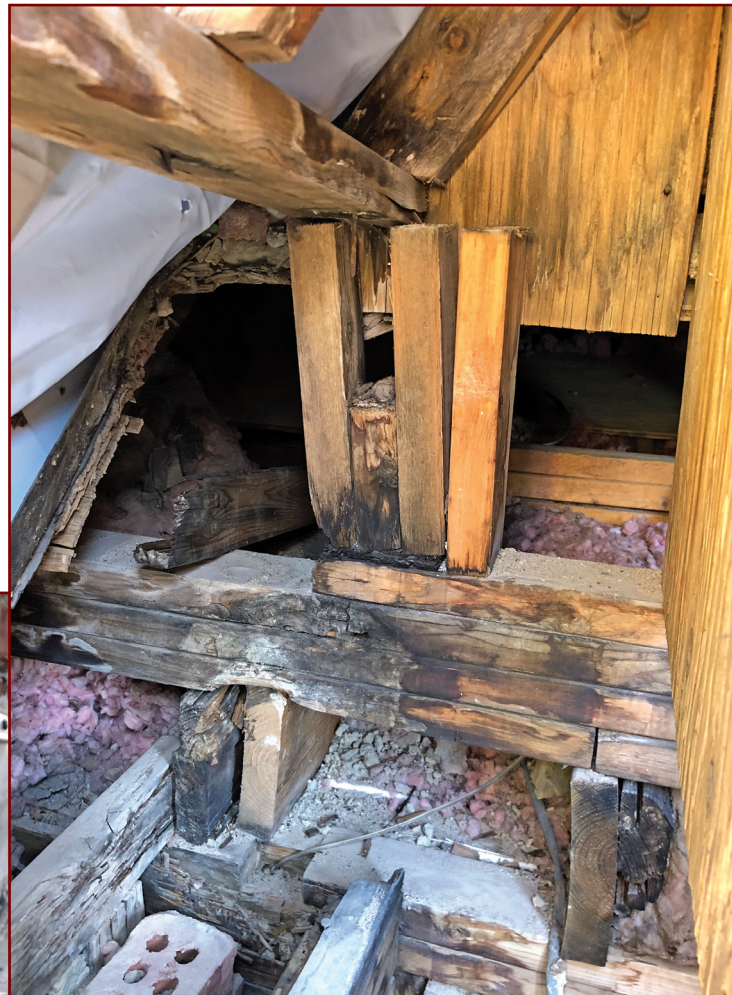
Figure 6 – Picture of framing damage due to improper flashing.
