Where Has All the Counterflashing Gone?

Underscoring Counterflashing Function and Value in Commercial Low-Slope Roofing and Waterproofing

By Sam S. Zalok, PE, and John N. Karras, PE

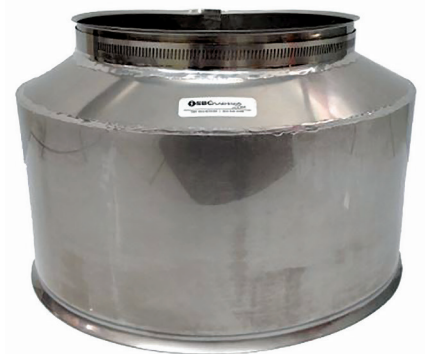
also sometimes referred to as a “rain shield,” “umbrella flashing,” “storm collar,” or “collar flashing.” The rain collar is often stainless steel, secured to the pipe penetration with a band clamp, and like a surface-applied counterflashing on a wall, the sky-facing edge is flared to receive sealant.

Figure 6 – Prefabricated stainless steel rain collar.

The authors are sometimes told that stainless steel rain collars are prohibitively labor intensive to fabricate in the field. However, in today’s roofing/waterproofing marketplace, prefabricated rain collars can be sourced from manufacturers and shipped direct to project sites, much like general sheet metal counterflashings (Figure 6).

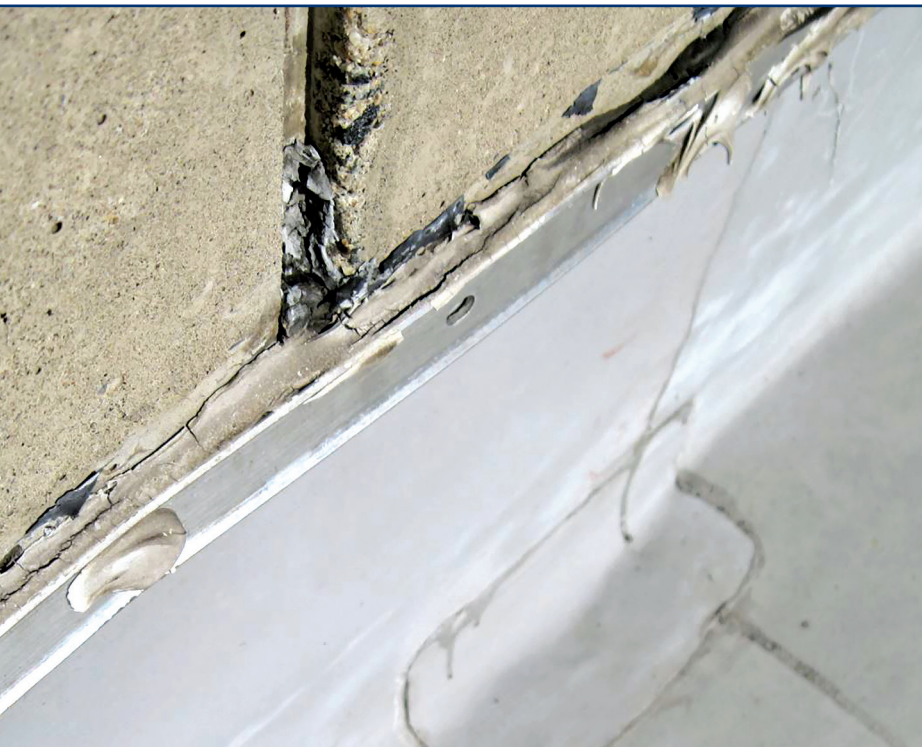
designer must consider not only the field of the overlying wall, but also the conditions at vertical joints of cast-in-place or precast concrete walls. At such vertical joints, reglet-set counterflashing is a better choice than surface-applied counterflashing, given that the latter, since it does not extend into the vertical joint, may result in a leakage vulnerability at each vertical joint (Figure 8). Note that at vertical movement joints, the termination bar and counterflashing should only be secured to one side of the joint to accommodate differential movement.

Figure 8 – Vertical joint in precast concrete wall system.

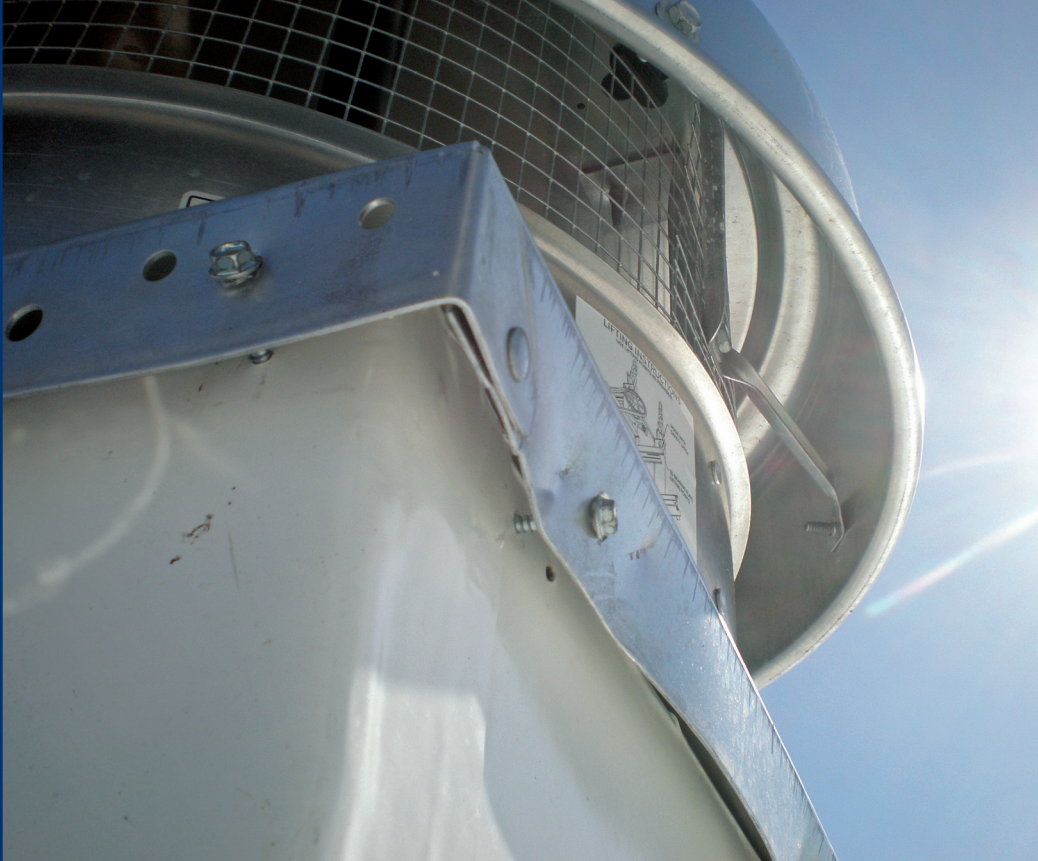
Figure 10 – Gap between downturned flange of exhaust fan and base flashing.

This water leakage vulnerability is exacerbated when the plan dimensions of the equipment's downturned leg are sufficiently larger than the base-flashed curb such that a gap remains between the back side of the leg and the base flashing (Figure 10). When such a gap is present, so too is a heightened air leakage vulnerability. Consequently, design and construction teams should ensure that mechanical equipment curbs include not only a sufficiently tall counterflashing, but also provisions for an air seal between the curb cover and the base flashing.

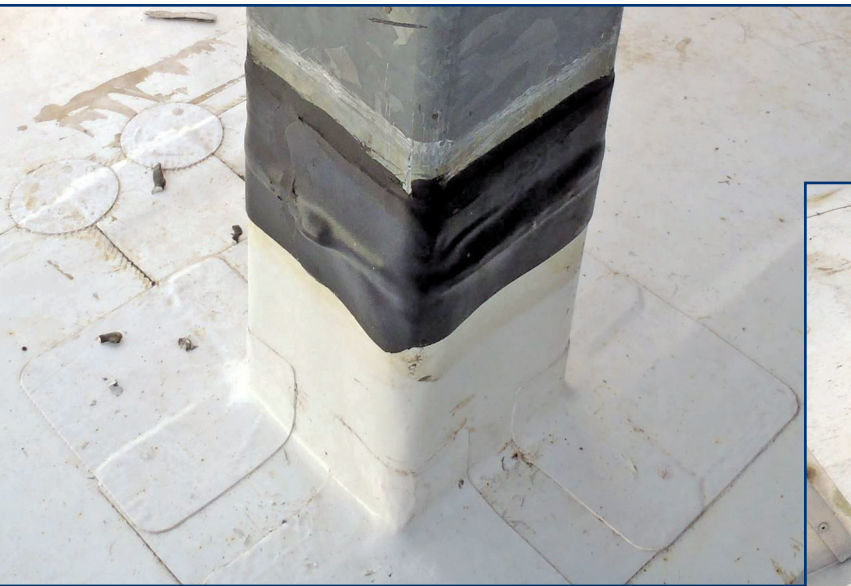
- HSS column penetrations (Figure 11a) where, as described previously, a band clamp does not provide continuous compression on the "flats" of the HSS member, warranting use of a pliable/uncured membrane that can conform to the HSS shape and traverse over the underlying band clamp
- Sheet metal ducts (Figure 11b) where the membrane can conform to the rectilinear shape of the duct and the duct cannot accept mechanical fasteners (to attach metal counterflashing) without risk of air leakage or other duct-related performance problems

Figure 11a – Elastomeric membrane counterflashing at HSS column.

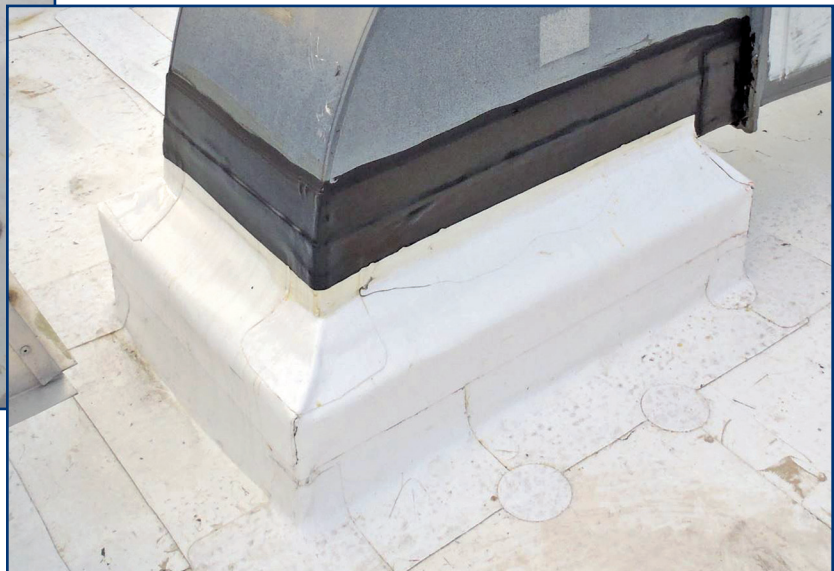
Figure 11b – Elastomeric membrane counterflashing at duct penetration.
