# Investigation of Exposed Concrete Façades

By Alexis Brackney, AIA, SE

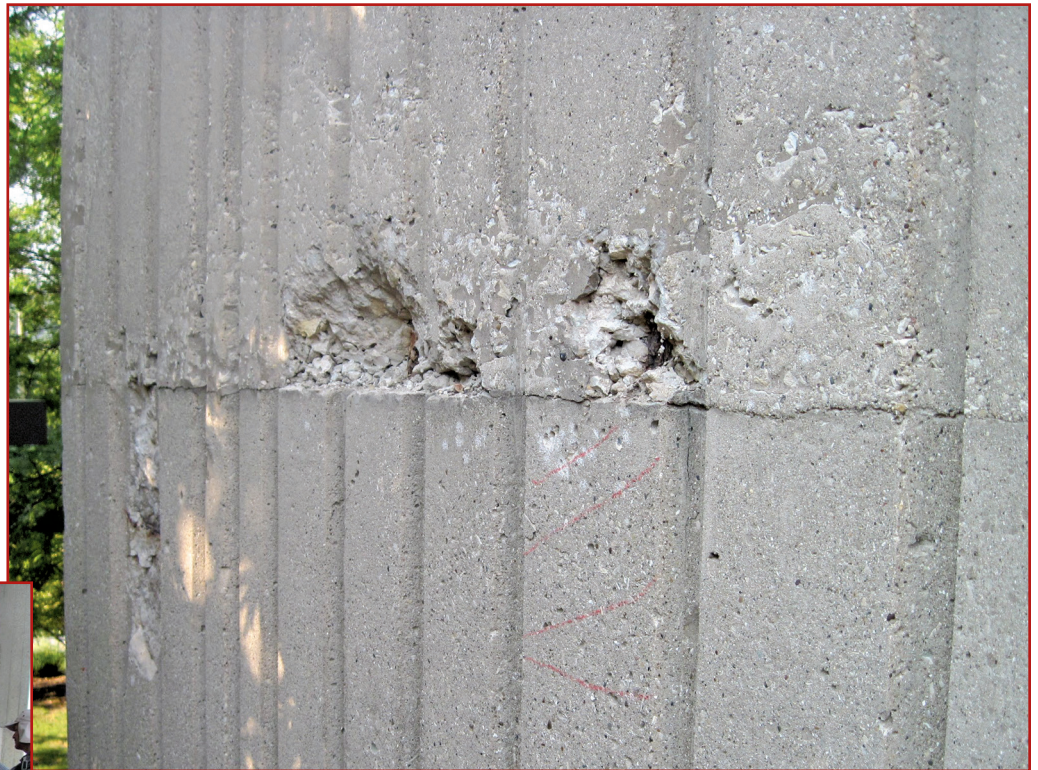
*Figure 2 – Concrete spalling observed during investigation of a concrete façade.*

After decades of exposure to the elements, concrete façades may exhibit deterioration in the form of cracking, delamination, or spalling (Figures 1 and 2). Exposed reinforcement bars are unsightly, and continued expansive effects of corrosion may lead to potentially hazardous situations for pedestrians and property below. Further, cracking and deteriorated transitional areas can offer paths for moisture migration into the building and result in interior leakage.

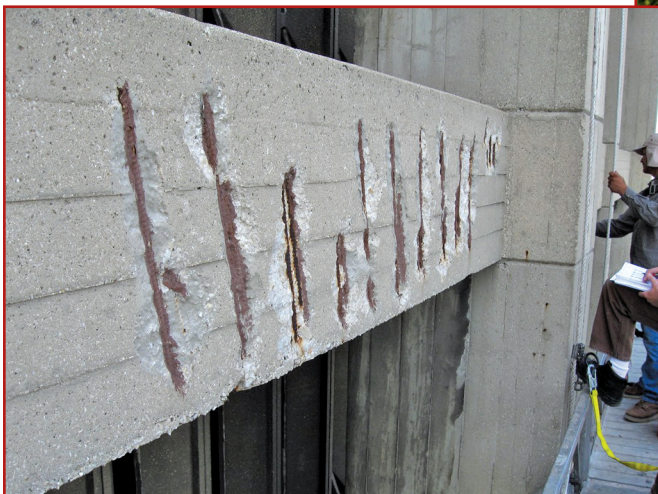
*Figure 1 – Spalled concrete and exposed reinforcement bars observed during a façade investigation. Many bars had less than ½ in. of concrete cover.*

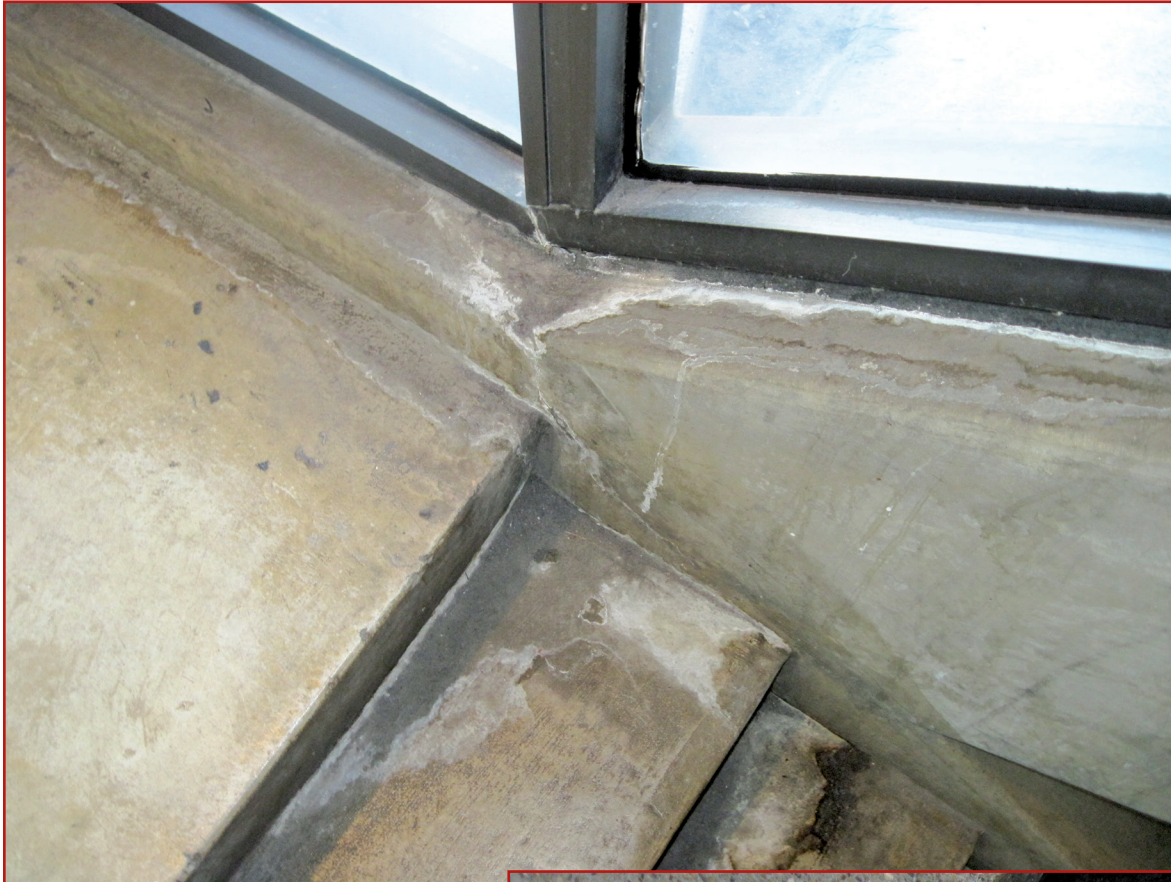
*Figure 4 – Through-wall cracking and failed sealant resulted in leakage at this concrete stairwell.*

Of course, spalling concrete represents a great threat to the safety of pedestrians around a building. However, even minor cracking can lead to interior leakage and affect the quality and the comfort of the building occupants. Investigation of leakage at a concrete stairwell indicated that through-wall cracks and failed sealant at the perimeter of the steel window-wall system contributed to water ingress at

interior stairs (Figure 4). Investigation of a precast concrete window system found that deterioration of the concrete resulted in leakage at

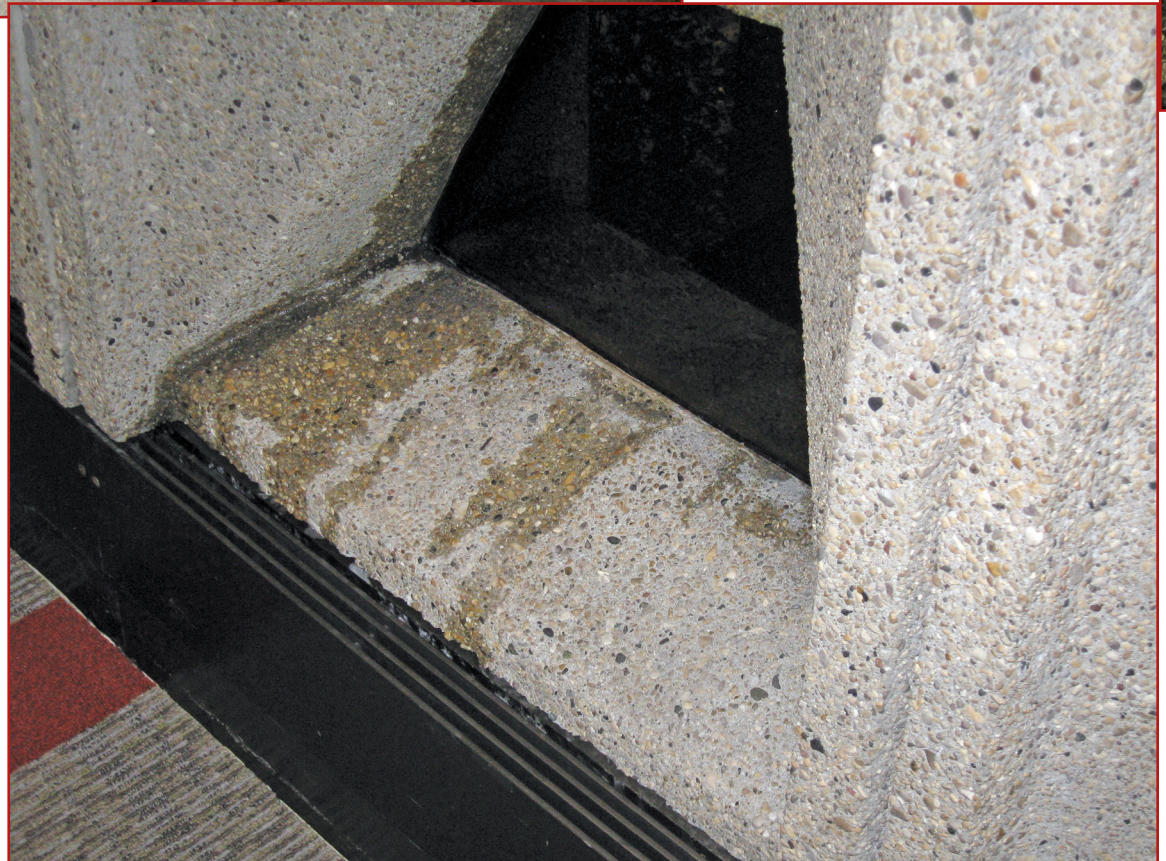
*Figure 5 – Interior leakage at precast concrete window system.*

the building interior (Figure 5). Aged sealant around the window perimeters and localized spalling contributed to the leakage.

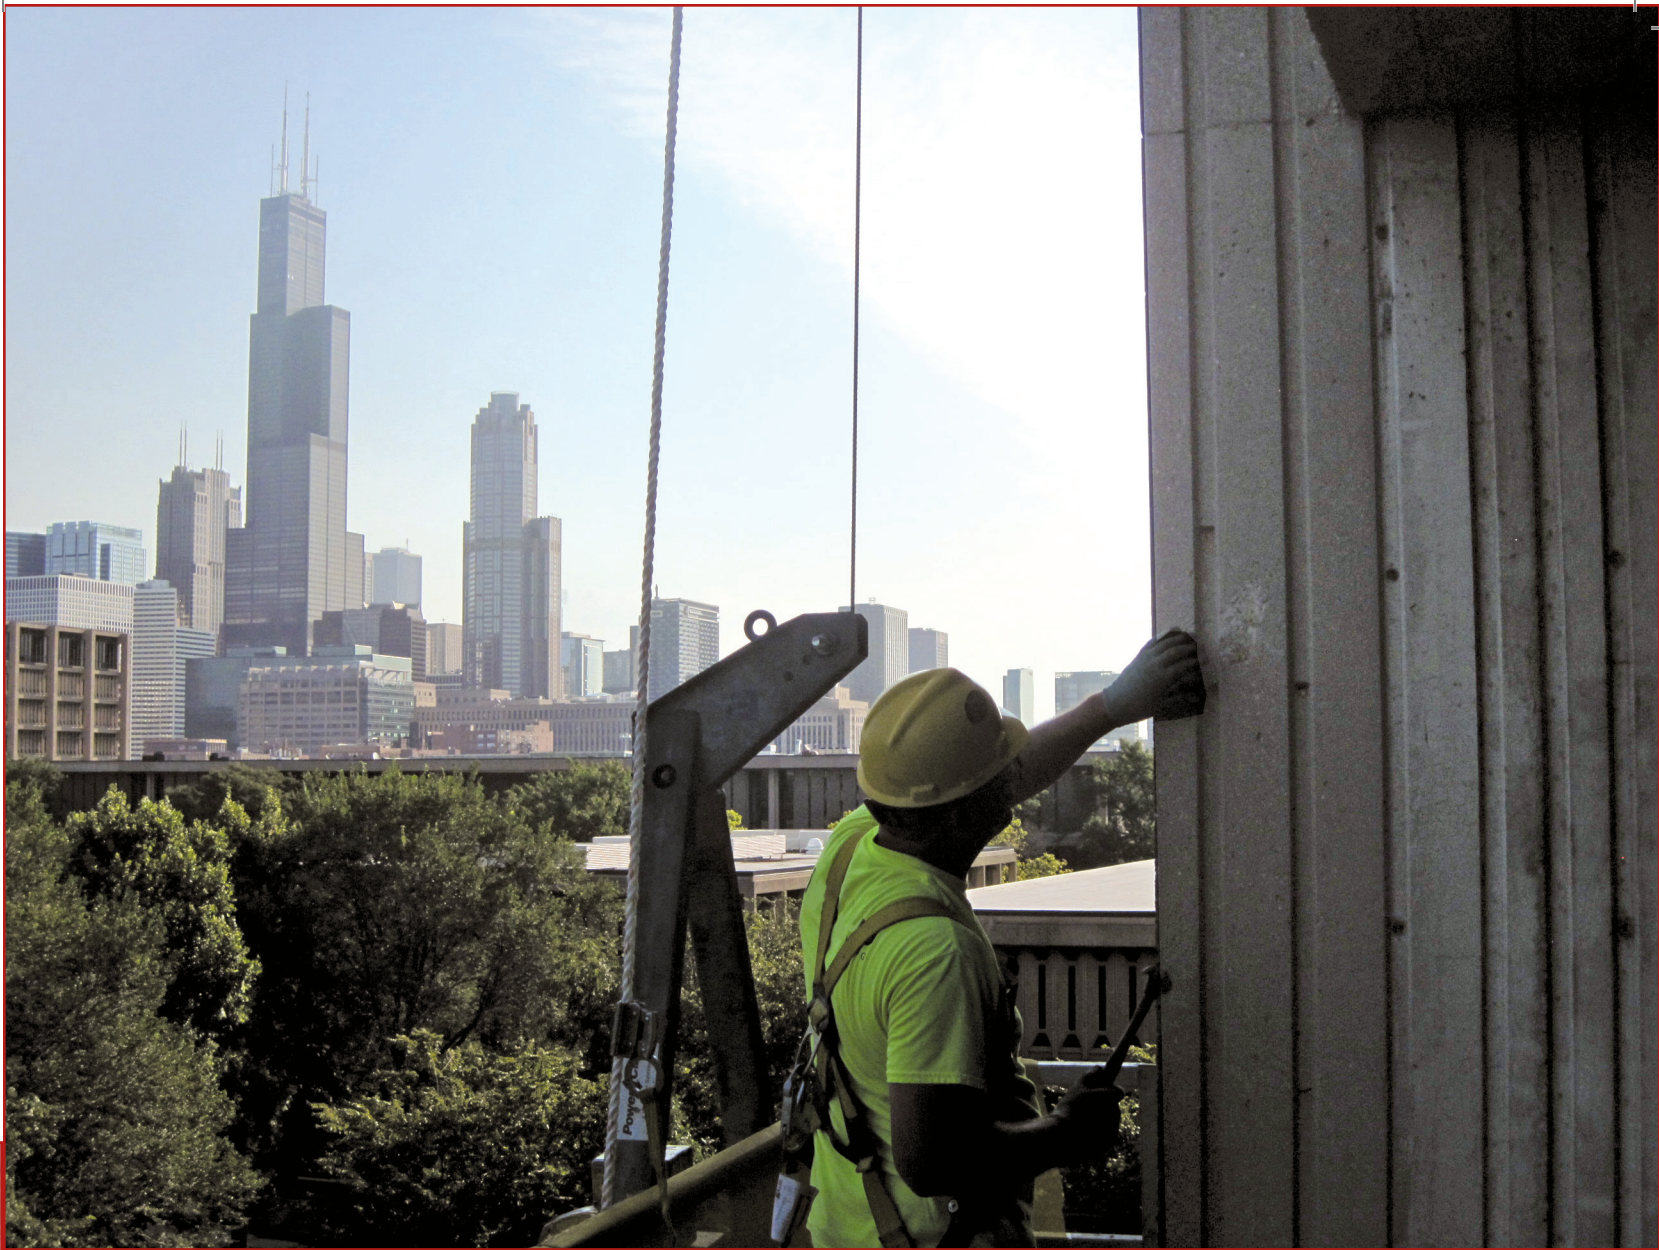
*Figure 6 – Façade inspection of exposed concrete from suspended scaffold.*

Façade inspections should generally consist of visual surveys of the entire façade supplemented by hands-on and close-up evaluation of enough area as practical to provide a comprehensive assessment. Scaffolding, boat-swain chairs, and lifts should be used to provide hands-on access to upper levels of the façade. Hands-on techniques such as hammer sounding to detect subsurface delaminations and nondestructive testing generally give the inspector a more complete view of the extent of deterioration that may be present. In concrete façades with low-cover concerns, ground-penetrating radar (GPR) surveys may be performed to measure concrete cover over embedded reinforcement. Nondestructive measurements may also be confirmed by drilling holes at reinforcement to measure cover at representative locations.

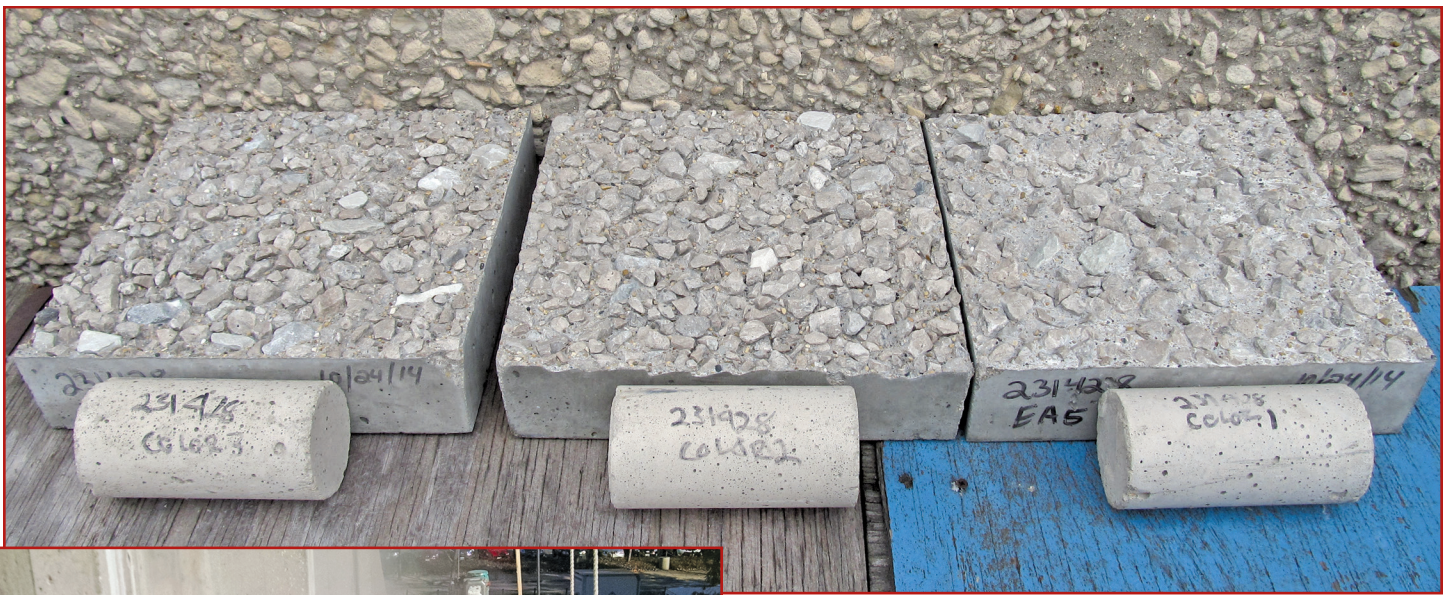
Figure 7 – Mock-up samples of exposed aggregate concrete.

properties of the existing building. Mock-ups may include trial patch repairs on the façade, or separate mock-up samples that may be moved around to multiple elevations or façade elements. It may be helpful to view the mock-ups under multiple lighting conditions (such as full sunlight or shade). Multiple mock-ups should be used to represent different concrete elements or textures, such as concrete with exposed aggregate and smooth concrete with visible form lines (Figure 7).

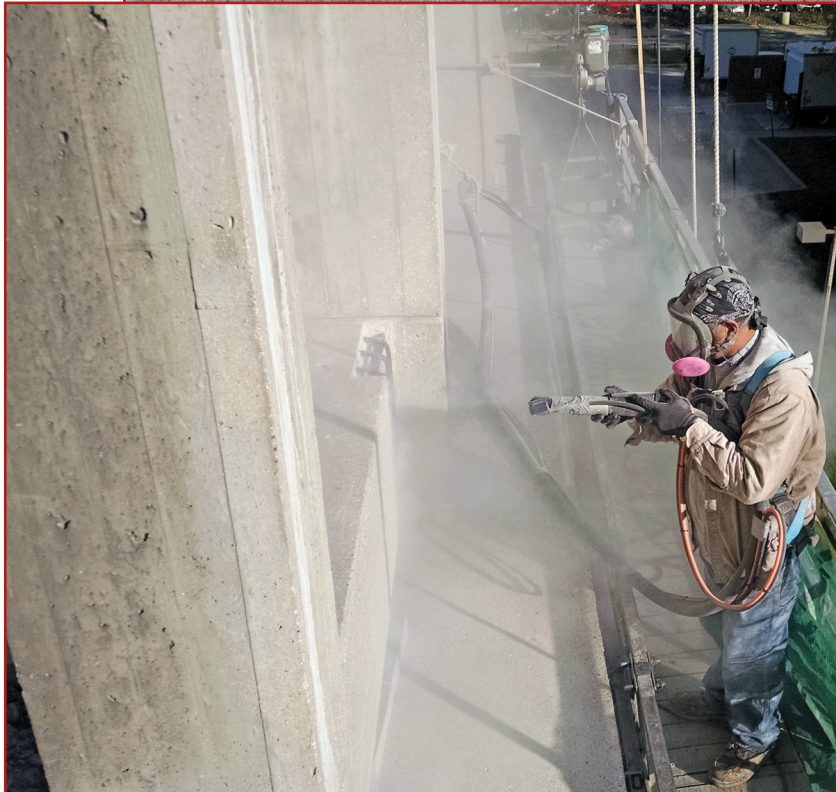
Figure 8 – Soda blasting used during concrete façade cleaning.

desired results. For example, dry sand blasting is an aggressive technique that may cause damage to older concrete. Alternately, soda blasting is a non-destructive cleaning method that can be used for more delicate concrete façades. Soda blasting uses compressed air to apply sodium bicarbonate (baking soda) to a concrete surface (Figure 8). Trial cleaning should be performed at selected locations to determine its effectiveness before cleaning the entire façade.
