Got Shrinkage?

Why Wood Shrinkage Analysis Is Required by the Code

By Ray Wetherholt, F-IIBEC, RBEC, PE and Derek Hodgins, RBEC, PE, CCCA

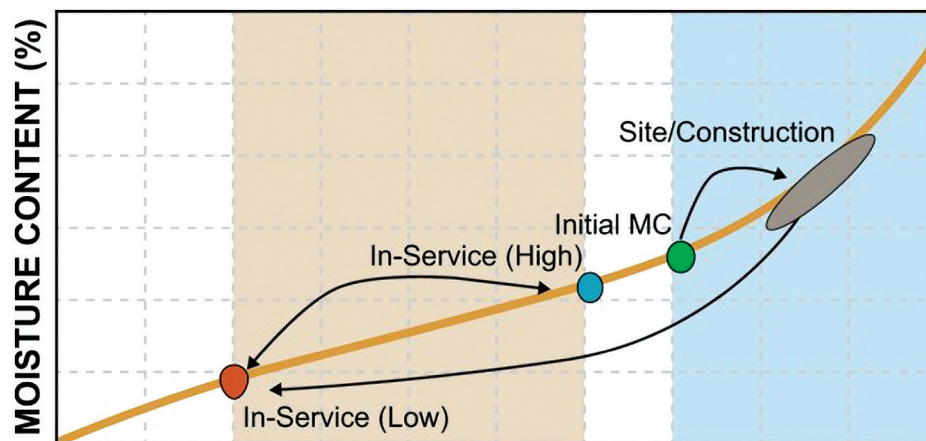
Figure 1 – This graphic showing the relative range of expected wood moisture content during a typical project. Source: RDH Building Science, Inc.

dimensional change in wood associated with a change in (loss of) moisture content. Figure 1 shows the relative range of wood moisture content that is expected during a typical construction project. Wood changes dimension in three directions: longitudinal (parallel to the grain), radial (perpendicular to the growth rings), and tangential (tangential to the growth rings). However, it is the tangential direction that is the most significant. Because the framing at floor lines often includes wood “bands” that are oriented such that the tangential shrinkage is vertical, the frame height is shortened. Figure 2 shows a typical floor construction configuration and the zone of most significant shrinkage. Obviously, the change in moisture content influences the extent of wood shrinkage. The wood species also influences the extent of wood shrinkage. On mid-rise wood-framed buildings that are four to six stories tall, wood shrinkage can be well over 1 in. The amount of time to experience the shrinkage related to moisture will be dependent on time of year and local climate. For instance, a desert location in summer should dry much faster than a location in Seattle built during the winter.

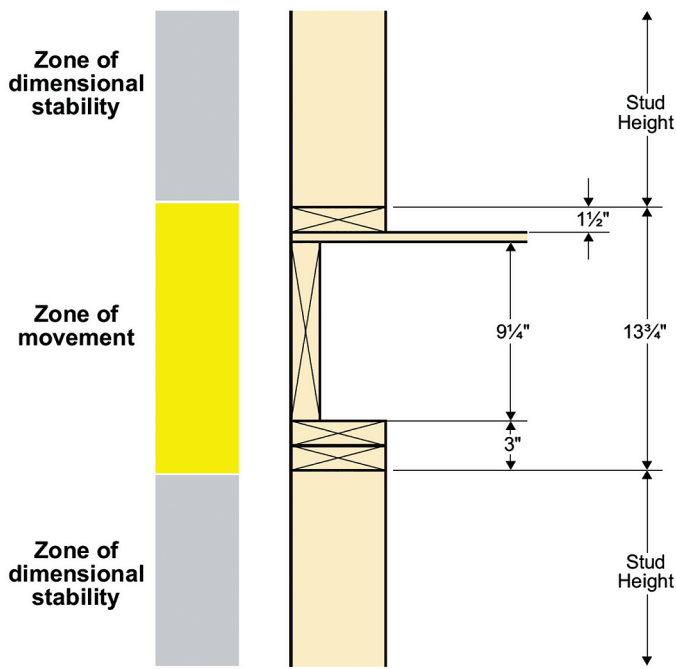
Figure 2 – This figure shows the zone of most significant wood shrinkage, located at the floor line.

Wood shrinkage is cumulative, from the bottom of the building to the top, with the most significant movement at the top floor.

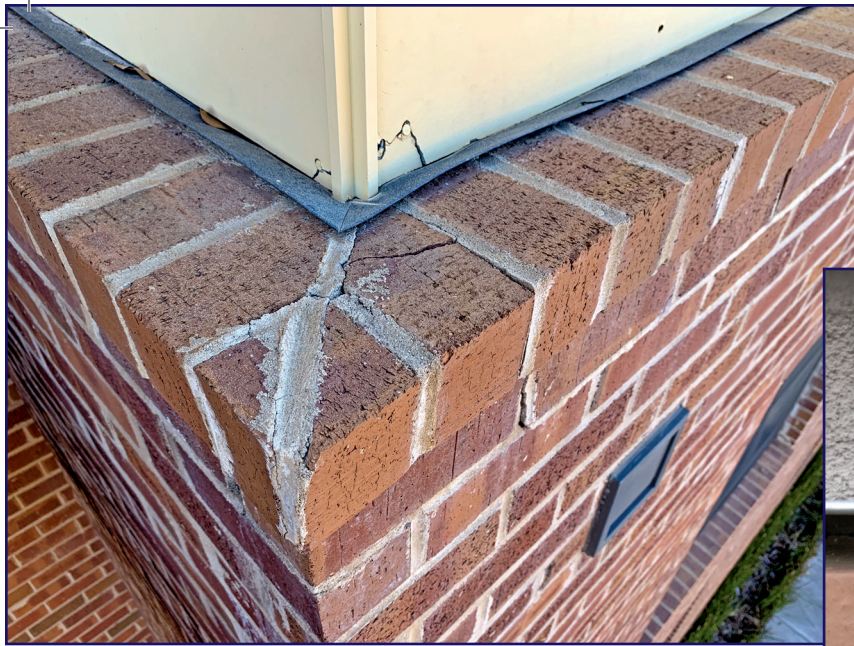
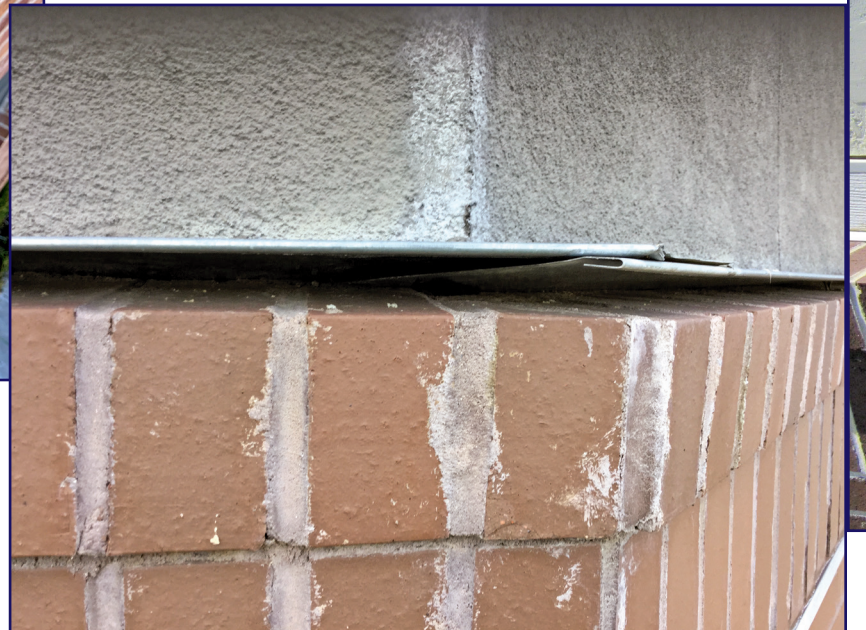
Figure 3 – These two photos show the upward rotation of flashing caused by wood frame shrinkage.

walls shrink, the wall framing (and everything attached to it) is displaced vertically downward. If the vertical leg of through-wall flashing is attached to the exterior-wall framing, and extends over a somewhat independent cladding material, such as brick veneer or stucco, flashing rotation can result. Figure 3 shows two examples of this type of flashing damage.

Specifically, as the framing shrinks downward and the brick expands upward (do not forget that brick is the smallest it will ever be at the time of manufacture—it only grows in service), the flashing gets pulled into the wall cavity behind the brick veneer, causing the sloped leg of flashing to rotate upward.³ The flashing that you were counting on to direct water away from the building has now become a trough that holds water against the building, and if your flashing does not have end dams (which are not required by the IBC, but are required on housing by the NBCC), the flashing will direct concentrated flows of water into the exterior wall assembly. The concentrated areas' intrusion can result in significant

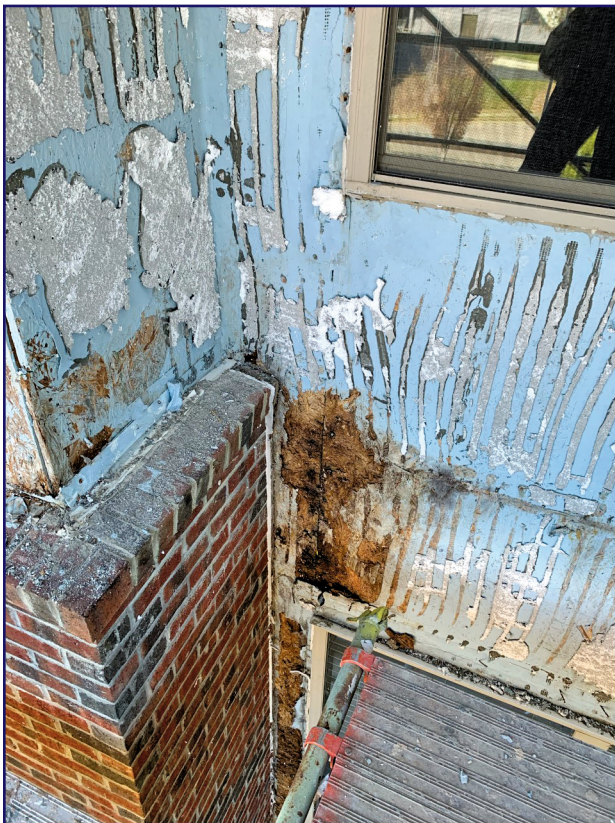
Figure 4 – This figure shows concentrated water intrusion and associated damage.

damage, including wood decay, mold, and corrosion of fasteners, among other issues. Figure 4 shows a typical example of concentrated water intrusion and associated damages.

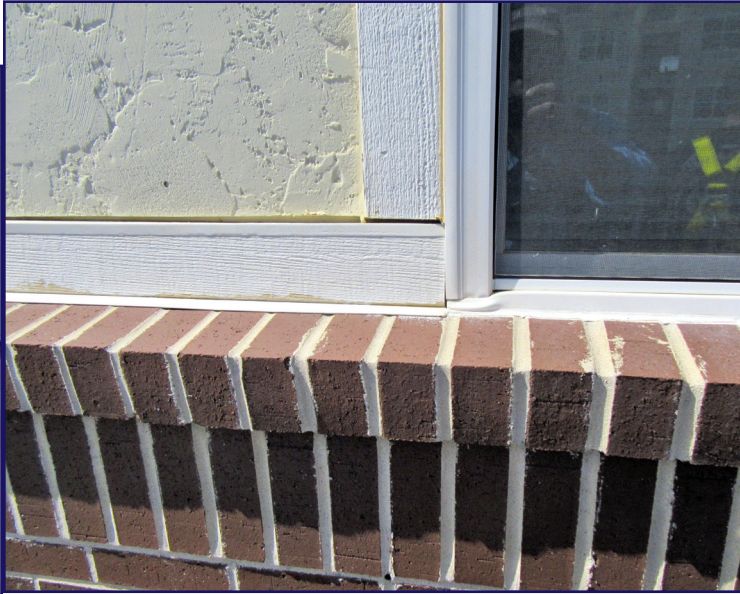
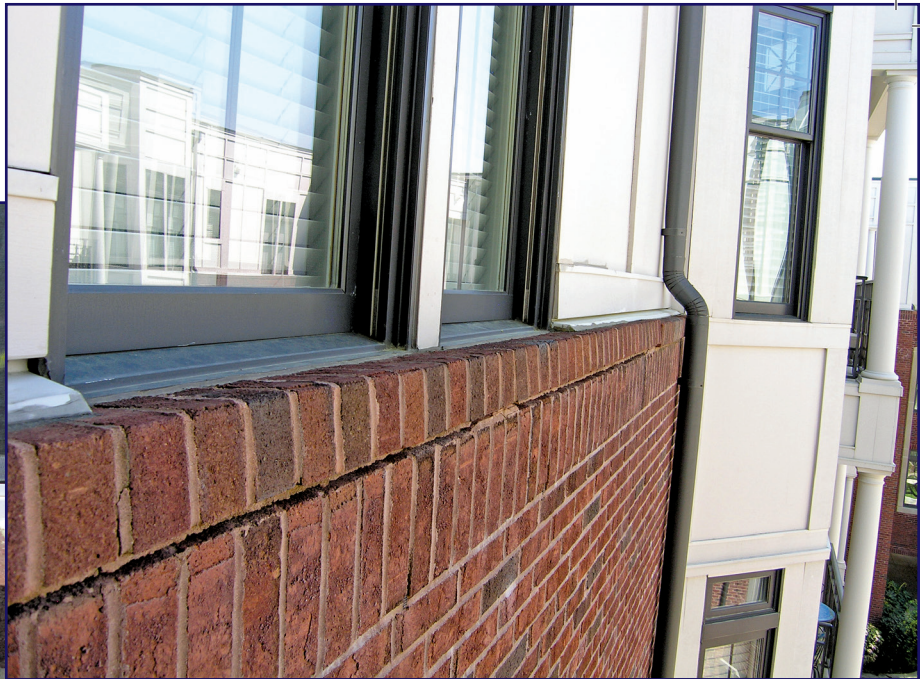
Figure 5 – These photos show window and brick veneer damages caused by wood shrinkage.

Probably the most common and easily identifiable issue related to wood shrinkage is the collision of brick veneer and windows. The fact is, if you terminate a few stories of brick veneer against (or even close to) the bottom of a window, damage will result if you have not considered the shrinkage. If this condition exists on a building—even one that is only a few years old—you are likely to find damage. When the damages are significant enough, this observation can be made while driving by in a car or during a casual stroll. The brick and window cannot avoid crashing into each other. The windows are attached to the wood-framed wall that is shrinking and moving downward. The brick veneer is attached to the wood-framed wall to provide lateral restraint, but is allowed to move vertically in a limited range. As the brick veneer expands, it pushes against the bottom of the window frame and everything else that is attached to the wall, and collides into the brick veneer. The photos in *Figure 5* show examples of window damage (crushing)

and brick veneer damage (cracking), both caused by the process described previously.

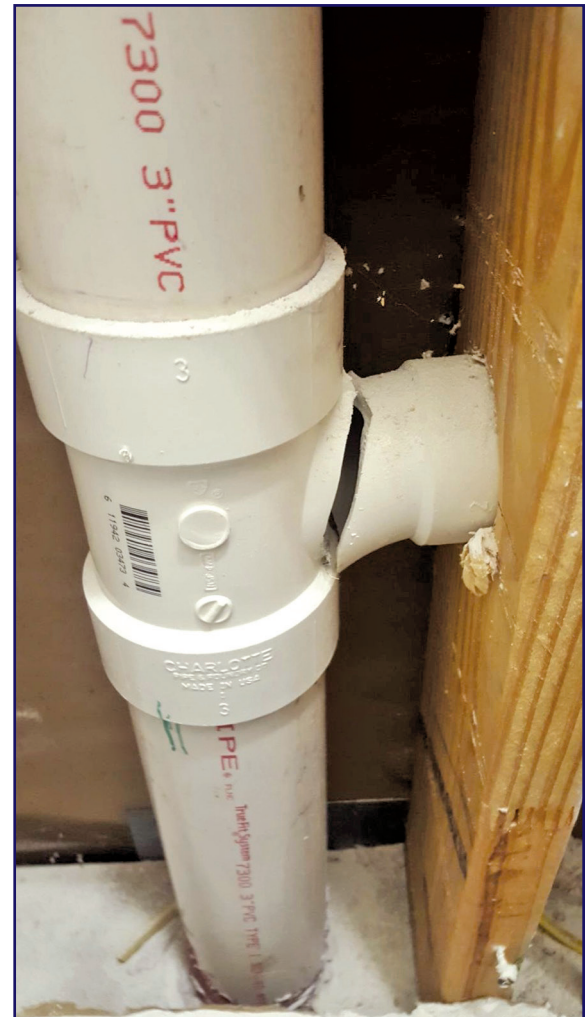
Figure 6 – This photo shows damages to PVC pipe caused by wood shrinkage.

Another problem that can be caused by wood shrinkage is broken PVC plumbing pipes. Specifically, if a hole is cut through wood-wall framing to accommodate a plumbing pipe, the hole will need to be cut larger than the diameter of the pipe, such that a gap exists above the pipe that is equal to or greater than the shrinkage that is determined by the code-required analysis.⁵ Remember that shrinkage is cumulative, from the bottom of the building to the top, with the most significant movement at the top floor. It is important that, as the wood framing moves vertically downward, it does not come into contact with the PVC plumbing pipes. If a sufficient gap is not provided in the wood framing above the PVC plumbing, the wood framing can damage the plumbing, sometimes breaking a pipe clean off, as shown in *Figure 6*.
