# Mid-Century Modern Heritage Conservation

By Mike Grummett, PEng

The project described in this paper included a 2016 condition assessment to gain an understanding of the current condition and performance of the Qube's building enclosure, followed by conservation work.

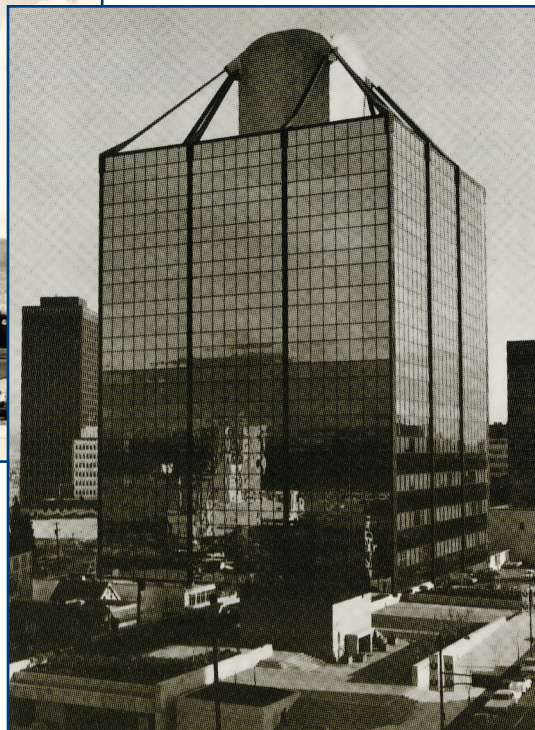
*Figure 8. Cladding covers were repositioned, and custom-colored sealant strips were renewed.*

To address the gaps in the cladding covers of the curtainwall system, the covers were re-

and preformed silicone sealant strips were specified and installed at the horizontal and vertical joints in the metal cable coverings (Fig. 8).

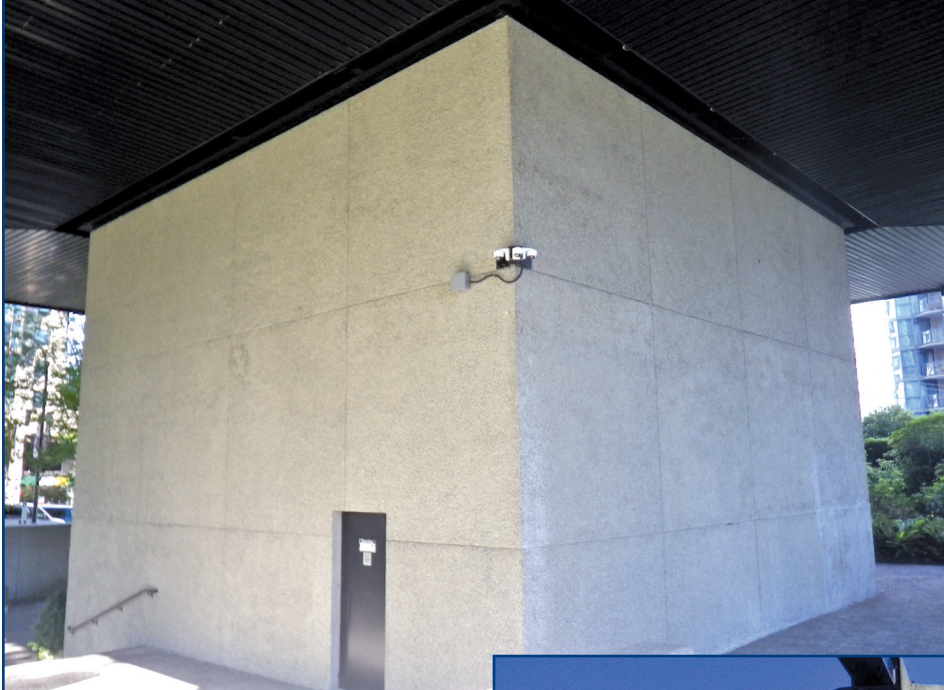
Figure 3. Central concrete core at grade.

At the ground-floor level, the exterior concrete walls are protected by the overhang created by the base of the building above (Fig. 3). The walls of the core have little or no exposure to exterior moisture in this area. At the roof level, the exterior concrete walls form the mechanical penthouse and are exposed to the weather on all elevations with no overhang protection or cap flashings (Fig. 4). During our review, we observed spalling and exposed reinforcing steel, areas of previous concrete repairs, and staining and organic growth associated with wetting.

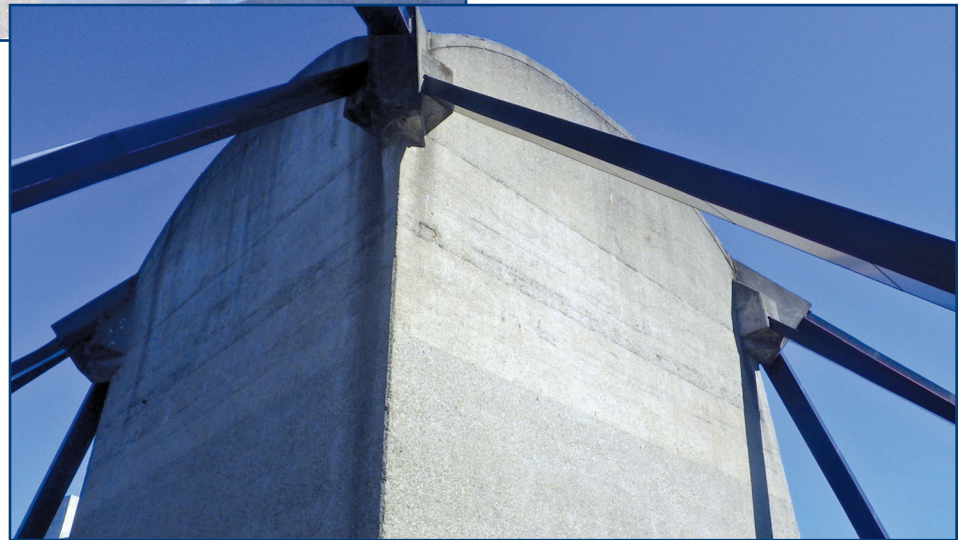
Figure 4. Exposed-aggregate concrete core at roof level.

At the rooftop level, the upper concrete core was experiencing high levels of organic growth and concrete deterioration due to the low slope of the tops of the walls and projections. Following targeted concrete repairs at both locations, polymethyl-methacrylate liquid-applied membrane was applied to the low-slope elements (Fig. 6). A color additive was specified to help the coating blend with the adjacent materials. The liquid-applied membrane allowed for easy installation over the curved surfaces.

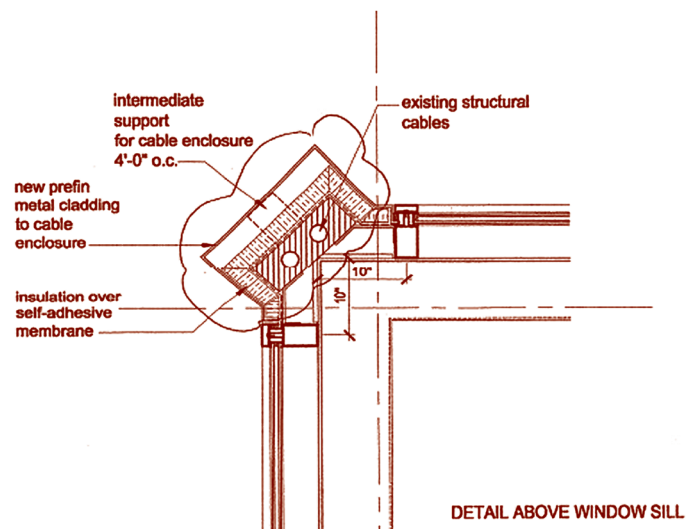
As part of the 2006 residential conversion of the building, the cable cladding was updated and replaced. Behind the metal cable cladding, rigid insulation and a self-adhesive air barrier membrane transitioned from the cable enclosure to the adjacent curtainwall assembly (Fig. 5). Horizontal and verti-

cal joints in the metal cladding were sealed with preformed silicone sealant strips. At many locations, these preformed sealant joints had failed adhesively as they aged.

Figure 5. Typical cable enclosure at corners from 2006 conversion.

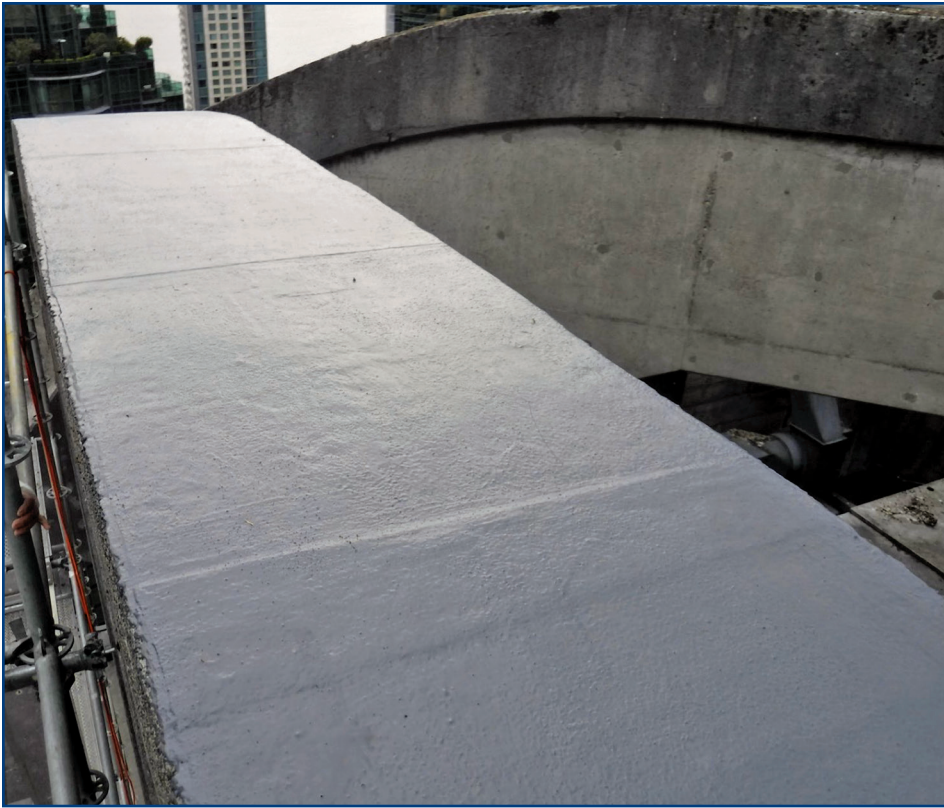
*Figure 6. The horizontal tops of the concrete core and the cable enclosures were finished with a colored coating of polymethyl-methacrylate membrane.*

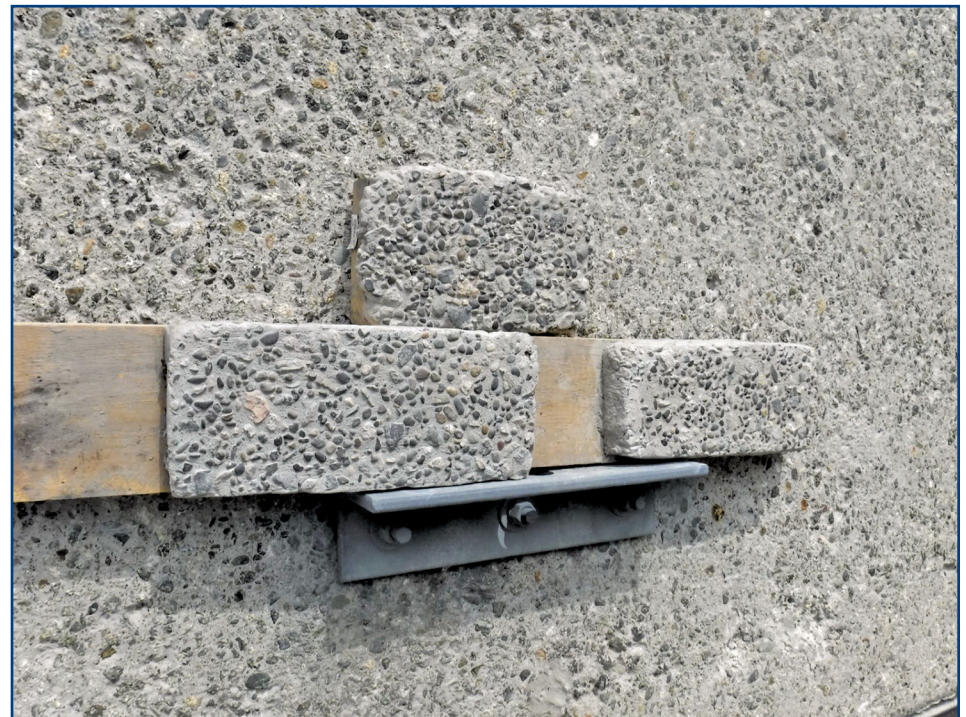
*Figure 7. Careful selection of color additives and aggregate types produced a mixture design that was compatible with the existing concrete.*

The vertical surfaces of the exposed-aggregate concrete walls required targeted concrete repairs to address areas of delamination, spalling, and exposed reinforcing steel. While minimizing the appearance of patched concrete is always challenging, this challenge was compounded by the exposed aggregate finish and variations in the color of the original con-

crete. The two original lifts of concrete used to place the concrete walls had slightly different colors. To accommodate the variances in appearance and achieve a suitable match, the team prepared 12 unique mock-ups with various combinations of color additives and aggregates added to the fiber-reinforced repair mortar (Fig. 7). Before color-matching with the existing concrete began, the walls were lightly washed to remove surface contamination and staining. It was important to establish parameters for the addition of color additives and aggregate types, and this effort involved close collaboration with the manufacturer's technical representative so that the installer could make minor variations in the mixture to best suit the areas that the project team was trying to match.

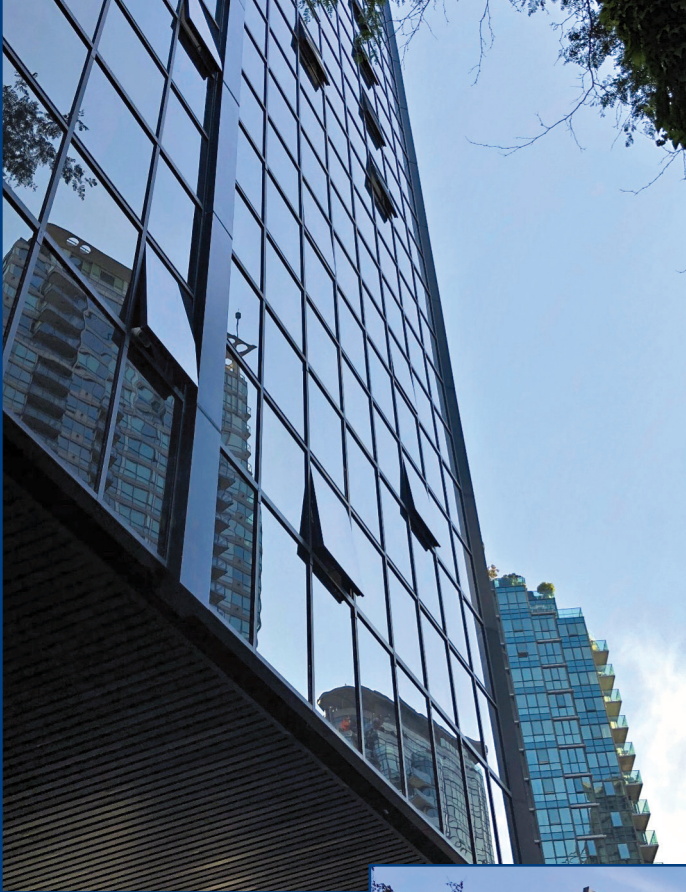
At many locations, there were significant gaps between the sections of vertical cladding covers, including areas where the sealant between cladding covers had failed due to age. These joints in the vertical cladding covers typically occur above each section of spandrel glazing panel.

sitioned and small, prefinished metal-deflection clips were installed. The metal clips were prefinished in a custom color to match the existing curtainwall and installed to ensure deflection allowances were maintained. Custom-colored

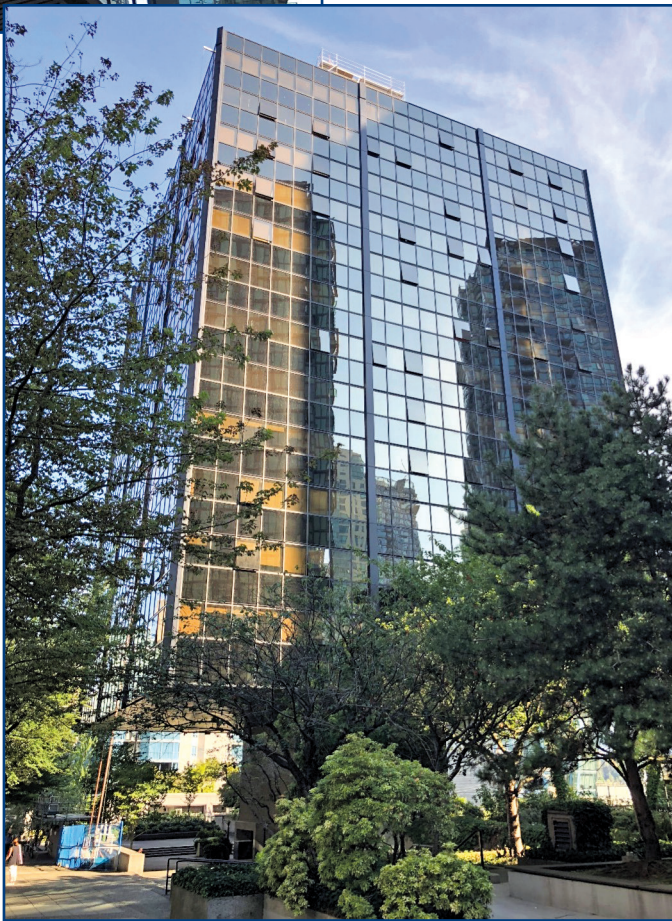
*Figure 9. The Qube after conservation.*

The unique designs and materials of mid-century modern buildings such as the Qube can present considerable challenges to heritage specialists and engineers; however, standard practices apply. A properly implemented conservation project extends the physical life of the building enclosure's existing character-defining elements and helps ensure that the building maintains its historic value for years to come (Fig. 9).
