Remediating Leaks in Below-Grade Structures and Plazas

By Paul Buccellato, AIA, RWC, REWC, FASTM, F-IIBEC

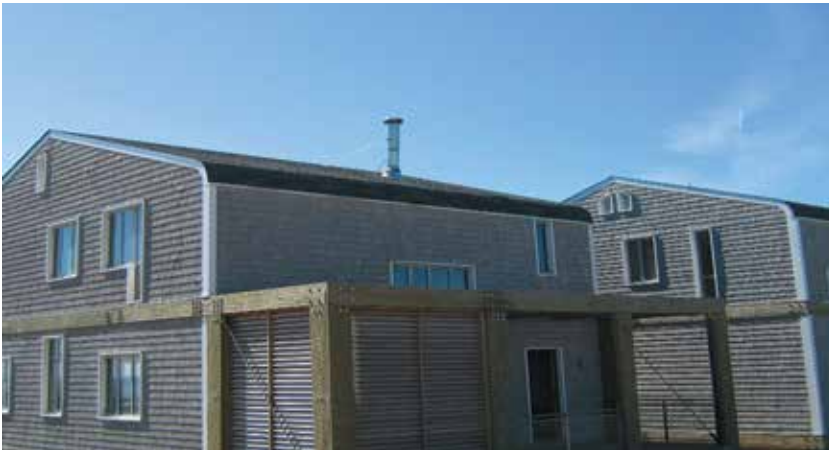
Figure 1. Absence of gutters can cause additional recharging of soil from roof runoff.

- Gutters that are undersized, absent (**Fig. 1**), too widely spaced, or clogged
- Lack of drainage or blocked drainage in areaways or window wells
- Relocation of underground water tables from their normal flow at nearby construction sites

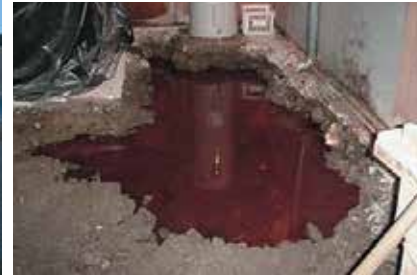
Figure 2. Oil (petroleum) infiltration can be identified by color and odor.

- Oil can originate from a ruptured fuel line or tank (**Fig. 2**).
- Rust stains on the interior of a concrete foundation can come from reinforcing bars attacked by aggressive soil chemicals.

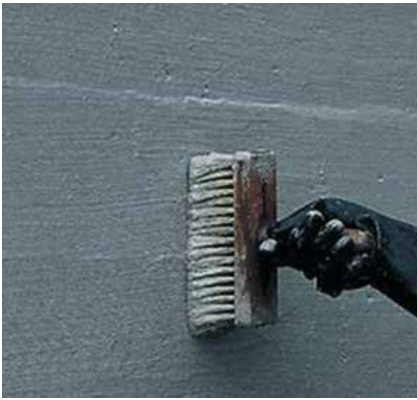
Figure 4. Crystalline waterproofing being applied by brush.

Surfaces must be mechanically abraded to open the pores. Cracks and joints must be routed out at least 1 × 1 in. (25 × 25 mm) and a cementitious mortar forced into them. Surfaces to which the materials are to be applied must be kept moist for 36 to 48 hours after application, or as specified by the crystalline manufacturer. The material can be applied by brush or air spray (Fig. 4). Crystalline waterproofing is typically applied in two coats.

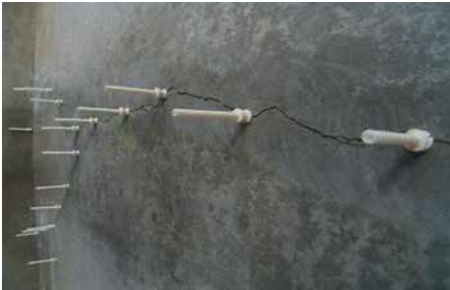
Figure 7. Port installation for epoxy injection.

Epoxy injection requires workers who have the knowledge to select the most appropriate products with the correct viscosity and the skill to apply those products with the proper injection pressure and timing (Fig. 7). Cleaning cracks is crucial where epoxies are injected.

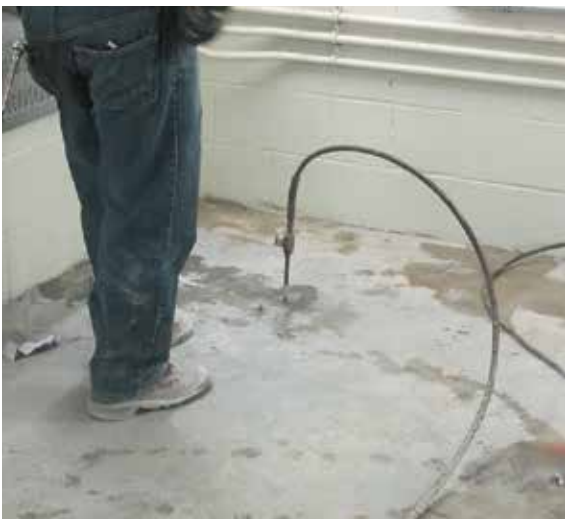
Figure 8. Urethane grout injection at a horizontal concrete slab.

Hydrophilic urethane gels react with water and expand to form a flexible resin that maintains its watertight integrity even during limited concrete movement (Fig. 8).
