Fifty Years of Roof Consulting

By Jim D. Koontz, PE, RRC

This paper was originally presented at the 2023 IIBEC International Convention and Trade Show.

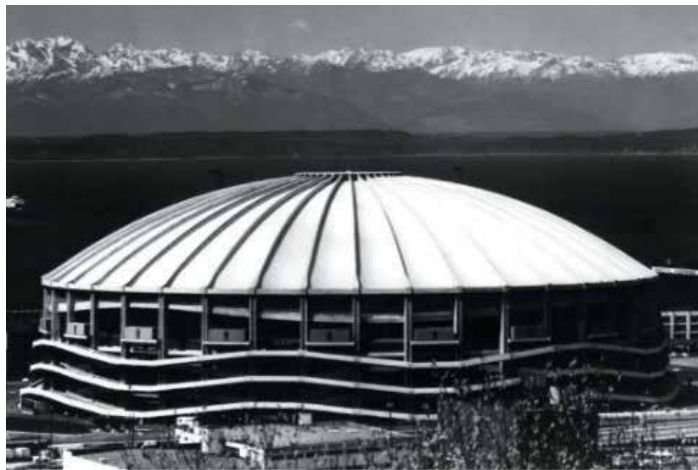
Figure 2. The Kingdome, Seattle, Washington.

REI was retained by the insurance carrier for King County on two different occasions. The first inspection involved a problem with a solvent-based coating applied over a polyurethane foam (PUF) roof also known as spray polyurethane foam (SPF) roof. The roof on the Kingdome consisted of a Tectum panel

covered with reinforced concrete deck that was overlaid with SPF roofing, which was covered with an elastomeric coating (Fig. 2).

Two passes of solvent-based elastomeric coating had been applied over an existing SPF roof in 1993. The first pass of coating had not fully cured prior to the application of the second coating; the cool, cloudy, rainy weather in Seattle may have exacerbated this problem. The second coating did cure.

After the two coatings were applied, birds began to peck at the foam roof. One theory was the birds were getting high on the underlying uncured solvent, like sniffing glue. The peck holes were about an inch in diameter and extended into the polyurethane foam.

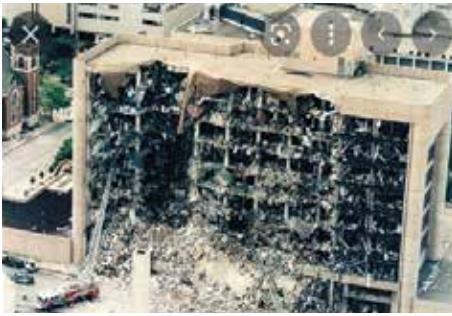
Figure 4. The Alfred P. Murrah Federal Building in Oklahoma City, Oklahoma, after it was bombed.

The Alfred P. Murrah Federal Building opened on March 2, 1977, and was named for an Oklahoma native who was one of the youngest federal judges in US history. I had worked on the building for the GSA. The roof was a ballasted EPDM (Fig. 4).

The blast or shock wave from the explosion blew out windows and doors, resulting in the pressurization of the inside of the buildings. Consequently, roofs and structural decks were uplifted and damaged.
