# PROCEEDINGS

# 2023

# IIBEC

**INTERNATIONAL  
CONVENTION  
& TRADE SHOW**

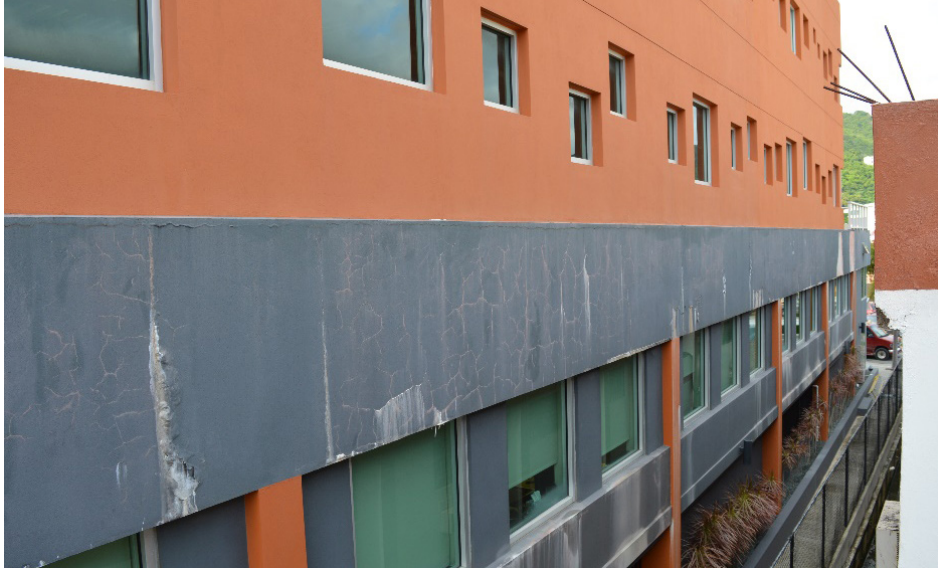
**FIGURE 2. Concrete beam between the first and second floor where metal lath was used with stucco.**

of thumb is to install control joints in the stucco directly in line with control joints on the building. In addition, stucco directly applied to a consistent masonry base usually performs well and minimizes the potential for cracks to develop unless there are bonding issues. In the original design drawings for the Tortola International Pancake House, control joints were shown on the elevation plans for the stucco cladding, primarily at the substrate transition where concrete masonry units were used as infill between the structural concrete floor slabs. The installed stucco system included horizontal reveal joints placed along those areas where materials varied. The building design did not have expansion joints in the structure, and vertical joints shown in the drawings for the stucco cladding were not installed. ASTM C1063<sup>7</sup> states that stucco systems should have joints placed for dimensions exceeding 18 ft (5.5 meters), no panel size should be more than 144 ft<sup>2</sup> (1.4 m<sup>2</sup>), and the ratio of length to width should not exceed 2.5 to 1. At some of the locations on the Tortola Office Building, we observed metal lath behind the stucco and found that it was not continuous. Where the lath was discontinuous, the stucco cladding was continuous but transition details such as reveal joints or accessories for movement were not provided. Application of the stucco over metal lath did not seem to comply with the ASTM C1063<sup>7</sup> requirements, particularly where the concrete beam exists between the first- and second-floor levels (see **Fig. 2**).

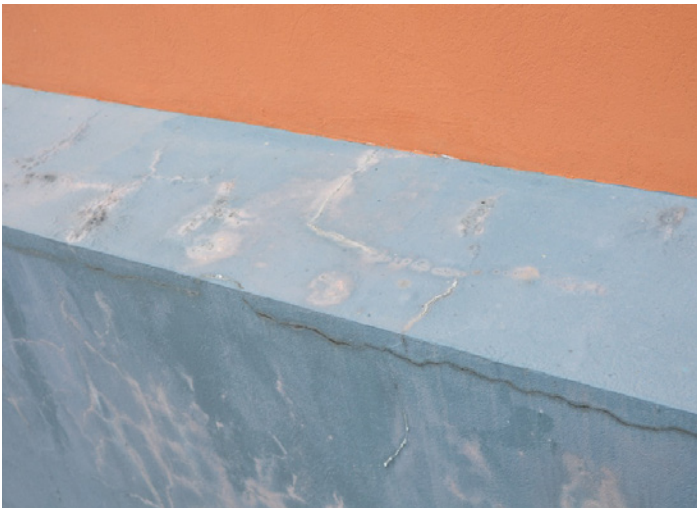
**FIGURE 9.** Stucco on water table is cracked.

application in the water table area was thicker than that at the vertical face. One of the worse areas of observed cracks was located where varying thicknesses of stucco combined with a change in plane at a building corner. Thicker areas of stucco tend to move differently from thinner areas, and the same applies to different planes (**Fig. 9**).

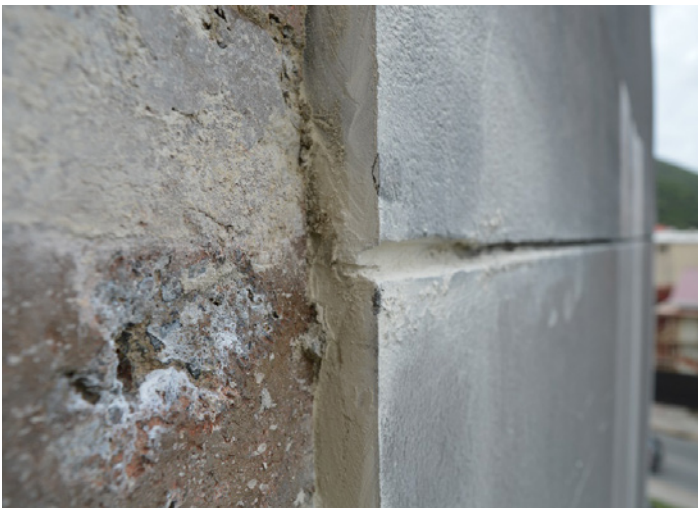
**FIGURE 10.** Destructive opening at a reveal of the stucco. No joint accessories were observed.

pieces with relative ease, indicating that failure was occurring at the bond line. No joint accessory was observed at the reveals. Joint accessories can be used to divide wall areas and control cracking as well as to control the stucco thickness (**Fig. 10**). ASTM C926<sup>6</sup> provides a list of waterproofing materials behind control joints for consideration, as this is where cracking is likely to occur.

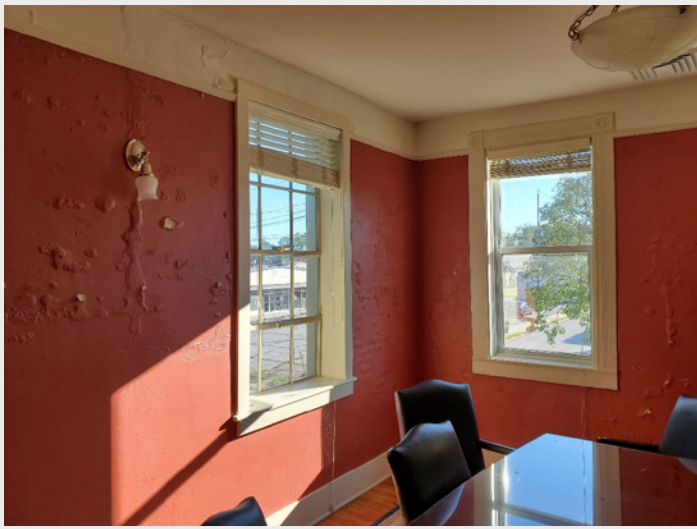
**FIGURE 6. Representative view of unadhered pockets of interior coating with efflorescence behind unadhered coating.**

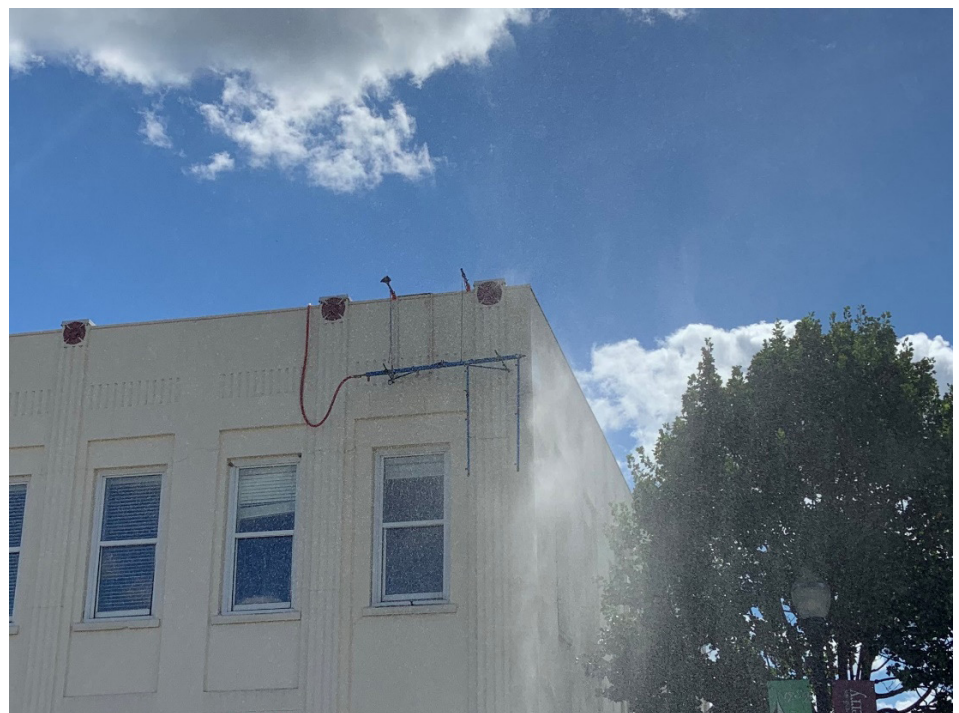
**FIGURE 8. Representative view of Modified ASTM E1105 testing of mass masonry.**

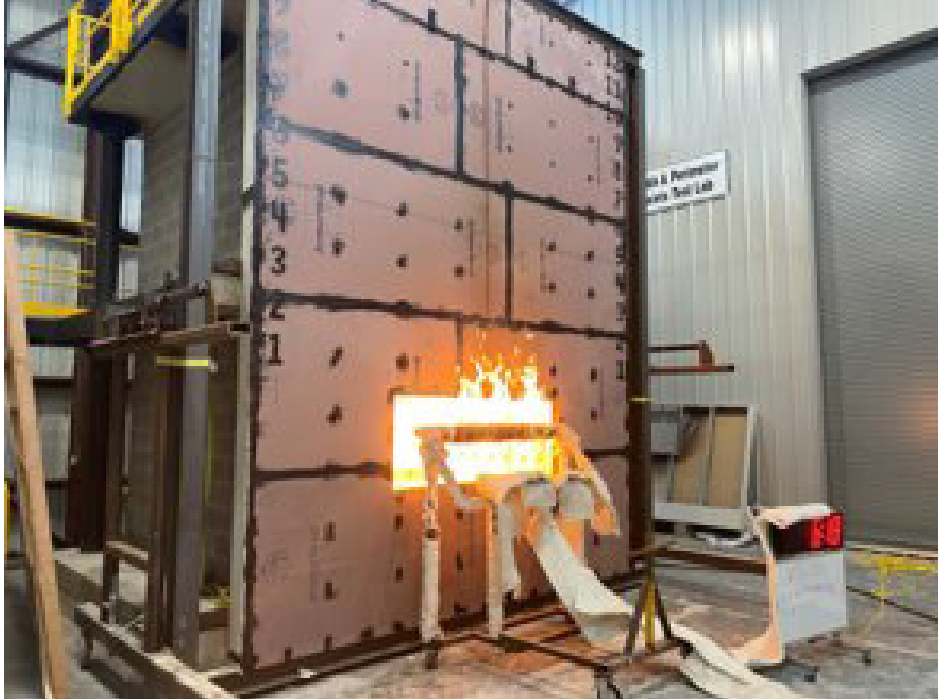
**FIGURE 8. NFPA 285 wall assembly while burning from both the exterior and interior.**

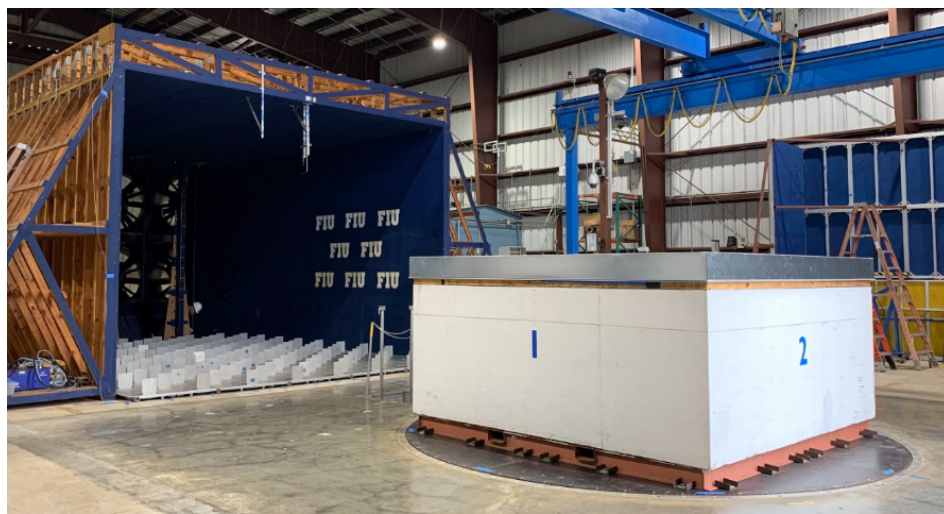
**FIGURE 5: Photo of a test deck in the wind tunnel (inactive).**

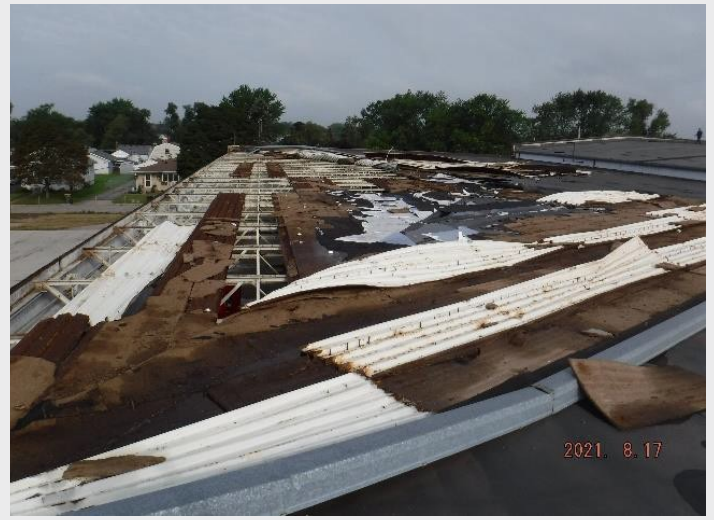
**FIGURE 4. Wind damage in the southwest corner of the roof.**

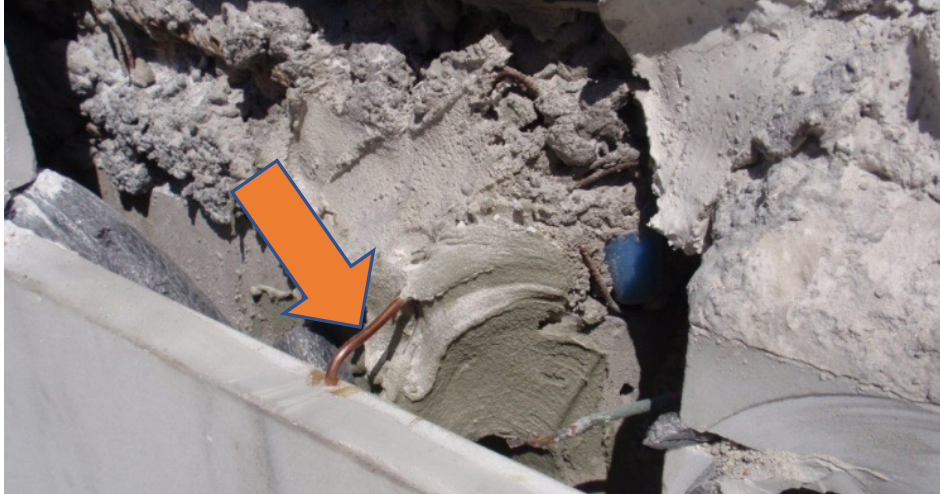
**FIGURE 12. View of copper wire ties originally installed as lateral anchors in combination with mortar spots. Note that the wire tie is installed very close to the inside edge of the panel rather than centered.**

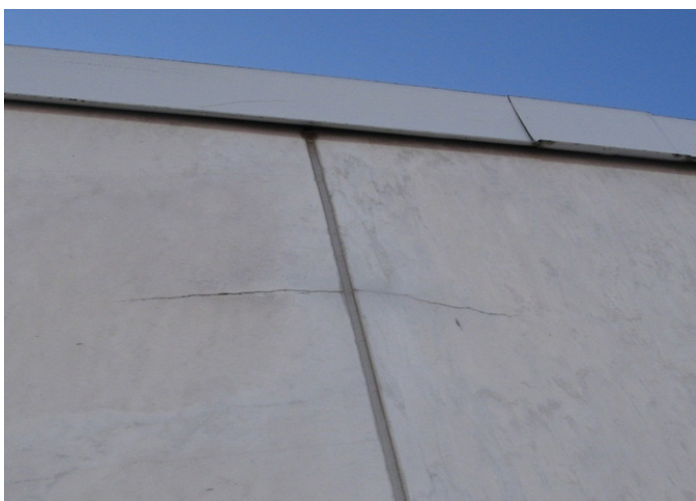
**FIGURE 13. View of typical cracking of panels.**
