Eye in the Sky—Mitigating Facade Access Risks through UAVs' Aerial Imagery

By Kimani Augustine, PE, and Michael Cobb

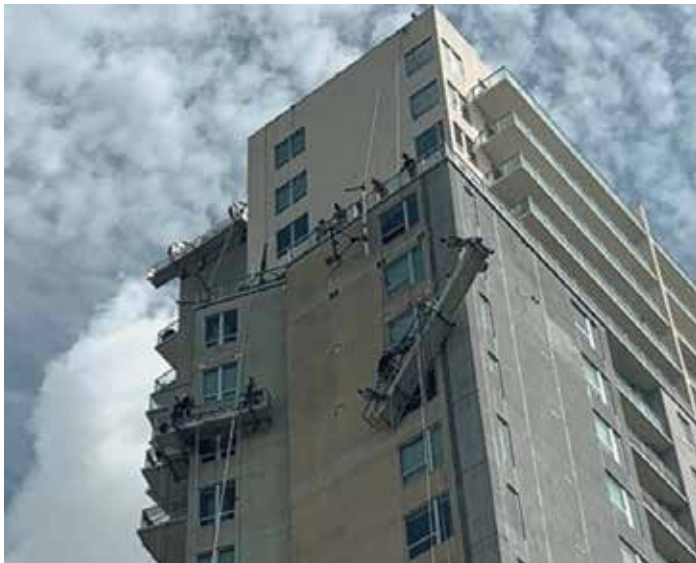
Figure 1. Swing stage collapse in Houston, TX.

includes swing stages, boatswain's chairs, and hung platforms. While suspended scaffolding is a proven and adaptable method of access, this approach still involves strict spatial requirements and other associated risks (Fig. 1). Firstly, according to OSHA general industry standards 1910.140(c)(13)², the roofs must either have the capability for the stage to be anchored to davit arms designed to resist 5 kips (22 kN) of load at the point where the staging steel wires are attached or have enough space and access to install outrigger beams with enough length to ensure that the lever arm can be balanced with counterweights. Secondary fall protection must also be provided by using tieback anchors for not only the staging equipment but also individualized ropes and tiebacks for each worker on the stage. It is also important to note that while suspended scaffolding, if properly operated by trained personnel, can be a relatively safe means of vertical access, there are also inherent potential hazards. One fatality was reported to OSHA in 2021 due to an accident on suspended scaffolding, and three severe-injury reports were noted.³

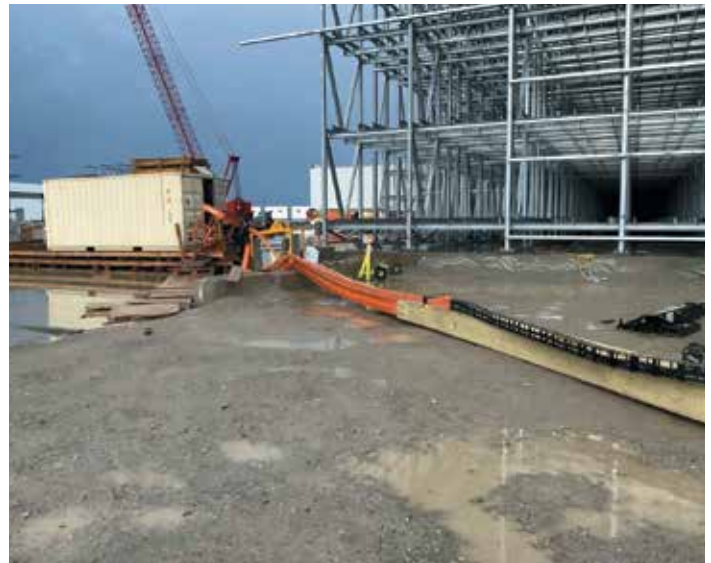
Figure 2. Aerial lift overturning collapse.

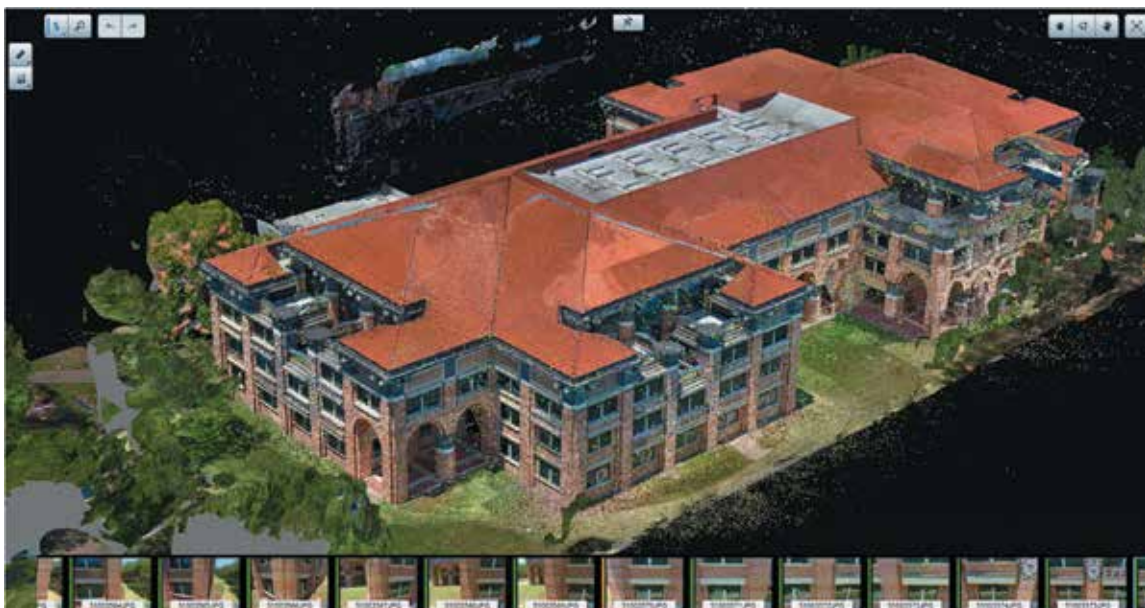
Figure 3. Photogrammetry model of a four-story institutional building from unmanned aerial vehicle imagery.

3-D photogrammetry, alternatively, utilizes a sequenced, overlapping series of photos to systematically document an area or volume. By

overlapping photographs containing identifiable, unique features, photogrammetry enables the recreation of a 3-D model utilizing these unique points to tie the photographs together. Photogrammetry is often utilized in conjunction with light detection and ranging (LIDAR) to create accurate scale models of buildings while also capturing detailed photographic data of the building.

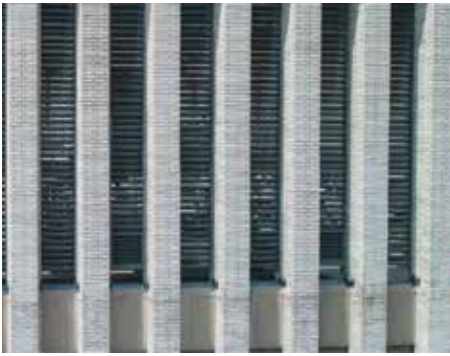
Figure 4. Aerial imagery of the exterior of a masonry-clad parapet.

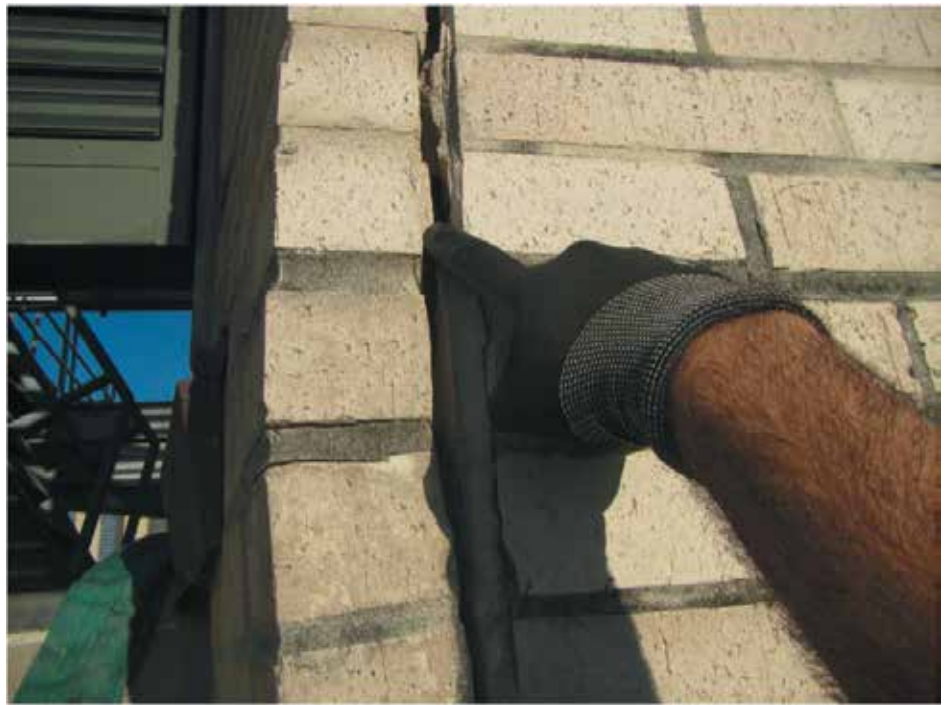
Figure 5. Arm's-length review of noted parapet distress.

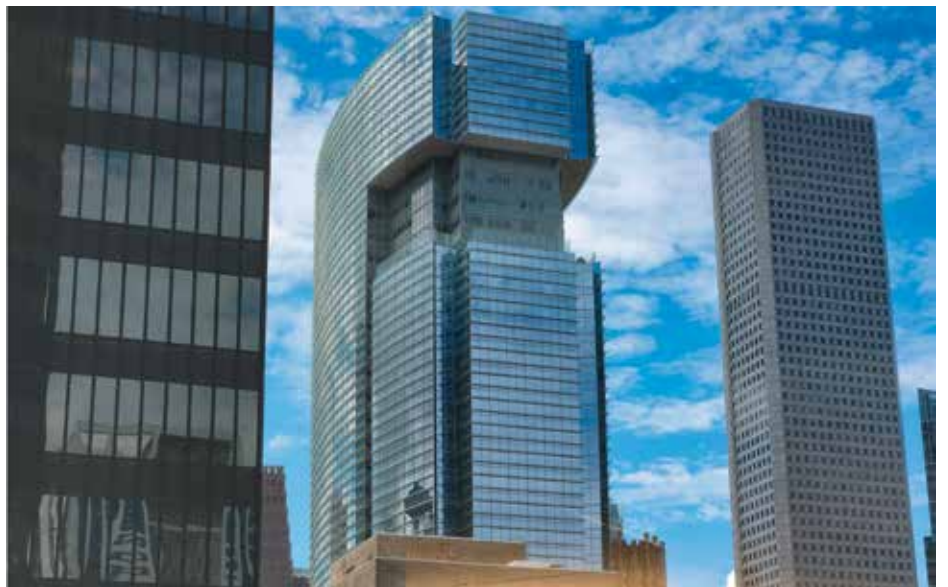
Figure 6. High-rise building with elevated atrium and glass sunshades.

Another area where UAV imagery provides a cost and safety advantage to owners and maintenance teams is in buildings with complex geometry. Buildings with elevated atria and curved surfaces provide challenges to traditional access methods designed to be deployed from roofs and ascend vertically or to be accessed from the ground level. For more contemporary architecture, UAV imagery thrives. However, as architecture becomes less ortholinear, traditional means of two-dimensional field notes become increasingly challenging to capture individual elevations and the use of 3-D models for field documentation becomes critical. Meanwhile, these complex shapes are often challenging or not viable to access using suspended scaffolds or aerial lifts and are often uneconomical to access via traditional fixed scaffolds. These risks can come from elevated atria with protruding architectural features (Fig. 6), multiple atria with limited roof access to these locations,

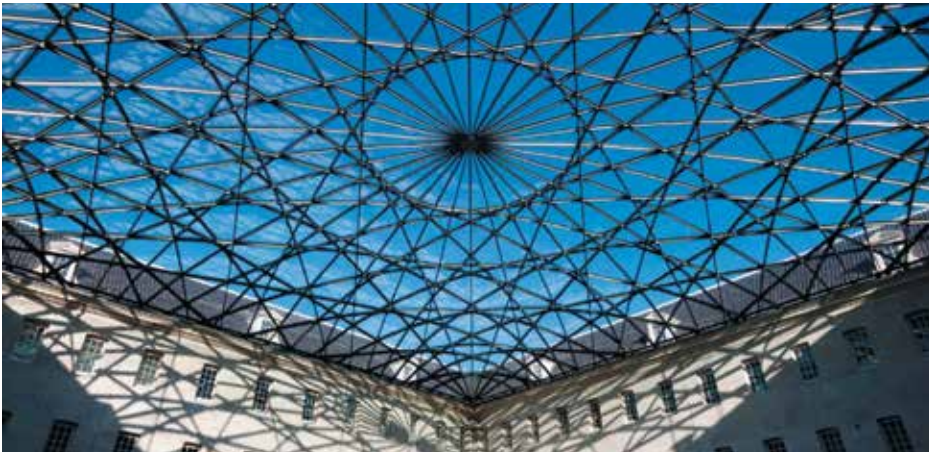
Figure 7. Nonstandard grid shell at Het Scheepvaart Museum in Amsterdam, The Netherlands.

cantilevered enclosures, or large spanning glass roofs with irregular framing (Fig. 7). Historic buildings also pose unique opportunities for the utilization of UAV imagery. Historic buildings often have limited roof access and roof capacity, tall cupolas or spires, or large cornices often with limited access to the facade around the buildings (Fig. 8).

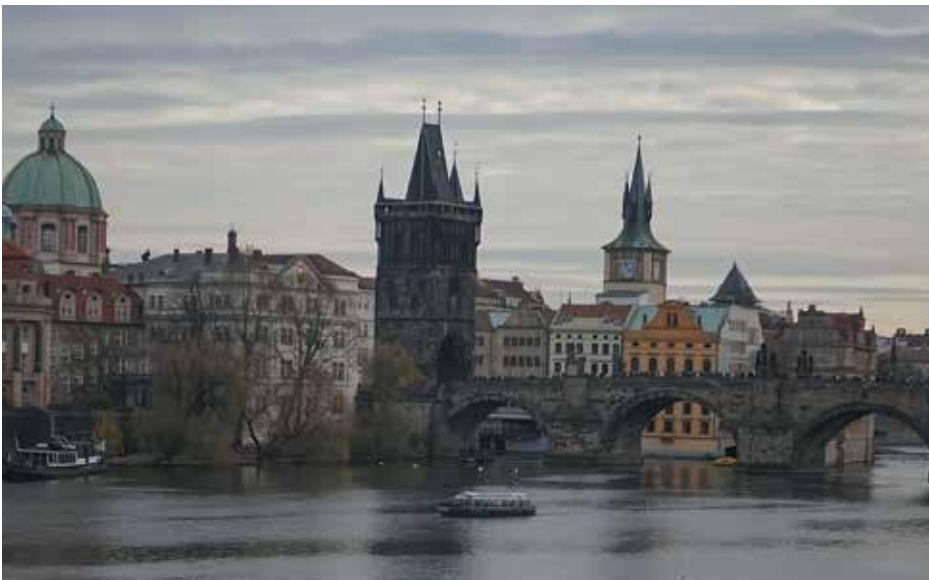
Figure 8. Medieval bridge tower over a river with limited roof access, in Prague, Czech Republic.

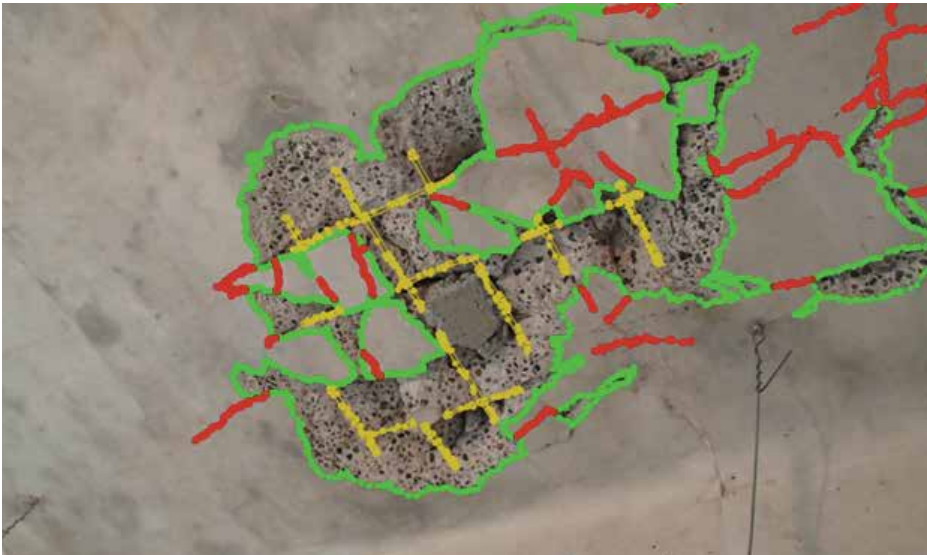
Figure 9. Automatic edge detection of spalling, cracking, and exposed reinforcement in concrete.

The latest optimization in the workflow process is the use of machine learning to detect distress in building materials, such as reinforced concrete, using photos. Vision-based automated crack-detection software for using deep-learning algorithms has recently moved from the academic to the enterprise space. Commercial off-the-shelf software is openly available for use, while engineering services companies have begun to offer bespoke systems focused on concrete crack and spall detection (Fig. 9).⁷ With an accuracy of greater than 70%, automated crack detection can reduce the time for the visual review of cracks by up to 85%.⁸
