# Adequate Ventilation of Low-Slope Roof Systems: The Need for Better Understanding and Guidance

By Domenico D'Amato, Eng.;  
Antonio Renzullo, Eng.; and  
Domenic Chiovitti, Eng.

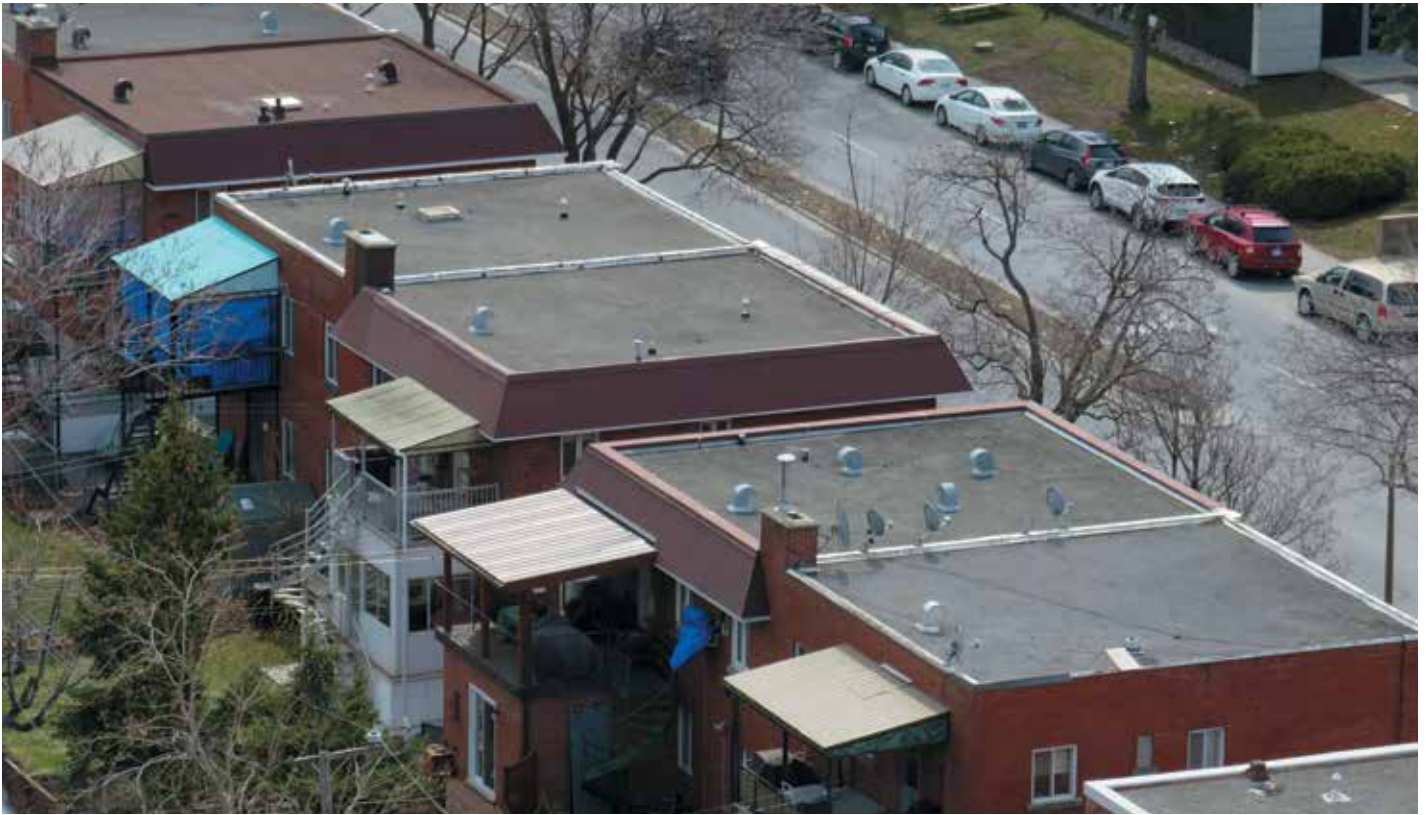
**Figure 1.** Various roof ventilation strategies employed for similar roofs in the Villeray/Parc-Extension borough of Montreal.

As shown in **Fig. 1-3**, the sides of many buildings on the island of Montreal are attached to other properties. In many cases, the adjacent properties use different ventilation strategies. Given these differences, it is important that

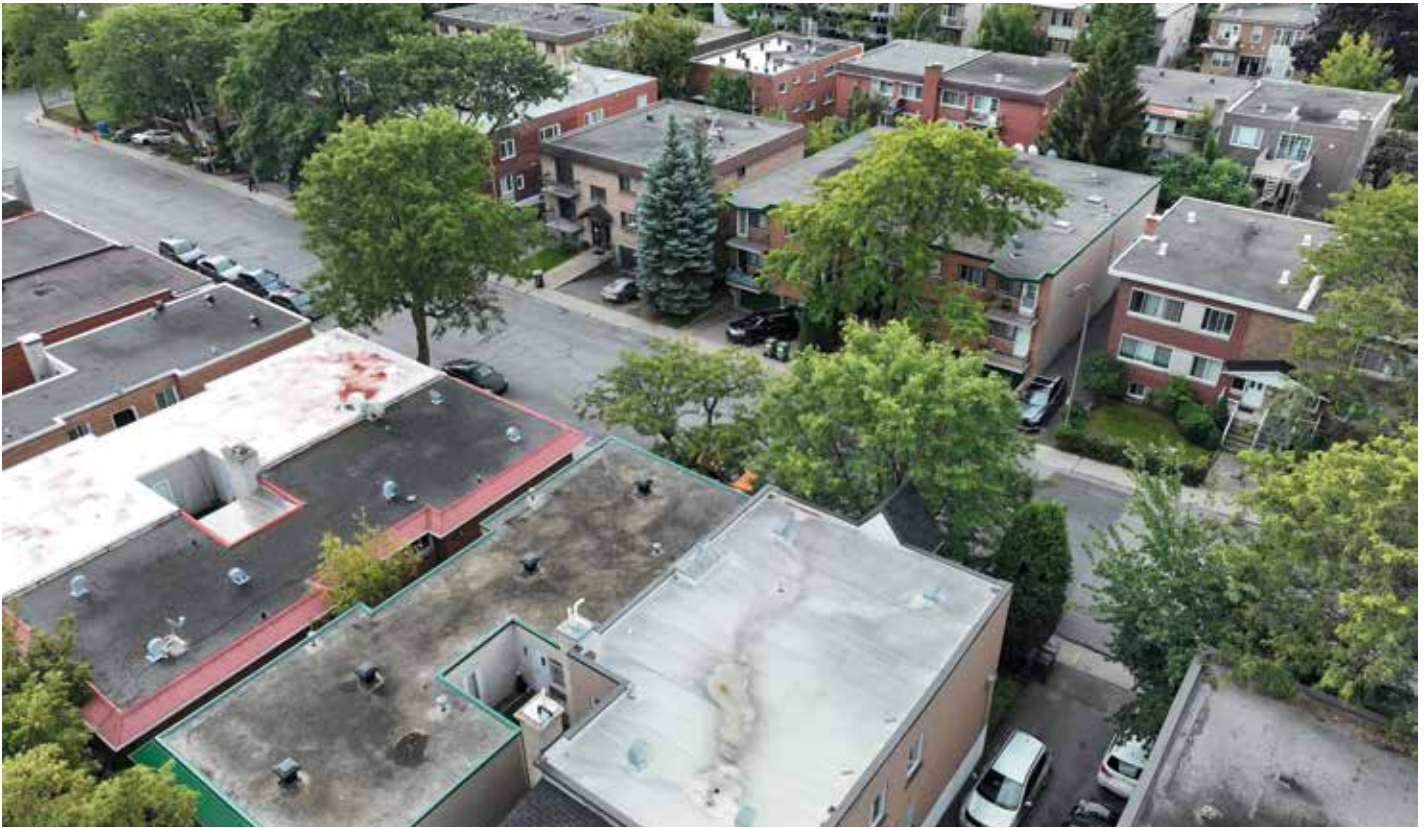
**Figure 2.** Various roof ventilation strategies are employed for similar roofs in the Notre-Dame-de-Grace borough of Montreal.

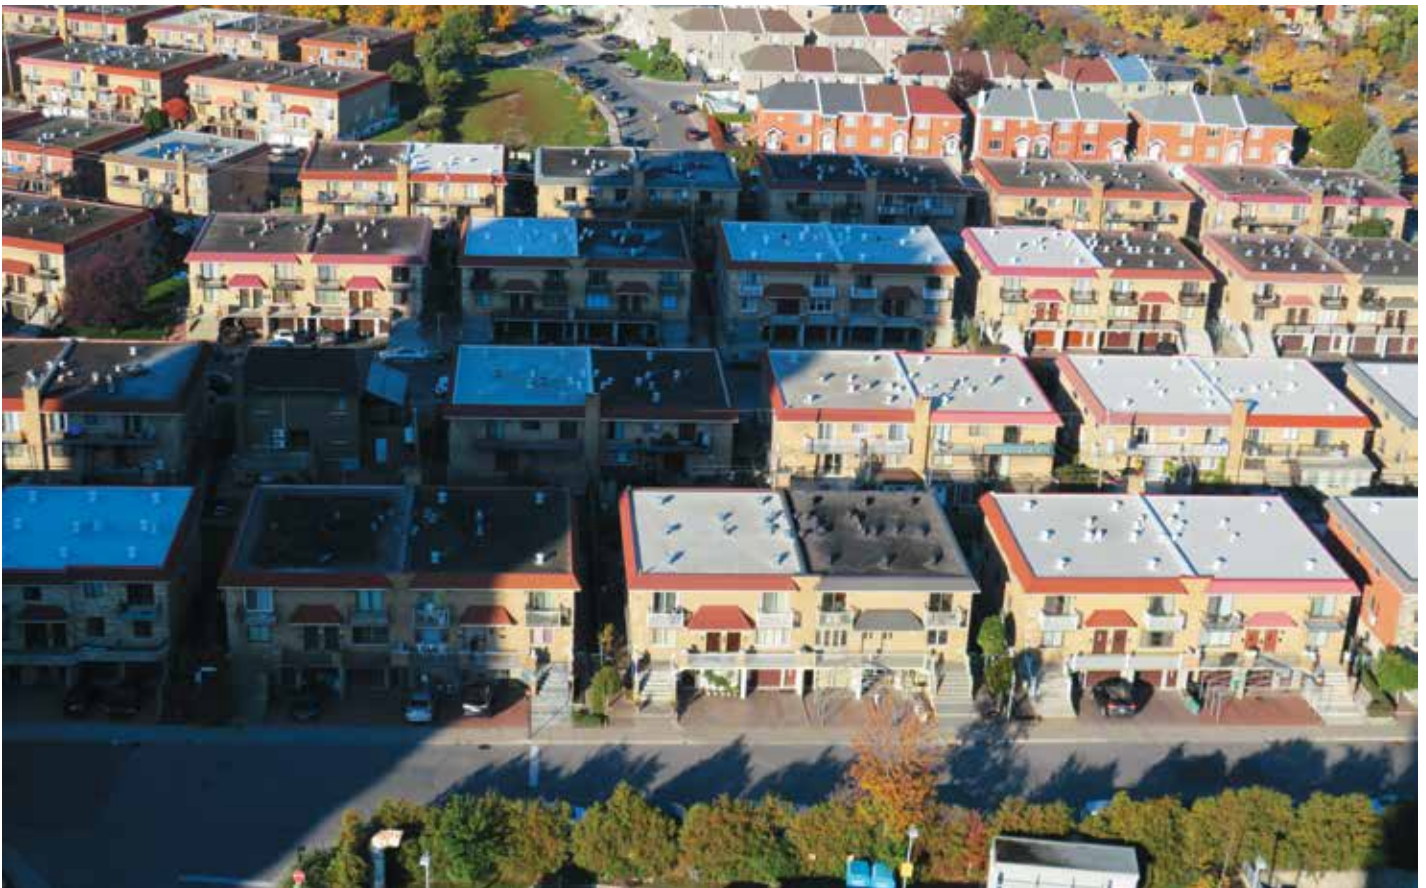
**Figure 3.** Various roof ventilation strategies employed for similar roofs in the Ahuntsic-Cartierville borough of Montreal.
