Fenestration Replacement: Identifying Design Solutions for Existing Buildings

By Scott Bondi, PhD, PE, LEED AP;
Leonidia M. Garbis, PE, LEED Green
Associate; and Michael Colella

This paper was presented at the 2023 IIBEC Building Enclosure Symposium.

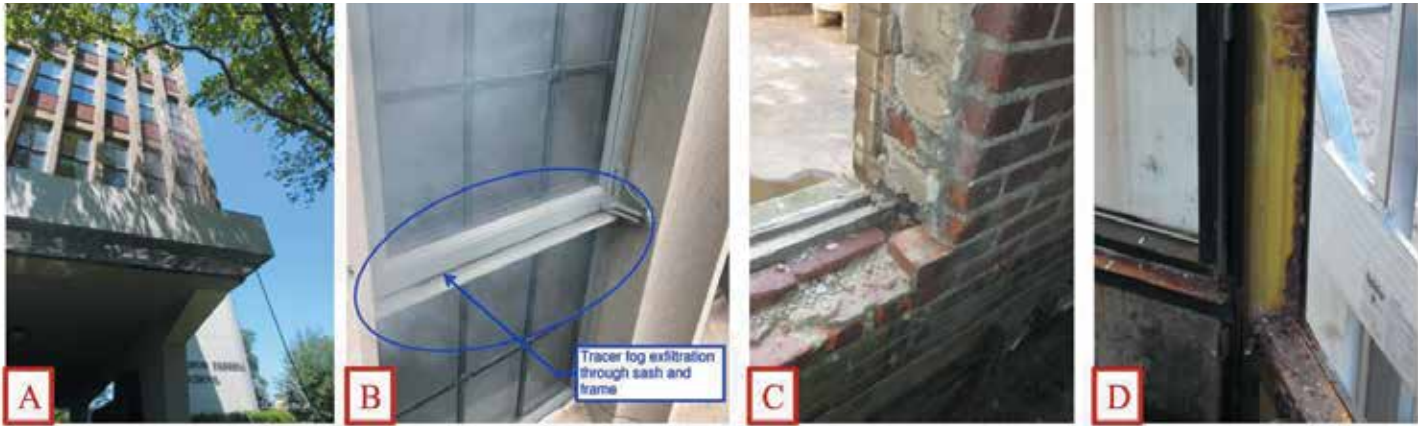
Figure 1. Invasive and noninvasive investigative procedures. (A) Water testing; (B) Tracer fog air infiltration testing; (C) Invasive opening at masonry; (D) Invasive opening at steel framing.

Identifying air drafts or water leaks within a fenestration unit is crucial to pinpoint issues with the fenestration or its interface with the adjacent wall assembly. Field investigations can be instrumental in determining the location and severity of such leakage. The methods used in such investigations can be classified as noninvasive or invasive procedures (**Fig. 1**).

ASTM E783² and ASTM E1105³ present noninvasive methods that can be used to measure air and water leakage, respectively (Fig. 1A), without disturbing existing conditions. Techniques such as tracer fog (Fig. 1B) or pressurization can identify the source of leakage from either the fenestration unit itself or the adjacent wall assembly.

Invasive field investigations offer detailed insights into structural conditions surrounding fenestration units. Invasive investigations can also be essential to understand how the existing building was constructed (Fig. 1C and 1D). Many older buildings do not have the same level of construction documentation that is expected of a modern construction project.

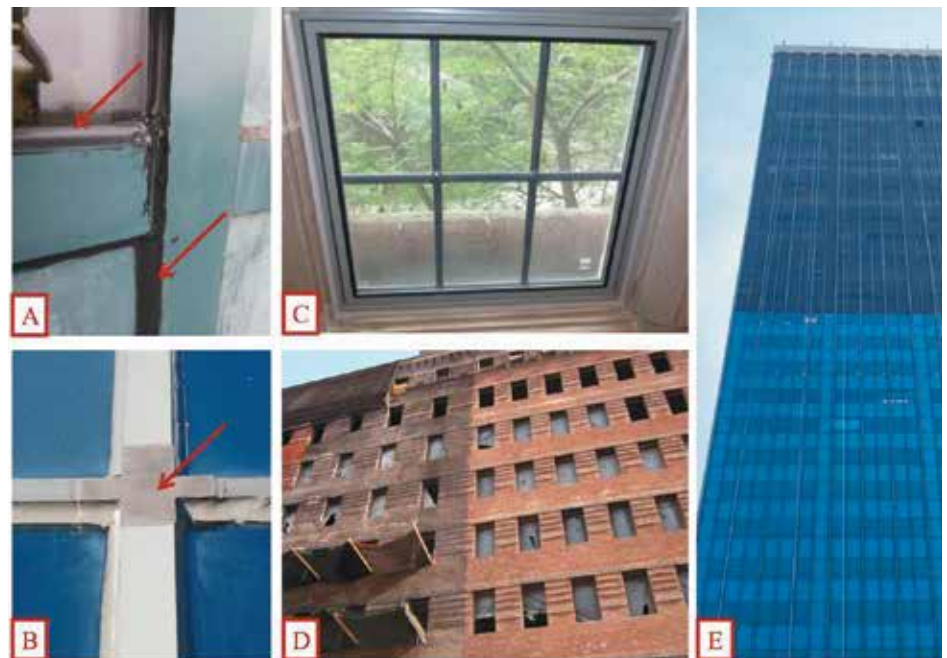
Figure 2. Design options for remediating fenestration issues. (A) New sealant joints; (B) Silicone sheet patches; (C) Storm window installation; (D) Window replacement; (E) Overcladding with curtainwall system.

In certain cases, modifying existing fenestration can be a more practical option than complete replacement. Storm windows, whether installed externally or internally, may offer a viable solution for underperforming windows (Fig. 2C). They add an additional layer of glazing, improving thermal and acoustic performance without removing the existing system. This

Fenestration replacement provides an opportunity to start with a new, warranted system that can be properly integrated with the surrounding wall system (Fig. 2D). Improvements may include an effective air and water barrier, reduced air leakage, and enhanced thermal and acoustical performance. However, fenestration replacement brings its own challenges, such as the need to remove existing components and, especially for older buildings, the presence of

Overcladding is an alternative to replacement that is often used in older high-rise office buildings with curtainwall systems (Fig. 2E). It provides an opportunity to renovate the building's appearance while simultaneously achieving performance improvements. The overcladding process, which typically necessitates a custom design approach, involves placing a facade system outboard of the existing facade system, possibly requiring new anchorage back to the primary structure. Vision areas, louver areas, and spandrel areas can be incorporated into the design. This approach is often used to minimize disruption inside the building by using the existing facade as a temporary weather barrier and means of occupant protection during construction. Existing attachments and framing members may need to be worked around during the process. The project team has an option to keep or remove the existing facade in the final configuration depending on how the system is designed. Overcladding may appeal to owners because it may allow for maintaining partial occupancy inside the building during the work—a crucial factor for the owner's revenue.

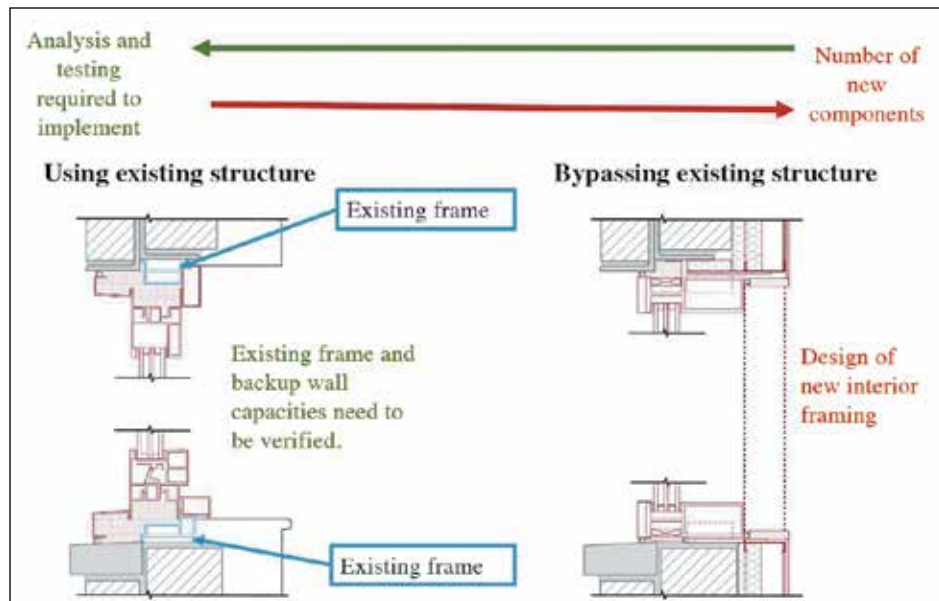
Figure 3. Considerations when interfacing a replacement fenestration system with an existing building.

One of the greatest challenges with a replacement fenestration system is how to best integrate it into the existing building (Fig. 3). Manufacturers' instructions and performance testing data are often available for fenestration systems. However, that information will not be specific to the particular project underway, so the designer will need to produce project-specific details to ensure the integration is effective.

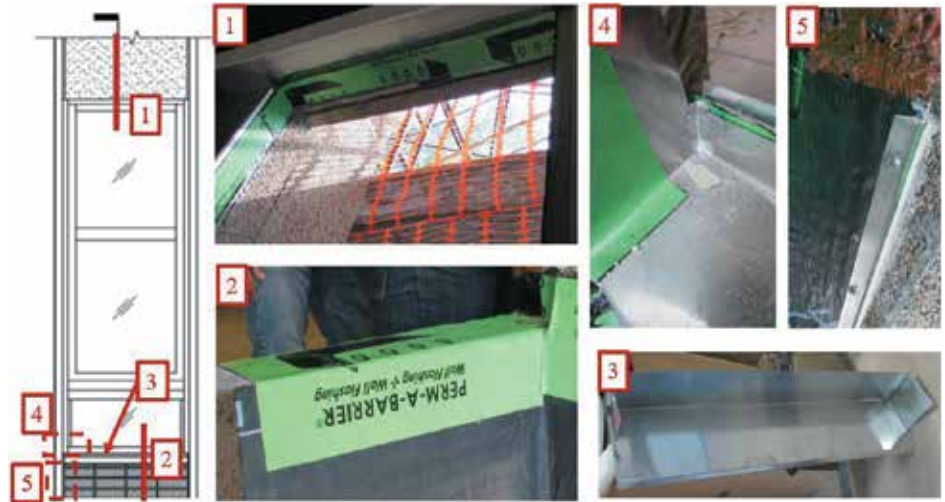
Figure 5. Perimeter waterproofing detailing. (1) Install perimeter waterproofing flashing membrane; (2) Lap sill waterproofing flashing membrane onto cavity wall waterproofing membrane; (3) Form sill pan flashing with fully soldered upturned end dams; (4) Lap jamb waterproofing flashing membrane into sill pan flashing; (5) Install termination bar along the edge of the wall waterproofing membrane.
