IIBEC International
Convention & Trade Show

MARCH 8-11
2024
PHOENIX

PROCEEDINGS

A Deep Dive into Hail-Caused Dents: A Study of Corrosion Resistance within Dents in Galvalume-Coated Steel Roof Panels

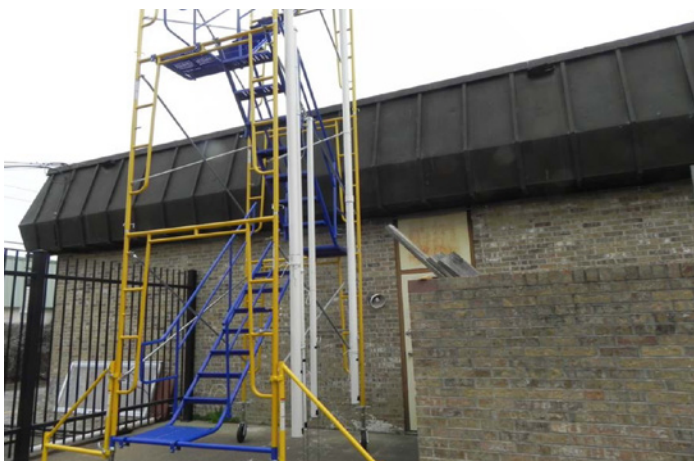
locations of the impacts were circled and noted on the panel. **Figure 2** shows the tower used to drop the steel balls and a view of a typical panel after the UL 2218 impact testing (in this case, the impacts shown were from 1.25- and 1.50-inch steel balls dropped from a height calibrated to approximate the energy of 1.25- and 1.50-inch hailstones).

FIGURE 2. Test apparatus.

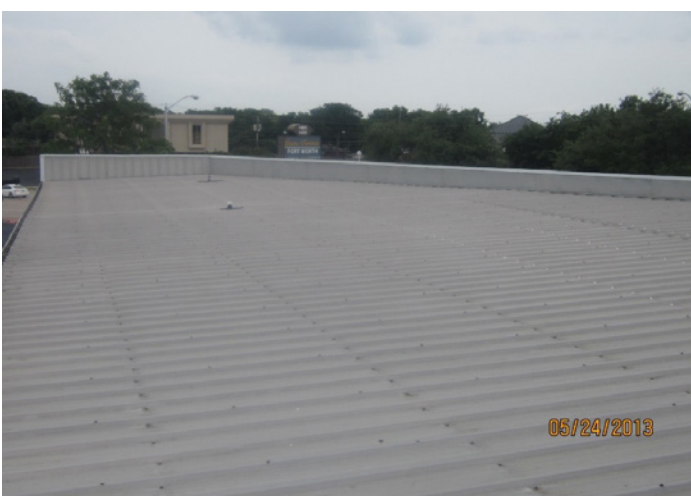
FIGURE 9. Photograph of the case study roof taken in 2013, approximately 18 years after the hail event, when the roof was 27 years old.

The building that is the subject of this case study is a one-story strip shopping center built in 1986 and located on the east side of Fort Worth. The general construction consists of a slab-on-grade foundation with pre-engineered metal building framing and a 26-gauge Galvalume steel R-panel roof. The roof panels were attached to Z-purlins approximately 5 feet apart using screws with rubber washers. There were stitch screws at the side laps approximately 24 inches on center.

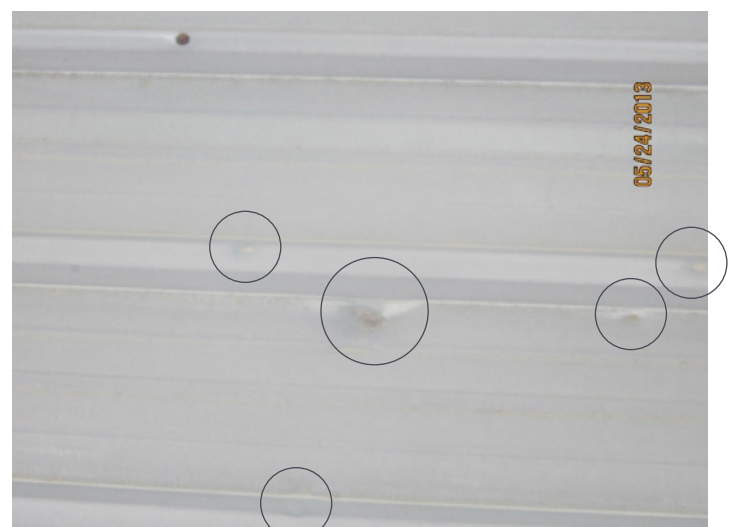
FIGURE 10. Photograph of the dents in the case study roof caused by the Mayfest Storm.

Numerous hail-caused dents were visually examined, including examination at 10x to determine if there had been any deterioration as a result of the hail-caused dents.

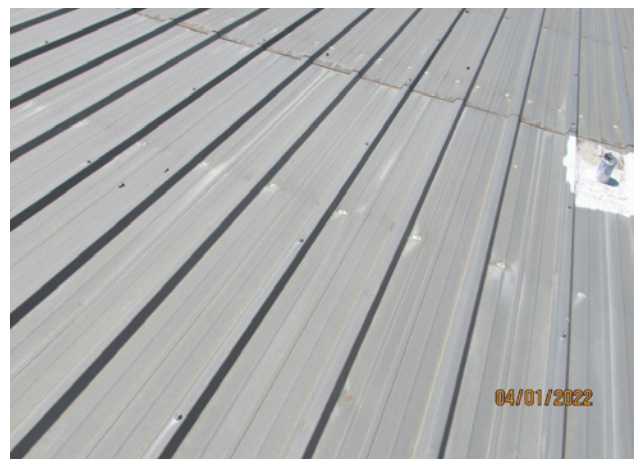
FIGURE 14. Photograph of case study roof taken in 2022 approximately 17 years after the Mayfest Storm.

Again, numerous hail-caused indentations were visually examined and

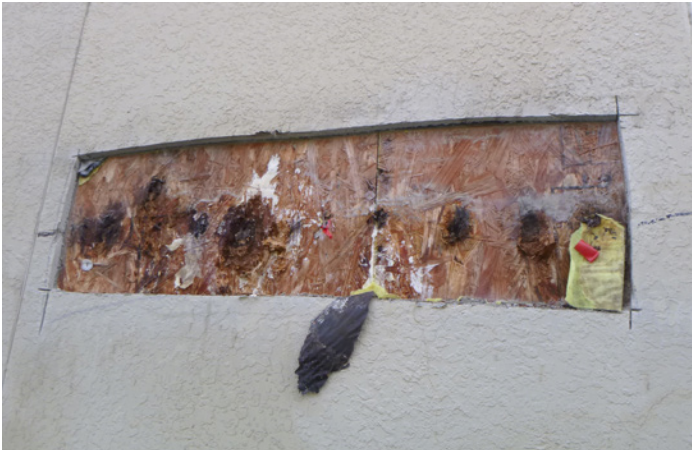
FIGURE 1. Example of damage resulting, at least in part, from fasteners installed between framing members.

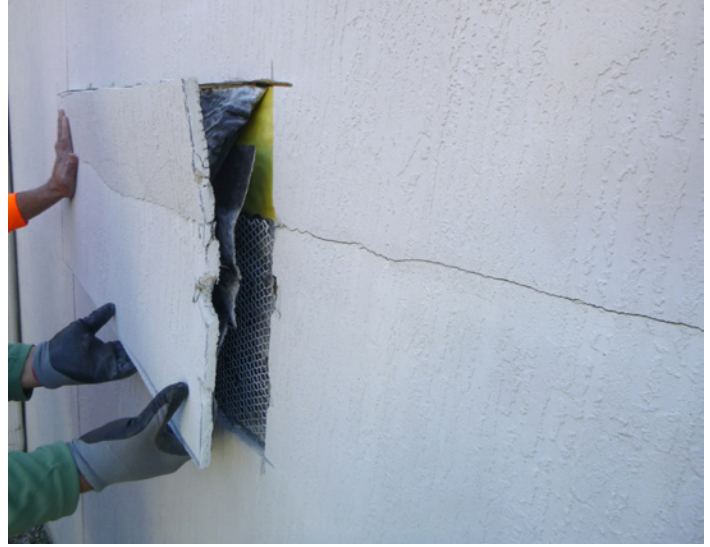
FIGURE 2. Example of damage resulting, at least in part, from lath not installed backing on backing and metal on metal.

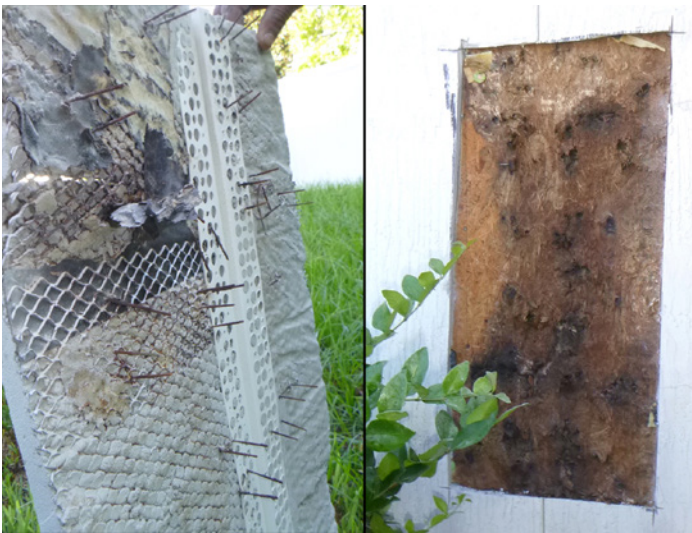
FIGURE 3. Example of damage resulting, at least in part, from the fastening down of the control joint accessory.

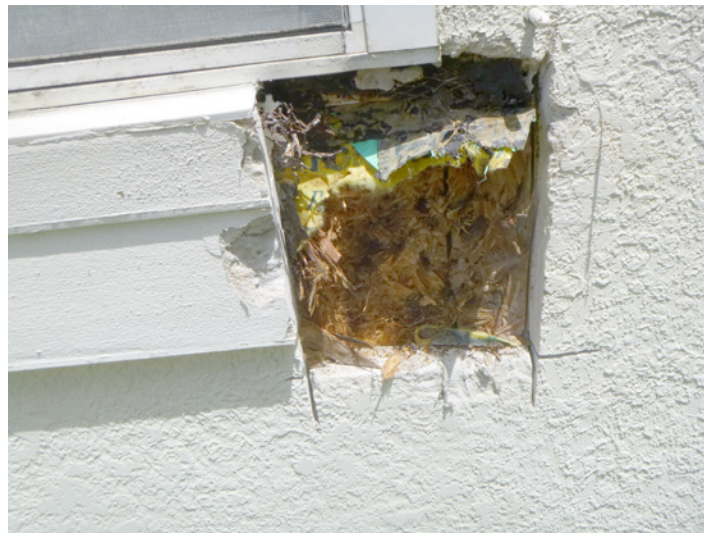
FIGURE 4. Example of damage resulting, at least in part, from improper separation between window and stucco.

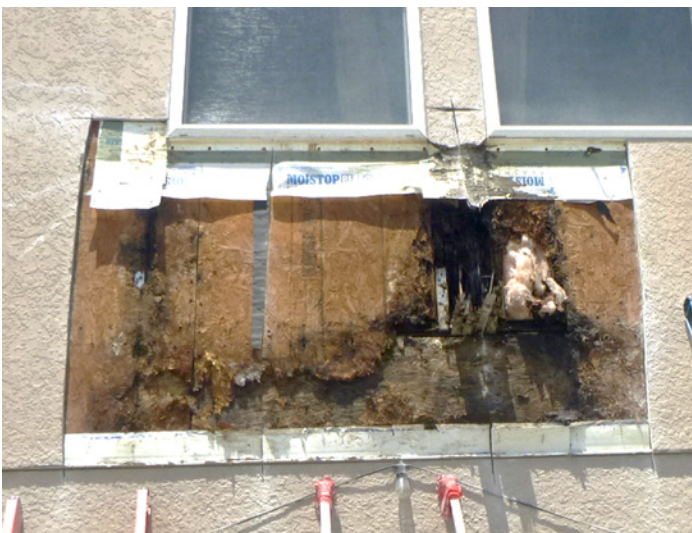
FIGURE 5. Example of damage resulting, at least in part, from improper separation between window and stucco.

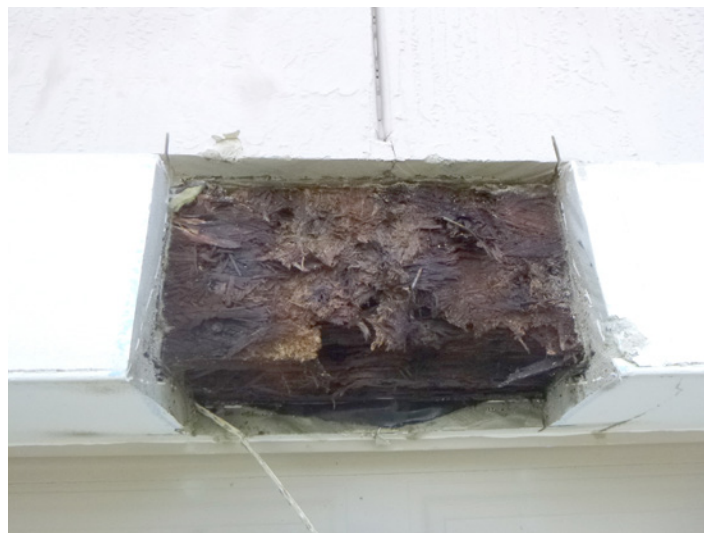
FIGURE 6. Example of damage resulting, at least in part, from a missing weep accessory at the horizontal-to-vertical intersection.

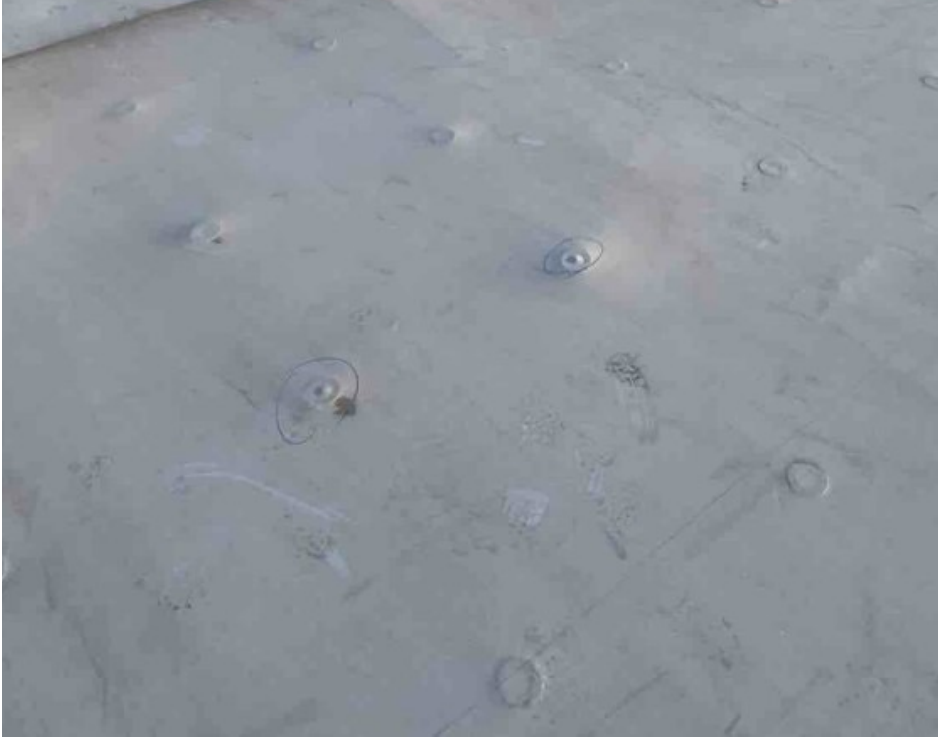
Observations of fastener withdrawal include multiple groupings of 20 to 50 fasteners per membrane lap and frequently the first 3 to 5 fasteners at the leading edge of the perimeter “finger” enhancements. It is

FIGURE 1. Extensive fastener withdrawal with no corresponding wind event.

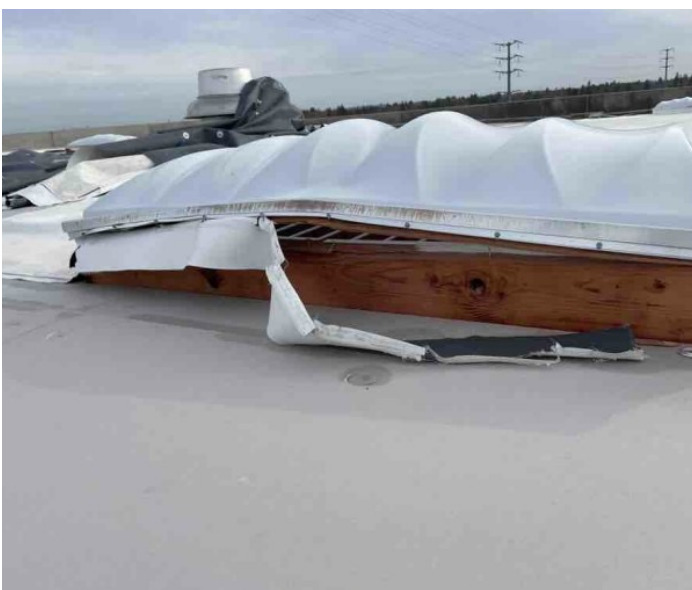
A 3,900-square facility in North Central California was documented with skylights, HVAC, and various smaller curbs separated from the deck (**Figs. 2 and 3**). The membrane did not appear to cause this damage. Holes were observed in the OSB decking at numerous locations as if internal pressure had pushed through it. Backed-out fasteners were observed not at the perimeter or corners where pressures are highest but rather in the field of the roof.

FIGURE 2. Curb and skylight separation from the deck.

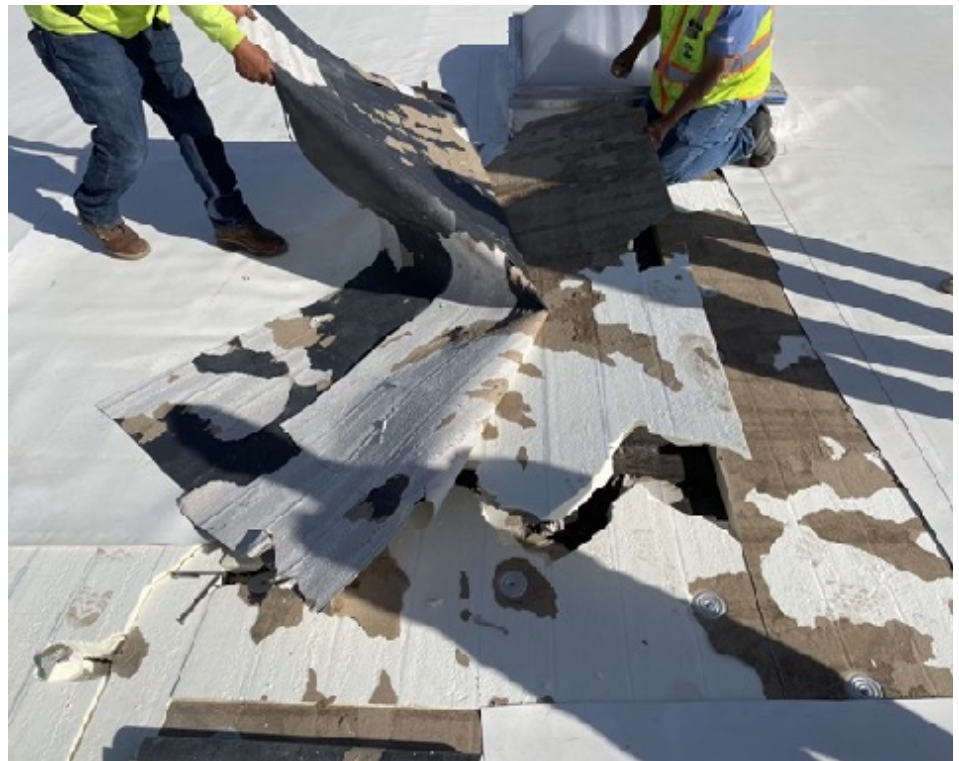
FIGURE 5. Fractured ISO with fasteners and membrane intact.

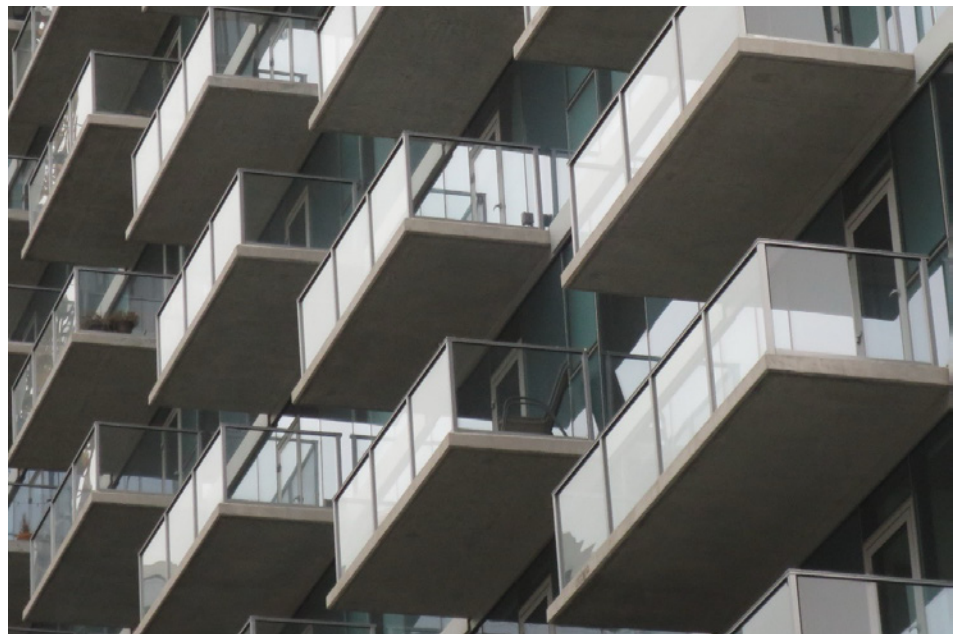
FIGURE 4. Concrete-Frame Balconies Cantilever Beyond the Building Exterior Wall.

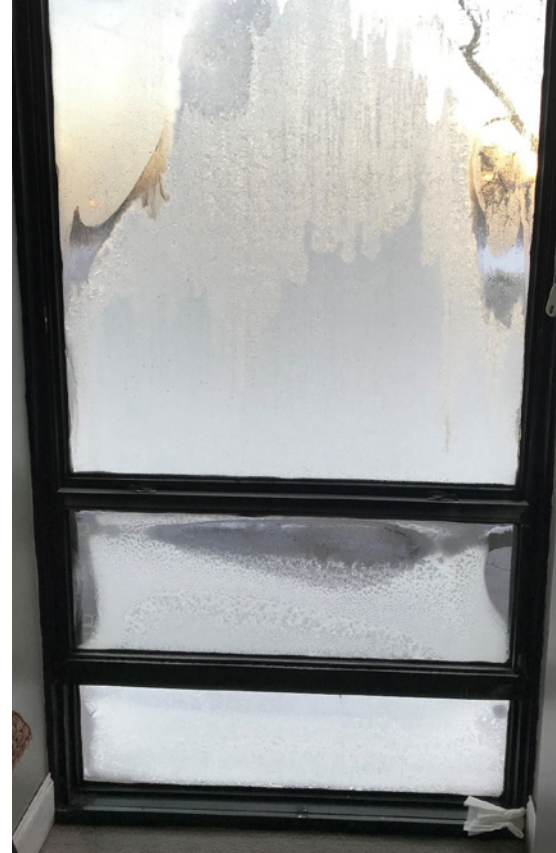
FIGURE 5. Condensation at a Concrete-Frame Building in a Cold Climate

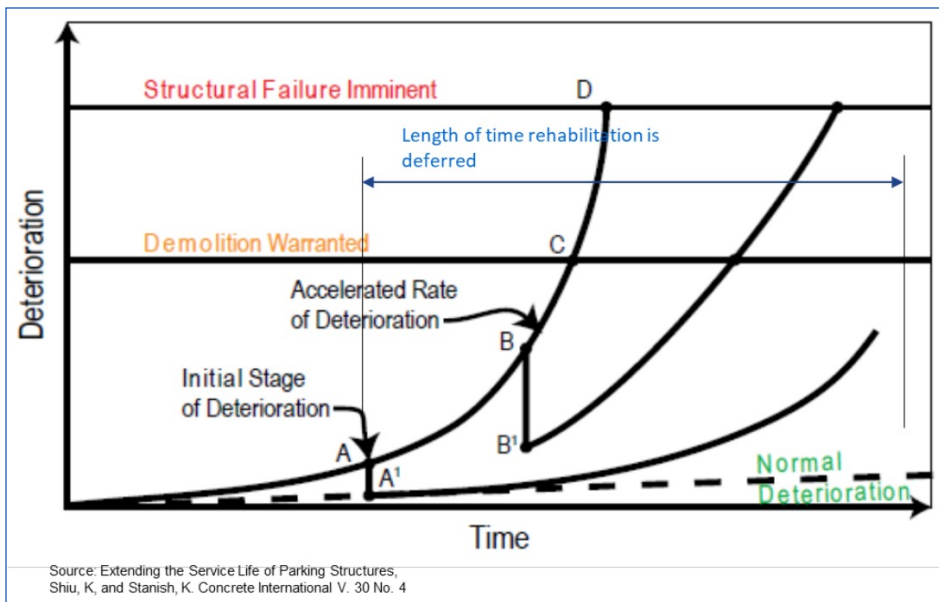
Though concrete high-rise buildings are often designed for long service lives, deterioration will occur due to various environmental factors. Concrete durability is defined by the American Concrete Institute (ACI)²⁰ as "the ability ... to resist weathering action, chemical attack, abrasions, and other conditions of service." Properly designed and constructed concrete structures are resistant to most natural environments; however, they can be exposed to conditions that initiate chemical and/or physical deterioration mechanisms. Following the onset of initial stages of deterioration, the deterioration tends to accelerate exponentially over time.²² Due to these factors, even the most durable concrete structures require periodic evaluation and routine maintenance throughout their design life to ensure safety and functionality. If maintenance and repairs are deferred indefinitely, structural failure can occur (**fig. 6**).

FIGURE 6. Schematic Representation of the Relationship Between Deterioration and Time of a Concrete Structure Exposed to Environmental Factors.

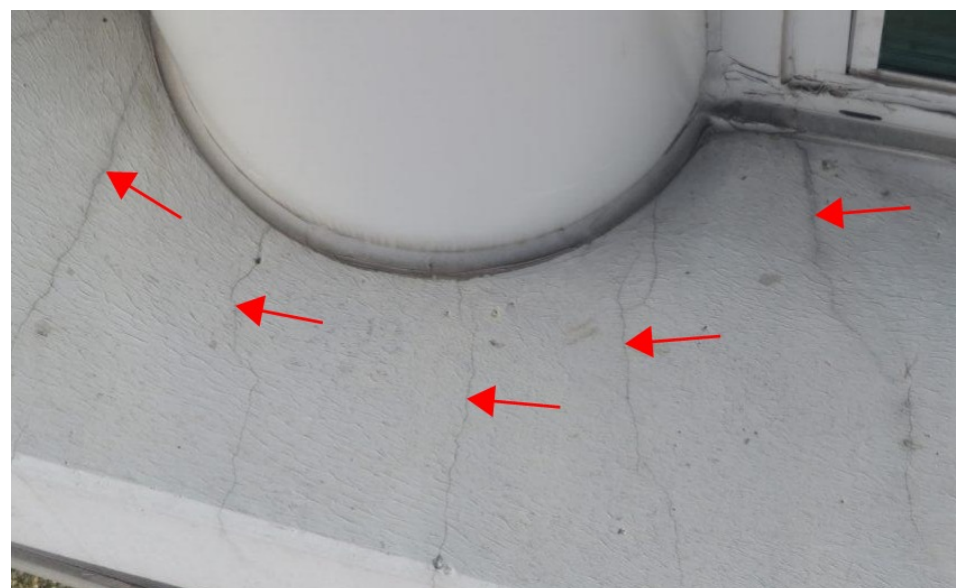
FIGURE 8. Cracks at Concrete Skyward-Facing Surface Extend Below Sealant Joints.

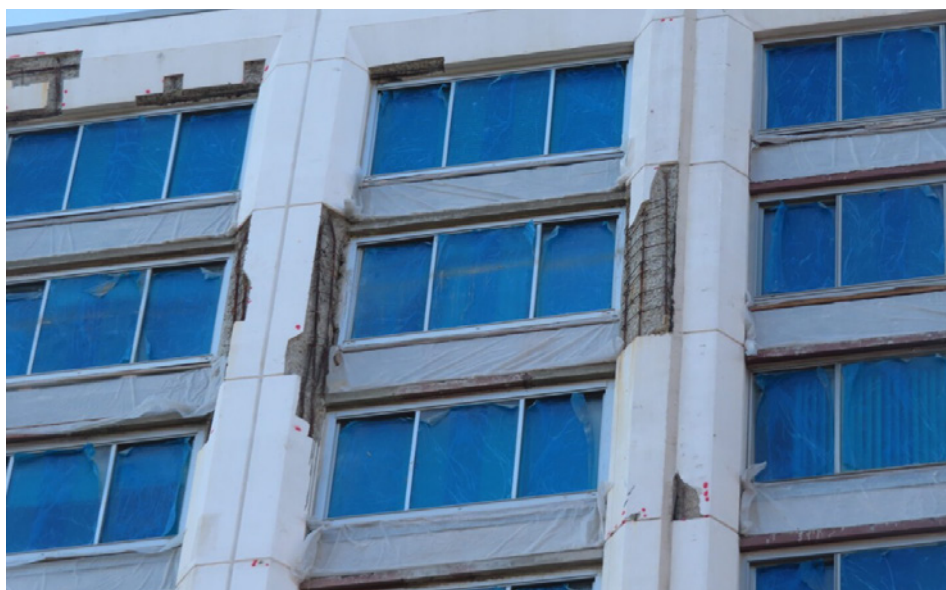
FIGURE 11. In-Progress Concrete Exterior Wall Repairs.

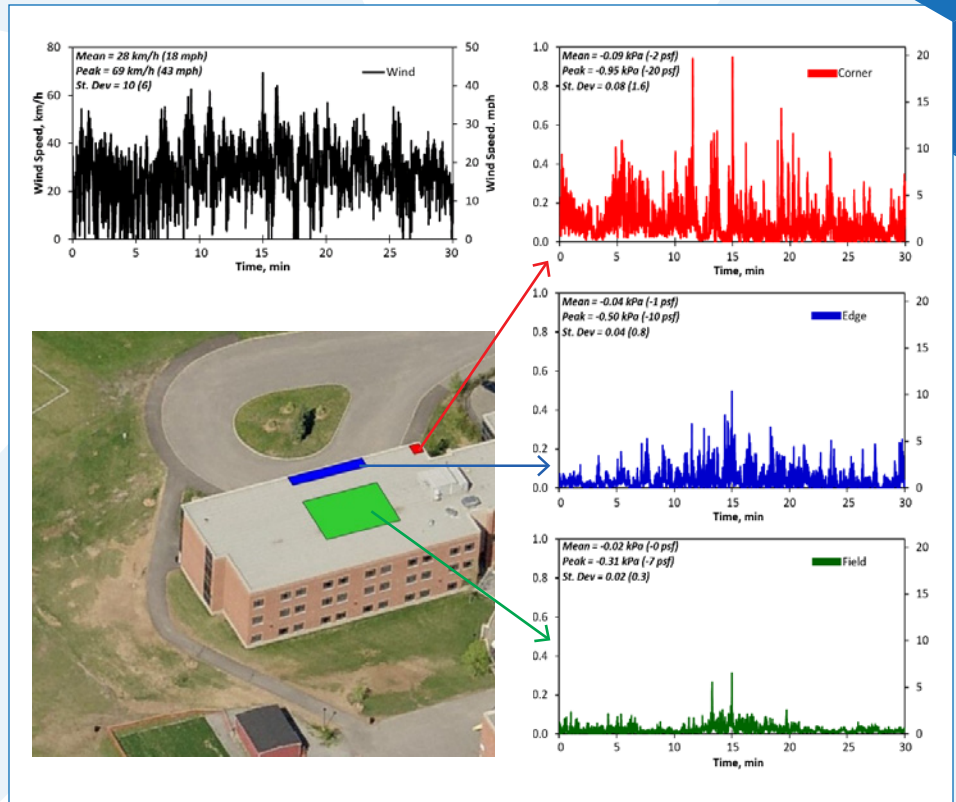
FIGURE 1. Wind and its effects on a school building roof measured in Ottawa.

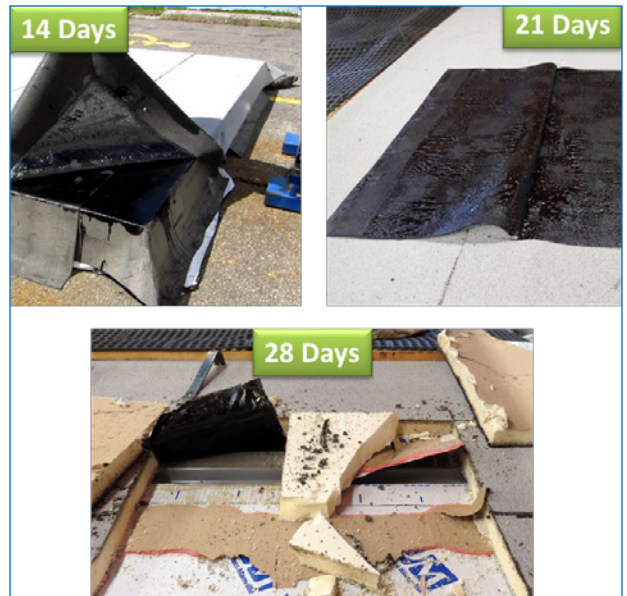
FIGURE 22. Failure modes varied with curing time for an AARS.

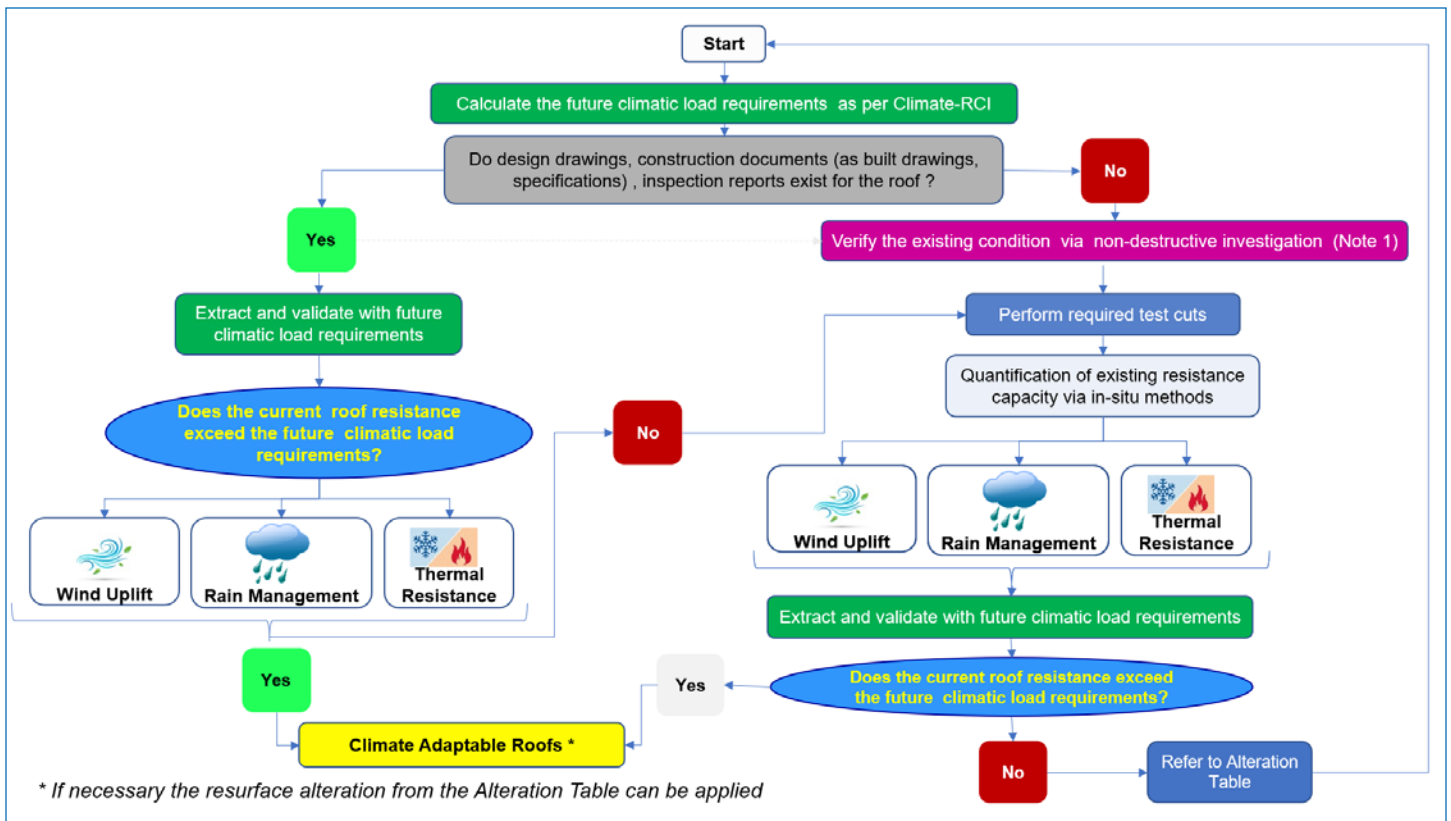
FIGURE 30. Framework for climate-adaptable roofs.

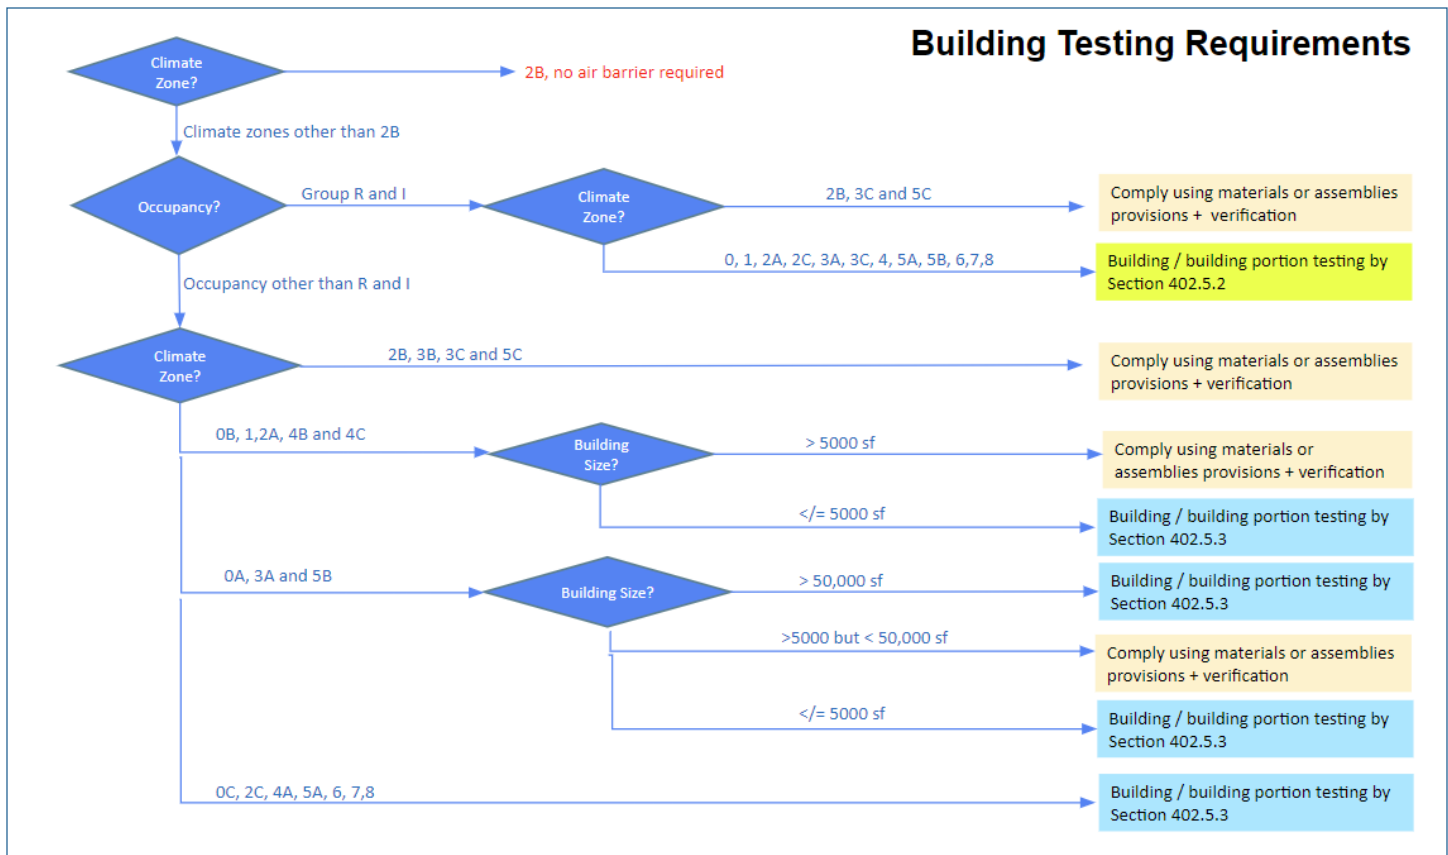
FIGURE 1. Building testing requirements decision tree for compliance IECC-2021 (Figure courtesy of Siplast).

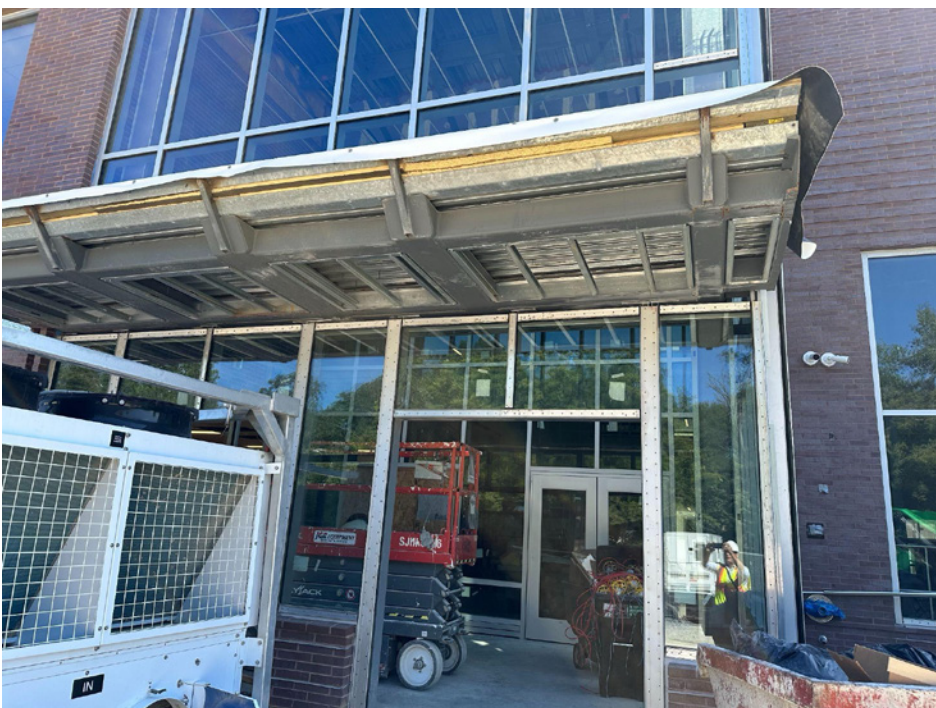
FIGURE 3. Canopy transition condition that is frequently a source of air leaks during a whole building airtightness test.

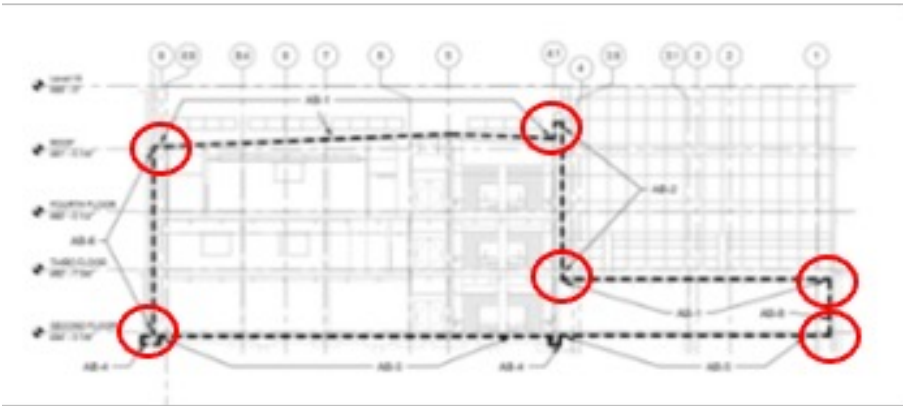
FIGURE 8. Plan and elevation using circles to call out details critical to the air tightness of the building enclosure.

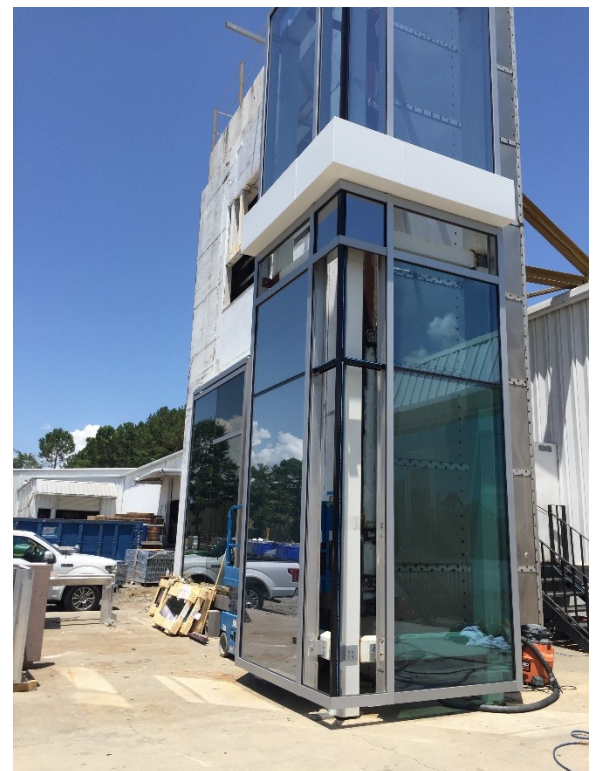
FIGURE 2. Example mock-up of fenestration system.

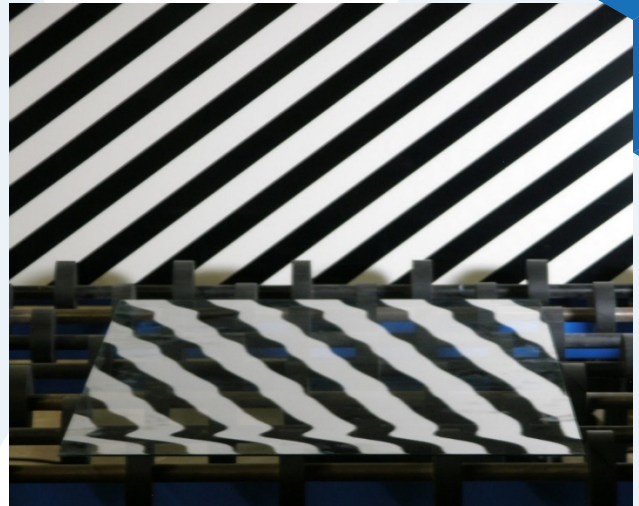
Prior to the advent of modern electronic glass scanning technology, glass fabricators relied on a “zebra board” for a subjective visual evaluation of the glass distortion (**Fig. 1**). Zebra boards are composed of straight lines (alternating black and white) and are positioned at the back end of the oven’s cooling section. This quality-control tool allows the operators to evaluate the glass right after it has been heat treated, and before it is unloaded for the next step of the fabrication process. It should be noted there are limitations associated with this visual inspection technique, as it is not

FIGURE 1. Zebra board visual evaluation of glass distortion on heat-treated glass.

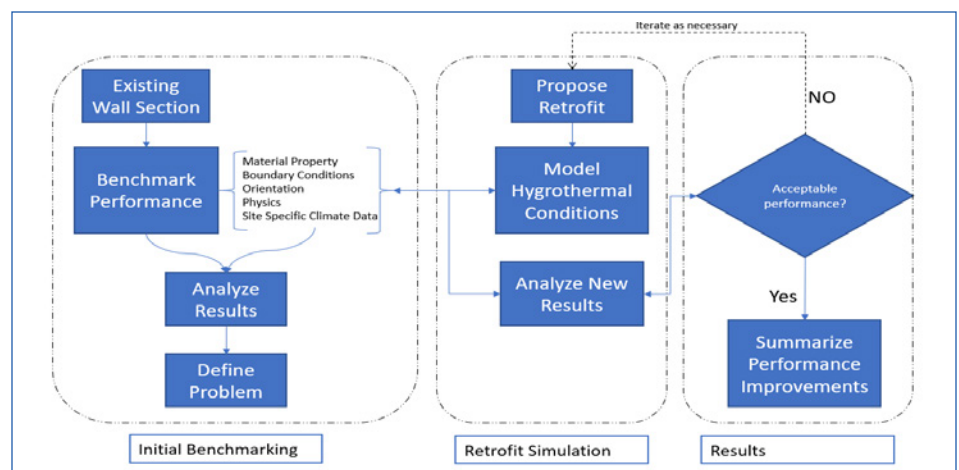
FIGURE 4. Proposed investigation process.

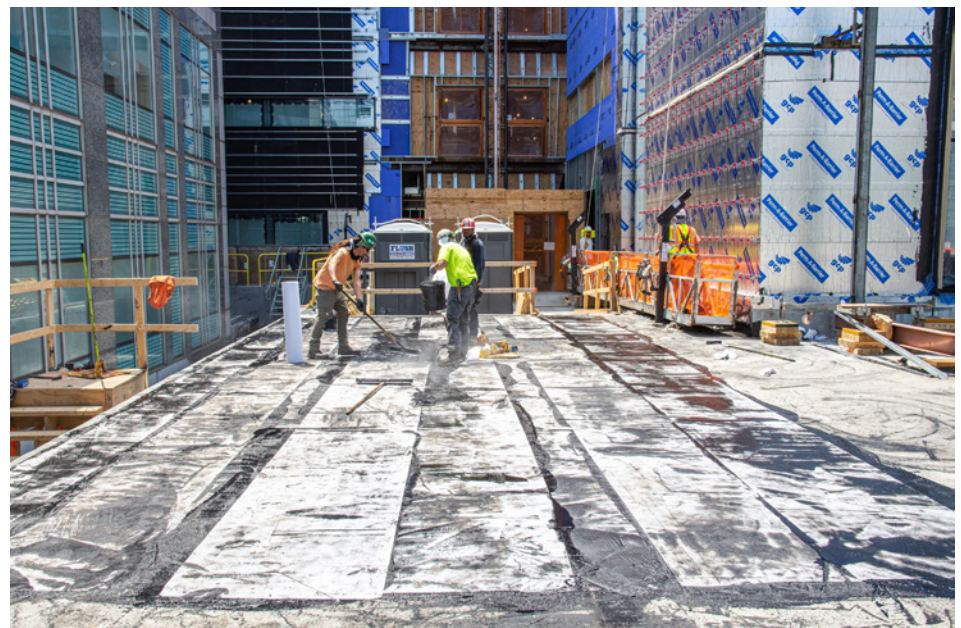
FIGURE 5. HRA Installation in Progress – *Credit Jensen Ying.*

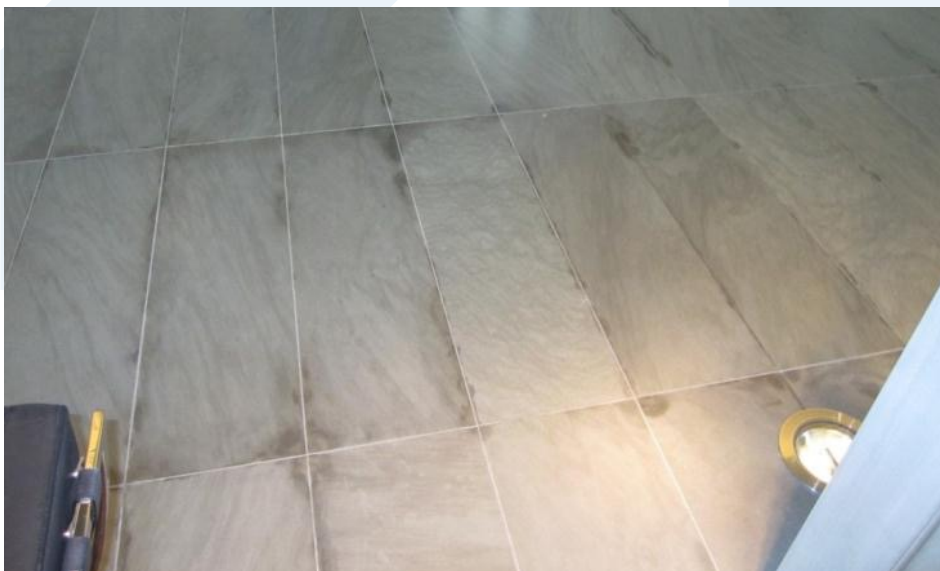
FIGURE 1. Permanently stained interior flooring from moisture exposure.

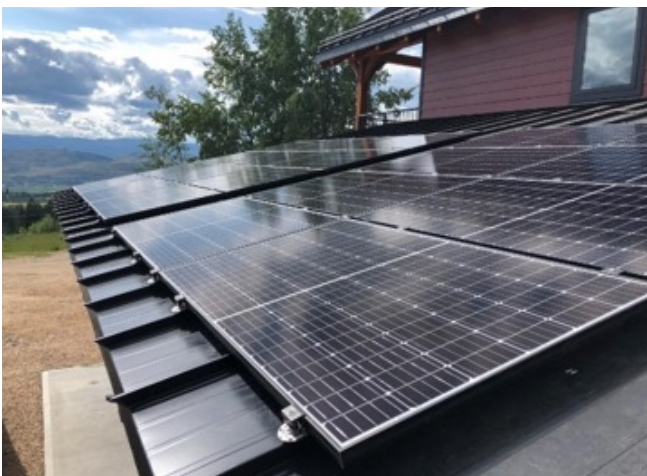
FIGURE 5. Flush Rail-less Mount.

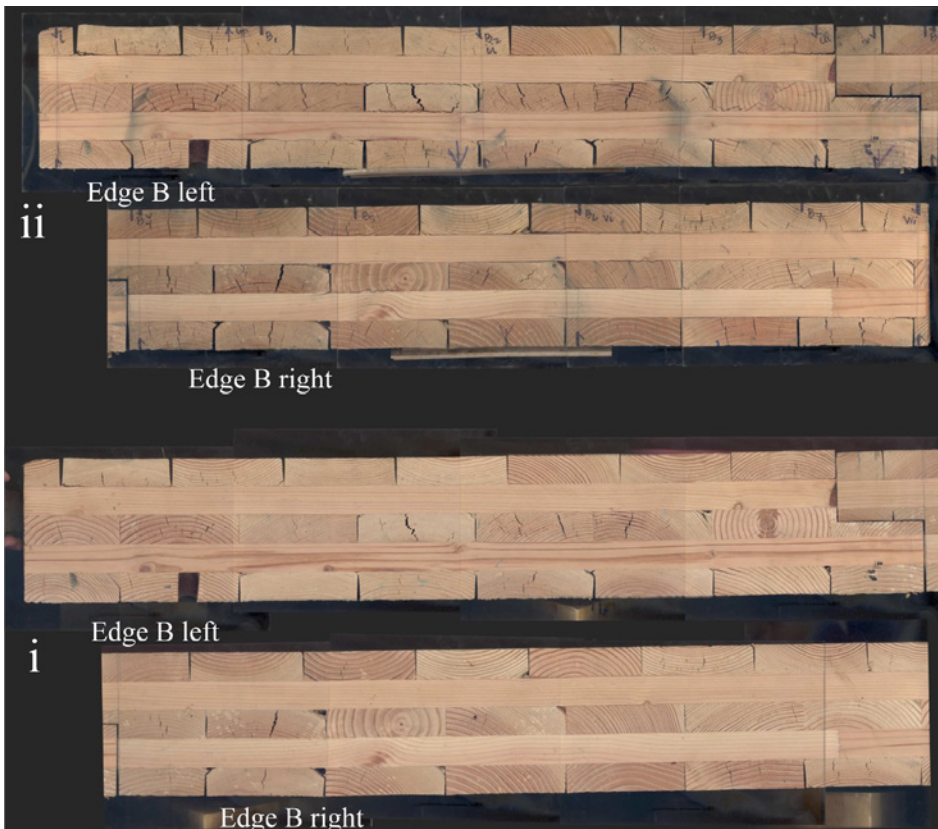
FIGURE 7. Figure from the 2019 study by Schmidt et al.¹⁰ i) Edge B before weathering; ii) Edge B after two cycles of weathering.

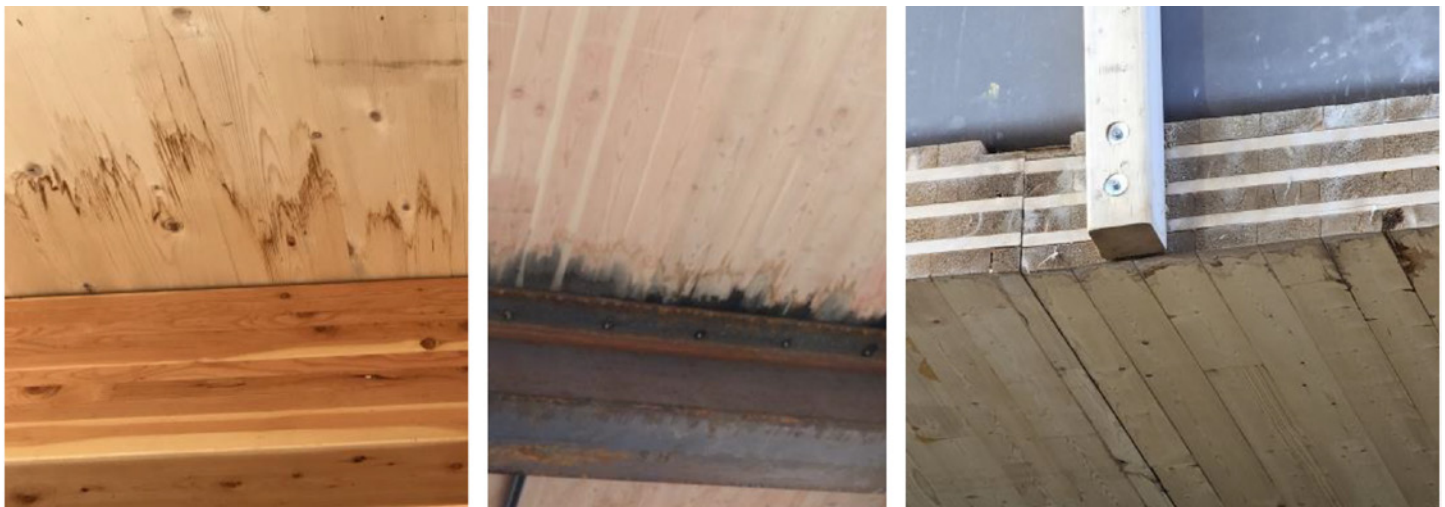
FIGURE 8. Damage due to moisture exposure from the 2023 RDH Building Science Laboratories evaluation.¹¹

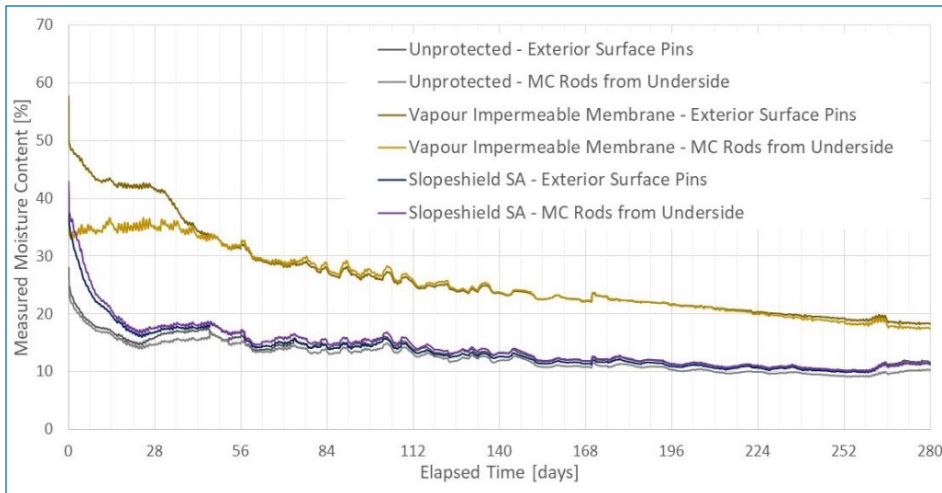
FIGURE 9. Moisture content sensor data during drying.

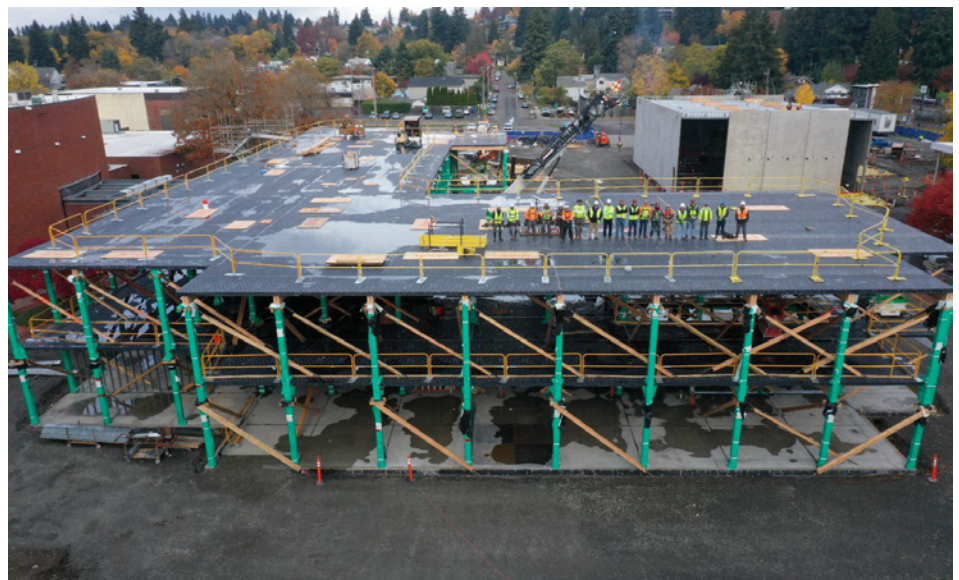
FIGURE 10. Moisture protection applied to the CLT floors as a vapor permeable self-adhered membrane and glulam columns using a vapor permeable membrane wrap.

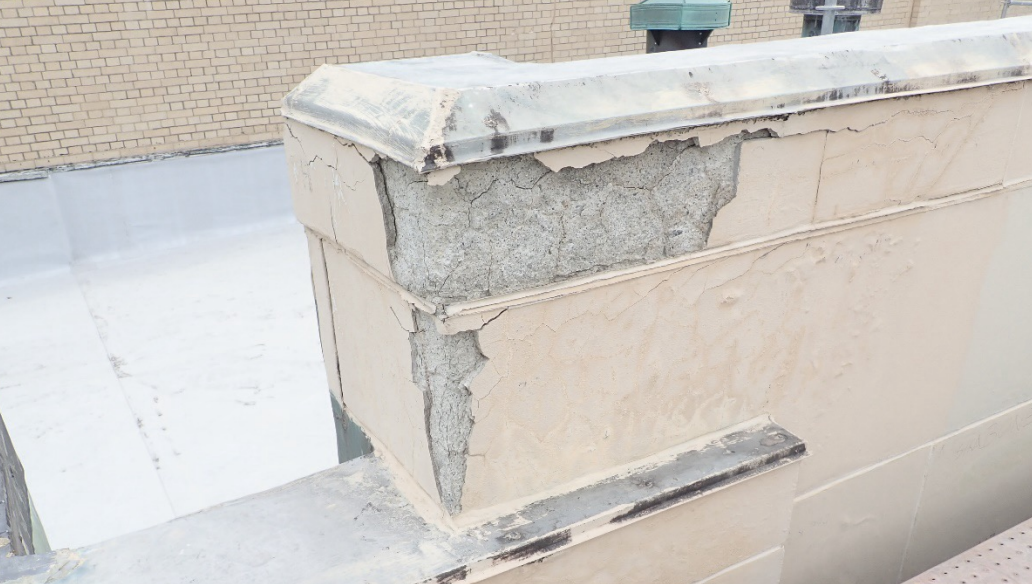
FIGURE 3. Cast stone units at the parapet with freeze-thaw damage and coating failure. Source: *Wiss, Janney, Elstner Associates Inc.*

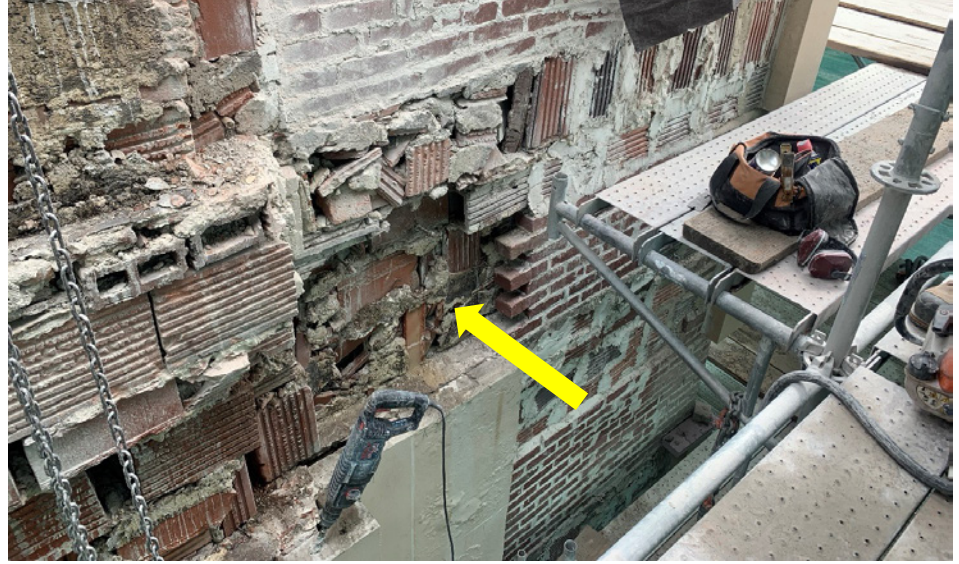
FIGURE 6. The removal of cast stone units from the sanctuary facade exposed structural clay tile back-up masonry. Note the void where 8-in.-deep (203-mm-deep) units were removed (arrow). *Source: T. Ikenouye, Wiss, Janney, Elstner Associates Inc.*

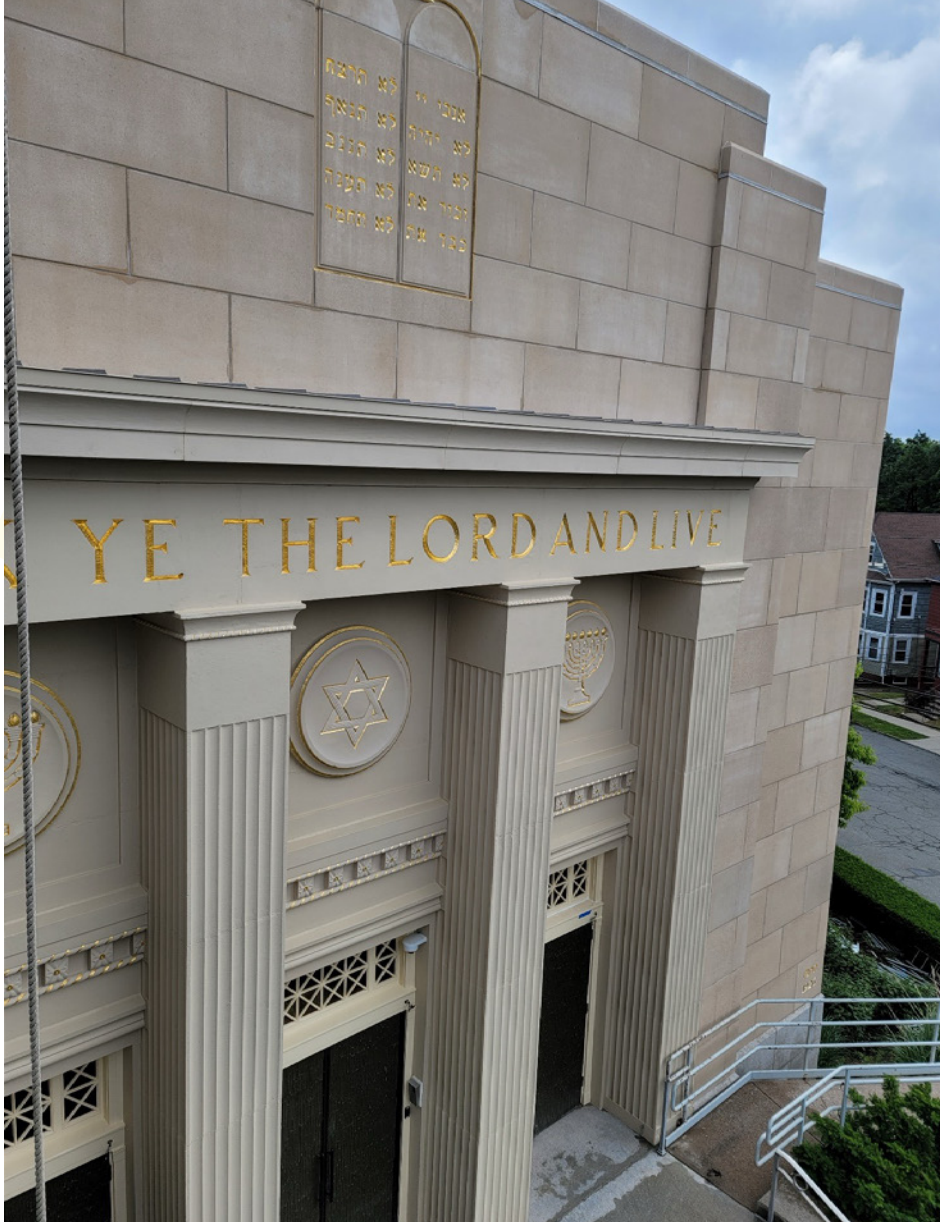
FIGURE 8. The restored Temple Emanu-El with new cast stone units, a glass-fiber-reinforced polymer cornice, and gilding completed.

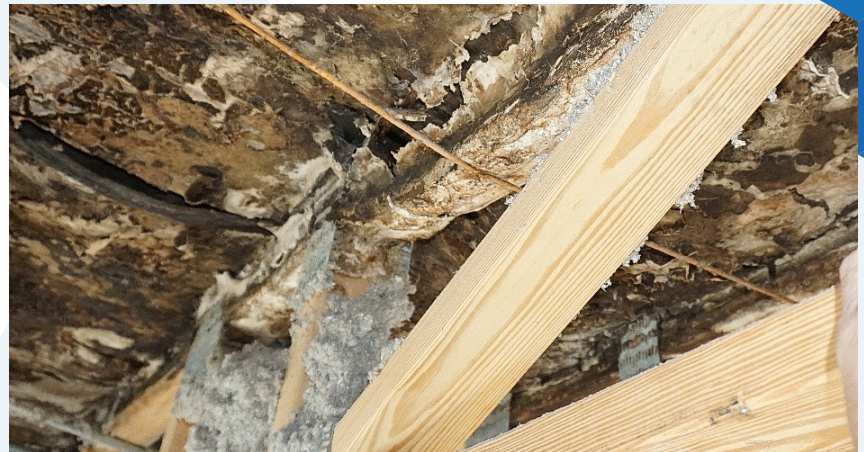
FIGURE 1. Sheathing and truss failure in insulated roof framing system (insulation removed to show distress).

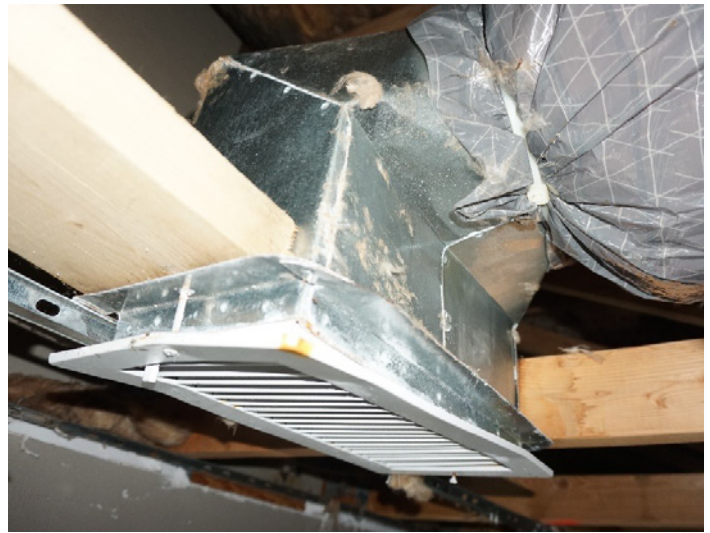
FIGURE 4. Zip tie connection of flexible duct to ceiling diffuser.
