IIBEC International
Convention & Trade Show

MARCH 8-11
2024
PHOENIX

PROCEEDINGS

A Deep Dive into Hail-Caused Dents: A Study of Corrosion Resistance within Dents in Galvalume-Coated Steel Roof Panels

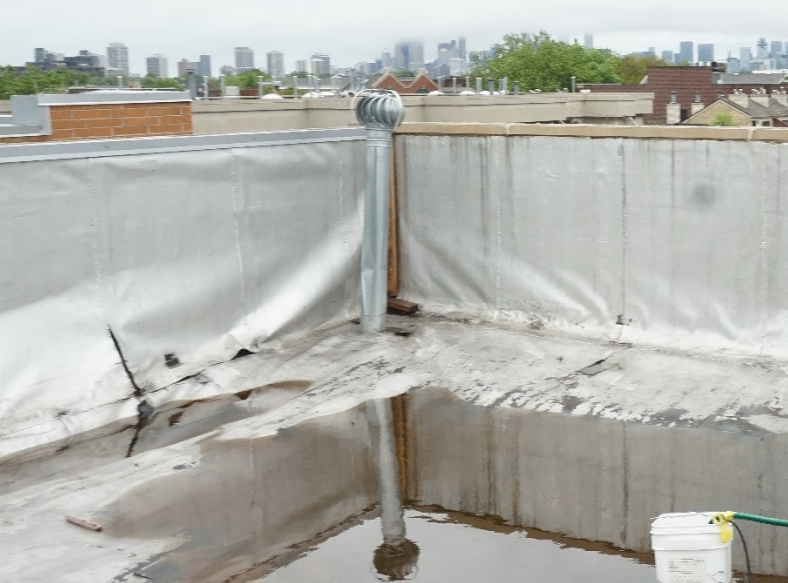
FIGURE 5. Turbine-style roof vent.

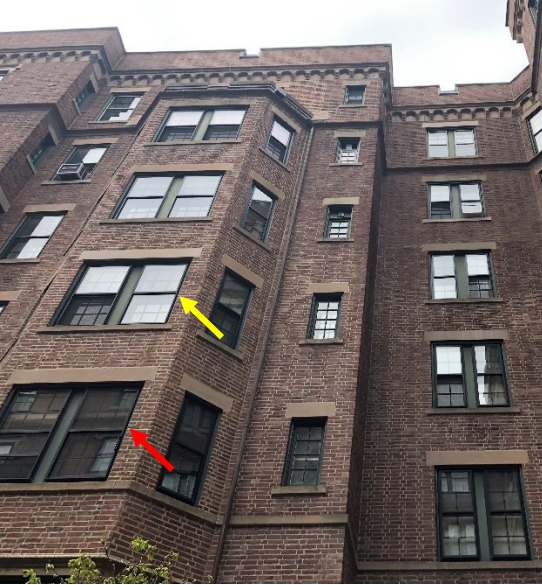
FIGURE 1. Figure 1. Storm windows installed at localized fenestration of a condominium building. Yellow arrow indicates a location with a storm window, red arrow indicates a location without a storm window.

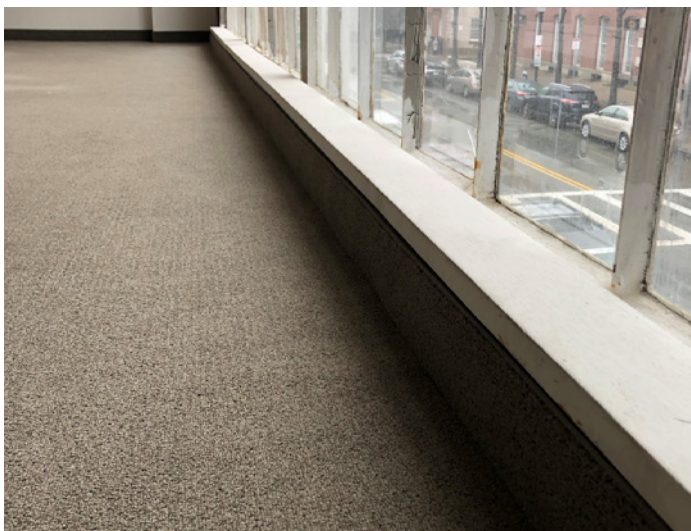
FIGURE 2A. Coating and glazing putty conceal corrosion of steel mullions.

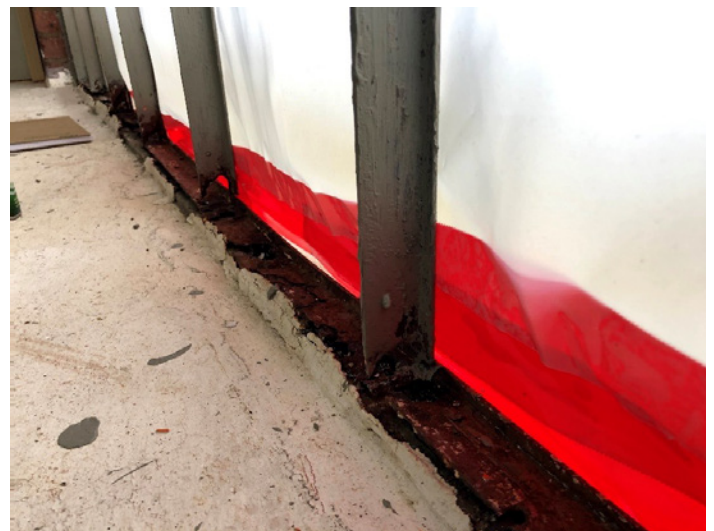
FIGURE 2B. Coating removal reveals extensive corrosion of steel mullions.
