Miami Beach, Florida
March 31 - April 5, 2005

How Do Roofs Wear Out?

**William A. Kirn, RRC
National Coatings Corporation
Camarillo, CA**

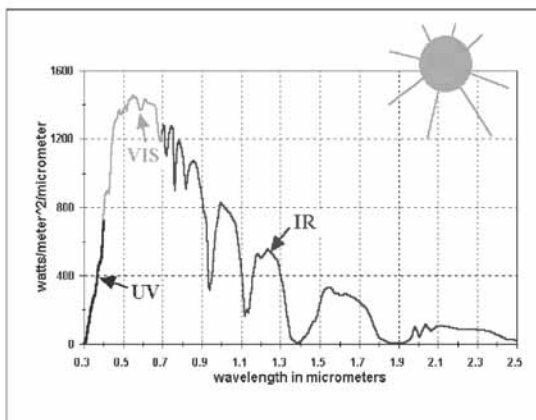
Figure 1

- Ultraviolet (UV)
 - 3% of total energy
 - responsible for sunburn
- Visible (VIS)
 - 40% of total energy
 - visible light
- Infrared (IR)
 - 57% of total energy
 - felt as heat!

The first factor contributing to roof degradation is sunlight. The same energy that causes sunburn and skin cancer on our bodies can also have a tremendous effect on roof deterioration. Roof membranes protected with granules, foil, ballast, etc. see less effects from UV, while exposed membranes receive the full force of the radiation. It has been said that "good weather is bad for roofs," meaning that the effects of sunlight are detrimental to the roof's watertight integrity and long-term service life. Water coming into a building is merely a consequence of the roof deterioration process. Consider the chart (Figure 1) showing the solar spectrum.

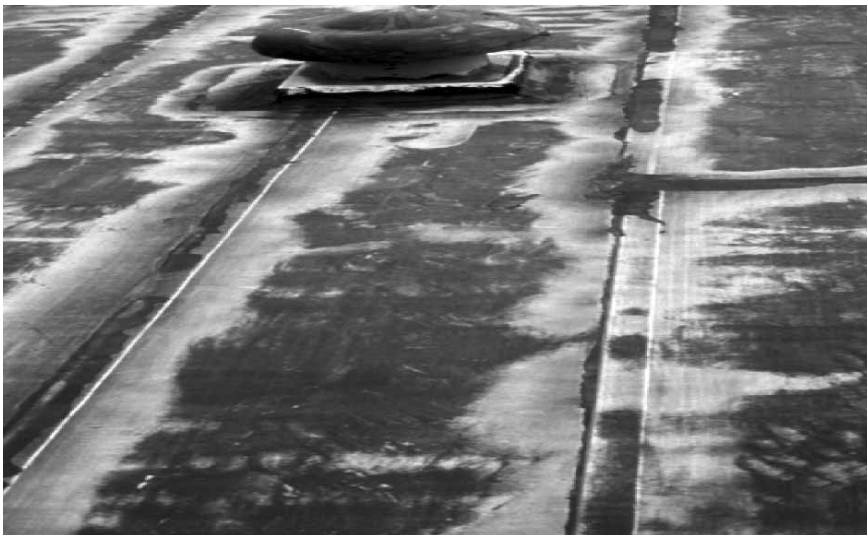
Photo 6: Loss of light fractions of APP modified bitumen roof.

Photos 5, 6, and 7 show the physical evidence of the exposed asphalt roof deterioration.

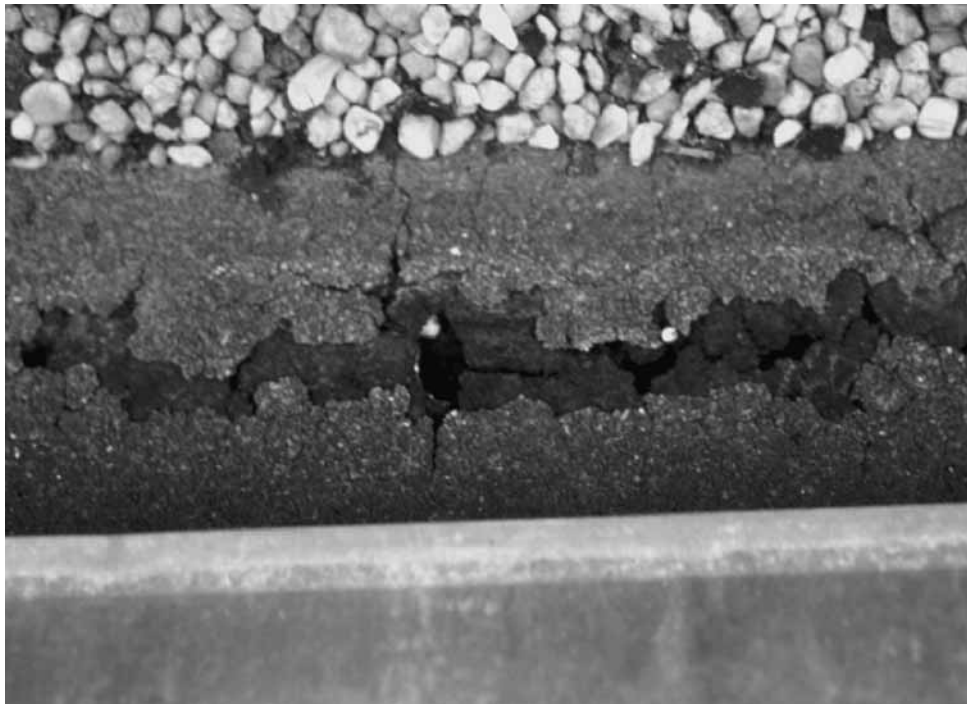
Photo 8: Degraded base flashing.

tensile strength diminishes over time. The reinforcement, which can be organic, polyester, fiberglass, or a combination of two different materials, begins to degrade and its tensile strength diminishes over time. This loss of strength is observed as cracking and splitting of the felts. This can be seen in *Figure 8* in the significant deterioration of the asphalt base flashing.

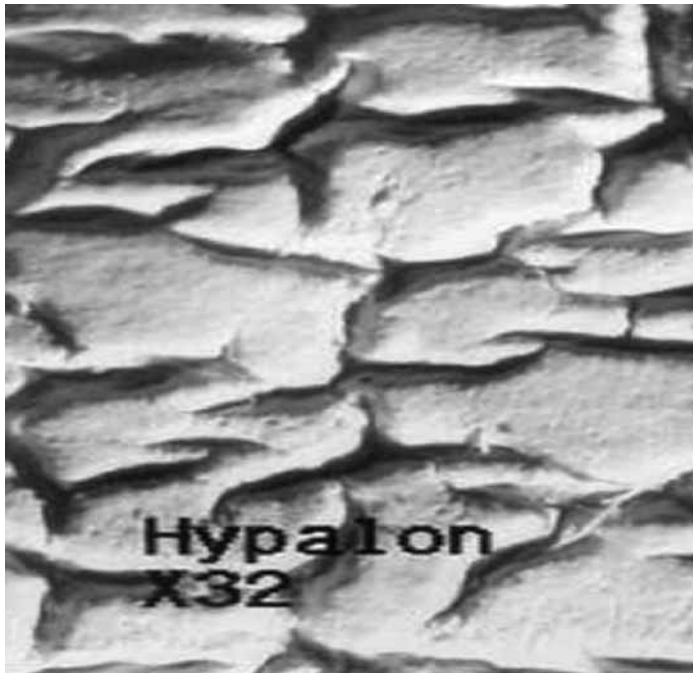
Figure 10: Surface deterioration of a thermoplastic single ply.

Studies conducted on other thermoplastic single ply membranes³ have shown the polymer to degrade via chain scission. This causes chalking, as the polymer, which acts as a glue to hold the pigments in place, loses its ability to hold the pigment. The photomicrograph below shows the surface erosion and deterioration of a single-ply membrane.

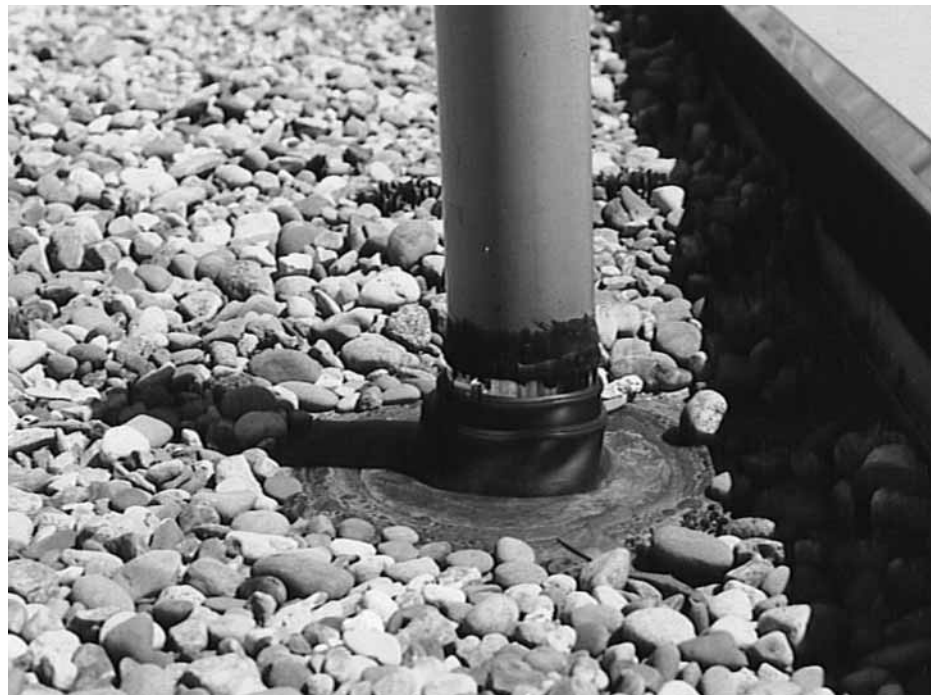
Photo 11: Stress on accessory due to membrane shrinkage.

Photos 11 through 14 show shrinkage and stress on accessories and terminations caused by oils leaching out of the membrane. Notice how the rubber boots are stretched in one direction, toward the center of the roof. This stress also creates tension on the field seams, causing premature failure and tearing away from the termination bar.

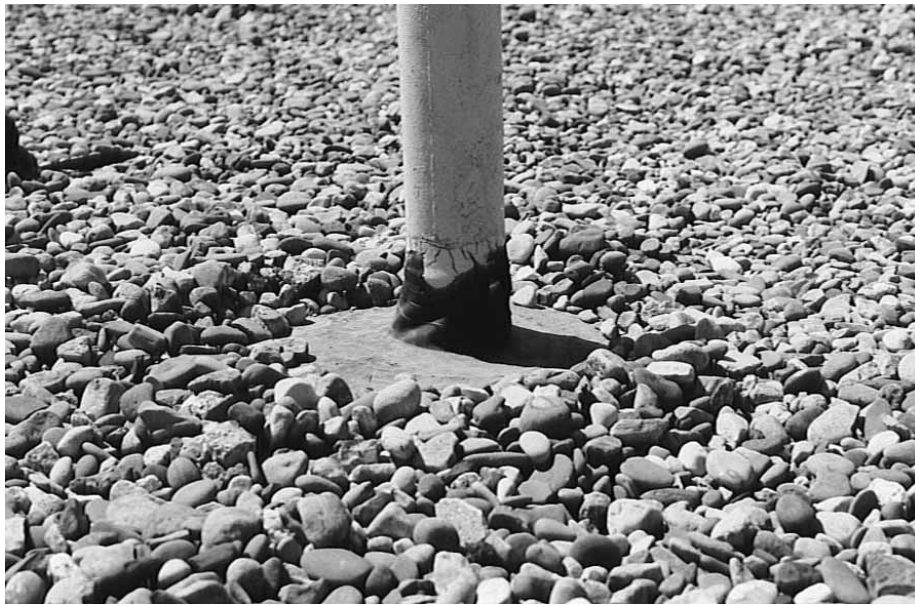
Photo 12: Stress on accessory due to membrane shrinkage.

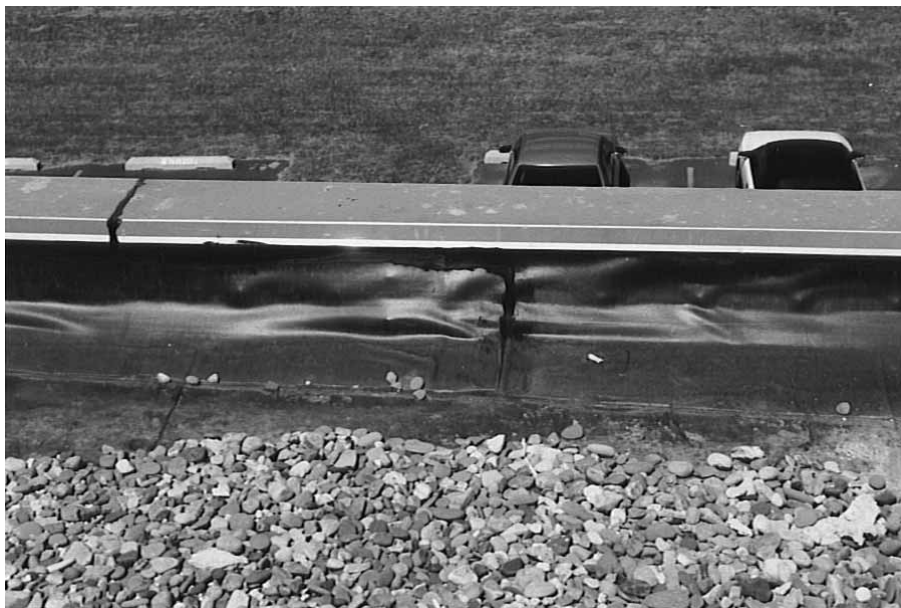
Photo 13: Stress on termination due to membrane shrinkage.

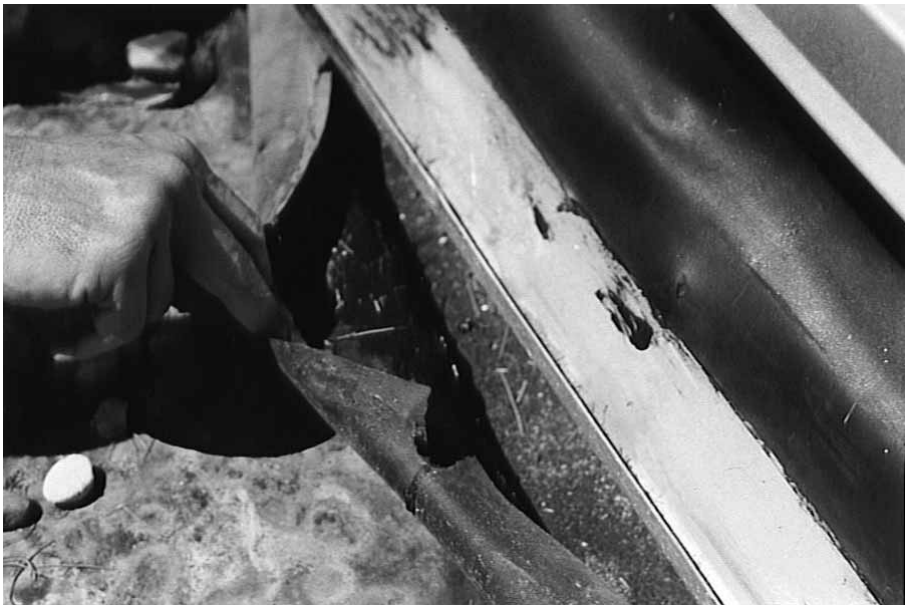
Photo 14: Tear at termination due to membrane shrinkage.

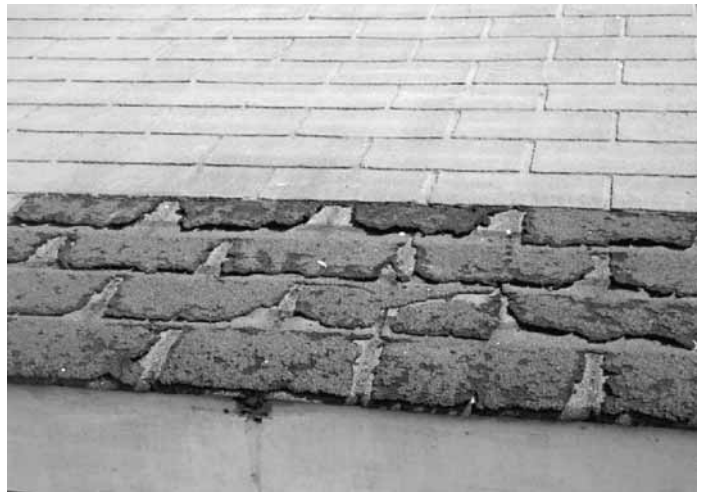
Figure 18: Asphalt shingle showing coated and uncoated sections.

Consider the asphalt shingle roof shown in *Figure 18*. This coating exposure was initiated in 1986 after the uncoated, 3-tab shingle roof had been exposed for about 10 years. The majority of the roof was coated with an acrylic elastomeric roof coating at 3 gallons per square. The small portion was left unexposed. After 10 years, this photo was taken. The exposed portion of the roof shows significant shingle deterioration, granule erosion, curling, embrittlement, and loss of integrity. By contrast, the coated section shows almost no deterioration.
