PROCEEDINGS

ICE SPHERE IMPACT TESTING OF PHOTOVOLTAIC SOLAR PANELS

JIM D. KOONTZ, RRC, PE

JIM D. KOONTZ & ASSOCIATES, INC.

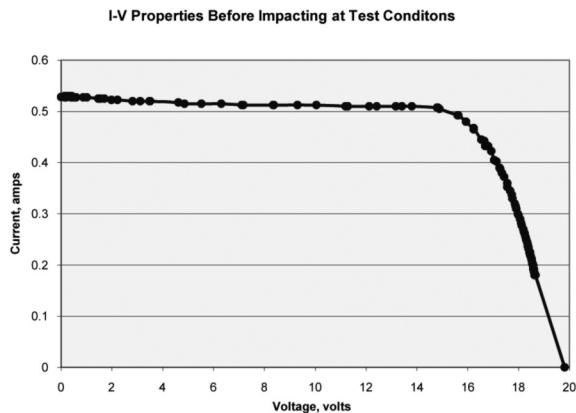
Electrical Characteristics at Test Conditions

Electrical Characteristics Normalized to STC, Approximation Method

Maximum Power, P _{MAX} , watts	7.70	Maximum Power, P _{MAX} , watts	9.41
Short-Circuit Current, I _{SC} , amps	0.53	Short-Circuit Current, I _{SC} , amps	0.58
Open-Circuit Voltage, V _{OC} , volts	19.81	Open-Circuit Voltage, V _{OC} , volts	21.87
