HORIZONTAL ABOVE-GRADE WATERPROOFING

KARIM ALLANA, RRC, RWC, PE

Building Envelope Technology Symposium

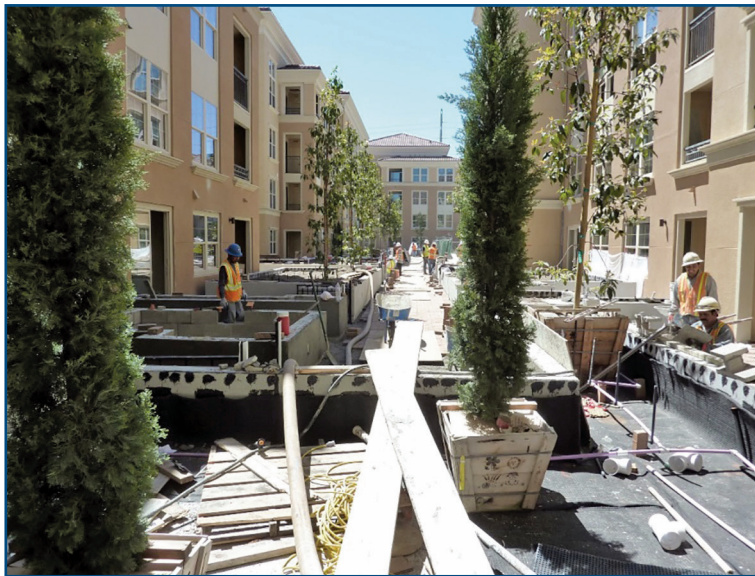
Figure 1 – Protected membrane components.

There are several base components of any protected system, as demonstrated in *Figures 1* and *2*: the wearing or traffic surface, a protection layer that sometimes doubles as isolation and drainage layer, a waterproofing membrane, and the structural deck or substrate. Additional systems may be necessary, and the order of the systems can vary, depending on the purpose and design of the deck, but the base components remain consistent across various deck types.

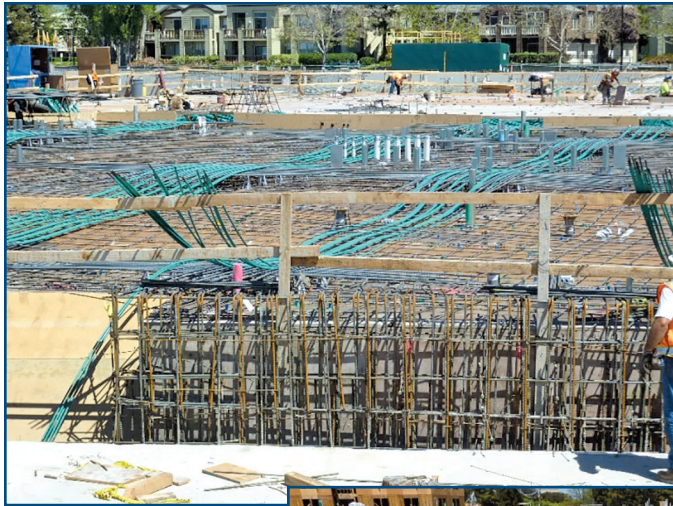
Figure 3 – Podium slab with tensioning cables and reinforcing steel.

Concrete slabs are the most common structural substrate for podiums. Slabs are either reinforced with mild steel or post-tensioned steel (*Figures 3* and *4*). The advantage of post-tensioned steel is reduced thickness—consequently, less concrete and less cost. However, the labor associated with tensioning cables is higher, and overall, the cost of post-tensioned slab can be competitive, depending on subcontractors.

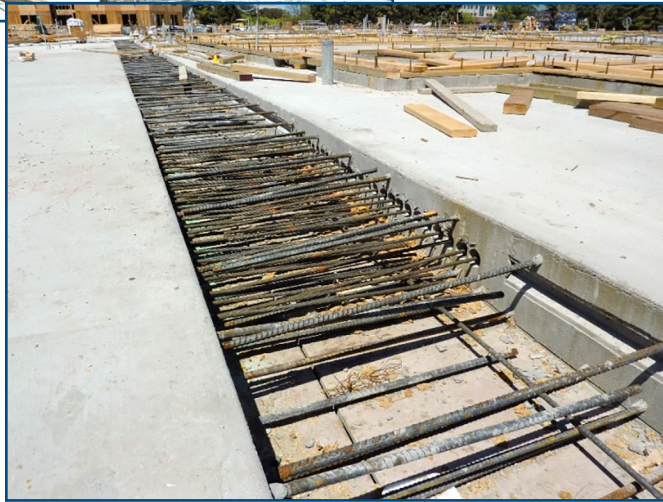
Figure 4 – Post-tensioned reinforced concrete slab under construction. Also common in steel structures is steel pan deck, with mild steel-reinforced concrete. Prior to the adoption of reinforced concrete, the two-way flat plate and one-way slab-over-beam systems were common; however, they are not used much anymore.

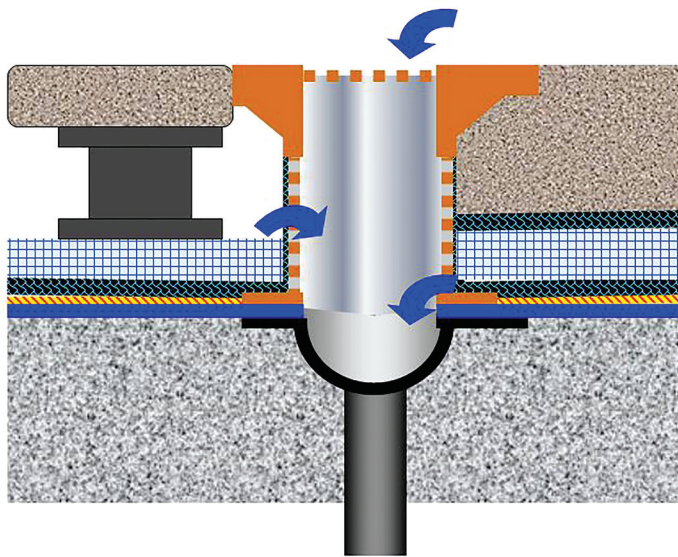
Figure 5 – Typical plaza drain configuration.

A typical plaza deck drain, as pictured in *Figure 5*, consists of a top-mounted inlet drain for surface drainage in addition

to a secondary inlet located at the membrane level for membrane level drainage. The podium drain body typically has an adjustable height and threads for proper installation and function. The location of the drain is important in preventing ponded water—both on the wearing surface and at the waterproofing membrane level. Standing water at the membrane level can damage certain types of waterproofing

Drains must have weep ports at the membrane level to allow the water to drain off the surface of the waterproofing. A typical plaza drain will handle the majority of the drainage and water runoff from the top inlet. However, podium assemblies that

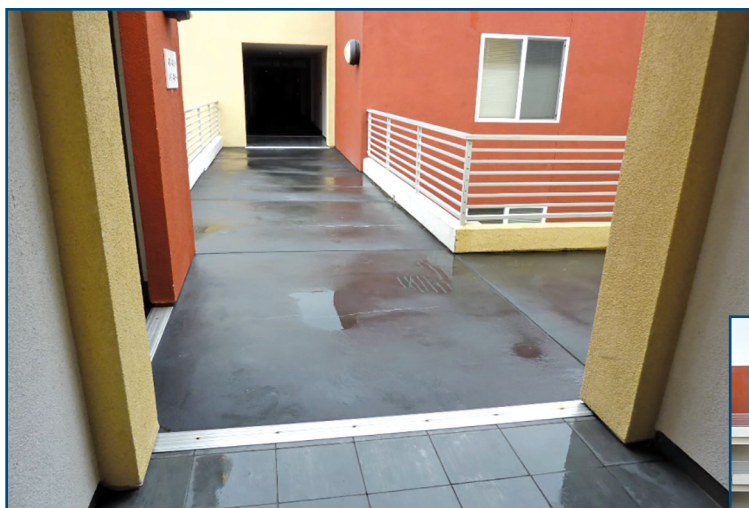
Figure 6 – Elevated public walking surfaces on wood deck with colored concrete and porcelain tile wearing surfaces, integrated with handrails, doors, exterior walls, elevators, etc.

The upper-most layer (also referred to as the wearing, pedestrian, or traffic surface) is usually composed of concrete or pavers that are subject to traffic by pedestrians, vehicles, or both (public walkways – Figures 6 and 7). This is the first line of defense against damage to the membrane and assembly

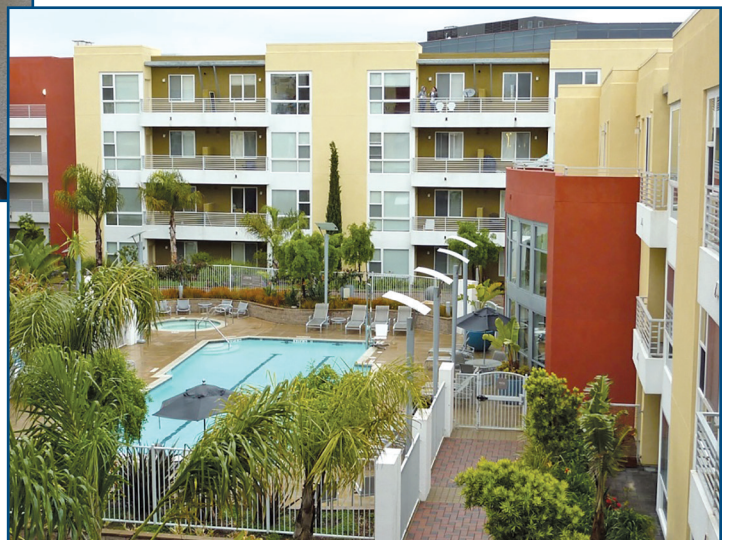
Figure 7 – Typical podium with concrete topping and pavers, shade structures, fences, planters, trees, pool, spa, light pole, free-standing walls, etc. integrated with building walls, fences, doors, pools, and planters.

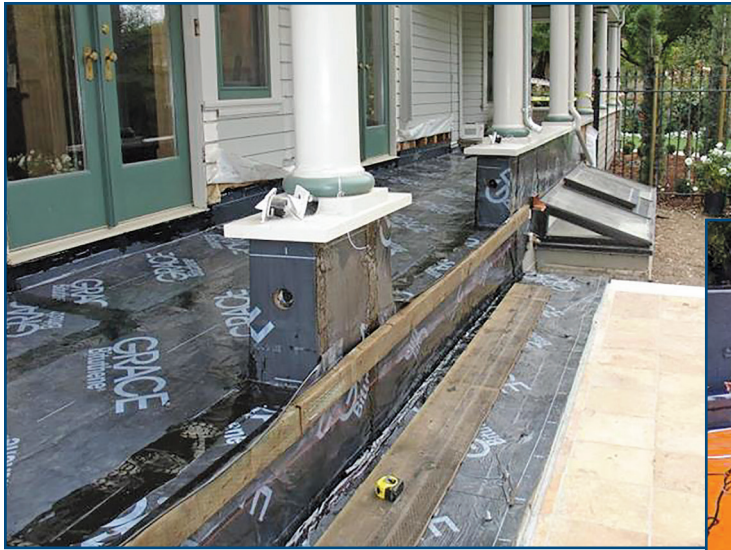
Figure 8 – Combination self-adhered modified-bitumen membrane with fluid-applied waterproofing.

Some of the most common fully adhered membranes in use today are hot-fluid-applied rubberized asphalt (HRA), modified-bituminous membranes (Figure 8), modified-bitumen sheets, and PVC (Figure 9). Many of these systems have been in service for over 40 years and are still performing well today.

Another common membrane selection is modified bitumen, which can be adhered, torched, or fluid-applied. Some self-adhesive SBS membranes use a combination of cold, asphalt-modified polyurethane, deck prep, and self-adhered sheets (Figure 8).

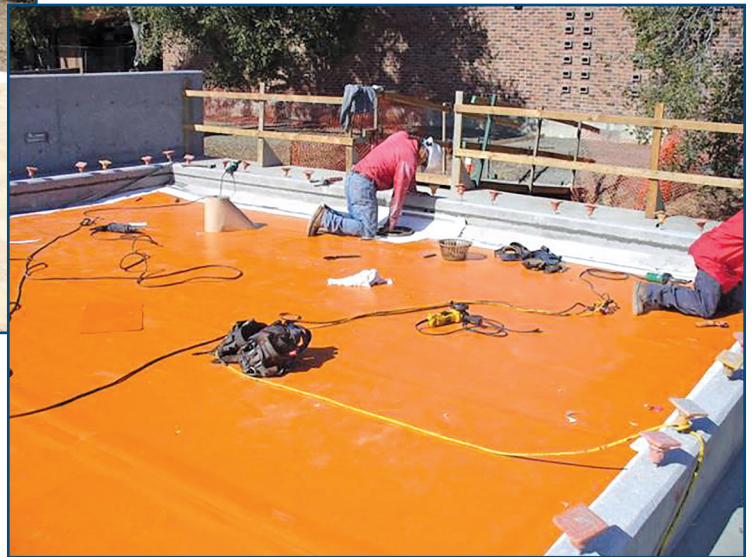
Figure 9 – PVC membrane.

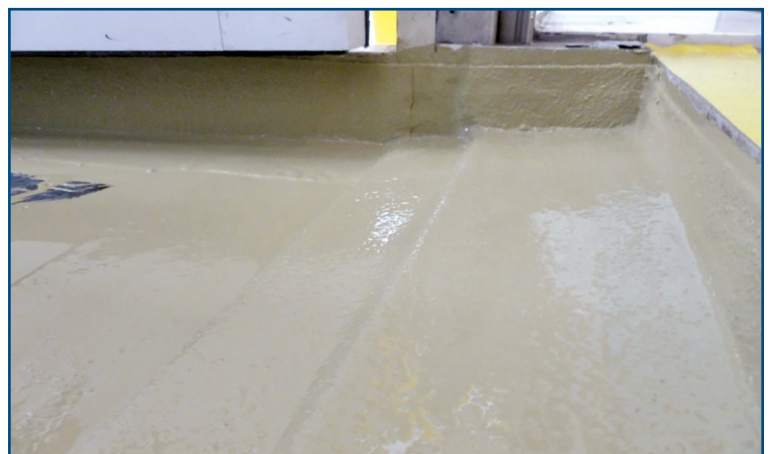
Figure 10 – Asphalt-modified polyurethane.

Asphalt-modified polyurethane cold-fluid-applied membranes (Figure 10) tend to be some of the least expensive products, very simple to install, and requiring little or no equipment, making them very popular. However, asphalt-modified polyurethanes have a very poor track record and tend to suffer from premature failure due to higher

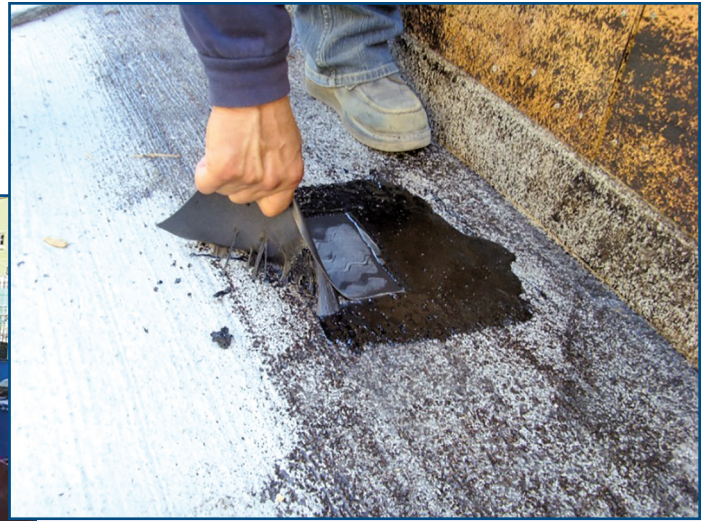
Figure 11 – Adhesion of membrane with sheet neoprene.

Based on my forensic review of many different types of waterproofing systems, HRA is one of the most reliable waterproofing membranes in service (Figure 11 and 12). Due to its reliability and relatively low cost, HRA systems have become very popular in new construction and are often used on large podium-type projects. HRAs require a specialized double-jacketed kettle to heat the asphalt; and for remedial construction, the smell of asphalt is sometimes a deterrent for occupied buildings. HRAs have the ability to be phased and joined

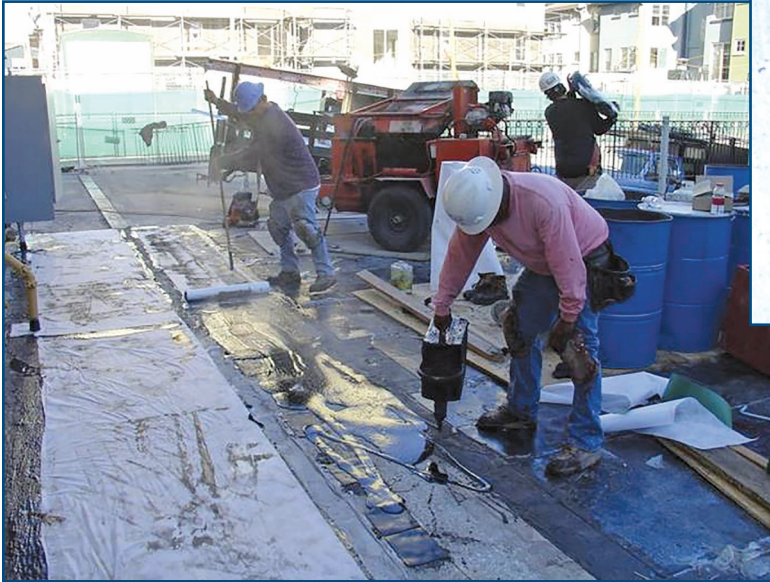
Figure 12 – Typical HRA application

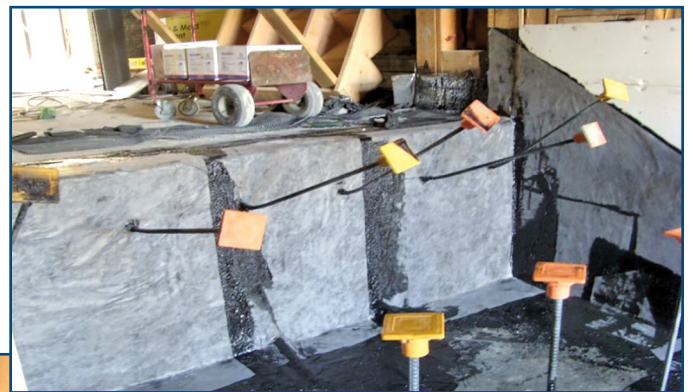
Figure 14 – Waterproofing around reinforcing steel.

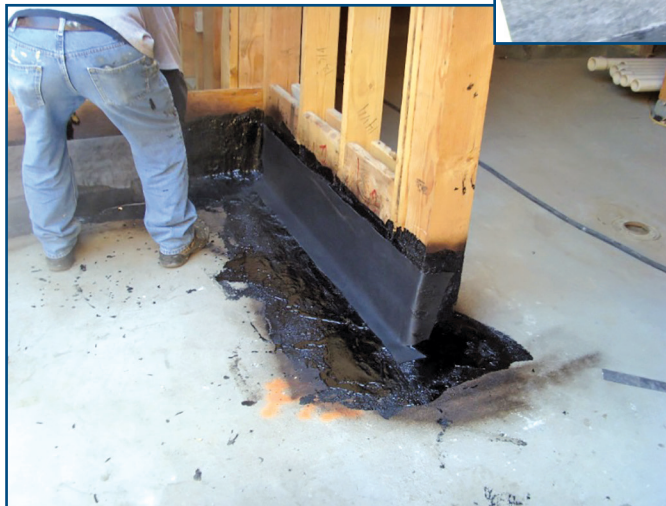
Figure 13 – HRA challenge – flashing buildup.

Nevertheless, there are multiple challenges to successfully installing HRA, the four most common being: adhesion failure to concrete, material and flashing build-up

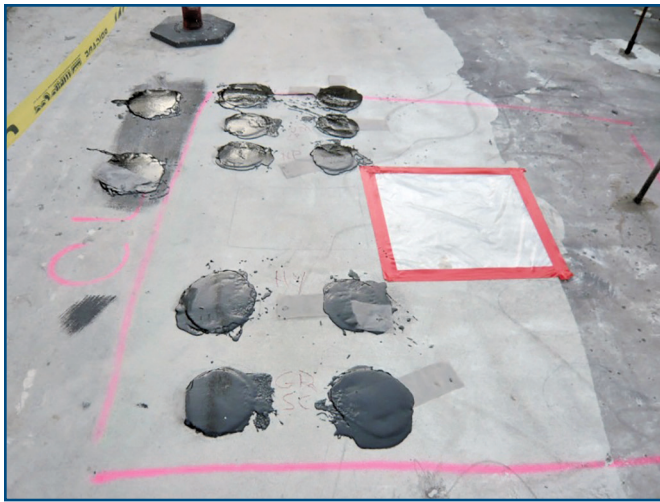
Figure 15 – Mat test (right) and various samples for pull test about to be performed.

And finally, HRA does not always properly adhere to the substrate, so regularly performing peel tests for testing adhesion is important. It is also important to check for moisture escaping the structural deck, using a mat test (ASTM C4263) to check for capillary moisture in concrete and by mopping some hot asphalt to see if it fizzes or pinholes.

Manufacturers of HRA don't offer specific guidelines for adhesion testing, but the most common method is using a reinforcing fabric or neoprene to perform a pull test (*Figure 15*). Pass/fail is best defined with cohesive/

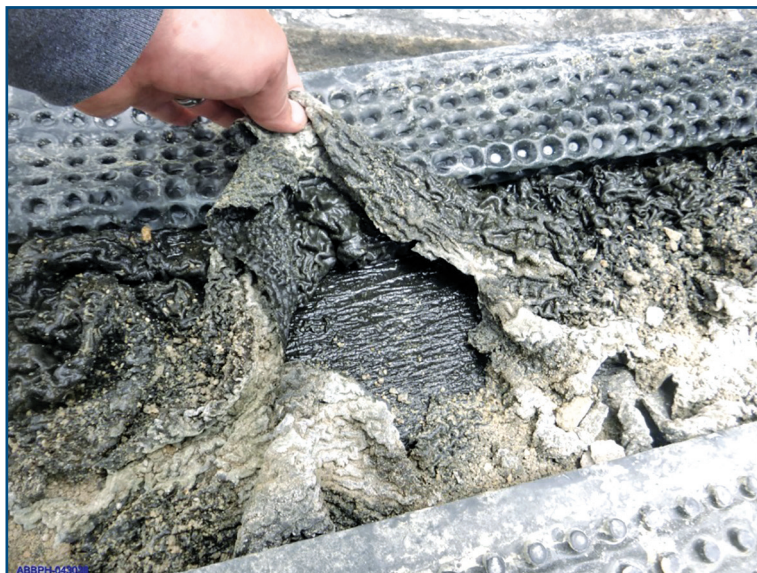
Figure 16 – Modified polyurethane membrane is swollen and looks like the texture of a brain and is referred to as “brainiac.” Prolonged immersion of the membrane results in swelling and water absorption far beyond the manufacturer’s published results.

permeability under standing water, which causes premature failure, swelling, and blistering (Figure 16).

Generally, the deck was uniformly sloped towards the gutter. However, due to the drainage mat being discontinuous across the middle of the deck, water ponded on the membrane in pockets of some areas. At the standing water areas, water stood on top of the membrane for long periods of time. While the drain mat can facilitate the flow of water, in a standing water condition, it can act as a vapor barrier and not allow the water to dry through the surface of the slab. Water standing on the membrane for extended periods of time caused the asphalt-modified polyurethane membrane to swell “brainiac” and fail (*Figure 16*).

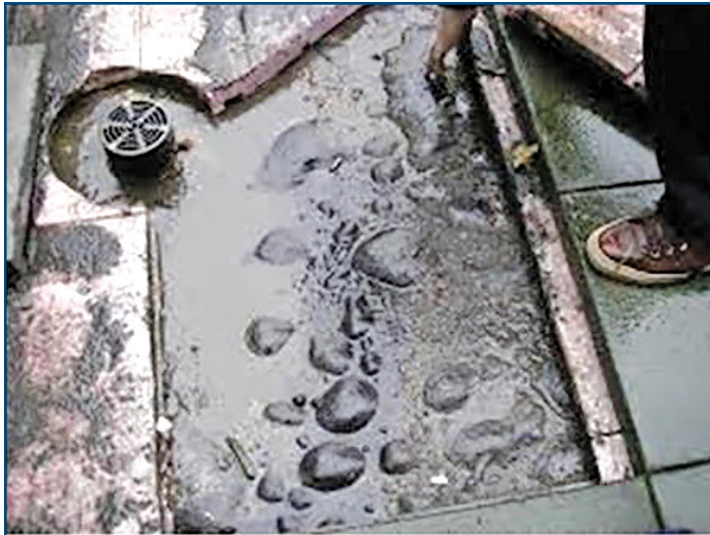
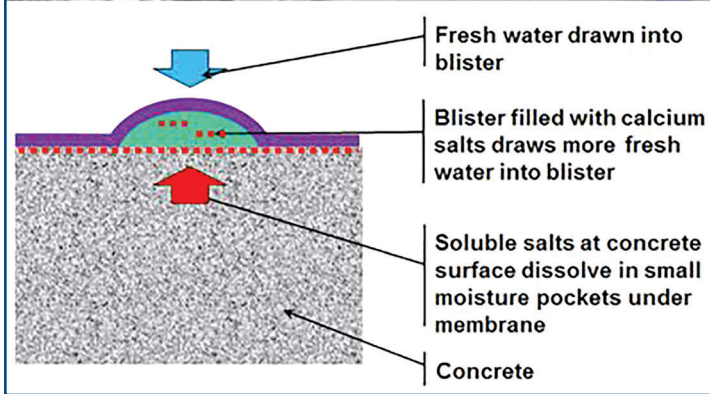
Figure 17 – Osmotic water-filled blisters.

start to accumulate on the concrete surface and not dry through the slab fast enough. This leads to moisture-filled blisters. Moisture-filled blisters mix with salts that are naturally occurring in concrete, and the saline solution creates an osmotic action and draws fresh water through the membrane. In reinforced concrete slabs, we have seen these blisters grow to the size of baseballs and footballs. Unreinforced membrane blisters are generally smaller (the size of a dime or silver dollar) before they burst or break.

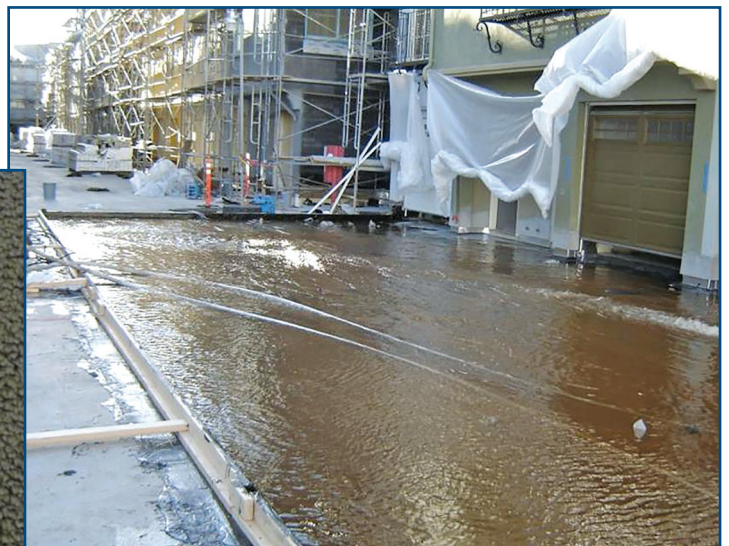
Figure 19 – ASTM D5957 standing water testing.

Water testing only tells part of the picture. Just because a horizontal waterproofing assembly is shown to be watertight from an industry standard ASTM D5957 test (depicted in Figure 19), doesn't mean a system is built watertight for the life expectancy of the system. Most systems may pass the ASTM 5957 test even if the system had a slow leak. Electronic field vector mapping

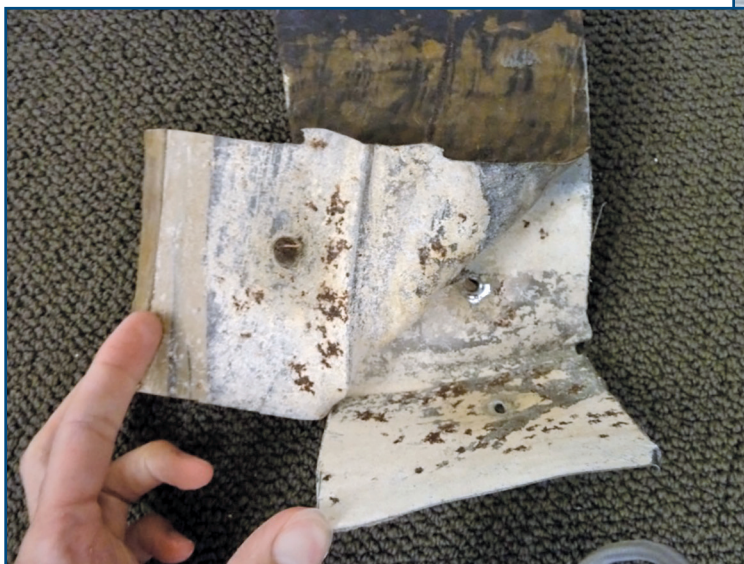
Figure 18 – Corrosion of galvanized sheet metal flashings under 90 mils of fluid-applied membrane.

modified polyurethane membranes can raise the moisture levels in plywood and cause corrosion of galvanized steel flashings (Figure 18). We have seen moisture content above 19% in many plywood substrates due to standing water and corrosion on sheet metal through 90+ mils of membrane thickness.

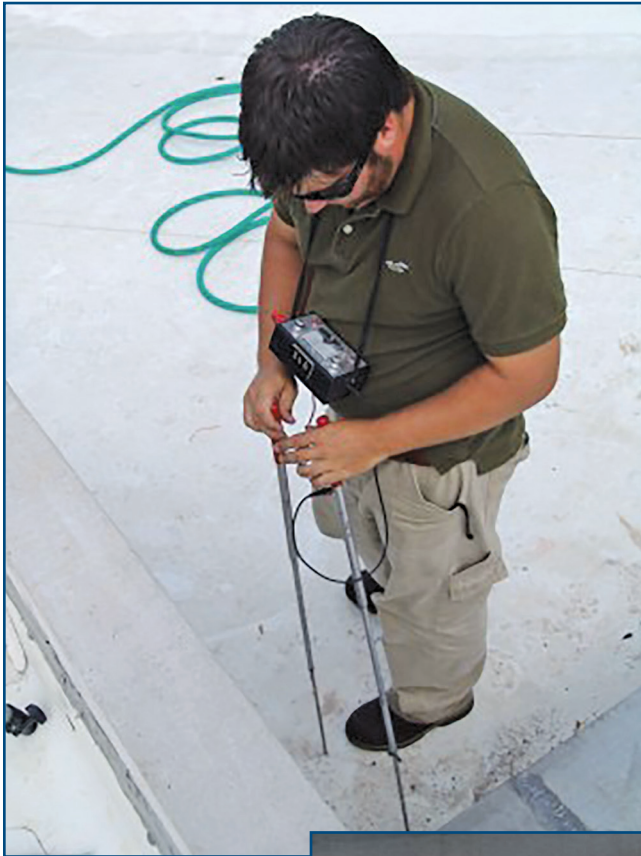
Figure 20 - Using potentiometer to discover source of leaks.

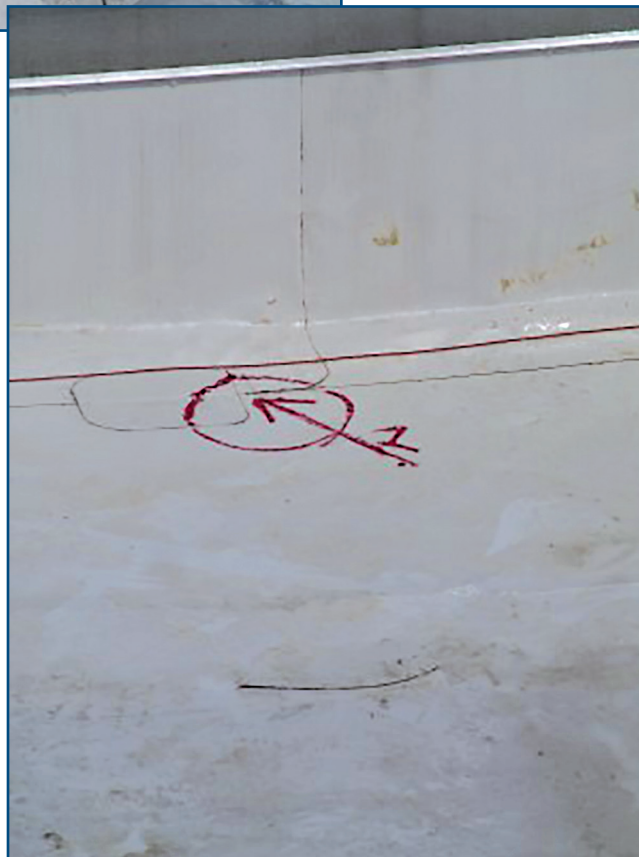
Figure 21 - Pinhole leak discovered using EFVM.

EFVM is a nondestructive testing method that uses electricity to precisely test the waterproofing membrane for leaks. EFVM is preferred over other traditional testing methods because it is nondestructive and the membrane can be tested without removing the overburden or ballast. It can be used on both hot- and cold-liquid-applied membranes, coatings, and other sheet membranes in addition to metal, concrete, and wood substrates, pro-

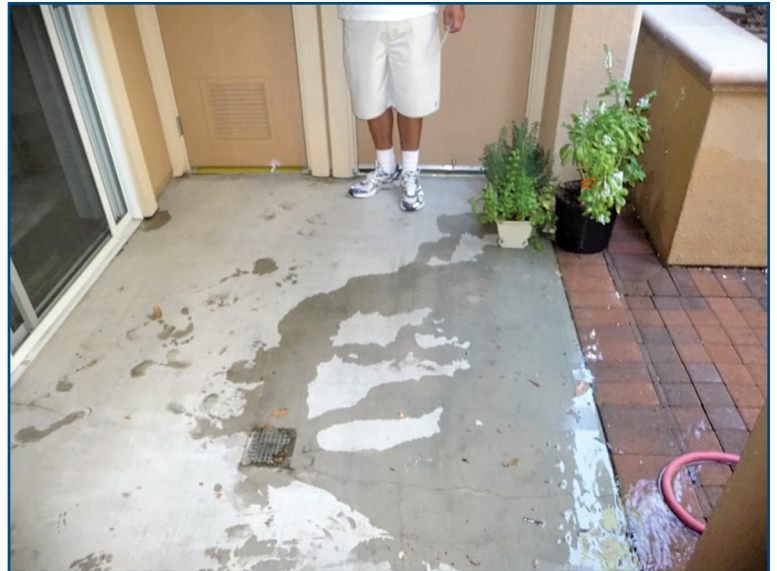
Figure 22 – Water flows from the door even though it never flows to it.

where near the sliding glass doors, and the surface water never made it to the door or the building walls, we observed leaks inside. We observed that the water began to emerge from the doorjamb, both outside and inside. The leak mechanism and mode of travel of water are depicted in *Figures 22* and *23*.

The weeps at the waterproofing membrane level were small relative to the drain, and the weep holes were clogged, allowing water to mostly drain off the topping slab and build a hydrostatic head at the surface. The control joints in the concrete and perimeter joints served as a conduit for water, filling up and creating hydrostatic head at the level of the topping slab.

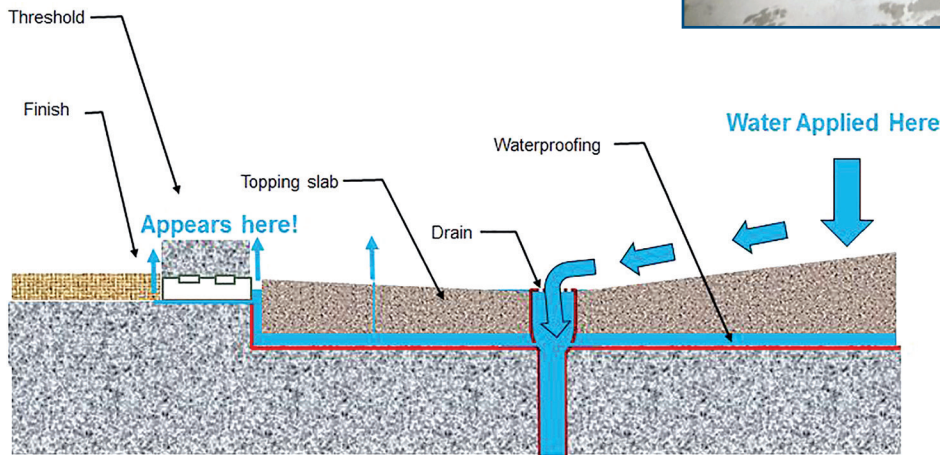
Figure 23 – Water flows under the topping slab and appears at door jamb.

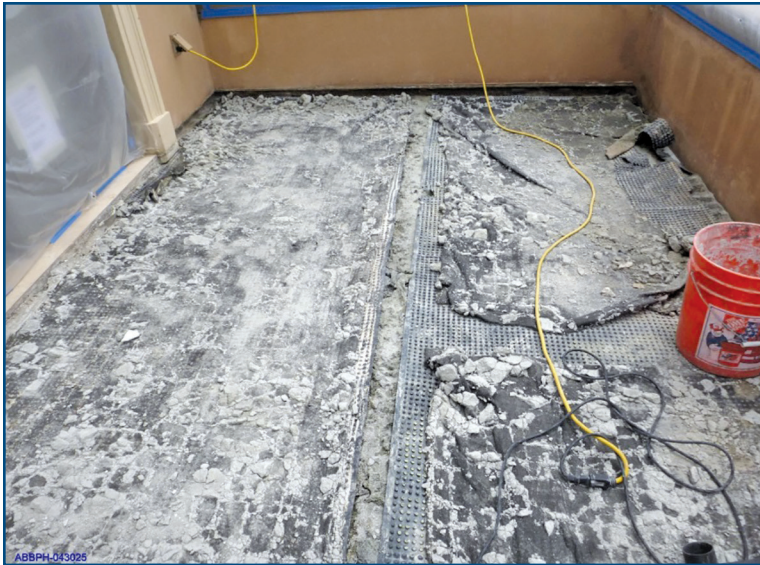
Figure 24 – On this wood-framed balcony deck, the drain mat was discontinuous down the center of the deck. This resulted in water not properly flowing and ponding on the upslope side of the discontinuity.

This case study depicts damage and failure caused by standing water on a modified polyurethane membrane (*Figure 24*). The hospitality project featured private balcony decks, built with plywood substrate sloped to drain in one direction with an internal stainless-steel gutter. The waterproofing membrane has a drainage board/mat with 2 in. of mortar bed and travertine tile.

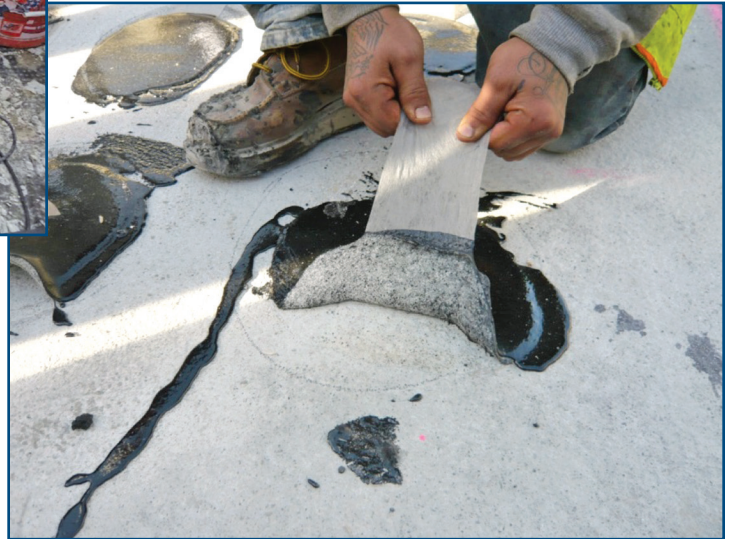
Figure 25 – Interestingly, the failure mode is in cohesion of the concrete, as opposed to adhesion of the membrane. The concrete slab surface had improperly cured and was soft and chalky.

making it easy to fail cohesively (Figure 25). The other type of adhesion failure was due to a water-based primer that didn't properly cure due to low temperature or had emulsified in the presence of water (Figures 26 and 27). Even though membranes passed adhesion tests before application, a month or two later, they failed to adhere.

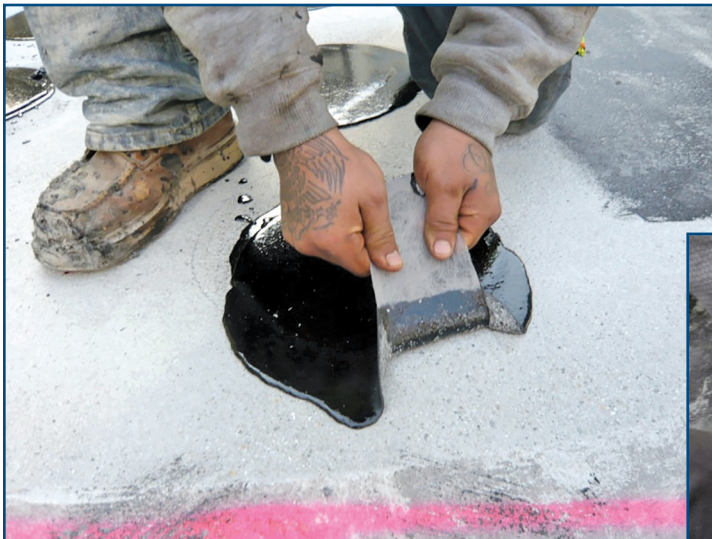
Figure 26 – This sample exhibits failure in adhesion due to a water-based primer that was used in the application that was not curing due to cold temperature.

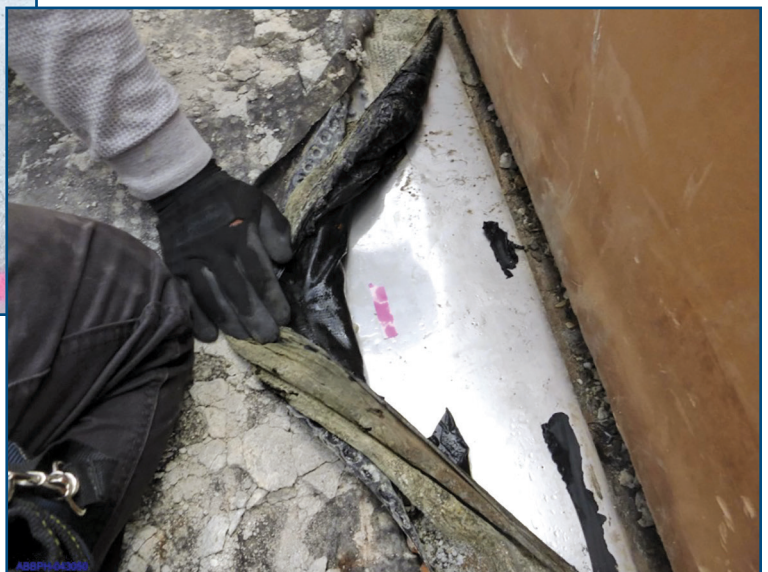
Figure 27 – Adhesion failure of cold-fluid-applied membrane to stainless steel flashing due to lack of proper priming and prep work.
