## DRONES: A NEW TOOL

WILLIAM WATERSTON, RRC, AIA

*WISS, JANNEY, ELSTNER ASSOCIATES, INC.*

# Building Envelope Technology Symposium

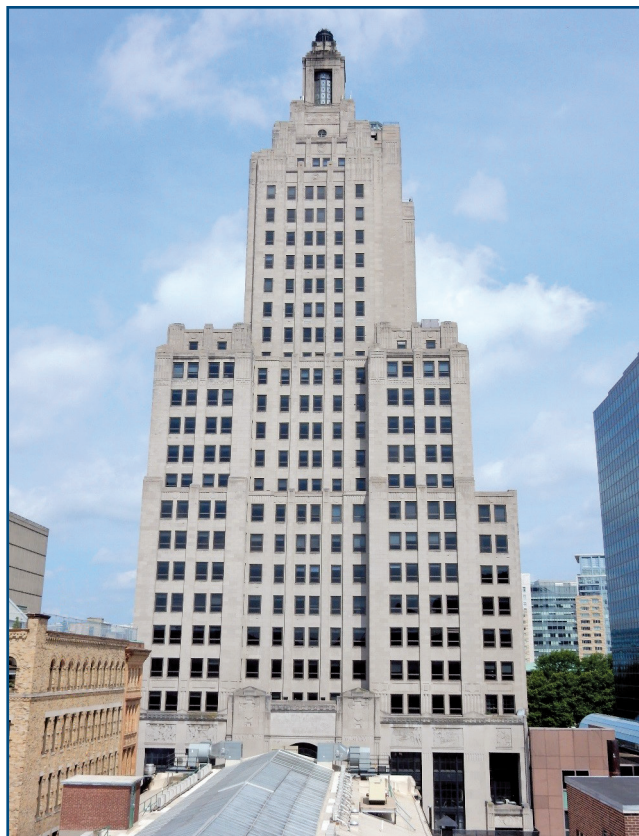
**Figure 1 – Building where rope access techniques were used in lieu of a swing stage.**

the façades of multiple buildings can be accomplished from the ground or neighboring structures using binoculars. Sometimes, we are required by a façade ordinance to provide an up-close observation of the materials on the building. This is often completed using a personnel lift or boom. More difficult or taller structures are often surveyed using swing stages by dropping down the face of the building on each elevation. In some cases, rope access techniques are an alternative to a swing stage, requiring highly trained professionals in both rope safety and façade assessment to complete the work. For example, this technique was used at an Art Deco-style building with many offsets and setback roof areas, proving it much easier to assess the condition of the limestone walls (*Figure 1*).

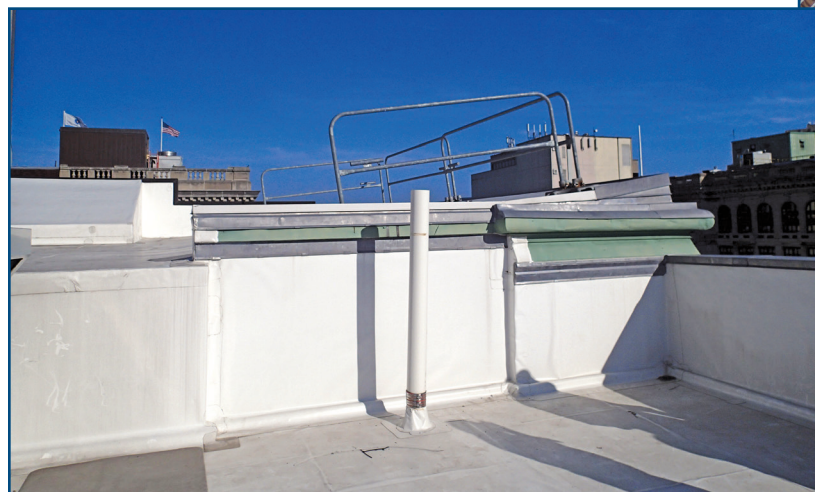
Figure 5 – Educational building in downtown Boston with mansard steep-sloped roof areas.

This building (Figures 5-8) is located in a congested portion of downtown Boston. It is a seven-story educational facility. The top floor contains a mansard roof covered with red slate. Regularly spaced, copper-clad

dormers protrude from the mansard. A survey of the façade was required to comply with the City of Boston Façade Ordinance.

There was a concern about falling slate. A single vertical sampling of the roof area that would be available from a swing-stage inspection was not adequate to determine the full extent of repair required. Maybe a big selfie stick would work, but the owner hired a contractor with a drone to photograph the areas. The contractor is a major Boston-based general contractor with staff and equipment to perform the work. The operator was experienced with the operation and control of the aircraft (Figures 9-11).

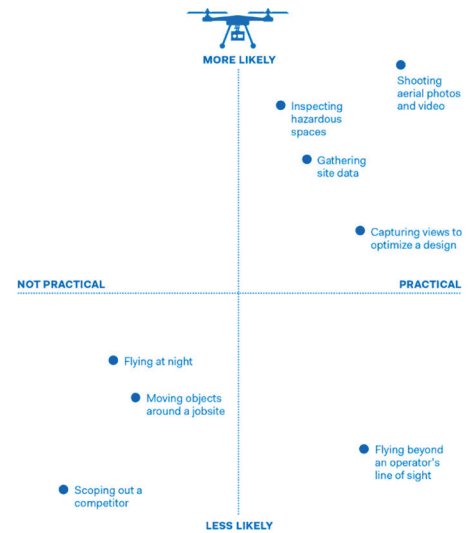
Just because you can (technically) use a drone, doesn't mean you should. We plotted potential uses of the technology in architecture and construction based on how likely each is to pass muster with the federal government compared to how practical the use is in the field.

Figure 4 – When to use a drone. From Architecture.

A recent article in *Architecture* magazine included the chart in Figure 4, outlining when to use a drone. The horizontal axis represents the practicality of the application, and the vertical axis is an estimate of the likelihood that the FAA will approve the application.

According to this chart, the use of drones to photograph building façades and roofs is classified as practical and is more likely to receive approval from the federal government.

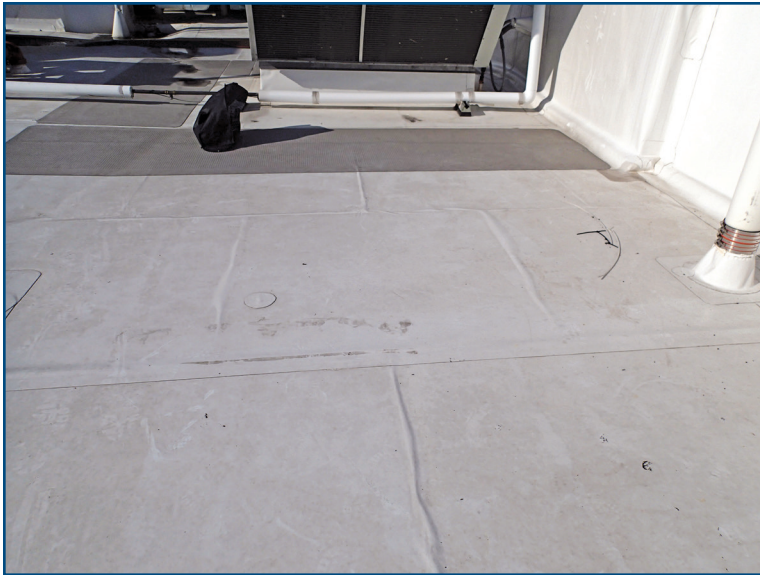
**Figure 7 – Low-sloped roof areas of educational building in Figure 5.**

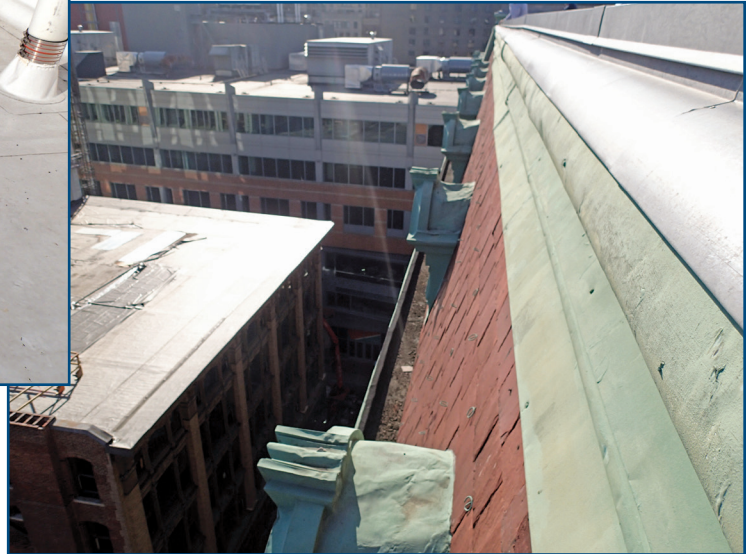
**Figure 8 – Steep-sloped mansard roof areas of educational building in Figure 5.**

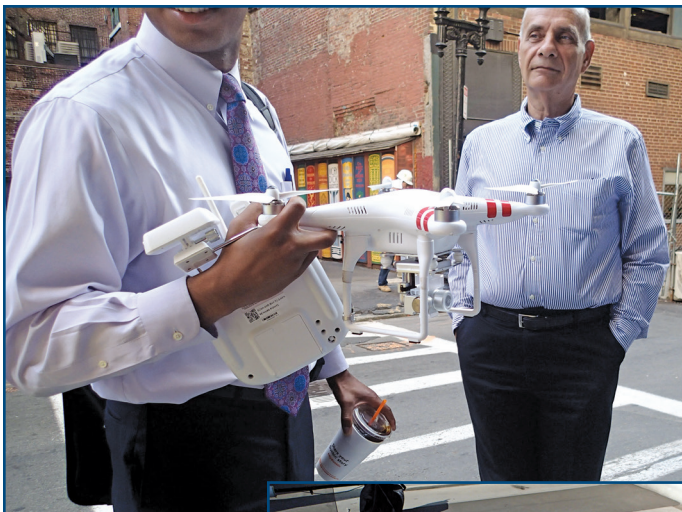
**Figure 9 – Drone and controller used to survey.**

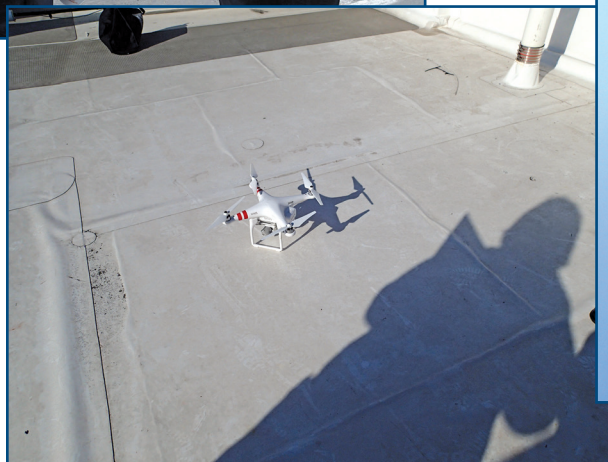
**Figure 10 – Drone ready to take off from low-sloped roof area.**

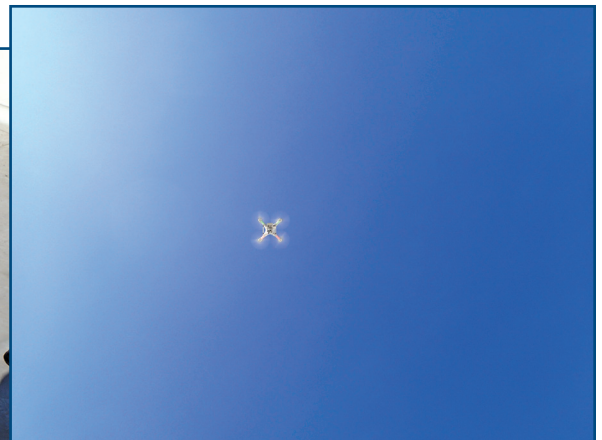
**Figure 11 – Drone in flight.**

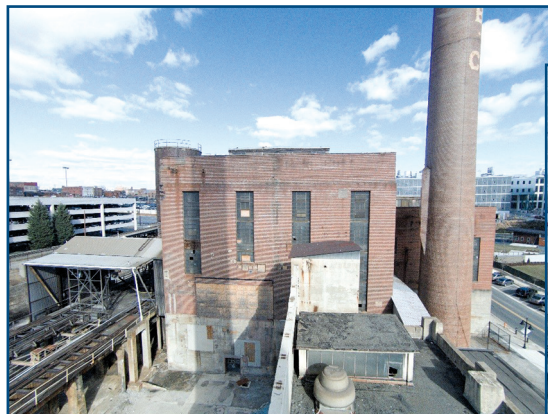
Figure 14 – Image from a drone.

ious components of the complex identified. The drone was used to photograph the conditions of the chimneys and silos (Figures 14 and 15).

The terra cotta shell face has sheared at the units near the base of the right silo. (A video of the images from the drone will be shown during the presentation.)

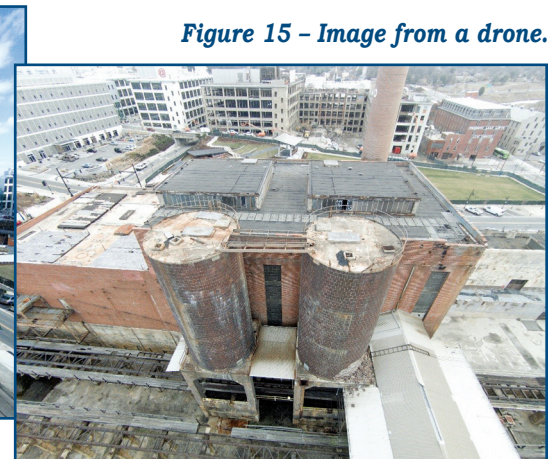
Figure 15 – Image from a drone.

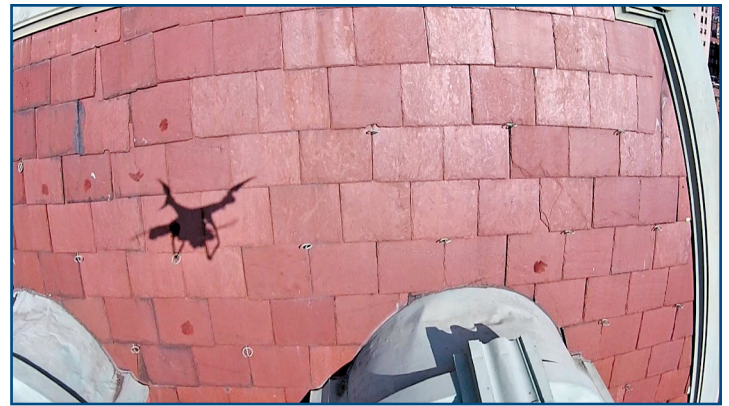
Figure 12 – Image from drone of steep-sloped, mansard roof area of educational building in Figure 5.

A report with images and types of deficiencies was prepared, including images from the drone (Figure 12).

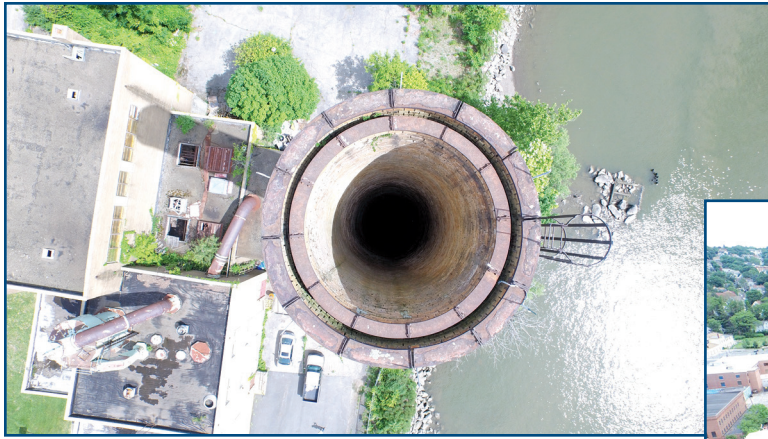
**Figure 16 – Image from a drone, looking straight down a chimney.**

Figures 16 and 17 show some dramatic photos from other assessments using a drone.

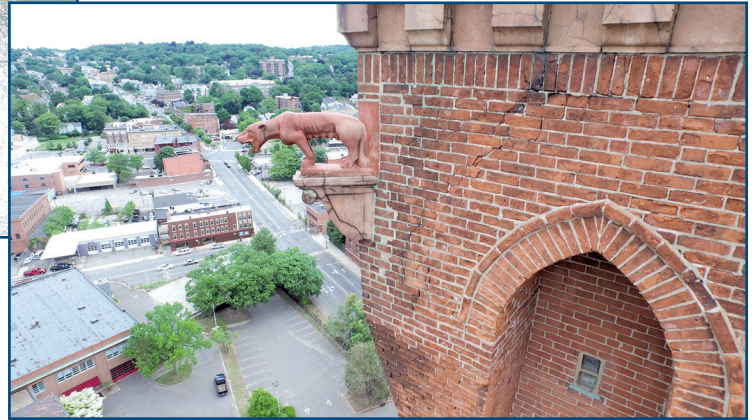
**Figure 17 – Image from a drone. Crack in brick masonry is visible.**

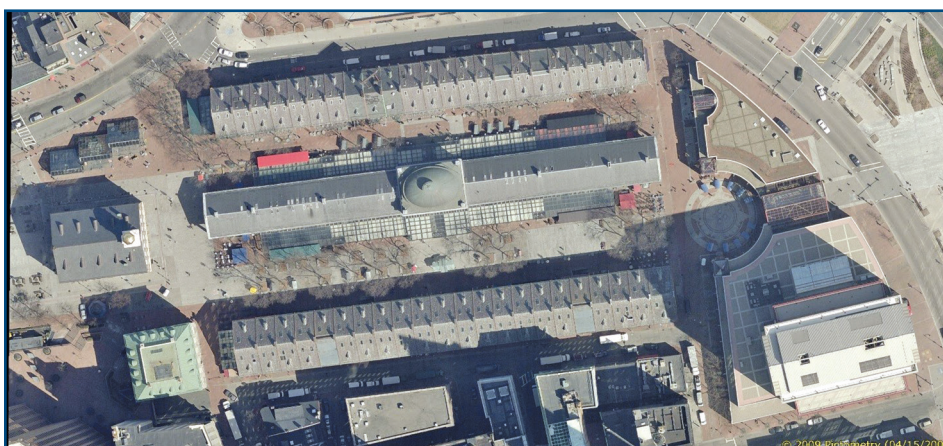
**Figure 18 – Aerial view of the three-building complex.**

WJE was asked to review conditions of a slate roof that was reportedly damaged by ice damming. The roofs are on a three-building complex that is a well-known tourist destination in Boston; the location is home to offices, retail, and restaurant tenants. The buildings are linear, with north, central, and south buildings. The central building is three stories tall and contains a large dome. The north and south buildings contain five and six floors, respectively, with dormers and skylights within roof areas separated by short brick masonry firewalls

that extend above the roof surface. The insurance claim suggested that a certain percentage of slate shingles were damaged over the winter and should be replaced. Trees are planted between the buildings, which block direct views from building to building. Because of the height of each building and the distance between buildings, views of the roofs from grade is prevented. Even views from neighboring buildings are difficult except from the parking garage on the north, where the north-facing slope of the north building is clearly visible.

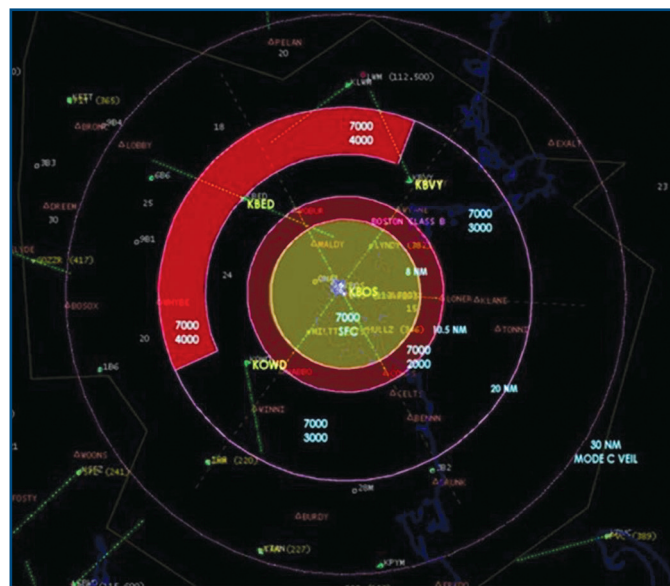
**Figure 20 – Boston Logan Airport airspace plan view.**

Figure 20 shows a Class B area. Figure 21 is a generic picture of a Class B area with the wider rings arranged like an upside-down wedding cake.
