IIBEC BUILDING
ENCLOSURE SYMPOSIUM (BES+)
NOVEMBER 9, 10, 12, 16, 17, 19, 2020

A Burning Question: Fire Testing of a Window Wall System With Spray Foam Insulation

Stéphane Hoffman, PEng

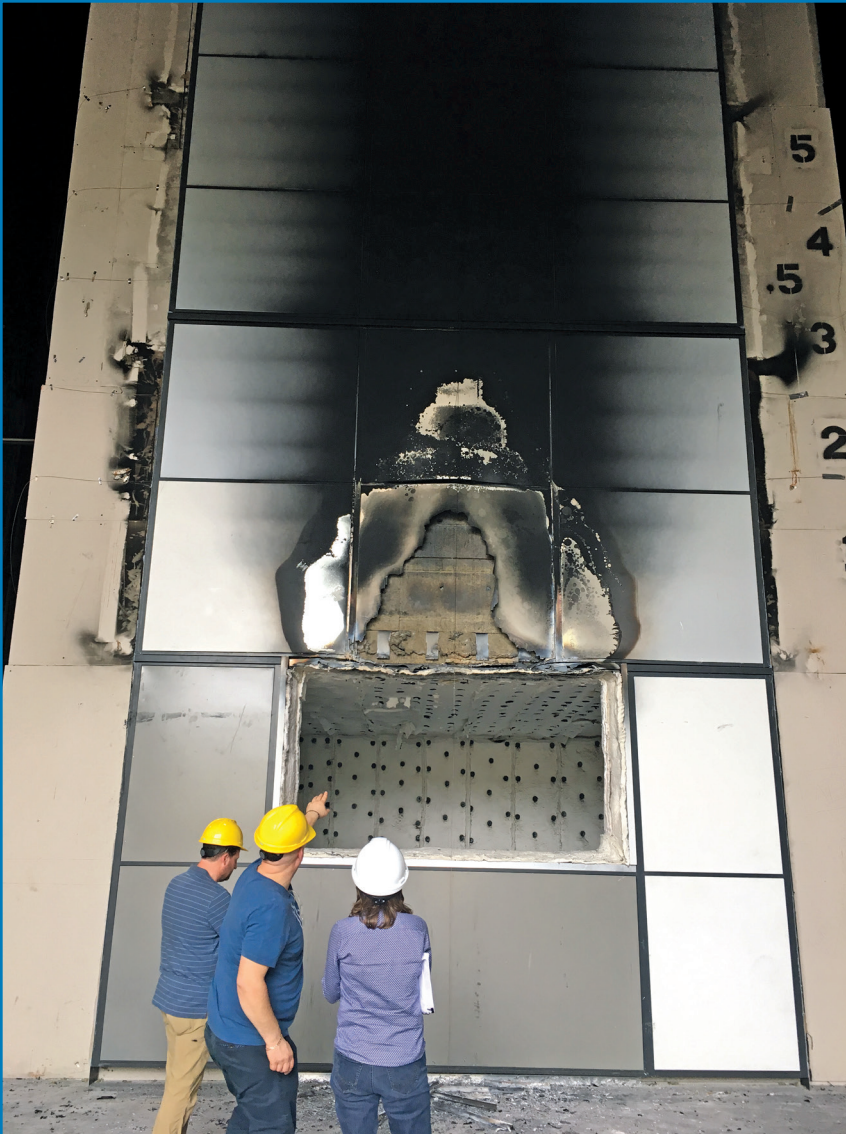
Figure 4 – Apex of burn pattern above window opening.

Following the test, a cone-shaped pattern was visible on the exterior metal panels. The apex of this pattern extended 2.5 m above the window opening (*Figure 4*). The metal skin of the exterior metal panel had fallen off, exposing the mineral-wool insulation to a height of 1.4 m (*Figure 5*) above the window opening. The slab-mounted deflection header at the opening was approximately 90% consumed. The top row of exterior metal panels showed only smoke damage and slight warping of the exterior metal panels. The window wall panels were then dismantled and observed for signs of damage. The top row of window wall panels showed no damage to the spray foam layer. The next row of window wall panels immediately above the window opening showed damage. The exterior metal panels on either side of

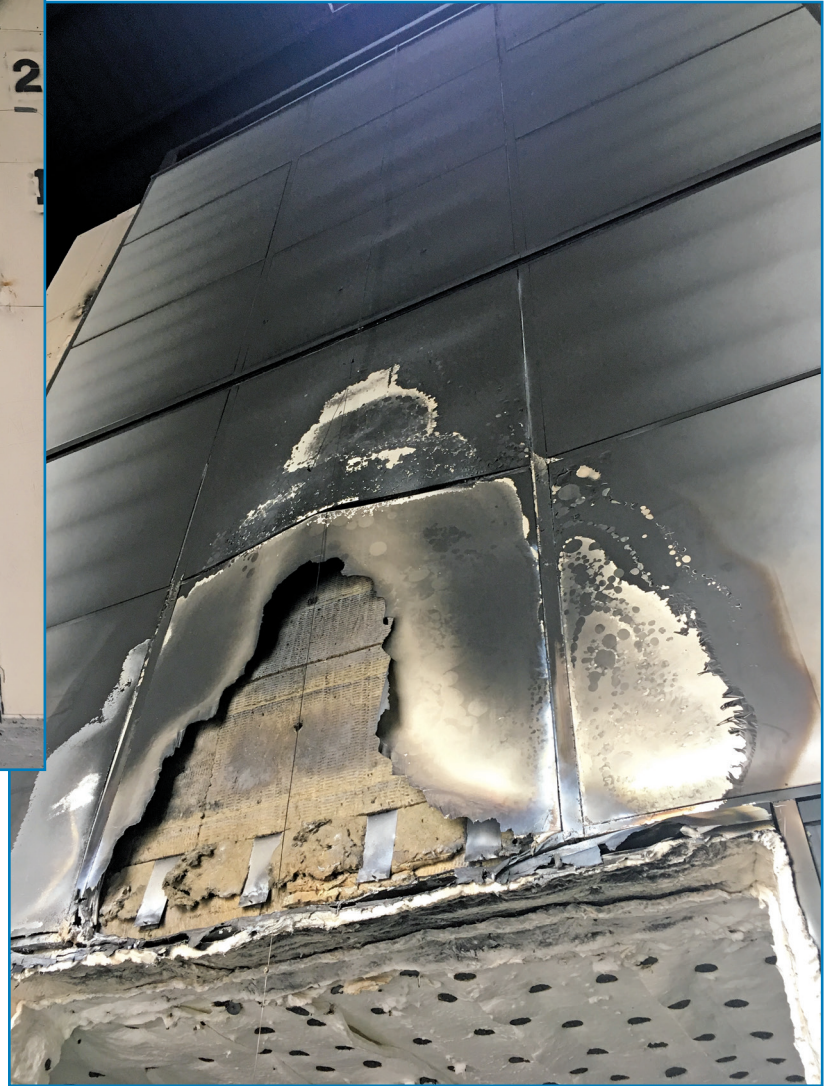
Figure 5 – Exposed mineral-wool insulation above window opening.

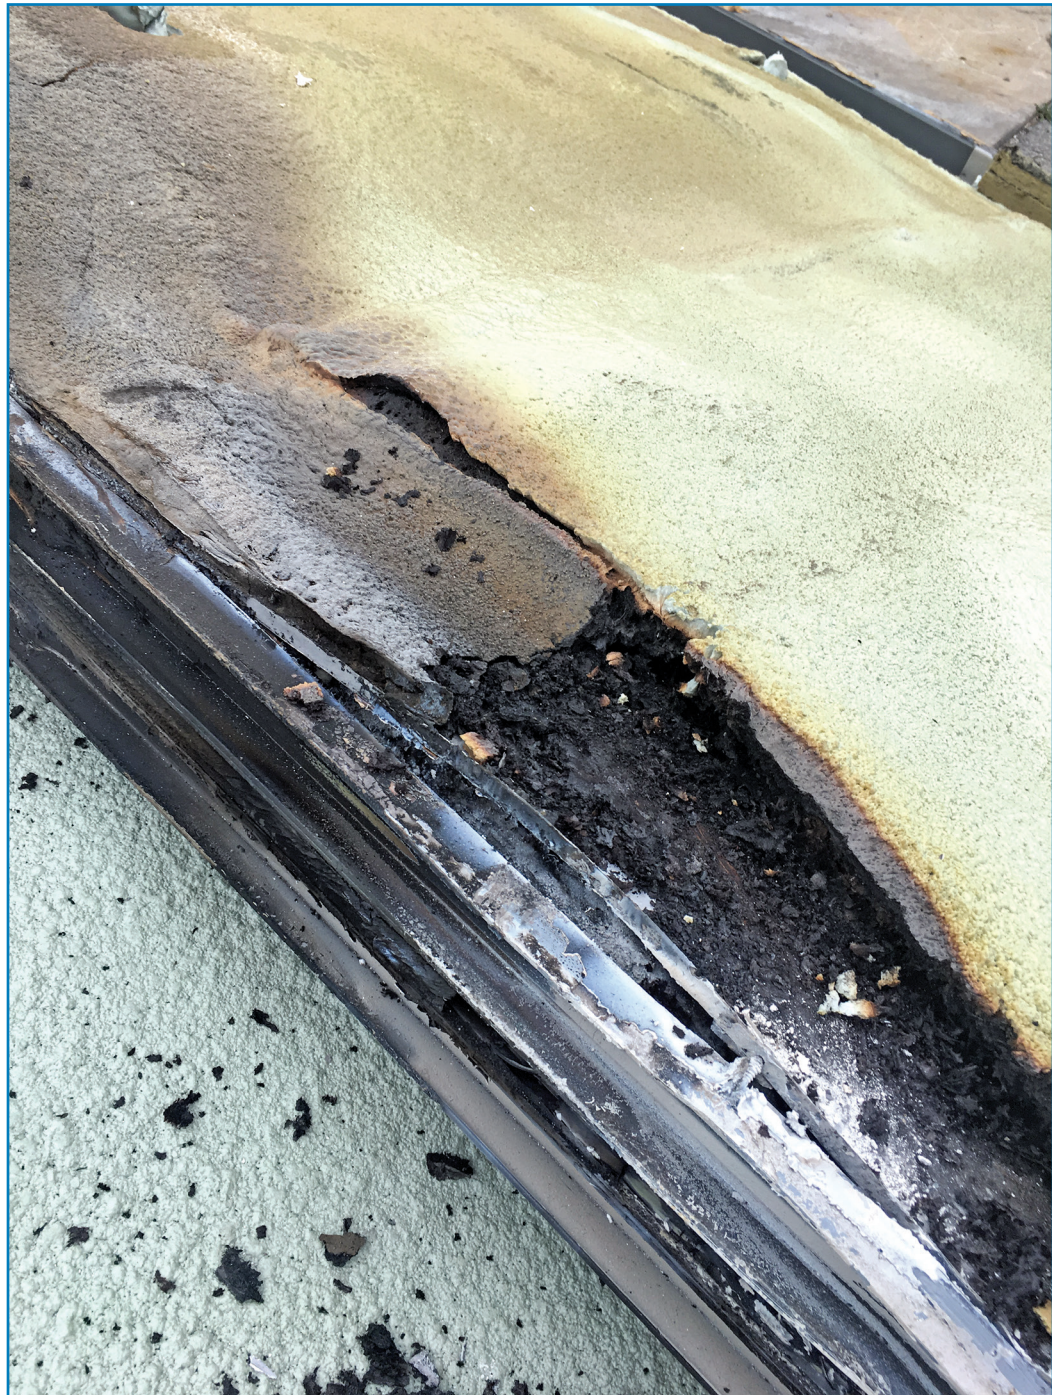
Figure 6 – View of localized charring of spray foam at vertical above-window opening.

the opening showed signs of smoke damage and warping. There was some sign of charring of the spray-foam insulation at the vertical window-wall panel joint, and the aluminum vertical mullion was also damaged (*Figure 6*). The center panel was more damaged. The exterior metal skin was melted to a height of 1.4 m. Approximately half the thickness of the spray-foam insulation remained. There was also damage to the vertical mullion. After removal of the
