# Moisture Movement and Condensation Control in Exterior Wall Assemblies

**Karim Allana, RRC, RWC, PE**

*Allana, Buick & Bers, Inc.*

**IIBEC 2020 Virtual International  
Convention and Trade Show  
June 12-14, 2020**

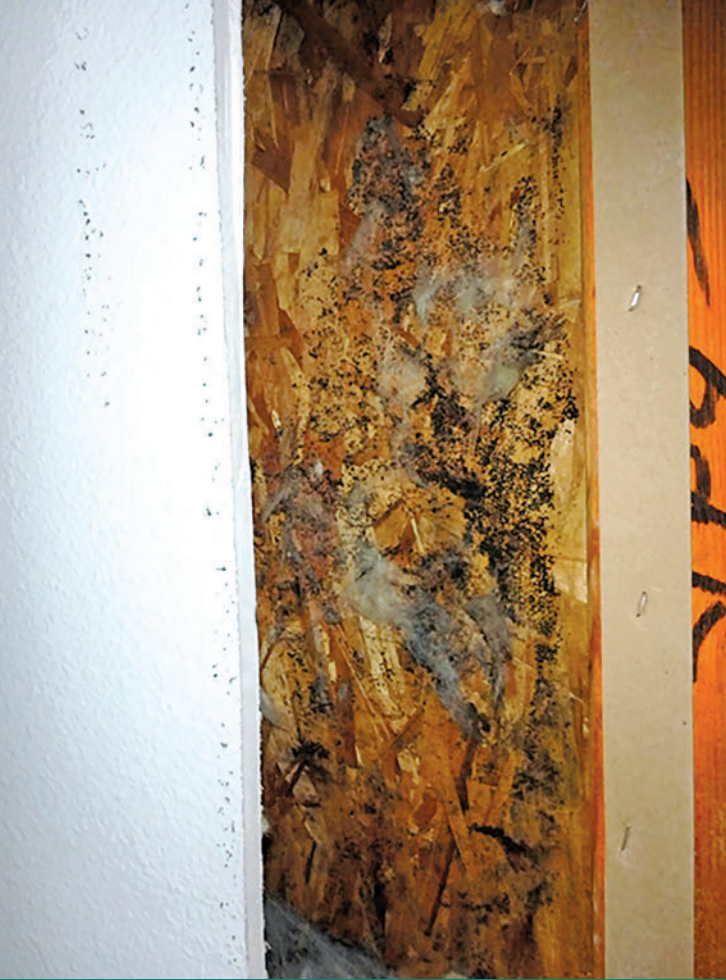
**Figure 1 – Decay on back side of OSB sheathing.**

We opened up gypsum board in the various units available to us and observed severe damage to the exterior oriented strand board (OSB) sheathing. Based on our visual observations, we identified several potential sources of wall and window leaks and proceeded to perform water testing to identify the sources of the leaks. We removed the interior gypsum board and observed severe damage inside the wall cavities. Most of the damage was on the back side of the exterior wood sheathing as seen in *Figure 1*.

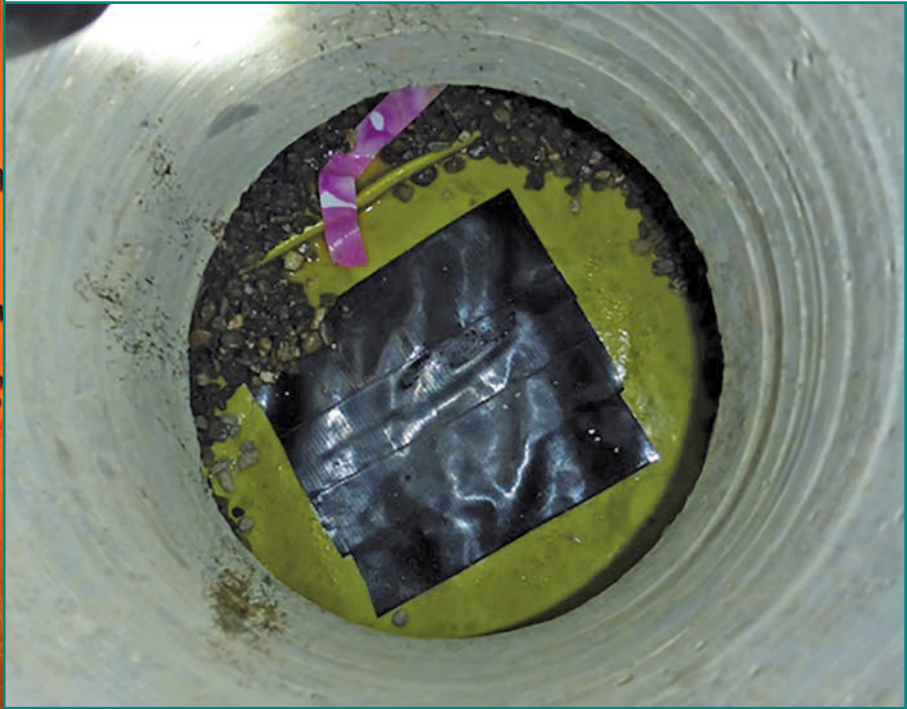
**Figure 2 – Water under concrete slab.**

Our investigation found that the foundation wall was allowing water from the landscape irrigation system to migrate under the slab, increasing vapor movement through the slab and potentially contributing to high interior humidity. Based on water testing of the foundation wall, liquid water migrated on top of the vapor barrier (as seen in *Figure 2*). We observed improper termination of the under-slab vapor retarders.

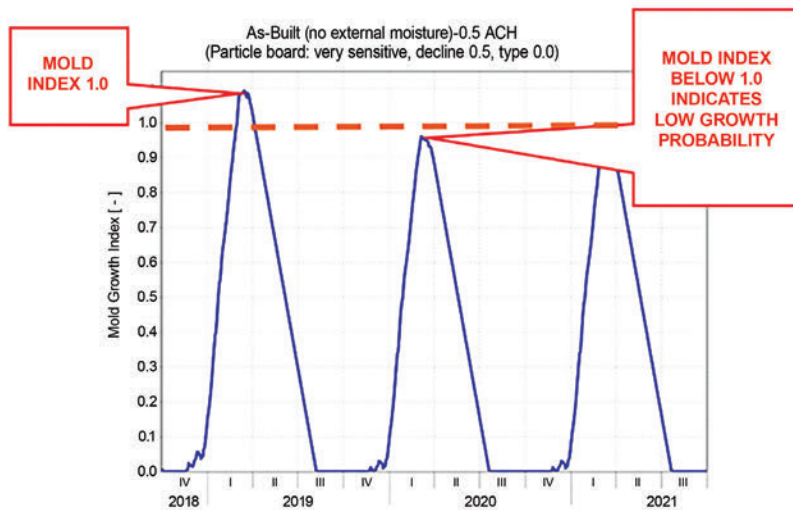
The WUFI results for Run 1 look good, but they do not represent actual site conditions. This is an example where “typical or default” input into the software will output results that do not represent real-world conditions.

Figure 5 – WUFI model Run 1: mold index.

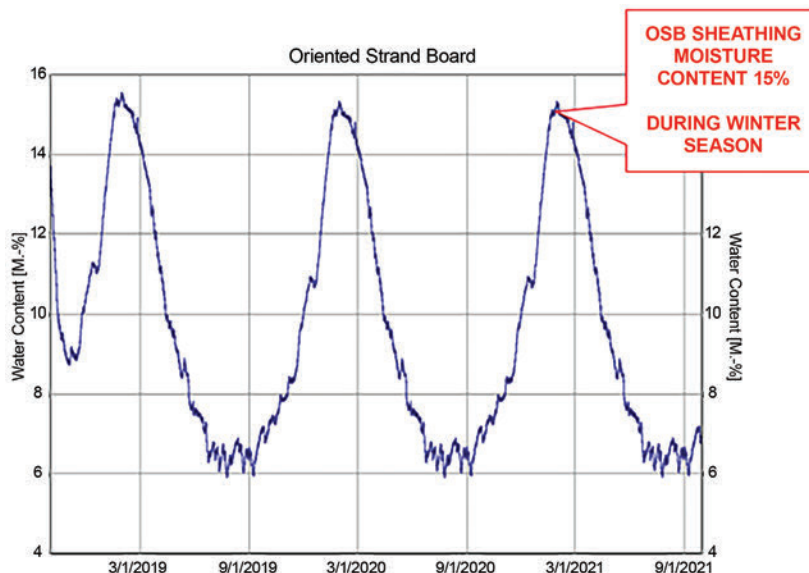
Figure 6 shows the modeled moisture content of the OSB sheathing. We can see that the OSB moisture content went as high as 15% during the winter season, according to the model.

Figure 6 – WUFI Run 1: sheathing moisture content.

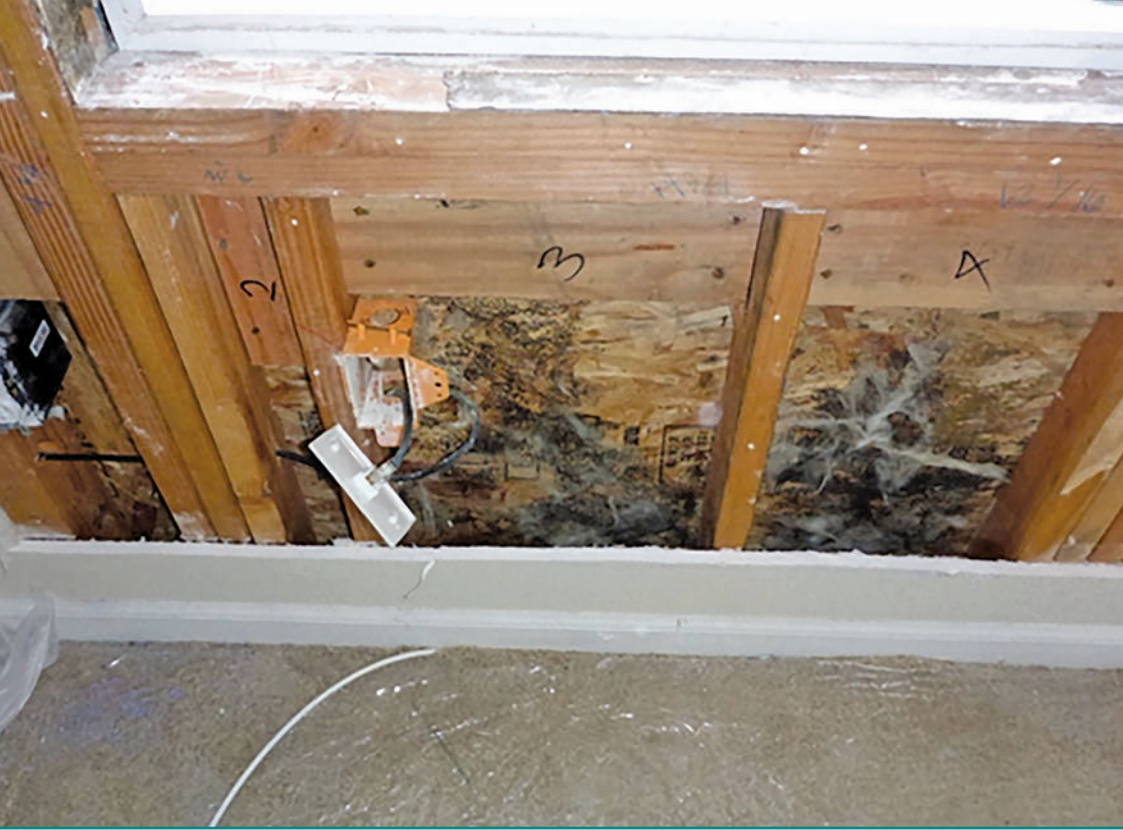
**Figure 8 – Biological growth on back side of wood sheathing after removing gypsum board.**

on the surface, and there were severely corroded fasteners through the exterior wood sheathing (Figure 8).

The overdriven and corroded fasteners indicated that the board had been wet for long periods of time. We removed the gypsum board and exposed the wood sheathing, which had heavy staining and
