Historic Industrial Building Reuse and the Building Enclosure

This paper was presented at the 2023 IIBEC International Convention and Trade Show.

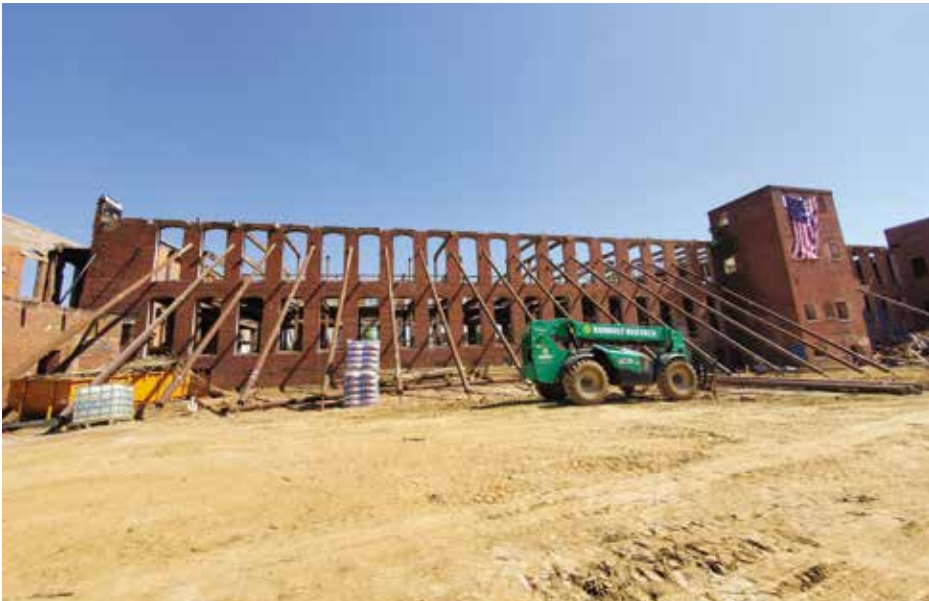
Figure 1. Overview of previous industrial mass masonry structure during construction of adaptive reuse project.

THE INDUSTRIAL REVOLUTION in the United States brought about large-scale industrial facilities throughout the country. During the late 19th and early 20th century, these industrial facilities were generally constructed using mass masonry. Mass masonry structures are composed of multiple-wythe brick masonry and may include stone, concrete masonry units, cast stone, and terra cotta. Mass masonry was common for industrial structures during this period, as brick masonry could be fabricated from local materials and could be manufactured in a size that was manageable for the labor force. In addition, this type of construction was adequate for the industrial use requirements of the period, as the load-bearing masonry walls had a long service life (**Fig. 1**).

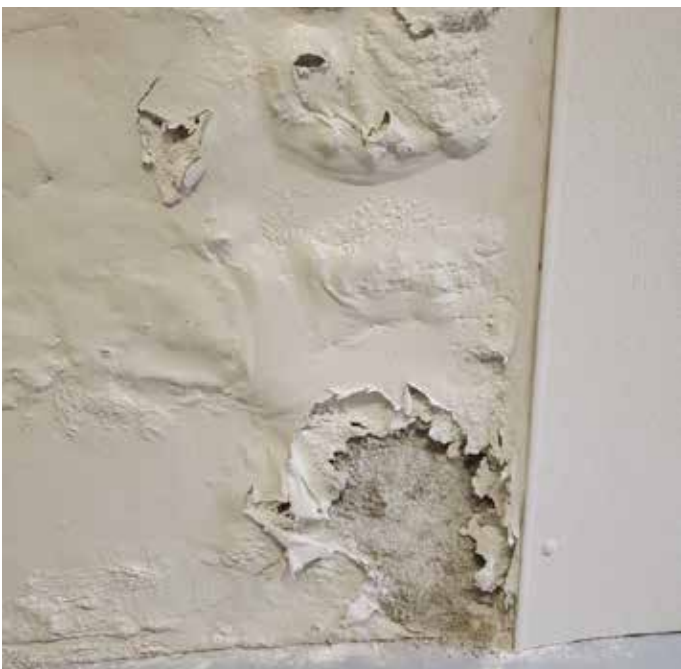
Figure 2. View of moisture-related damage to interior finishes.

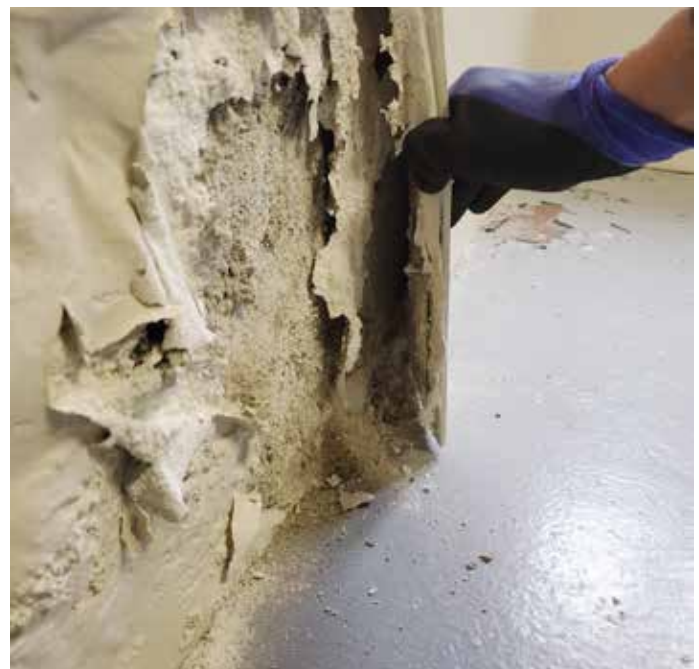
Figure 3. View of low permeability barrier installed at wall interior.

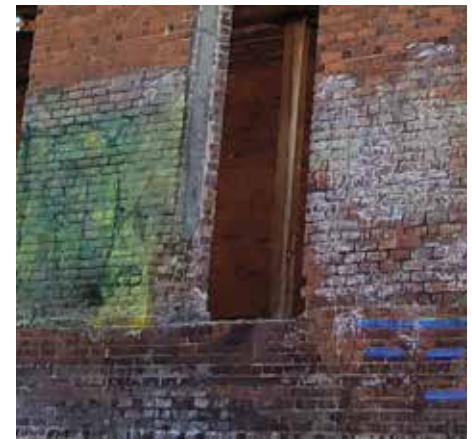
Figure 5. Representative view of masonry requiring restoration.

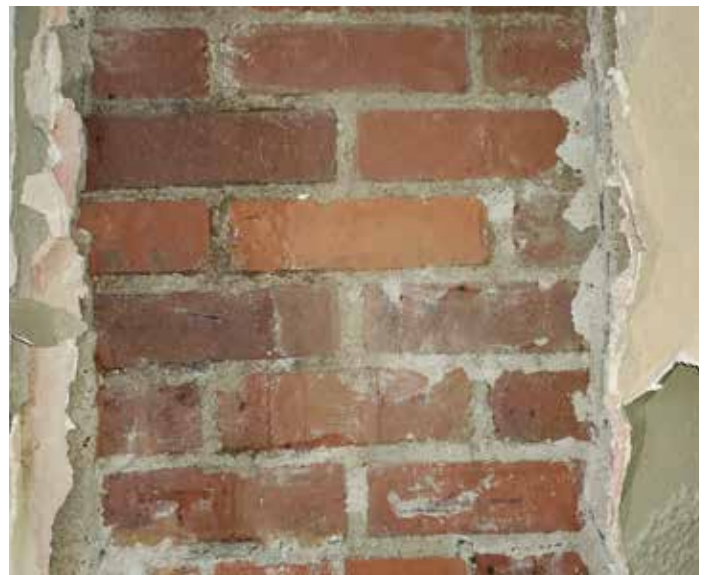
Figure 7. Representative view of damp portion of wall with water weeping from anomalies at the interior masonry surface.

Water intrusion at a condensed interior entry point indicates a more direct pathway through the masonry wall (Fig. 7).

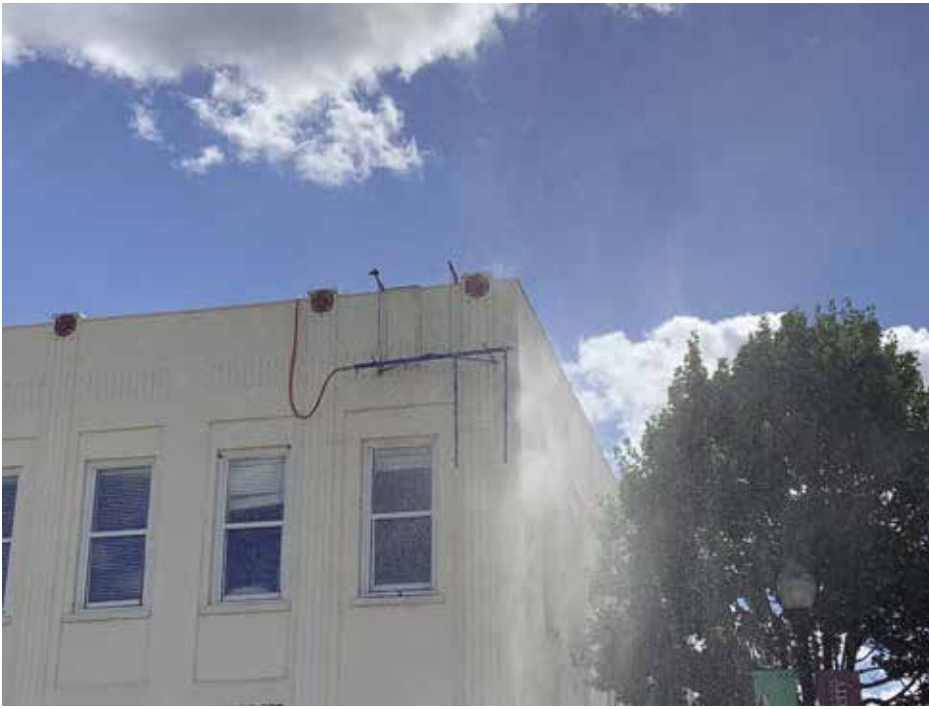
Figure 8. Representative view of Modified ASTM E1105 testing of mass masonry.

A modified ASTM E1105 procedure is available for testing of masonry (Fig. 8). It is titled *Using Modified ASTM E1105 to Identify Leakage Sources in Building Wall Systems*.⁵ This modified procedure recommends utilization of a similar water application rate, but instead of a 15-minute test duration, a 30-minute test duration is specified. This modified method lists

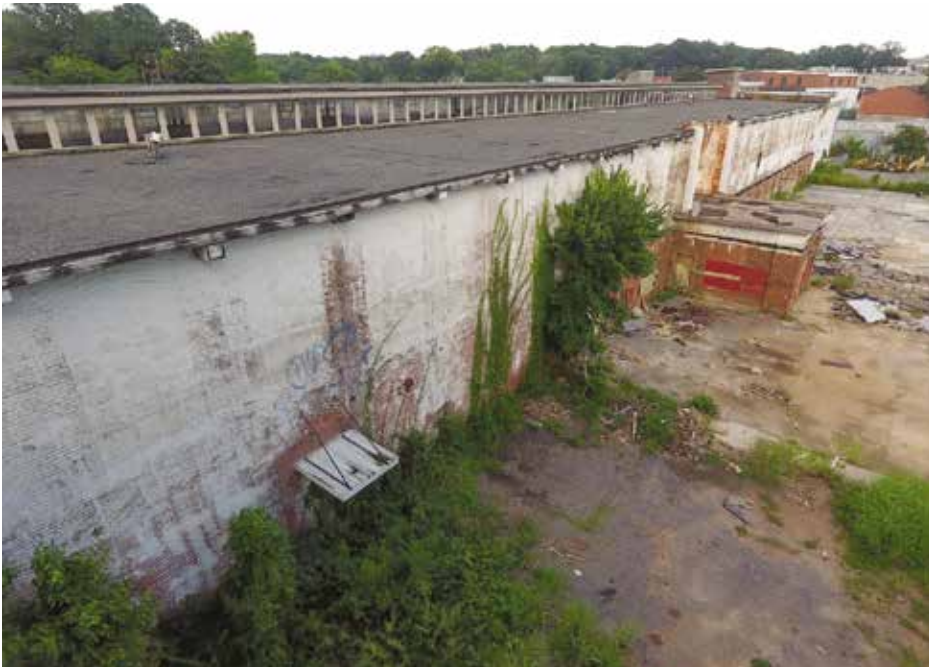
Figure 9. View of cotton mill constructed in 1897.

A former cotton mill constructed in 1897 was reimagined as a high-end apartment complex (Fig. 9). The two-story structure consisted of brick mass masonry wall construction with stucco applied over the brick at various locations. The spaces include primarily residential units, leasing office, recreational space, fitness room, and clubhouse. Construction consisted of interior and exterior renovations, including window replacement. The existing window systems were 12 feet tall with segmental arched tops replaced as part of the renovation. The arched head and jamb interfaces were mass masonry with the sill finished in concrete (Fig. 10). Shortly after the building opened, leaks were reported by residents at windows. Water testing was performed on the assemblies isolating the fenestration system and the surrounding construction independently. Windows installed in mass masonry construction require particular attention to detail, as the interfaces surrounding the windows provide opportunities for moisture to penetrate the masonry and migrate beyond the system and into the interior space. Upon investigation, it was determined that water intrusion was a combination of the assembly construction including sealant joints as well as migration through the masonry adjacent to the fenestration. Recommendations provided to the client first included the repair of the fenestration assemblies. Because the fenestration assemblies were customized, limited modifications could be provided

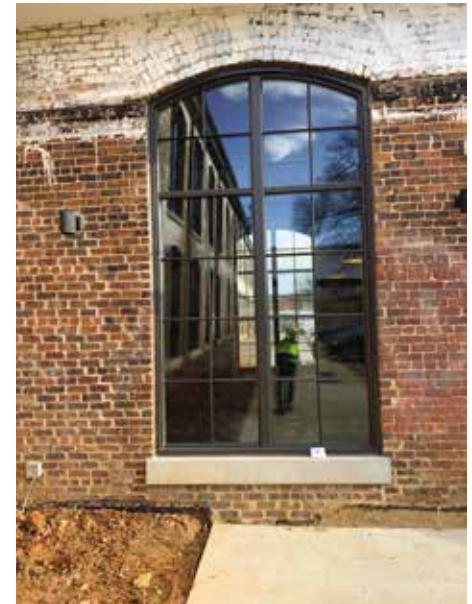
Figure 10. Representative view of new fenestration installed in existing mass masonry wall opening.

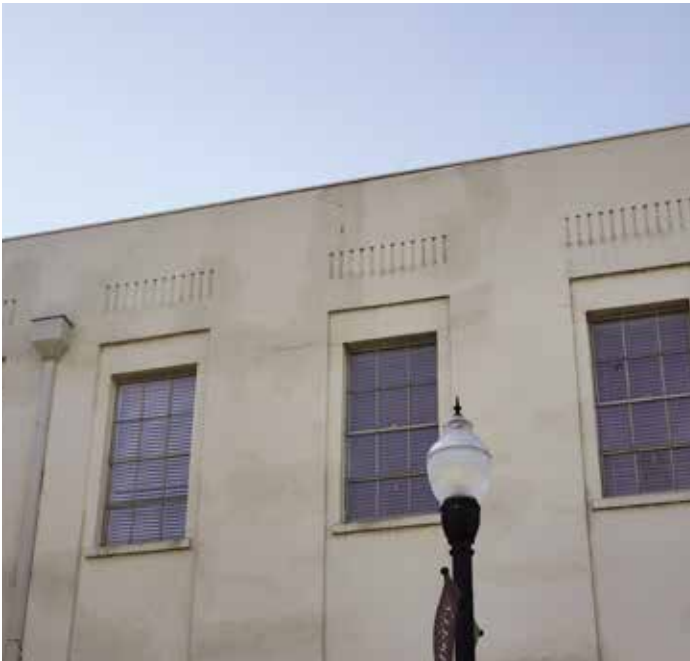
Figure 11. Representative view of cracking in stucco.

In recent years, the building owner had repaired numerous problems with the exterior and interior stucco (Fig. 11). The exterior cracks had been repaired in 2010 and 2016, yet the interior continued to experience water damage in the form of the soft stucco coat spalling and the interior paint bubbling. Terracon was contracted to do visual observations and water testing to determine the source of the water intrusion and interior damage (Fig. 12).

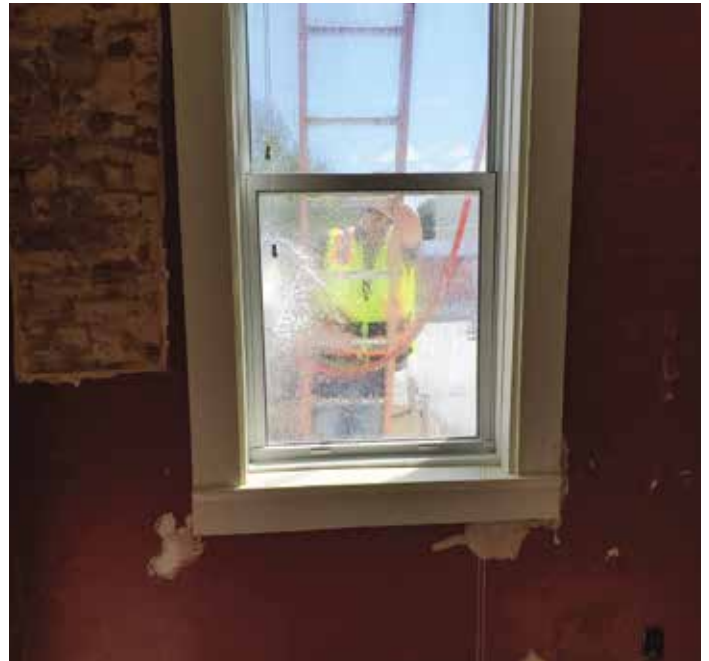
Figure 12. Representative view of forensic water testing.

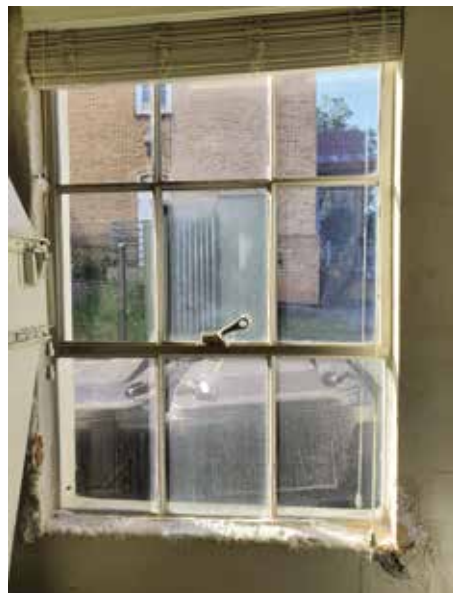
Figure 13. Representative view of original fenestration.

infiltrating the stucco substrate (Fig. 13). Through capillary flow and the drying of the exterior wall to the building interior, a significant amount of liquid water and water vapor were damaging interior finishes (Fig. 14). Difficulty arose in understanding which exterior conditions created which interior damage. Water from testing was revealing itself on the interior in locations unexpected by the testing team.

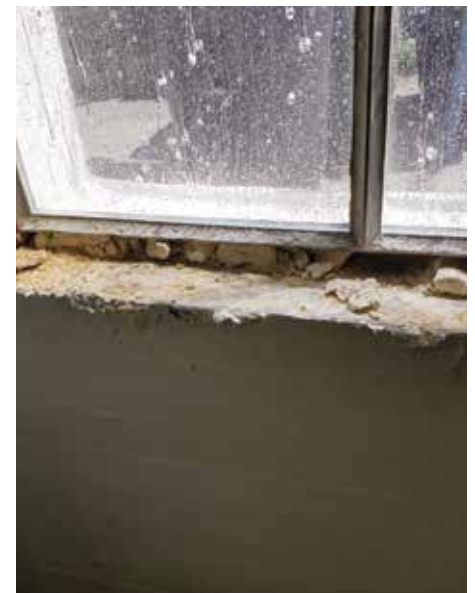
Figure 14. Representative view of soft stucco wrapped into the window rough opening.

couple of months. This was to ensure most of the walls would be dry enough to not create further problems with interior finishes. The interior finishes were also addressed. The soft stucco was recommended to be removed and replaced with cement stucco, which would be less susceptible to moisture damage. To help allow the wall to dry to the interior, high-permeability paint was specified.
