Mysterious Moisture Marks: Assessment of Water Stains at Window Glazing

By Patrick St. Louis, LEED;
Krishna Sai Vutukuru, PhD

This paper was presented at the 2023 IIBEC International Convention and Trade Show.

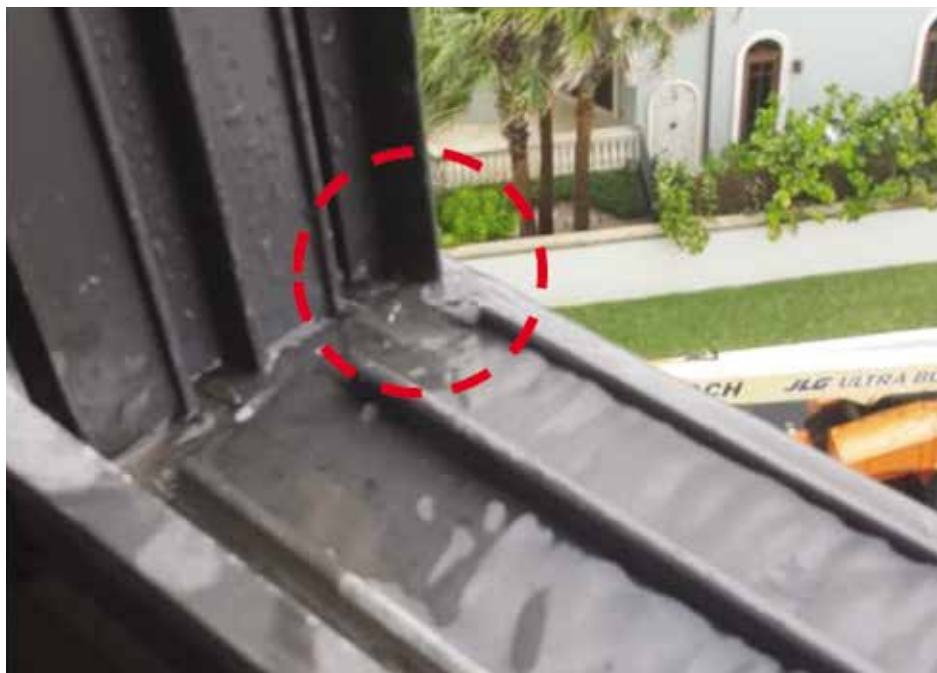
Figure 1. Base of sliding window was previously blocked and allowed water accumulation.

Typically, a single-hung system consists of two glass panels (sashes). Single-hung windows open vertically, with one window panel or sash moving up and down and the other sash remaining stationary. Thus, when you open the window, the upper sash is covered on the inside. How these sections move is the major difference between single-hung and double-hung windows. If the operable sash of the window is impeded from functioning properly, that could lead to gaps and seams that allow water intrusion. Field consultants who perform or oversee water penetration field-testing procedures such as ASTM E331⁶ should be knowledgeable at the vulnerability of each window type. ASTM E331 diagnostic water intrusion testing or a field modified version (based on site conditions), delivers water via spray nozzles near perimeter openings such as windows and doors. This growth may be related to poor insulation practices, which lead to a buildup of condensation within a grid pattern, with the water uniformly sprayed and directed at the vulnerable areas. Within properly installed single-hung windows, vulnerable areas likely include exposed fasteners, gaskets, and the operable sash. There are many other deleterious conditions at window bases that impede watertightness (Fig. 1).

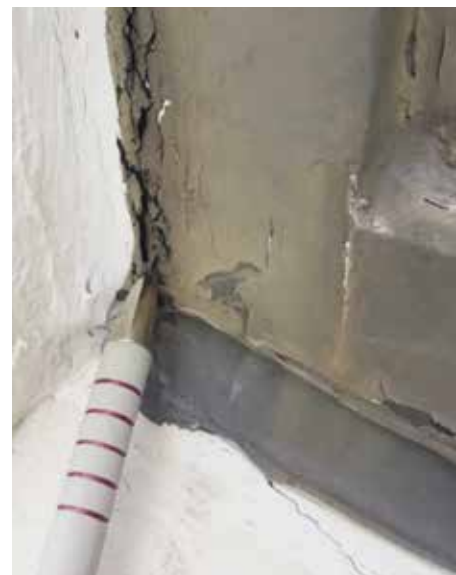
Figure 2. Aged sealant conditions around a window.

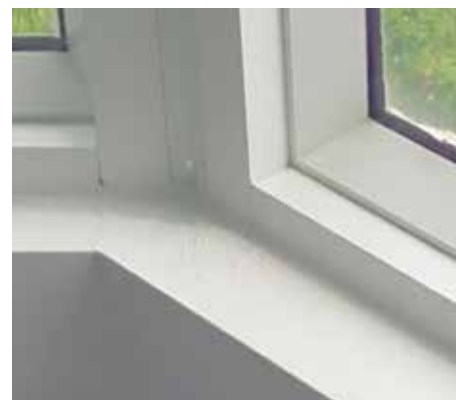
Figure 3. Improper assembly at the joining of window systems.

Although defects may be difficult to observe in an installed window system (Fig. 3), exposed defects may be noted during a visual inspection. Outside the wall, gaps and

unsealed elements might be noted in the exposed window joinery and miter joints. Separation and other defects tend to occur at the 90-degree angles of the corner miter joints. The lack of a firm seal at mull bars or at the joining of window assemblies may also allow water intrusions.

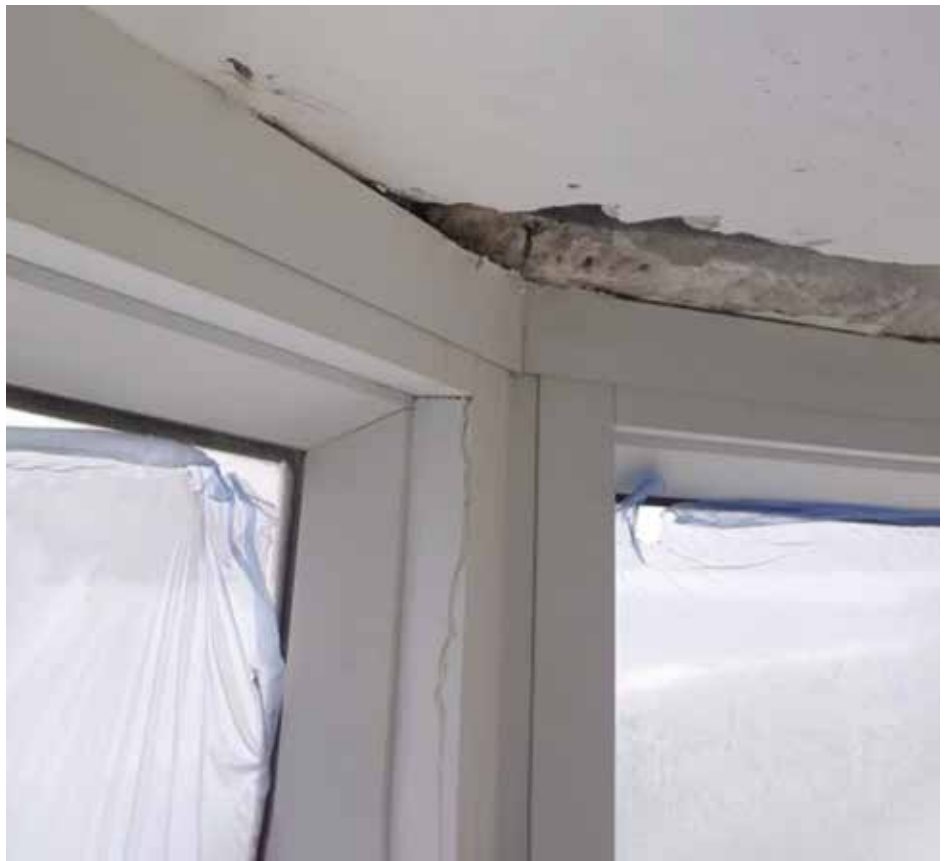
Figure 4. Red stains reveal compromised conduit not window assembly.

Another sign of a window leak is the appearance of stains or discoloration. The area could be dry or wet, and the stains may be copper, yellow, or brown residue. Growth of the stain over time is a likely sign of a leak. Reddish staining can also be a sign of corrosion of metal fasteners or structural rebar reinforcement (**Fig. 4**).

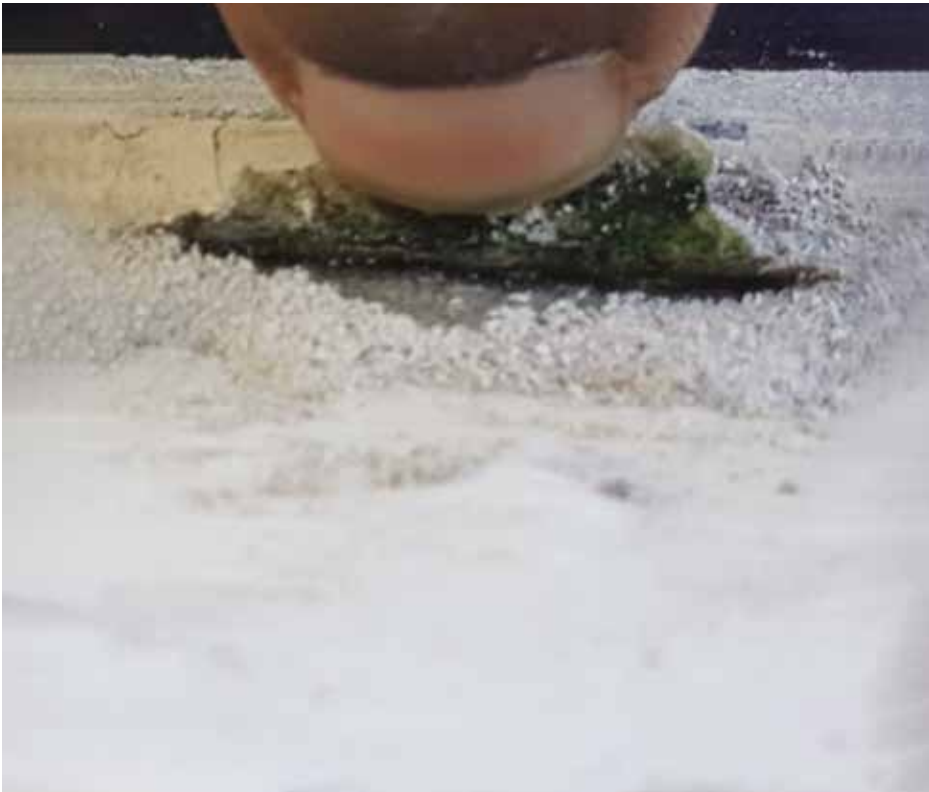
Figure 5. Example of bio growth.

Biological growth often occurs in areas of excess moisture such as bathrooms, kitchens, and basements. If it appears on or around windows in an area without any plumbing fixtures or any obvious sources of running water, the cause is likely a leaky window. Biological growth can look spotty and fuzzy (**Fig. 5**). In addition to being an eyesore, airborne spores can adversely affect health and well-being or produce musty odors. The odor often stems from areas where moisture has been accumulating for long

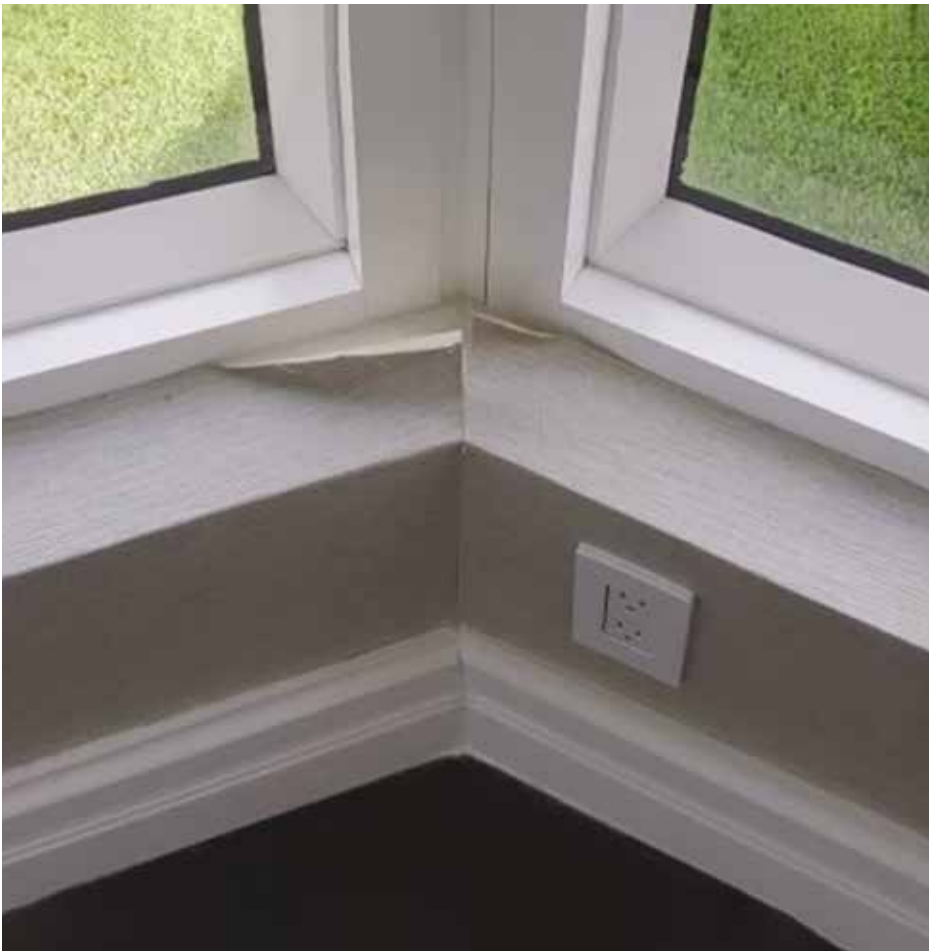
Figure 6. Distortion at window.

When drywall absorbs water, this can cause paint to fade and wallpaper to lose adhesion. Therefore, if the interior finishes adjacent to the window assembly begin to distort and peel away from the wall surfaces, leaks in the window assembly should be suspected. Water intrusion through the window assembly can also lead to fading or flaking of the window finishes. Distortions of the window frame such as warping will also compromise the window integrity (**Fig. 6**). Walls around the windows may also exhibit signs of significant separation gaps as the materials warp. Soft spots and spongy materials will sag because of the weight of entrapped water and as building materials deteriorate. The buildup of biological growth, wood rot, and pest infestation can add mass beneath the surface. Extensive warping could be the result of structural damage. These conditions merit additional review and are expensive to investigate and repair.

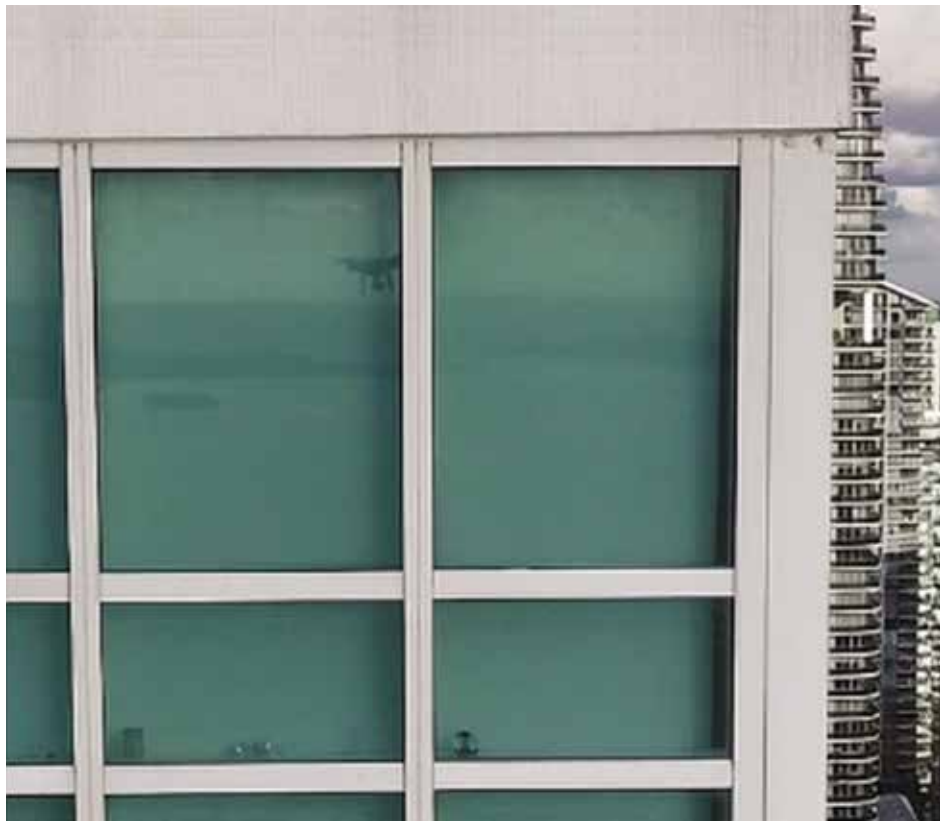
Figure 7. Example use of aerial drone.

Commercial unmanned aerial vehicles (drones) can be used to avoid the need for lift booms and scaffolding as staging equipment. When equipped with a high-quality camera lens, a drone may help the investigator visually note deviations in the facade (**Fig. 7**). Deleterious facade conditions may correlate with the moisture staining, water-related distortion, or biological growth witnessed within the building enclosure. The photographic survey performed by the drone can document from a variety of angles, positions, and heights any threats of structural failure, loss of facade elements, and other potential issues responsible for the water stains.

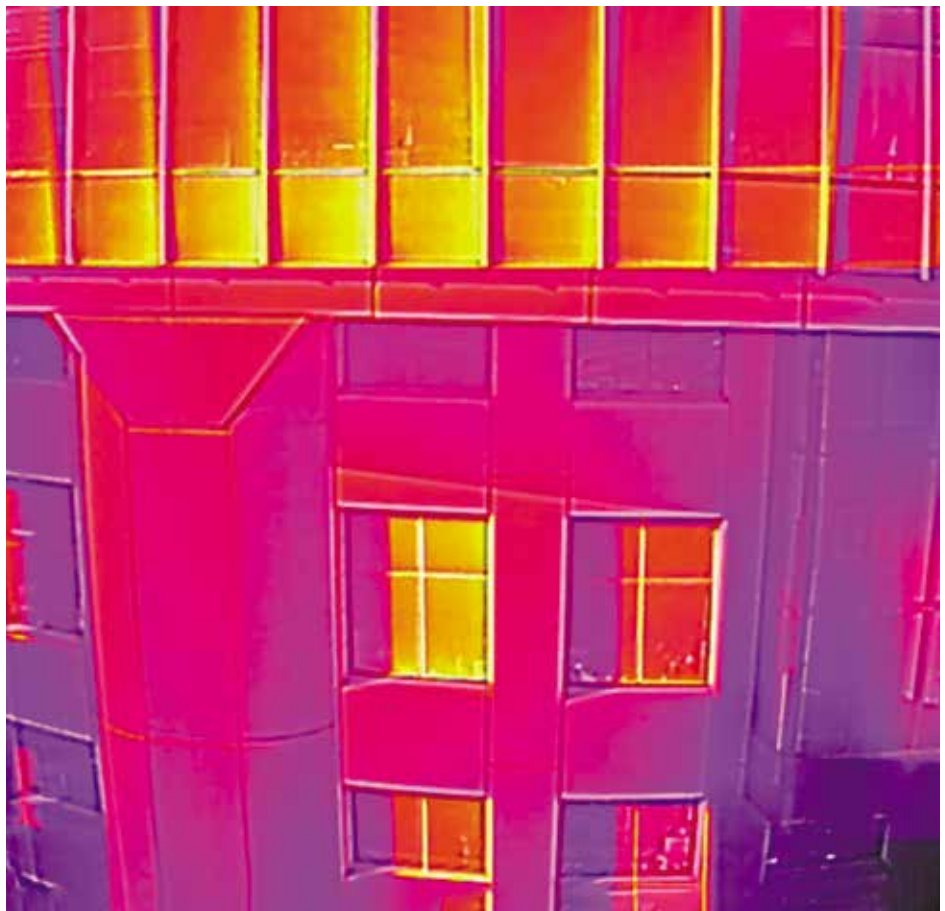
Figure 8. IR facade survey via drone.

Not all defects are visible to the seasoned investigator's naked eye or via the ocular lens of a typical drone camera. It is therefore fortunate that not all cameras are the same. Specialized drones with dedicated cameras with infrared (IR) thermography capabilities are available. The IR thermography can capture the temperature distribution on surfaces and relay that information on a visual spectrum. The drone can be maneuvered across the facade and over large areas in the search of abnormalities. It can also focus on specific areas that may correlate with locations of reported interior water staining. IR imagery may identify discontinuities of the building enclosure's facade that are

not visible by standard methods (Fig. 8). The speed of the IR assessment via drones allows the investigator to view "invisible" conditions within inaccessible areas in an expedited manner, thereby preventing future water damage. Thermal modeling of the facade while using fixed-measure temperatures as point of calibration can be ideal to understand, analyze, and provide recommendations for mitigation.

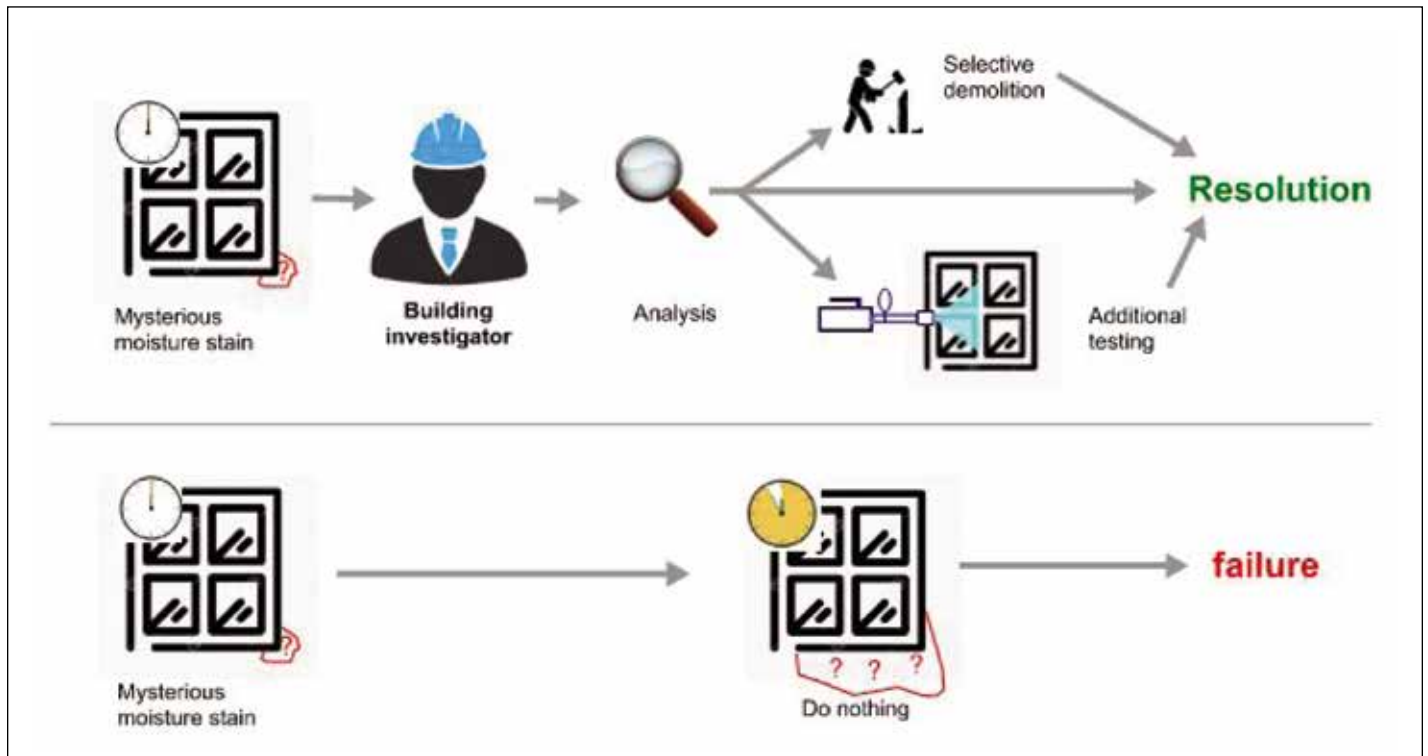
Figure 9. The path of assessment.

- Identifying the physical evidence around the window system without first making presumptions about the source or causality of the staining
- Gathering and documenting the visual information from both the interior space and the exterior environment about the window system and adjacent conditions
- Interviewing owners, tenants, and other stakeholders about the installation, use, and maintenance of the window system
- Reviewing past and present information about neighboring window systems and similar adjacent conditions
