**2024 IIBEC/OBEC BUILDING  
ENCLOSURE SYMPOSIUM**

# PROCEEDINGS

**Best Practices for a Successful Natatorium Enclosure . . . . .**4  
Jonathan Smegal, MASc, PEng; John Straube, PhD, PEng;  
Chris Schumacher, MASc, BASc, BTech, BECxP, CxA+BE;  
and Aaron Grin MASc, PEng

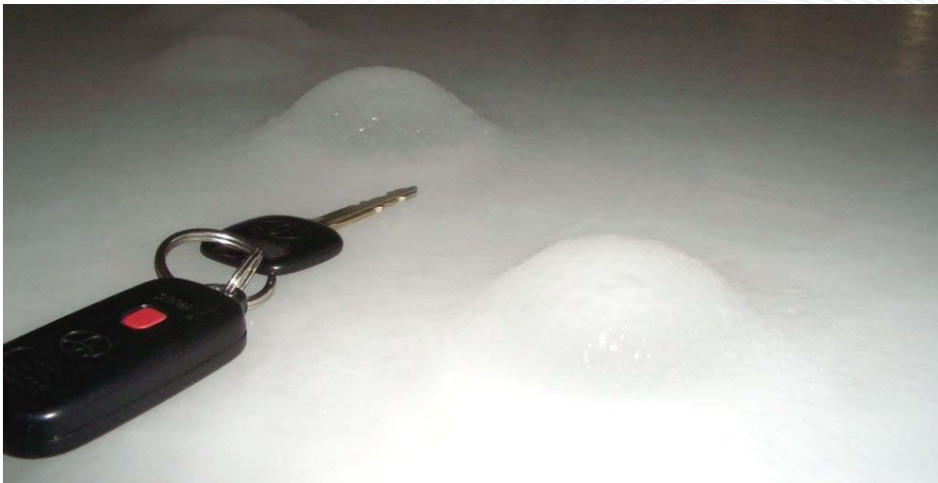
**FIGURE 6.** Mounding on ice formed when air leaked from the common areas and the pool leaked into the ceiling above the ice rink, condensed, and dripped onto the ice.

Case Study 3 was a project in 2006 at a community center north of Toronto that included a pool and ice rinks in the same building, separated by a foyer space. The issue at this building was mounding on the rink ice overnight (**Figure 6**). The mounding was greatest at the end of the rink closest to the foyer and pool and diminished with distance from the foyer. Our investigation determined that air leakage pathways were created on the interior near the roof of the building where the partition walls were not air-sealed to the underside of the roof. These pathways allowed moisture from the pool space and foyer area to

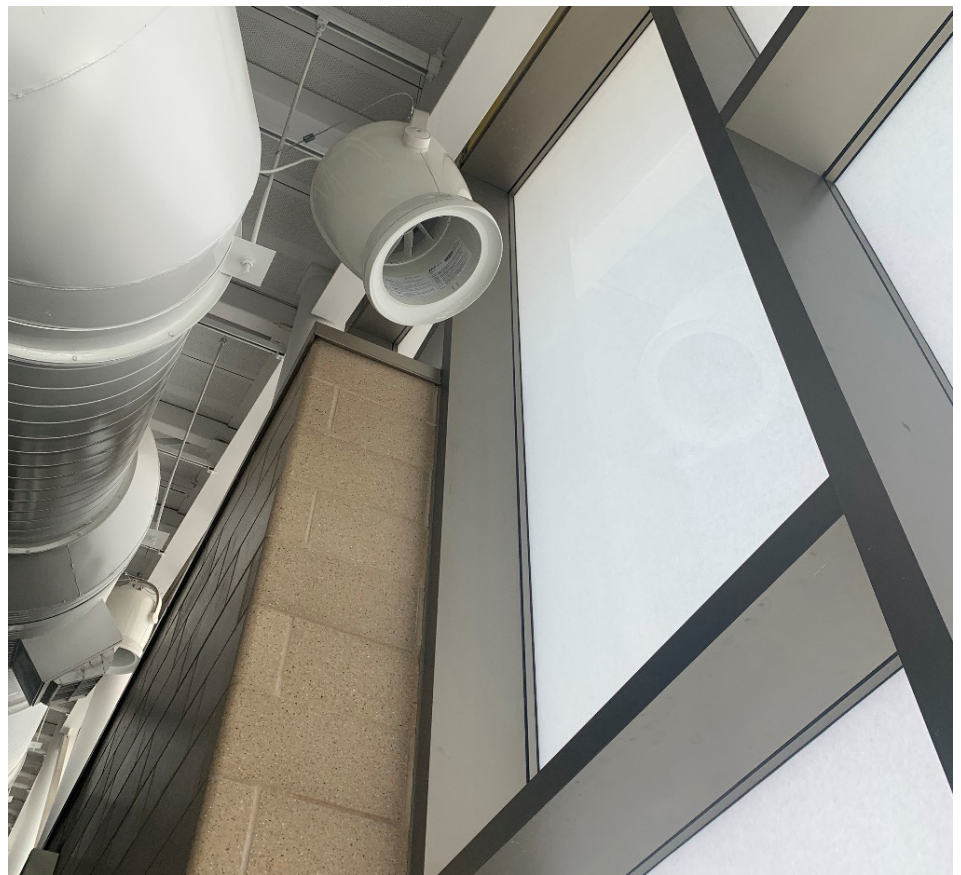
**FIGURE 14.** Fans were added during the building repairs to blow air directly over the windows to reduce condensation on the interior surfaces of the windows.

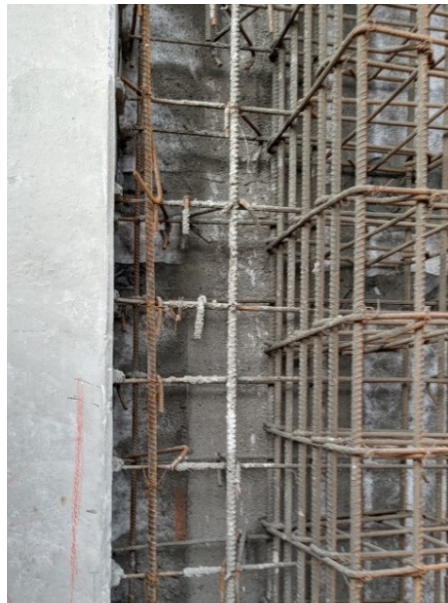
**FIGURE 3.** Shotcrete overspray on sheet membrane after form work was removed. No additional overspray removals were expected.

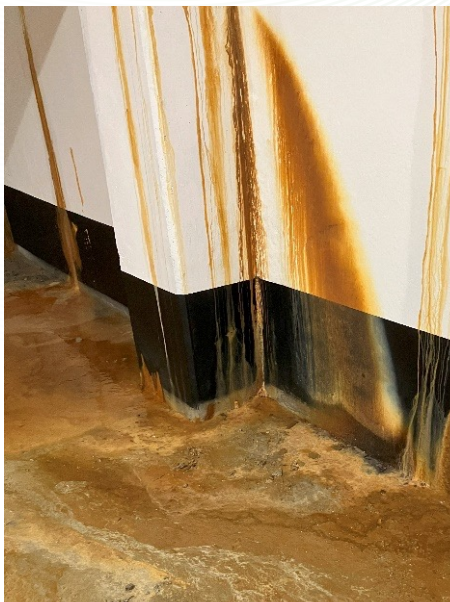
**FIGURE 5.** Water infiltration through foundation wall at column location.

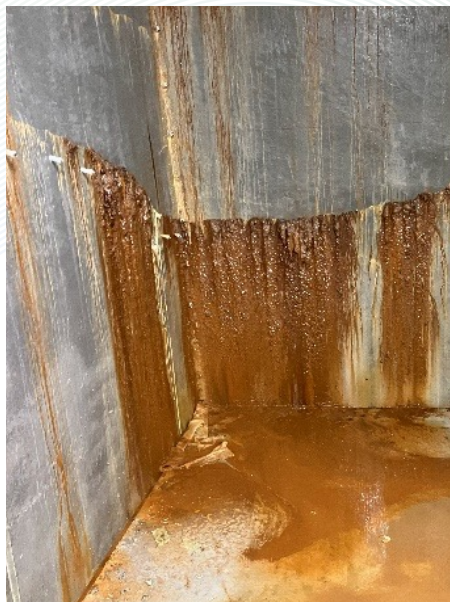
**FIGURE 6.** Water infiltration through foundation wall cracks at corner.

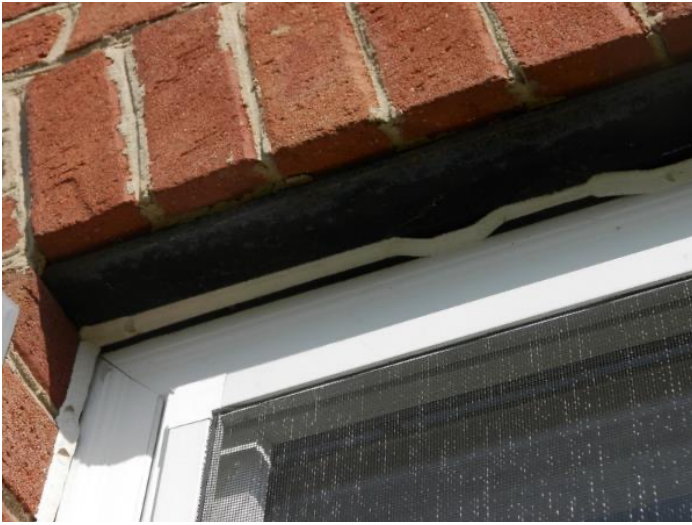
**PHOTOGRAPH 2.** Sealant separation at a window secured to wood framing due to shrinkage of the wood framing and expansion of the brick veneer. *Photo from Rimkus Archives.*

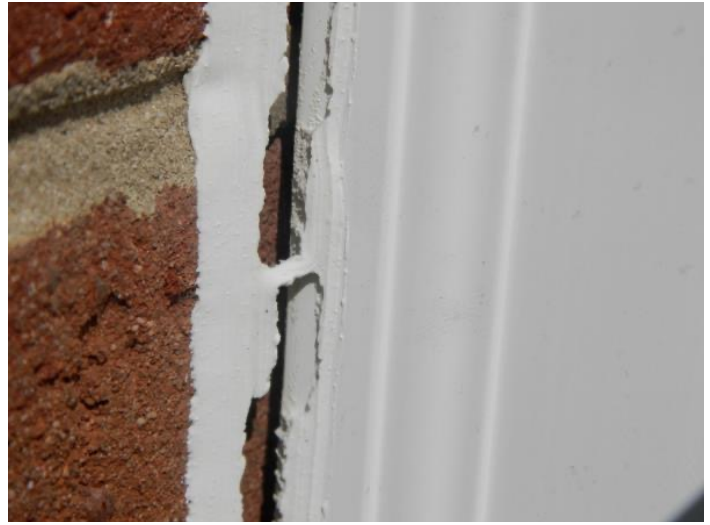
**PHOTOGRAPH 3.** Sealant separation at a window secured to wood framing due to shrinkage of the wood framing and expansion of the brick veneer. *Photo from Rimkus Archives.*

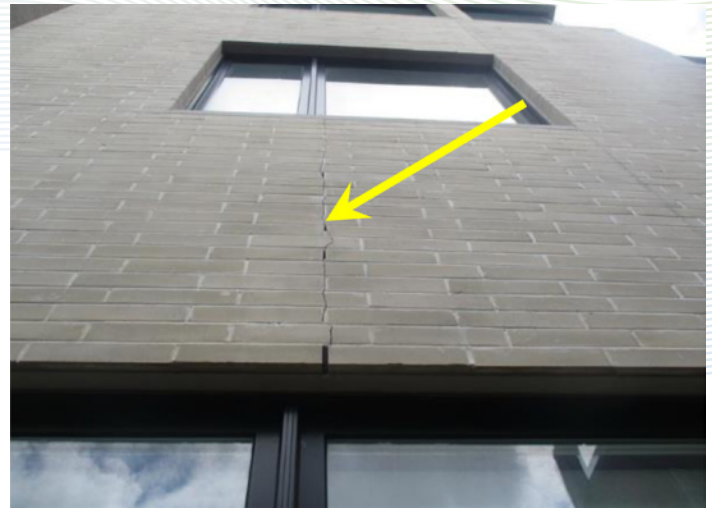
**PHOTOGRAPH 8.** A vertical crack. *Photo from Rimkus Archives.*

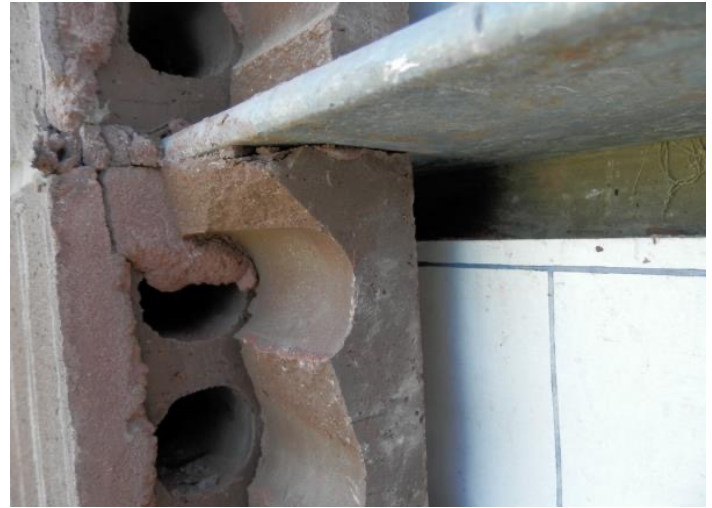
**PHOTOGRAPH 10.** A view of the steel shelf angle below a horizontal crack. *Photo from Rimkus Archives.*

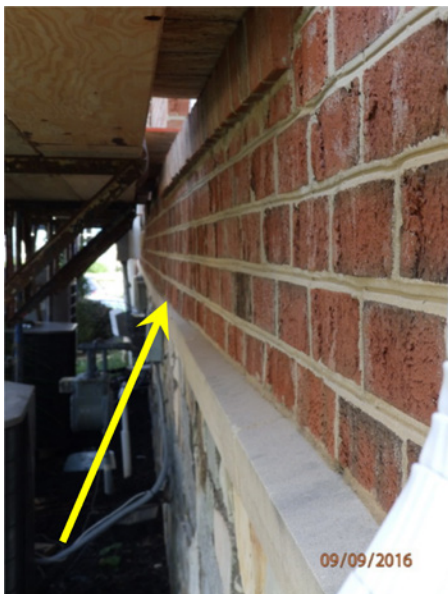
**PHOTOGRAPH 13.** Bowed brick veneer. *Photo from Rimkus Archives.*

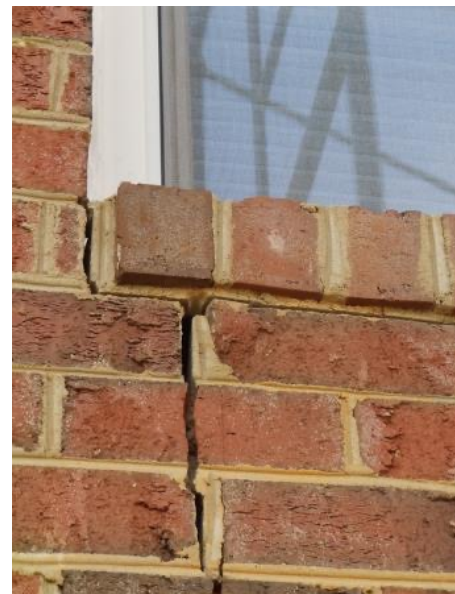
**PHOTOGRAPH 15.** A vertical crack in a bowed brick veneer wall. *Photo from Rimkus Archives.*

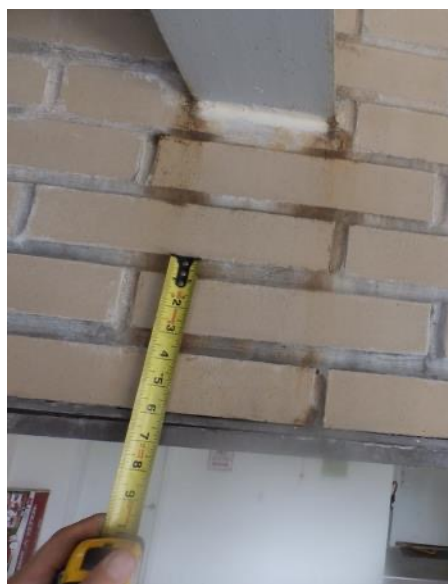
**PHOTOGRAPH 16.** Efflorescence on the brick-and-mortar joint surfaces. *Photo from Rimkus Archives.*

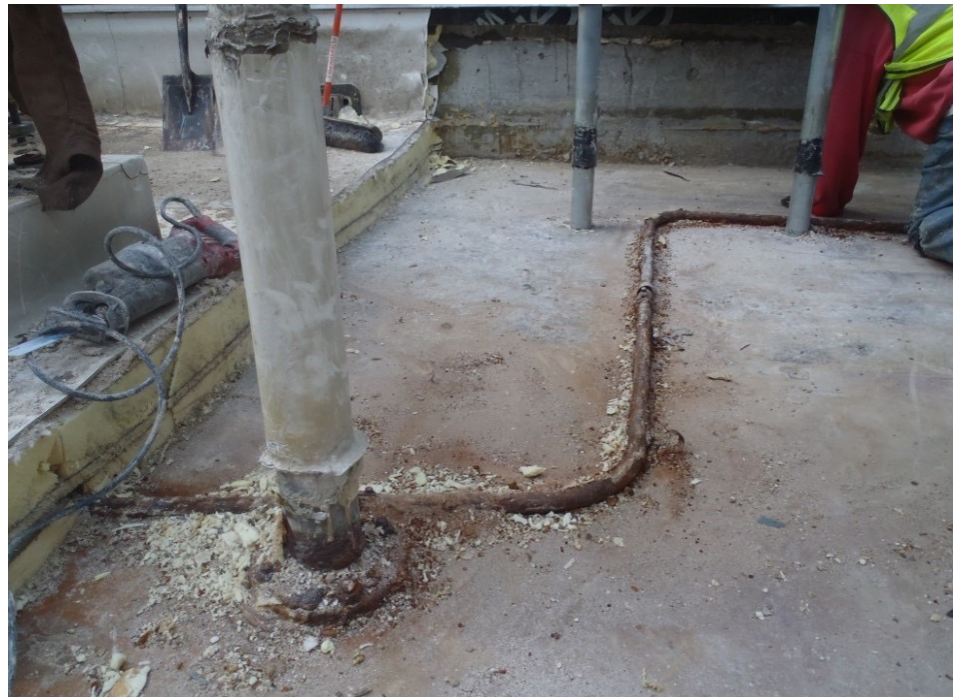
**FIGURE 8.** Electrical conduit on roof deck within roofing assembly.

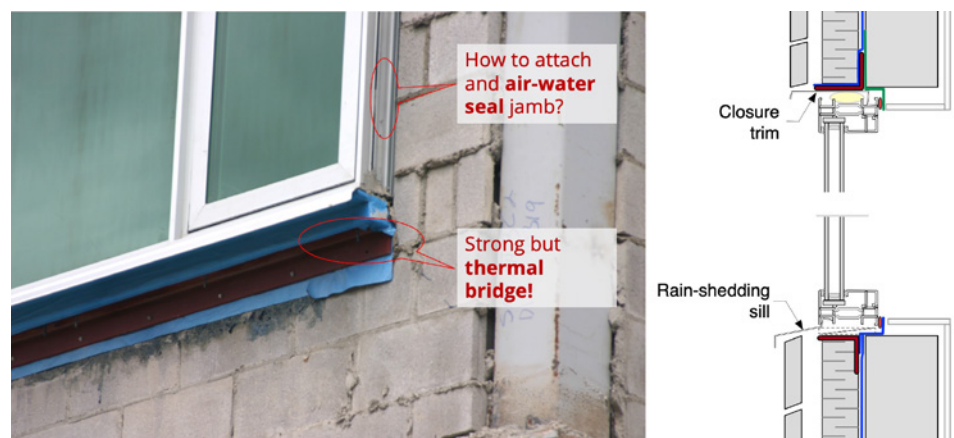
**FIGURE 5.** Steel angles provide structural support that allow windows to project outward, but impose significant thermal bridging.

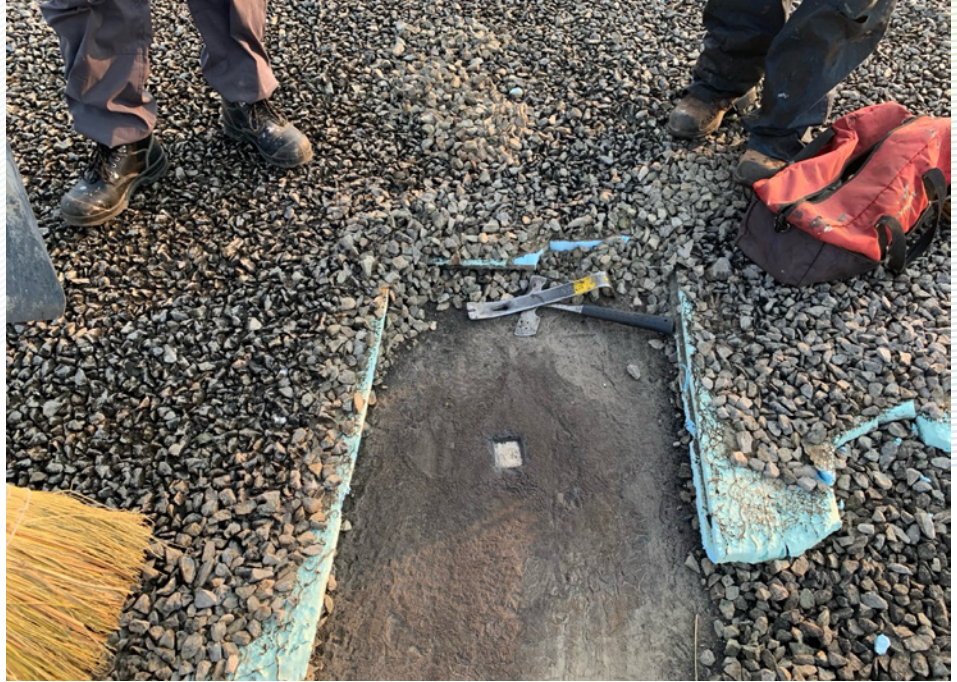
**FIGURE 4.** Test cut within existing roofing system.

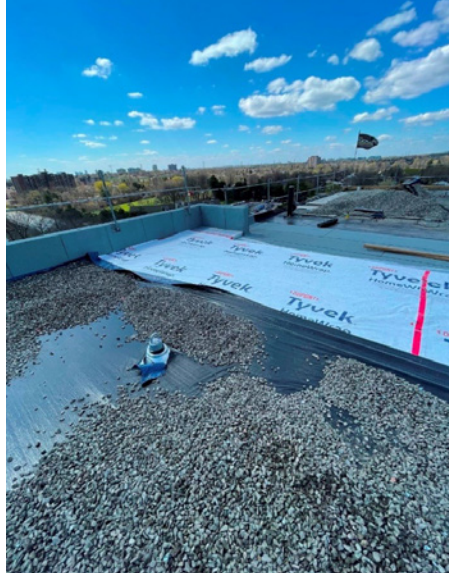
**FIGURE 7.** New protected membrane roof system under construction.
